Appendix 11

Analysis of Performance of the Inner Harbor Navigation Canal

Executive Summary

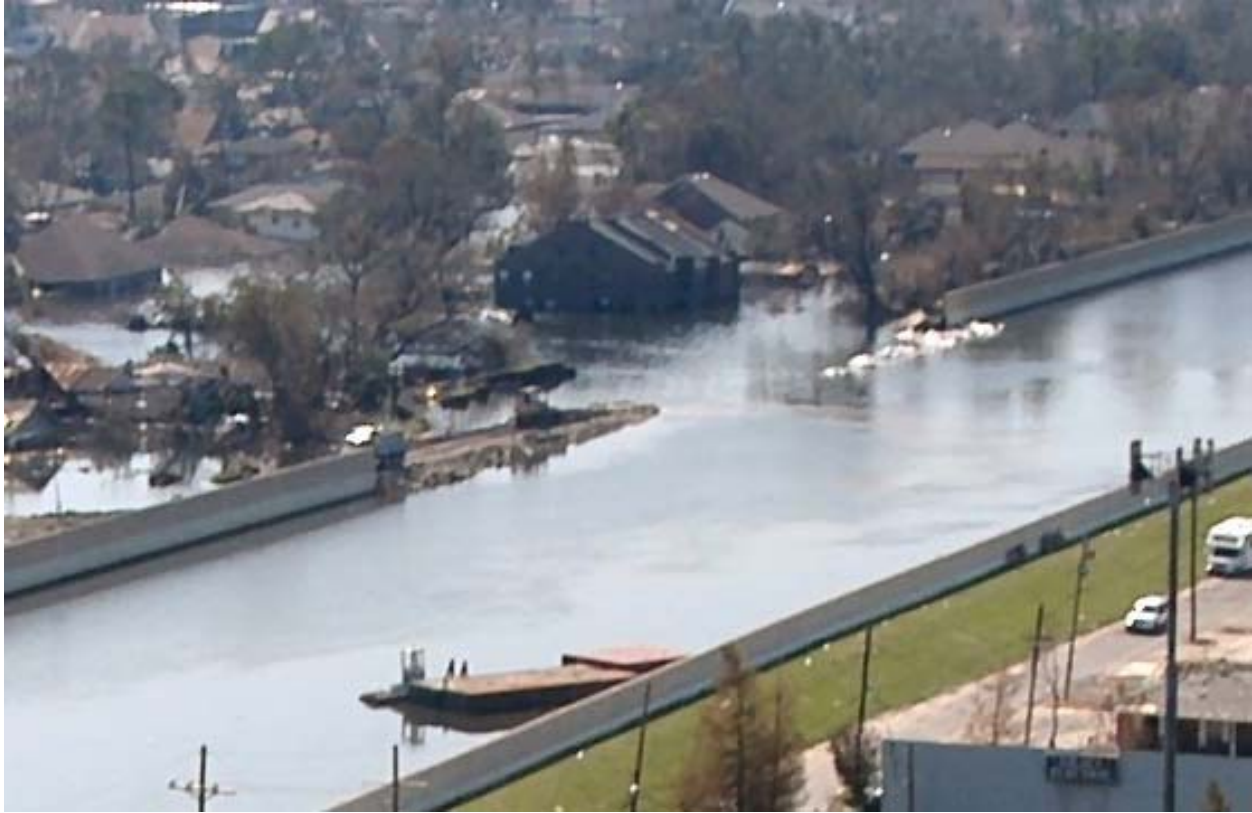
The 17th Street Canal breach is located on the east side of the canal just south of Hammond Highway. Figure 15-1 shows the breach shortly after Hurricane Katrina. The material samples were obtained from the (relatively) undisturbed I-wall sections at the north and south end of the breach. Concrete and rebar samples were obtained on Monday, 12 December and sheet piling were extracted on Tuesday, 13 December 2005.

Figure 15-1. 17th Street Canal Breach

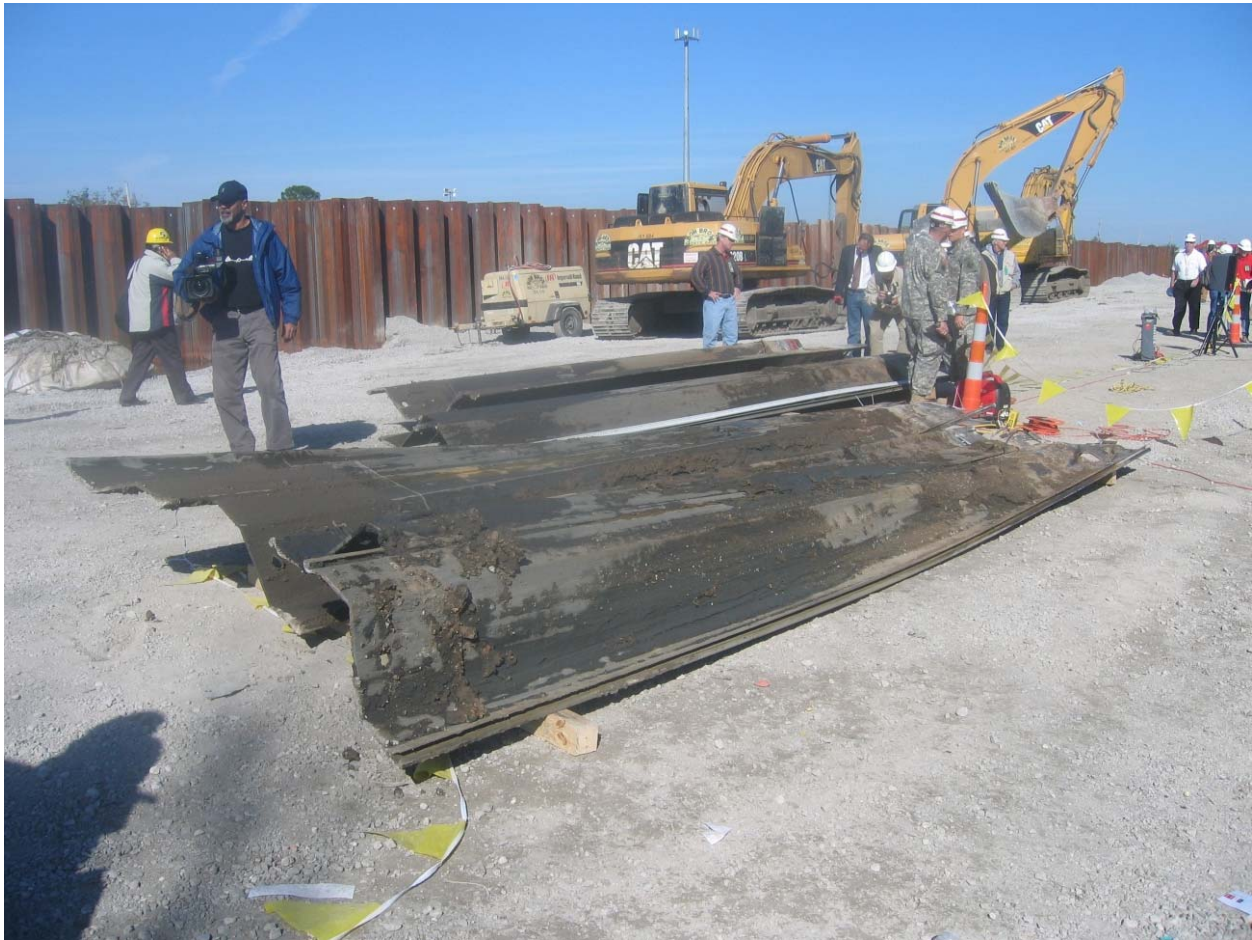
Figure 15-24. Sheet Piling Extracted from South End of Breach

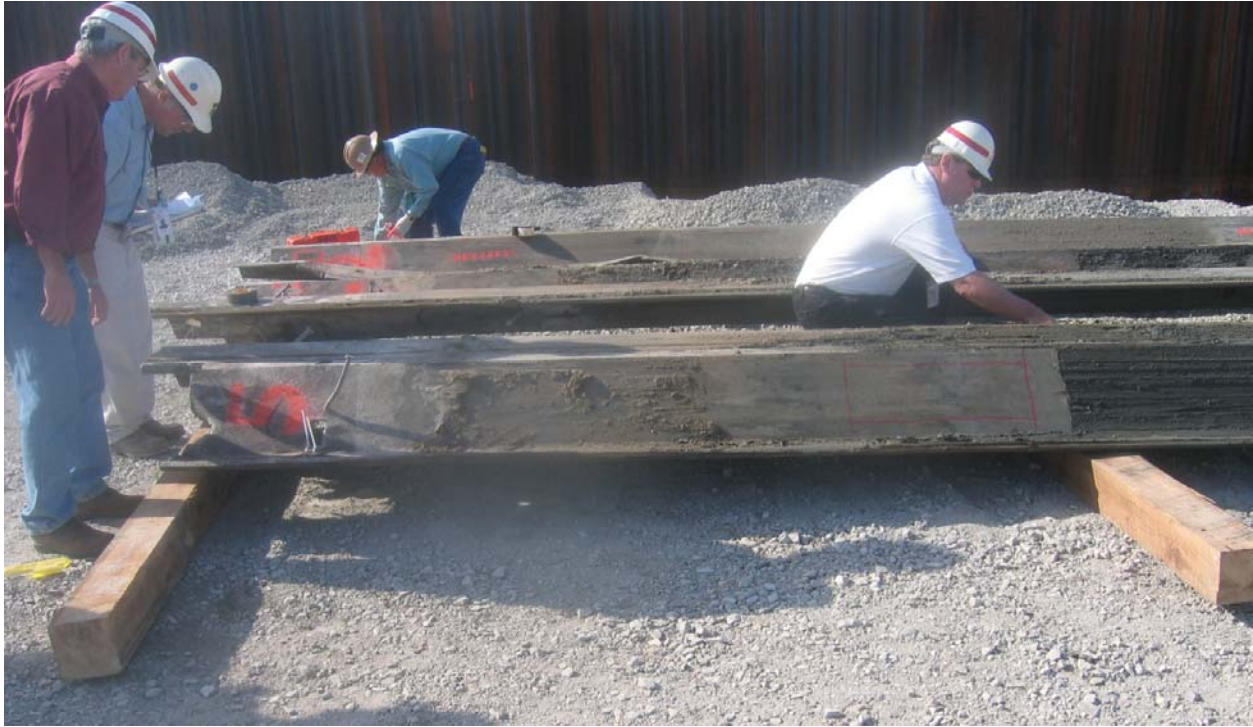
Figure 15-25. Sheet Piling Extracted from North End of Breach

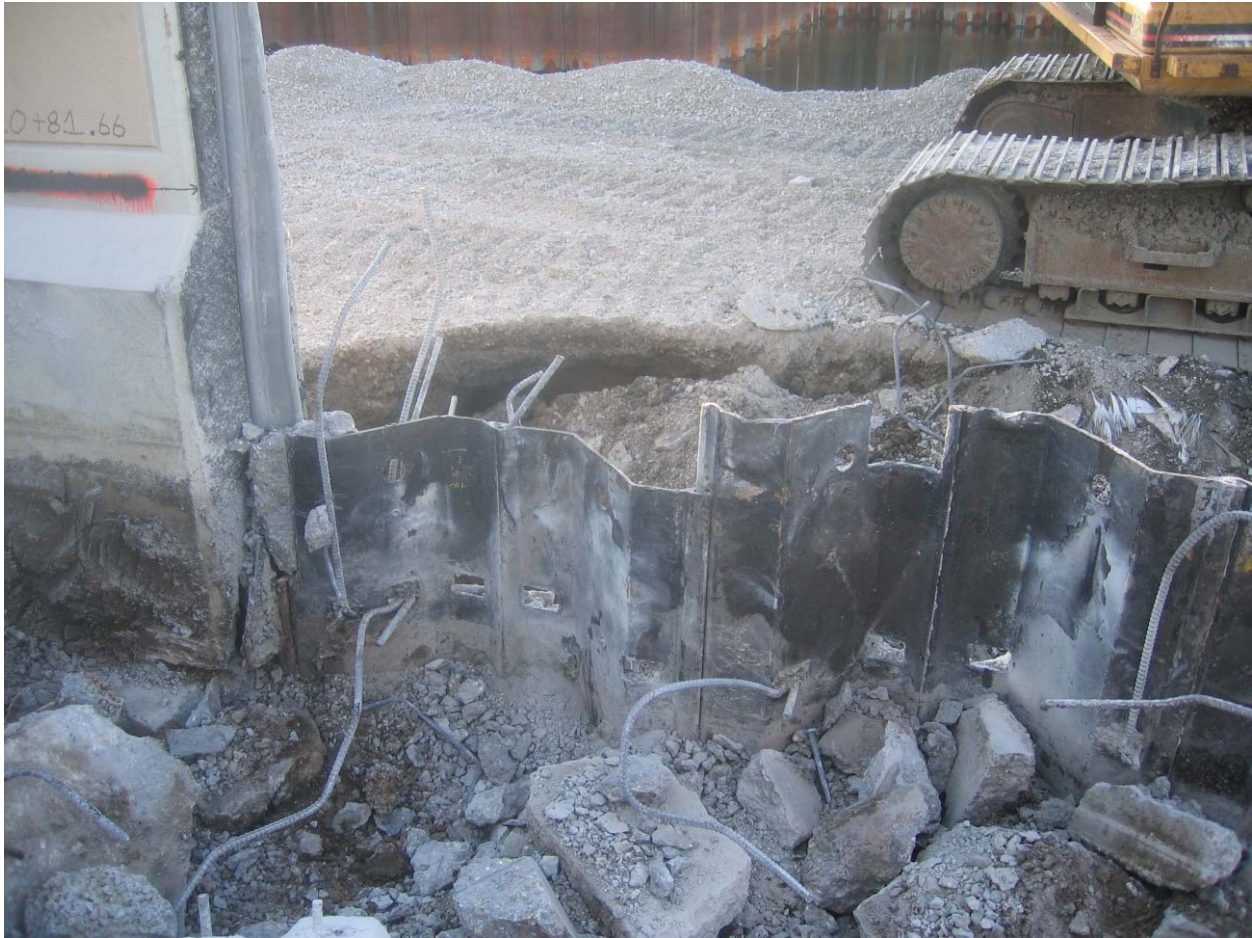
The sheet piling extracted from the 17th Street Canal breach site ranged in length from 23'-3" to 23'-8". The top of the pilings were at approximately elevation 6.25 ft. (The pilings adjacent to the expansion joints between wall panels were driven slightly lower as can be seen in Fig. 15-26. This was done to improve the performance and effectiveness of the expansion joint.) A 23'-3" piling length provides for a tip elevation of -17.0 ft. Obviously, piling driven with a lower top elevation have a correspondingly lower tip elevation.

Figure 15-26. Lower Top Elevation of Sheet Piling at Expansion Joint

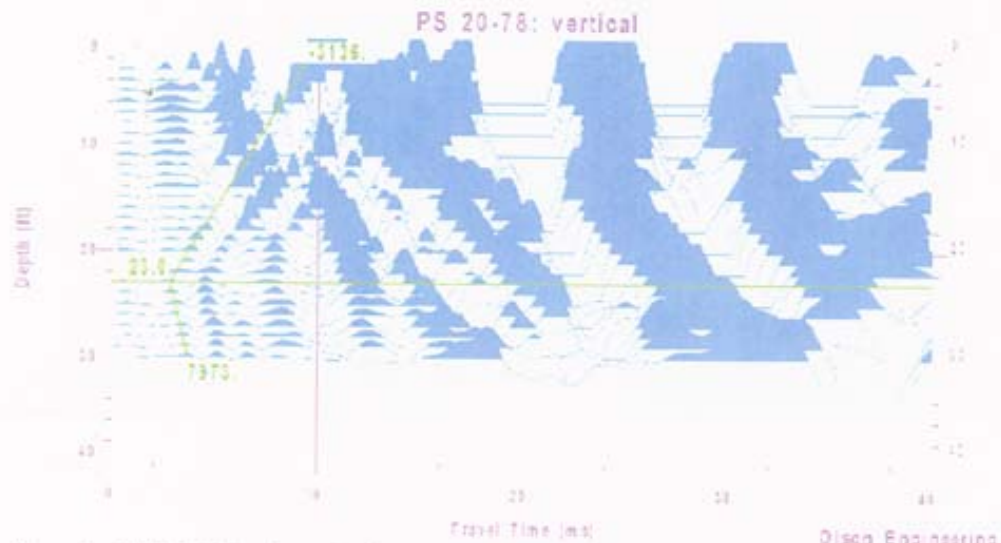
The PS data presented in Figures 1-5 were produced by 5 impacts which were averaged at each 1 ft test depth interval, filtered and normalized to the largest signal strength (global maximum display) to optimize the display of the diffraction events. Review of Figure 1 shows the diffraction event at 23.0 ft deep due to direct horizontal sheet pile impacts. There is also some energy occurring in advance of the diffraction event at shallower depths. In Figure 2 the horizontal impacts to the concrete wall also show a diffraction event at 22.7 ft deep, but a little less clear with more energy emitting from the concrete wall. By comparison, the diffraction event is clear at 21.8 ft deep for the angled downward impact to the chamfer in Figure 3. Apparently the more vertical impact to the chamfer put more energy down the sheet pile with less energy emitting from the wall. In Figure 4, the impacts to the top of the wall were further away from the ground and the sheet pile, so the diffraction event is quite clear at 21.5 ft. The impacts to the angled steel rod also produced a diffraction event at 22.6 ft as shown in Figure 5, but it was comparatively weaker, likelier due to less energy being imparted by the rod impacts.

Figure 1 - 17th St. PS Results at Station 20+78 - Sheet Pile impacted at ~ el. 1.5 (0.5 ft below bottom of levee concrete wall on protected side)

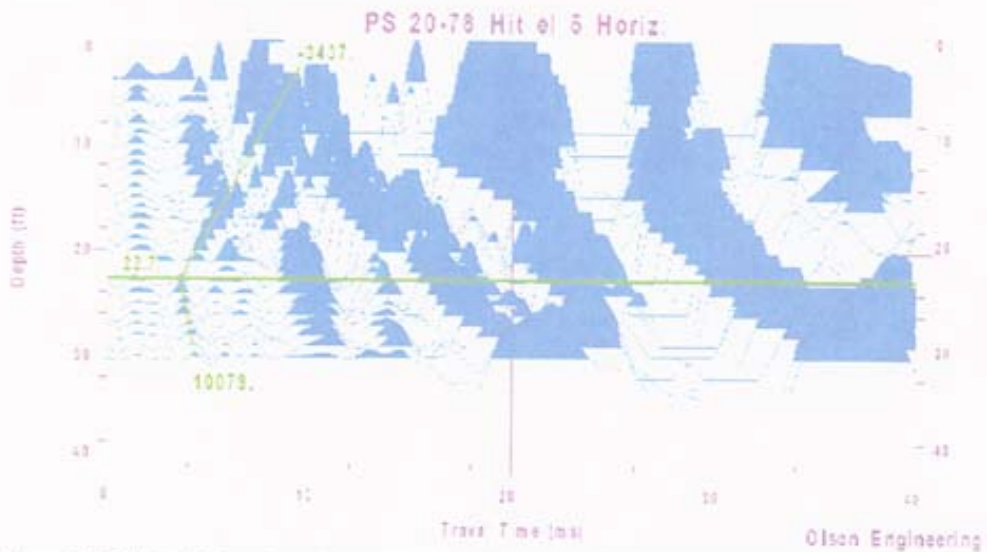
Figure 2 - 17th St. PS Results at Station 20+78 - Concrete Wall impacted horizontally at ~ el. 5 (~0.5 ft below chamfer edge on protected side)

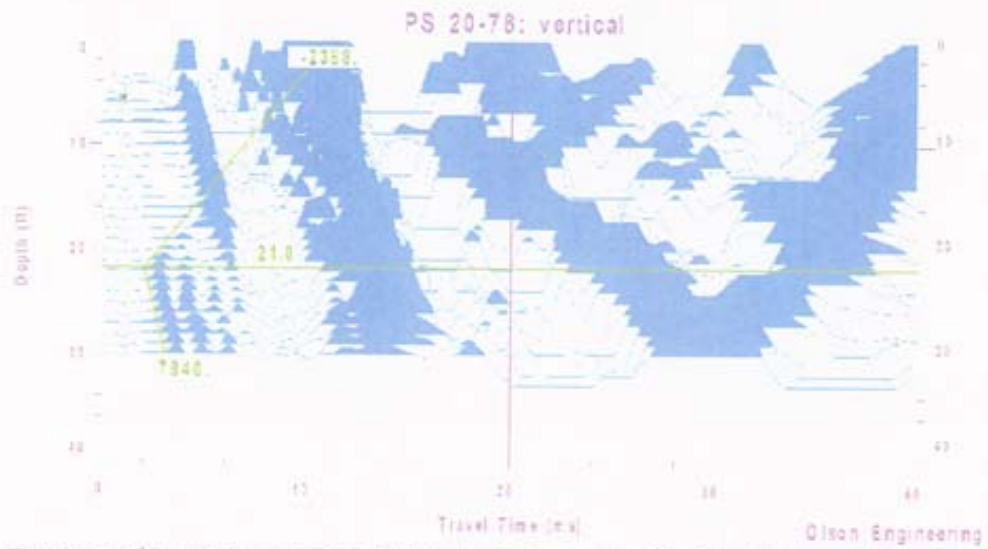
Figure 3 - 17th St. PS Results at Sta. 20+78 - Angled Impacts to Chamfer of Concrete Wall at Sta. 20+78 (~el. 5.75 on protected side)

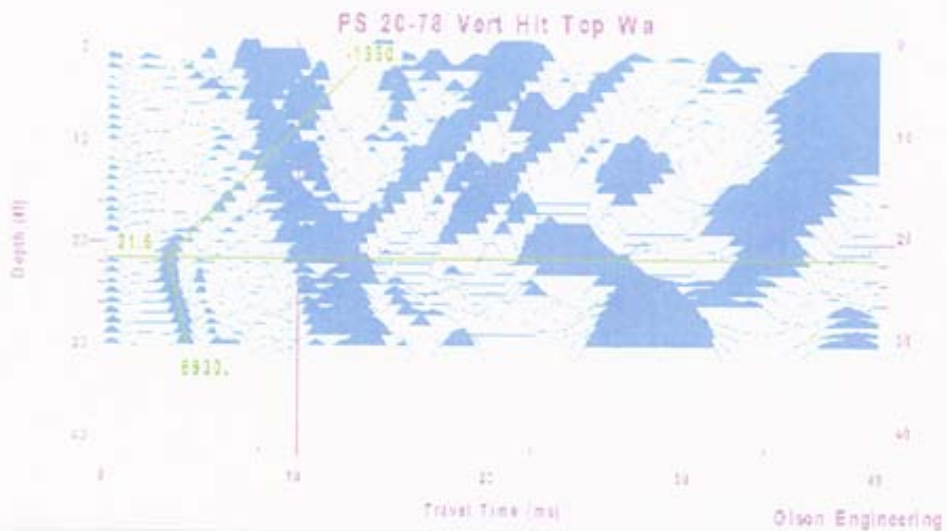
Figure 4 - 17th St. PS Results at Sta. 20+78 - Vertical Impacts to Top of Concrete Wall at Sta. 20+78

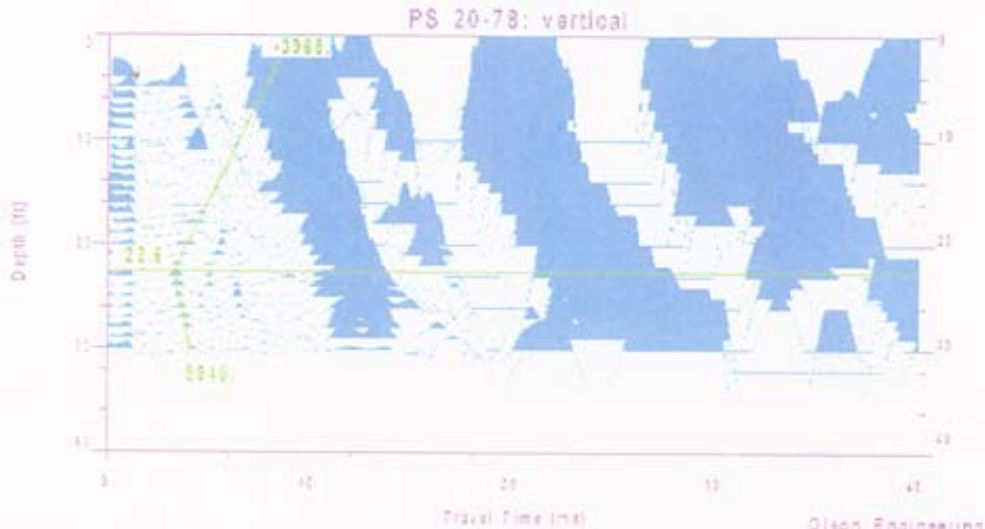
Figure 5 - 17th St. PS Results at Sta. 20+78 - Angled Impacts to 1 inch diameter, 6 ft long rod held against steel sheet pile at ~ el. 1.5 at 0.5 ft below concrete wall

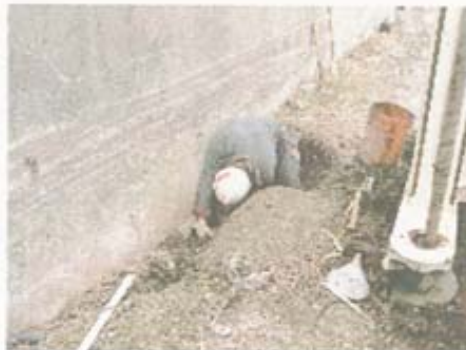
The IHNC re-tests were performed in an area of the wall that had been pushed back and the levee soils dropped down to expose a sheet pile on the canal side at Station 17+11 which was about 10 ft north of the USACE cased boring in this area. Shovels were used to expose enough of the sheet pile to impact it with the 3 lb impulse hammer as shown in Photo 9. The PS tests were done using a hydrophone in the 1 inch PVC casing installed by SESI with the Geoprobe rig as shown in Photo 10.

Photo 9 - IHNC 3-lb Impulse hammer impacts to sheet pile on canal side at Station 17+11

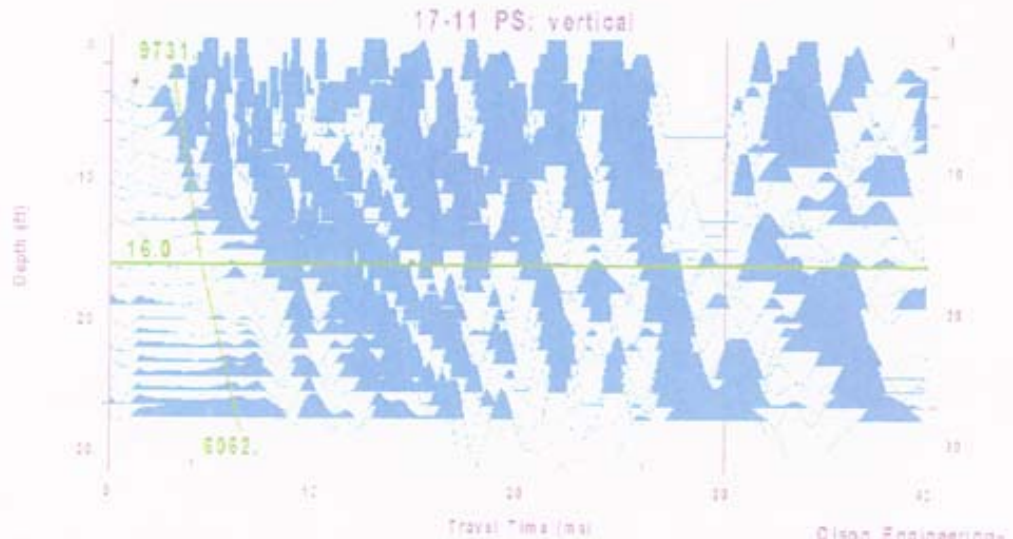
Review of Figure 6 for the case of direct horizontal impacts to the sheet pile shows a weak direct arrival wave front that is slower below the 16 ft depth of the sheet pile. However, no diffraction events are evident in this PS-based hydrophone test data. This may be due to the evident separation of the levee soil from the canal side of the wall due to the wall being pushed back by the breach forces. This apparent lack of tight contact between the sheet pile and the levee soils may have resulted in the diffraction event energy not being well coupled into the surrounding saturated soils.

Figure 6 - PS Results at IHNC Sta. 17+11 - Impact to Sheet Pile at ~ 0.5 ft below bottom of Concrete Wall on Canal Side

IHNC PS Re-Test Results at Station 17+11. The hydrophone-based PS re-test results at the North End of the south IHNC breach showed a weak direct arrival for impacts directly to the sheet pile that predicted the actual depth of 16 ft. However, only very tentative identifications of such direct arrivals were evident in PS results for either horizontal or vertical impacts to the levee concrete wall. None of the PS results at IHNC showed the clear diffraction arrival events at the pile tip depth found in all of the 17th Street PS re-test results. The lack of the diffraction arrival events may be due to the apparent lack of tight soil contact between the IHNC wall on the canal side as a result of the breach force pushing the wall back. Clear separation of the soil and wall was still evident at the surface in this area. Such lack of contact may have diminished the coupling of energy in to the soils from the diffraction event at the pile tip.

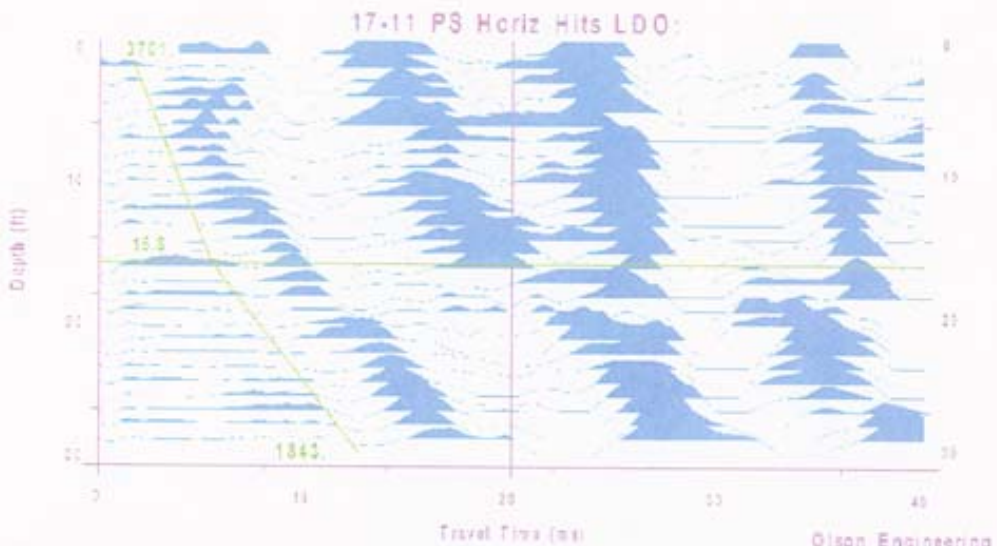
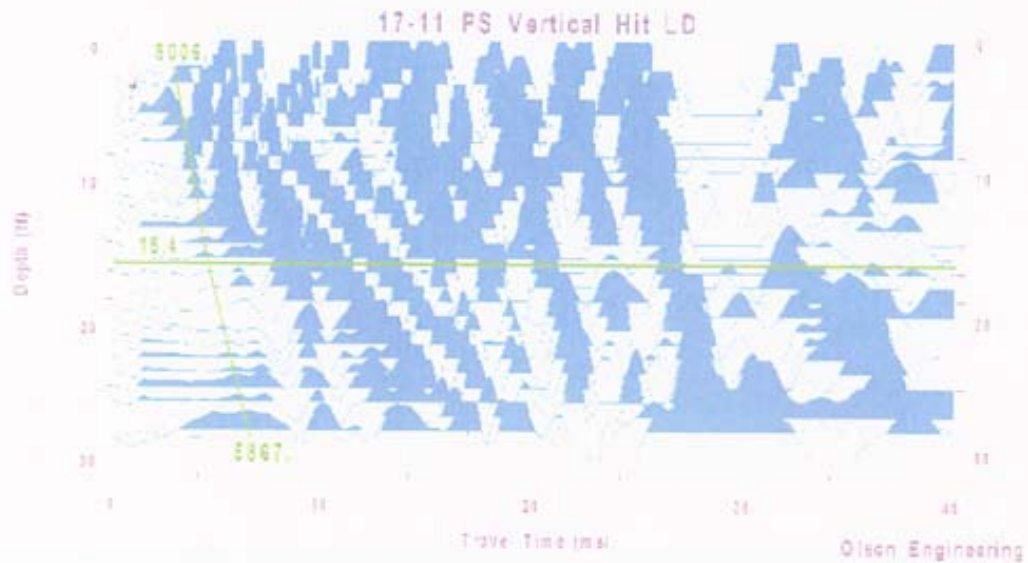
Review of Figures 7 and 8 for horizontal and vertical impacts to the concrete wall does not show clear direct arrivals when the apparent weak energy was picked as shown in the figures. No diffraction events are clearly evident in the figures either. These results further support the possibility that there is poor soil contact to the sheet pile on the canal side that diminished the diffraction effect in the IHNC re-tests.

Figure 7 - PS Results at IHNC Sta. 17+11 - Horizontal Impact to Concrete Wall at ~ 6.5 ft below top of Wall on Canal Side

Figure 8 - PS Results for IHNC at Sta. 17+11 for Vertical Impacts to top of 8 ft tall Concrete Wall

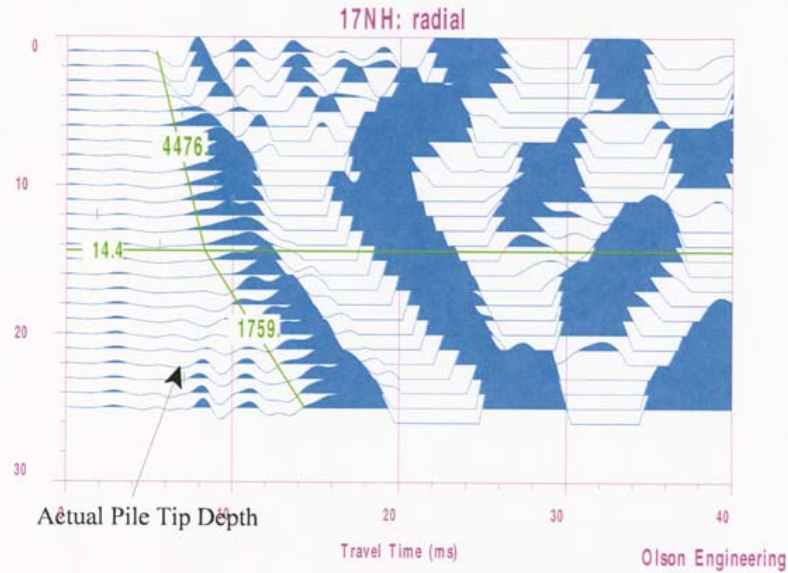
It is our understanding that four sheet piles at the north end and 4 sheet piles at the south end of the 17th Street levee breach area have been pulled, and that the our data interpretation of nearby PS results in north and south cased borings was shown to be incorrect. The actual embedded lengths were found to be approximately 17 feet below mean sea level (20-22 feet below the casing top elevation used in our investigation) with total sheet pile lengths of 23.5 ft.

Figure 1 17th Street Levee North Site, Initial PS Data Interpretation

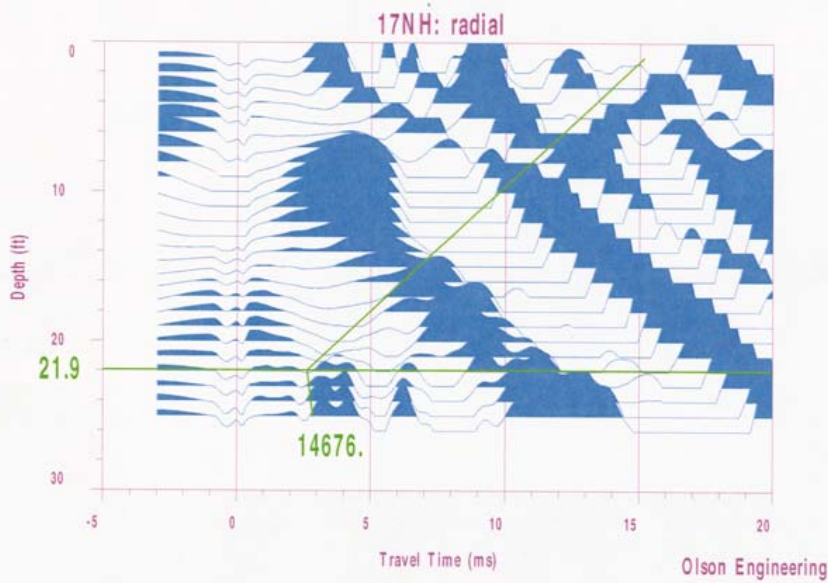
Figure 2 17th Street Levee North Site, Re-interpretation of PS Results

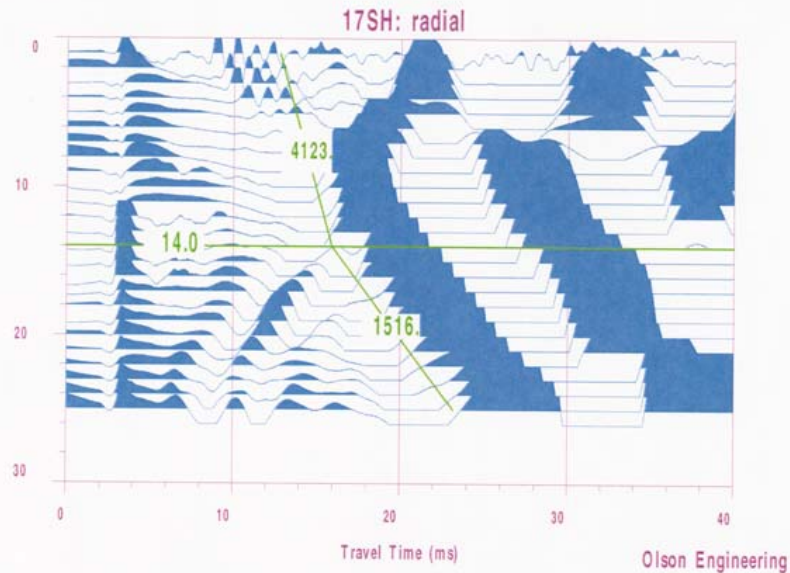
Figure 3 17th Street Levee South Site, Initial PS Data Interpretation

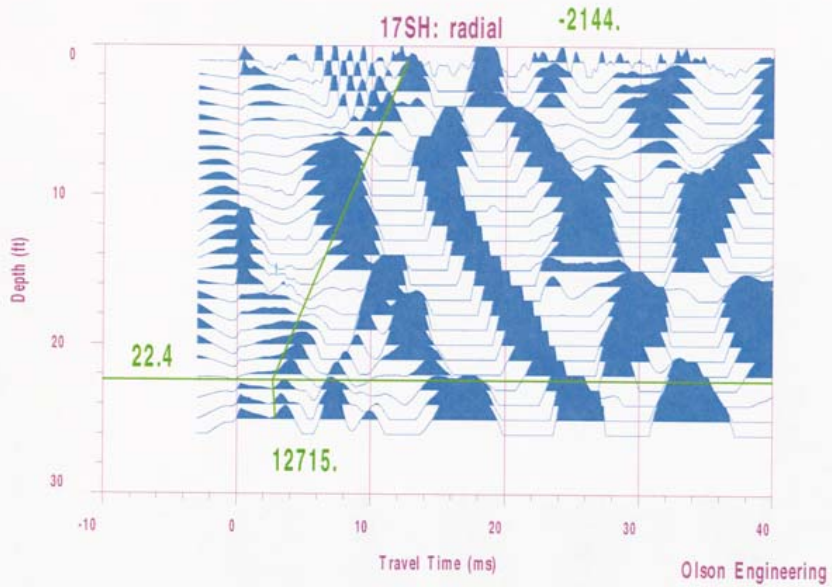
Figure 4 17th Street Levee South Site, Re-interpretation of PS Results
