HURRICANE PROTECTION

EMPIRE FLOODGATE

PERIODIC INSPECTION REPORT NO. 2

4 OCTOBER 1978

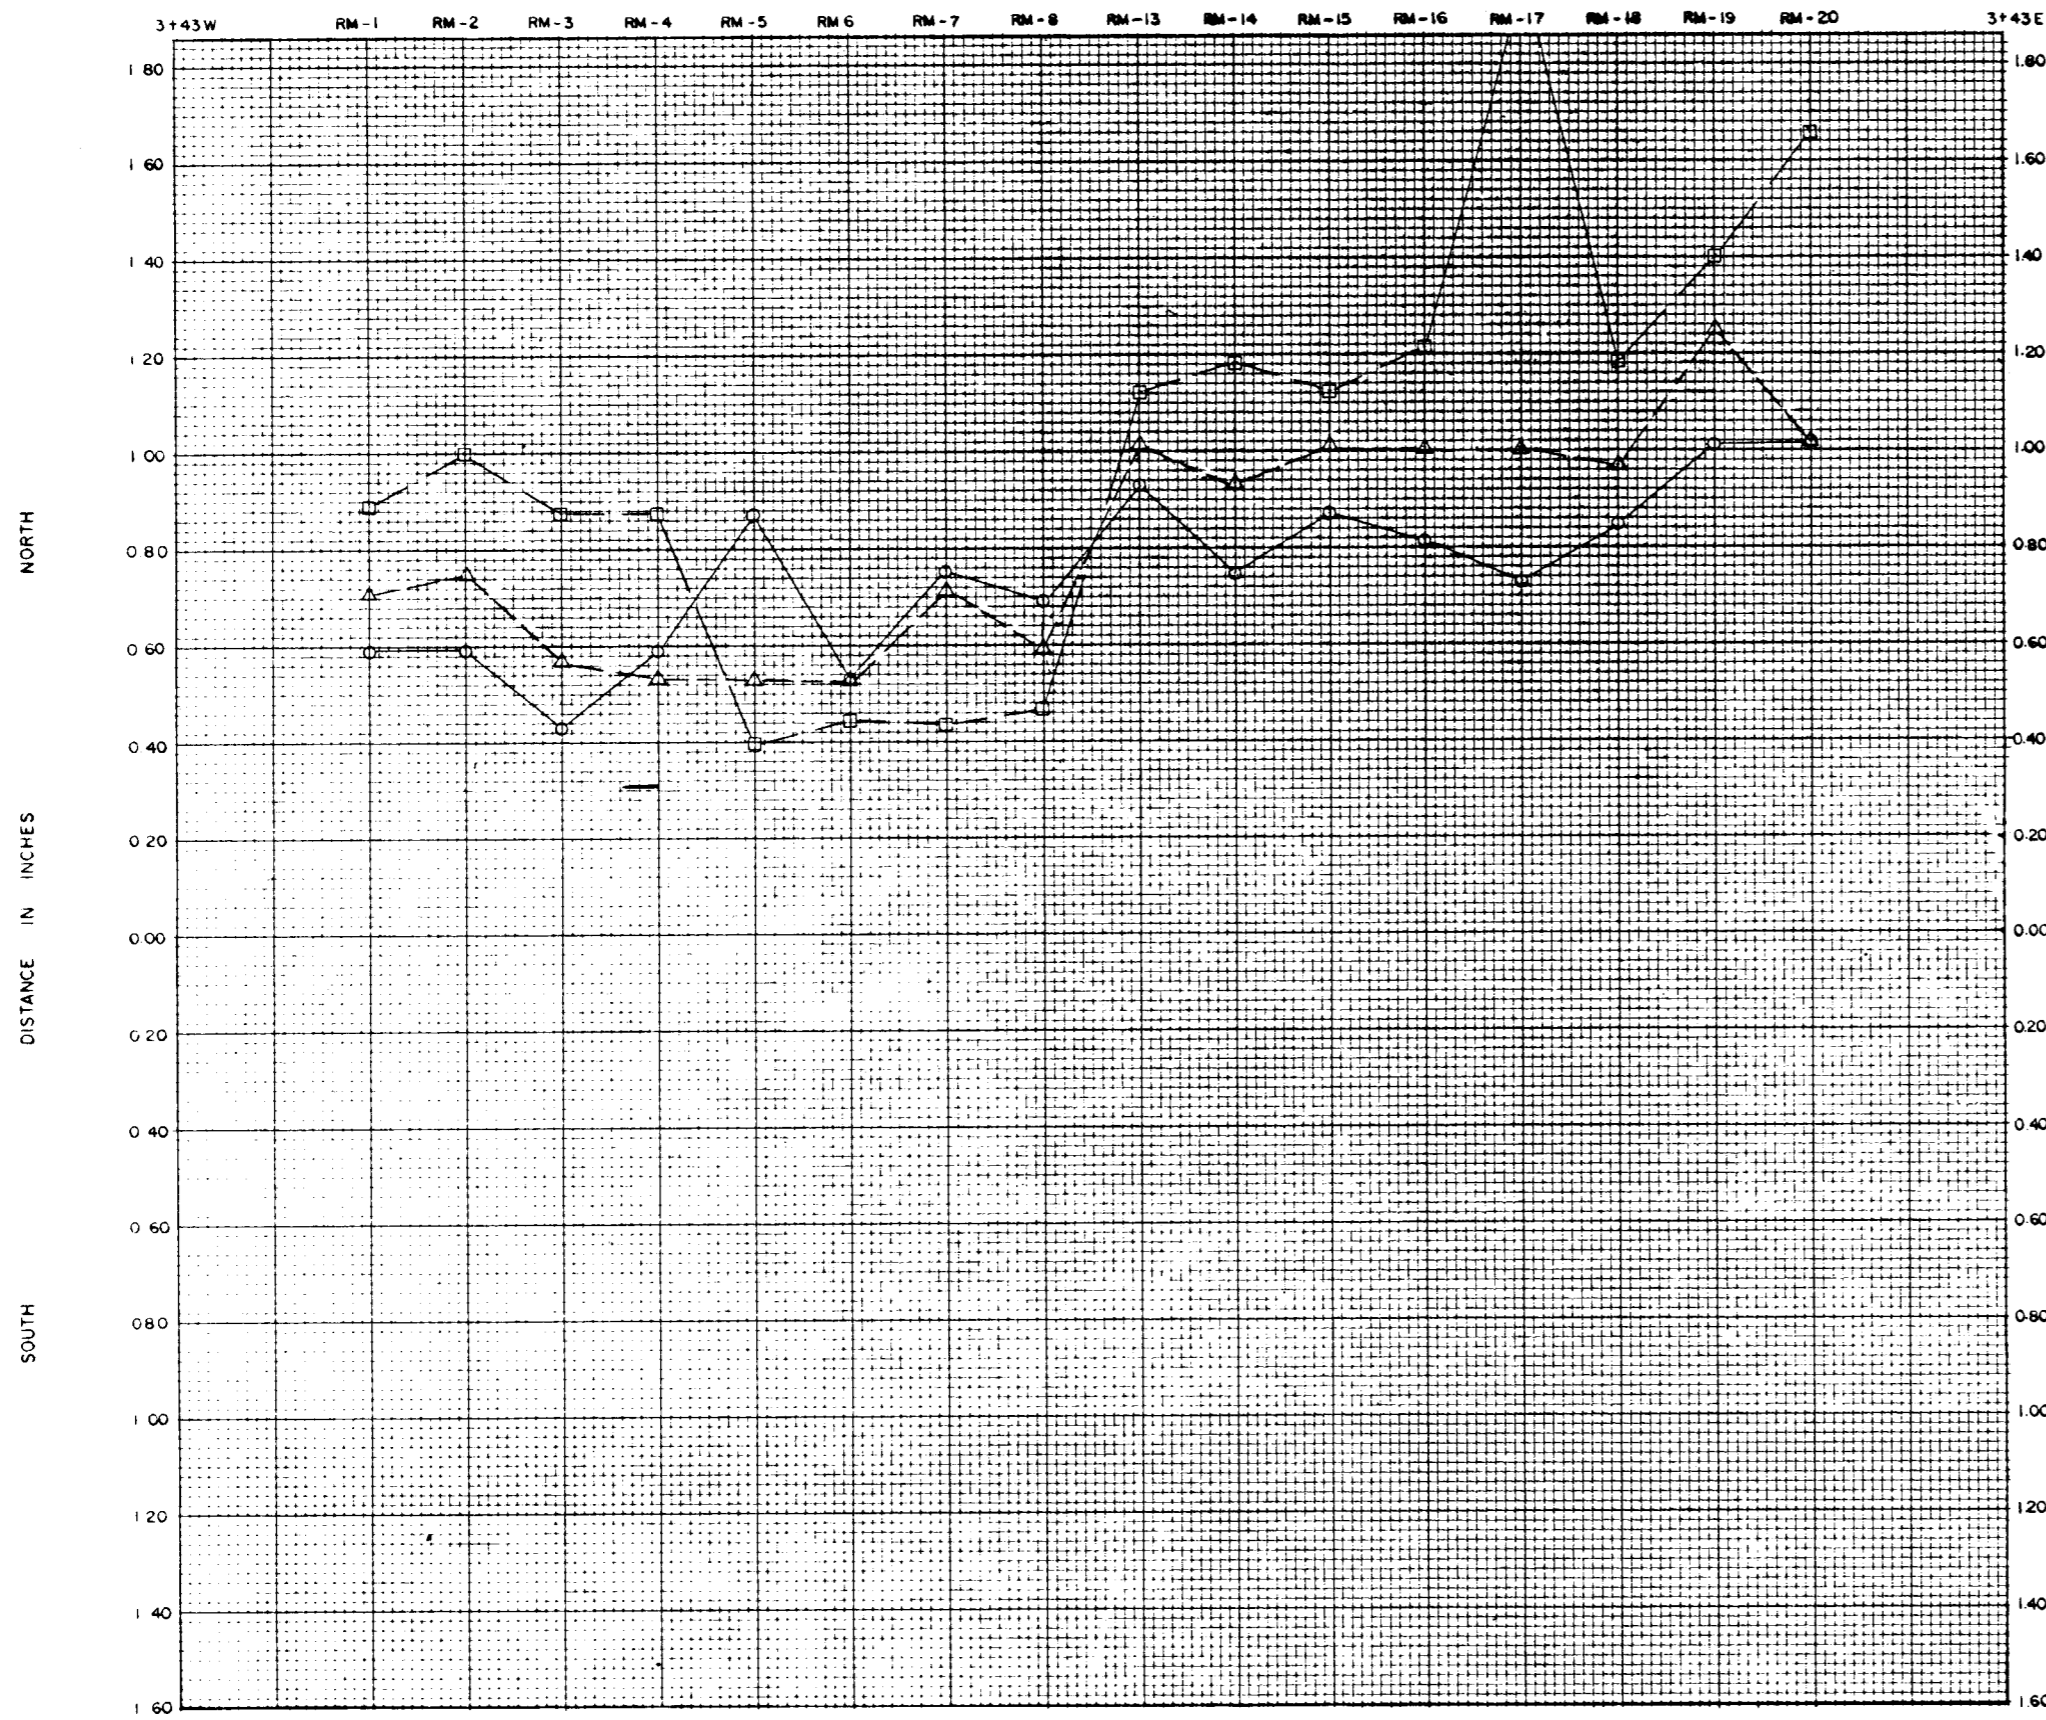
NEW ORLEANS TO VENICE, LA
 HURRICANE PROTECTION REACH B-1
 PERIODIC INSPECTION
 EMPIRE FLOODGATE
ALINEMENT
DIFFERENTIAL CHART
 U.S. ARMY ENGINEER DISTRICT, NEW ORLEANS
 CORPS OF ENGINEERS
 SHEET OF SHEET FILE NO M-4 27323/

a. Alinement. The alinement surveys indicate an apparent movement to the north. However, no indication of any horizontal movement of this magnitude was observed during the inspection. Moreover, the reference marks (3+43E & 3+43W) used as the basis for the measurement reflected vertical movement (settlement) of 1.08 feet and 0.8 foot, respectively. The magnitude of horizontal movement, if any, could not be determined, but the reliability of the reference marks for precise measurements is questionable. For future surveys, consideration will be given to establishing new reference marks beyond the zone of influence of the levees adjacent to the structure.

a. Alinement. Alinement survey is based on two reference marks 3+43E and 3+43W. Between Dec 75 and Sep 78, mark 3+43E settled 1.05 feet and mark 3+43W settled 0.80 feet. Therefore, the alinement survey indicating that the structure possibly moved to the north is erroneous. No indication of horizontal movement was observed in this inspection.

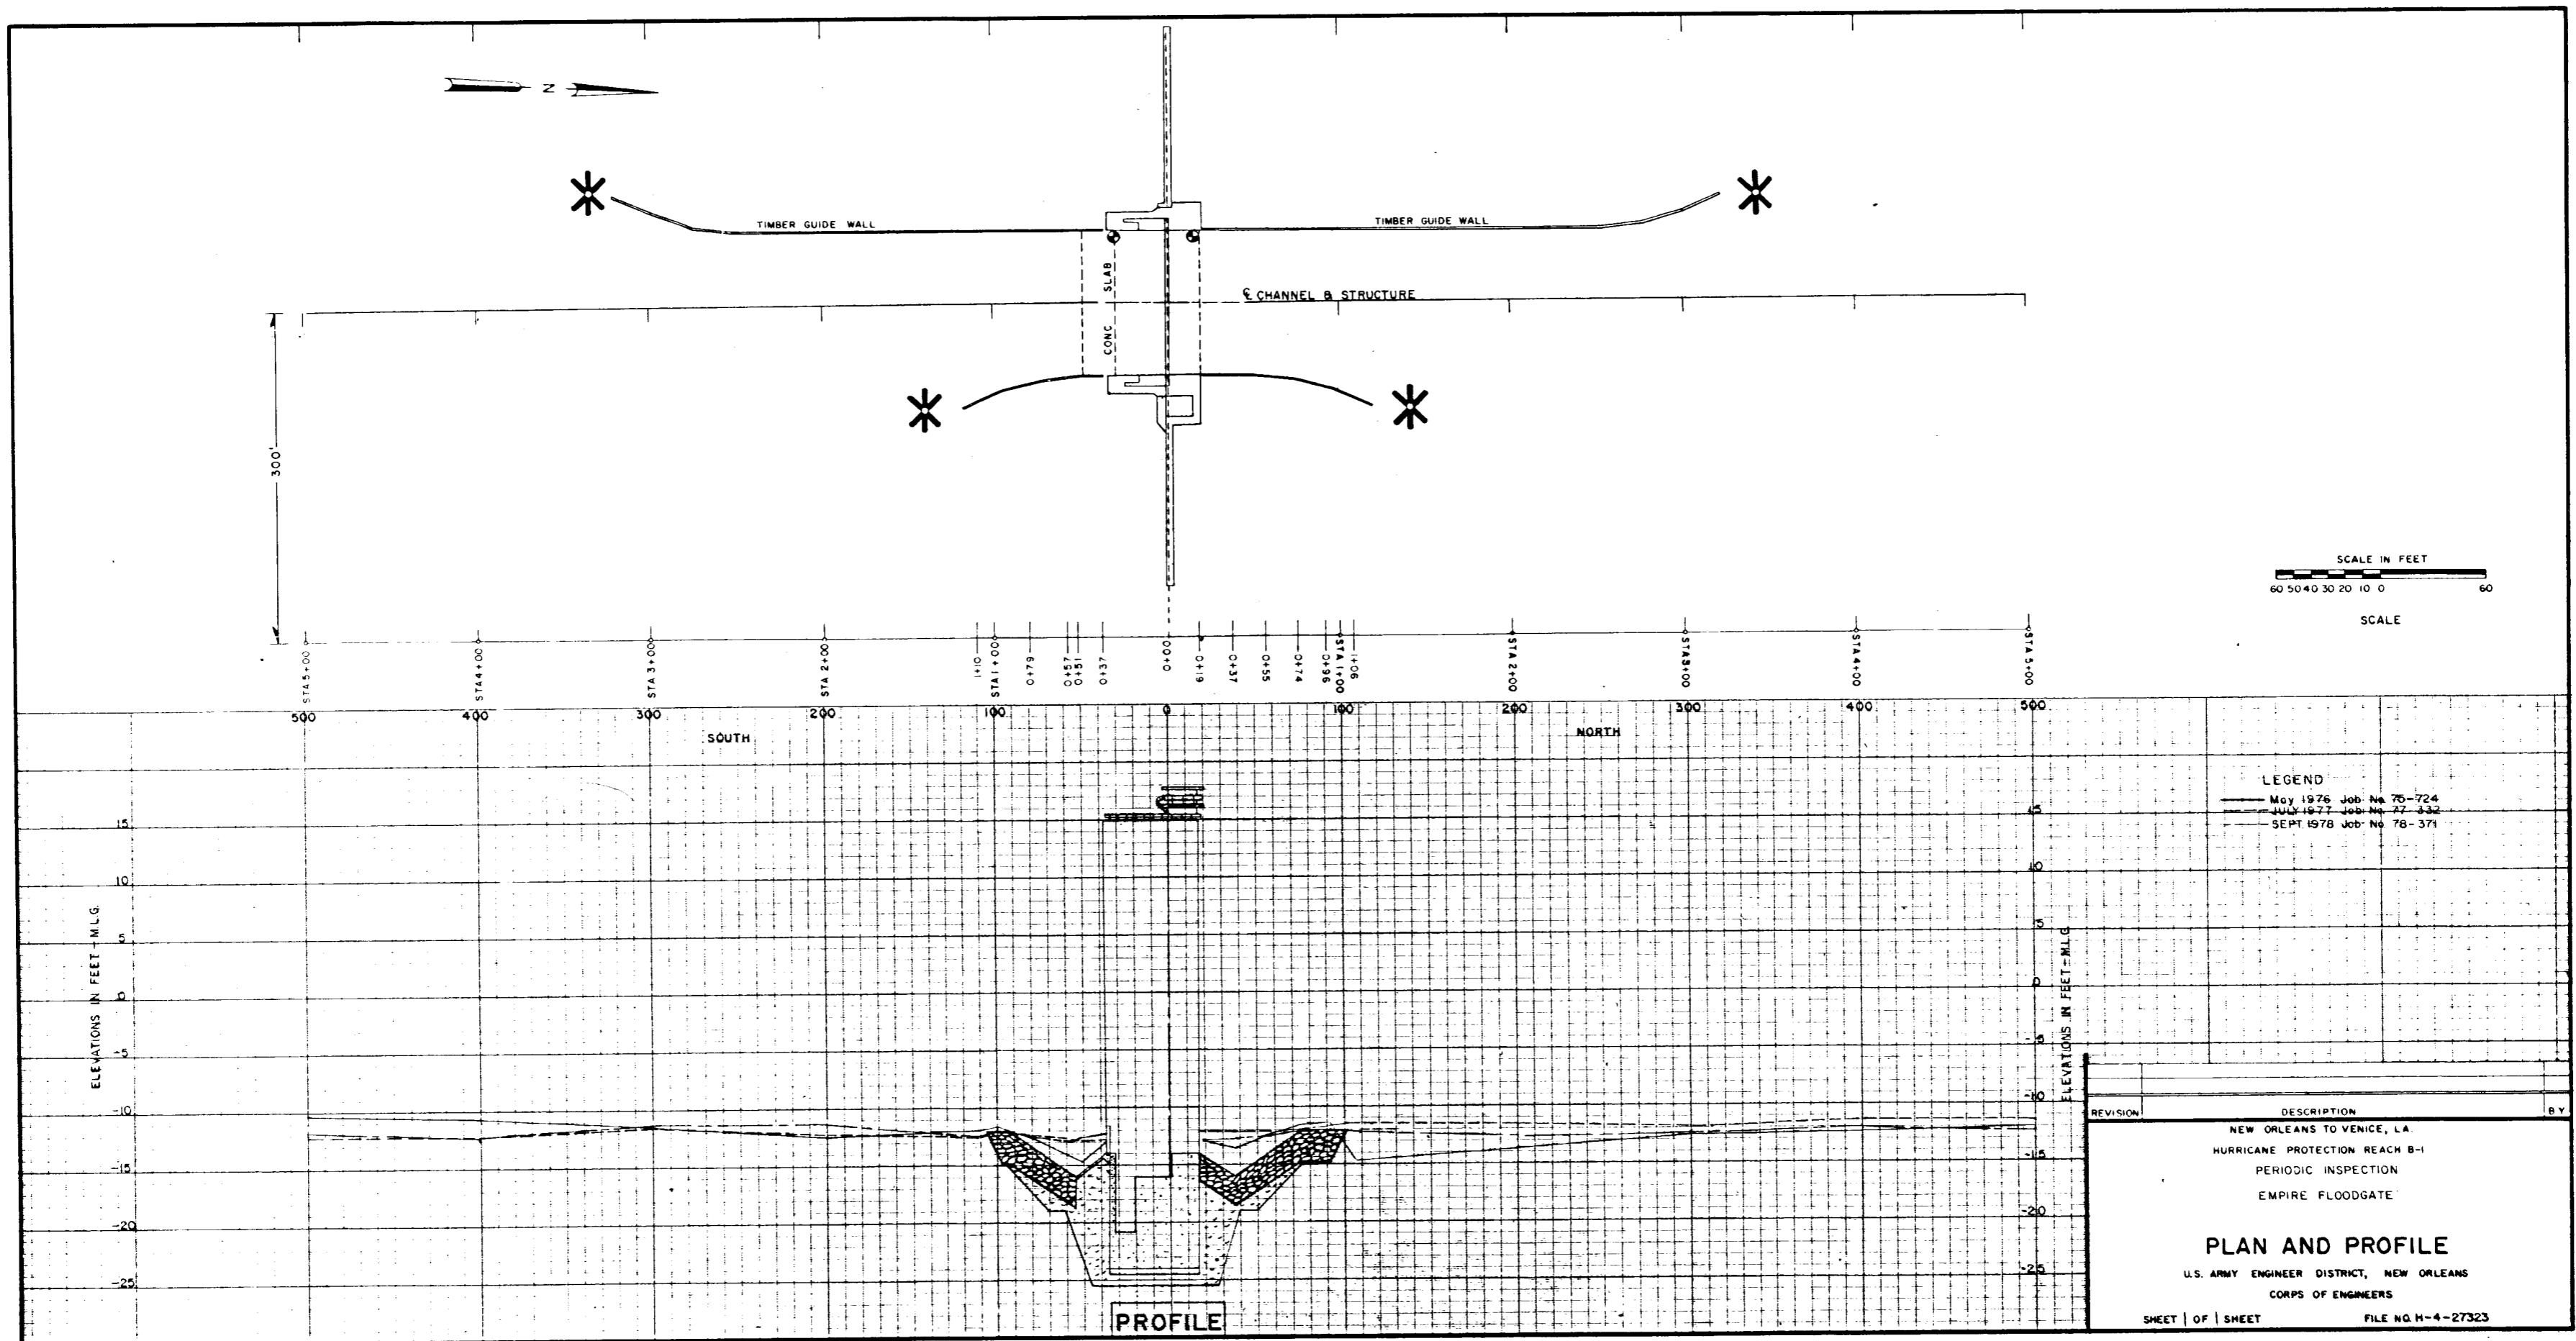
REVISION	DESCRIPTION	BY
	NEW ORLEANS TO VENICE, LA. HURRICANE PROTECTION REACH B-1 PERIODIC INSPECTION EMPIRE FLOODGATE	
PLAN AND PROFILE		
U.S. ARMY ENGINEER DISTRICT, NEW ORLEANS CORPS OF ENGINEERS		
SHEET 1 OF 1 SHEET		FILE NO. H-4-27323

b. Settlement. Between December 1975 and May 1976 very little settlement has occurred at the structure. Between May 1976 and July 1977, settlement survey shows greater settlement than previous survey. Present survey of September 1978 shows some points on sheet piling and levee apparently rebounding slightly. It also appears that elevation of PBM is questionable. Elevation of PBM will be reestablished in next survey. No distress cracks were observed at the structure in the inspection.

b. Settlement. Between December 1975 and May 1976 very little settlement has occurred at the structure. Between May 76 and July 77, settlement survey shows greater settlement than previous survey. Present survey of September 1978 shows some settlements and some rebounds. It also appears that elevation of PBM is not accurate as it should be. Elevation of PBM will be reestablished in next survey. The subsequent survey may show true picture of structure and reference marks. No distress cracks were observed at the structure in the inspection.

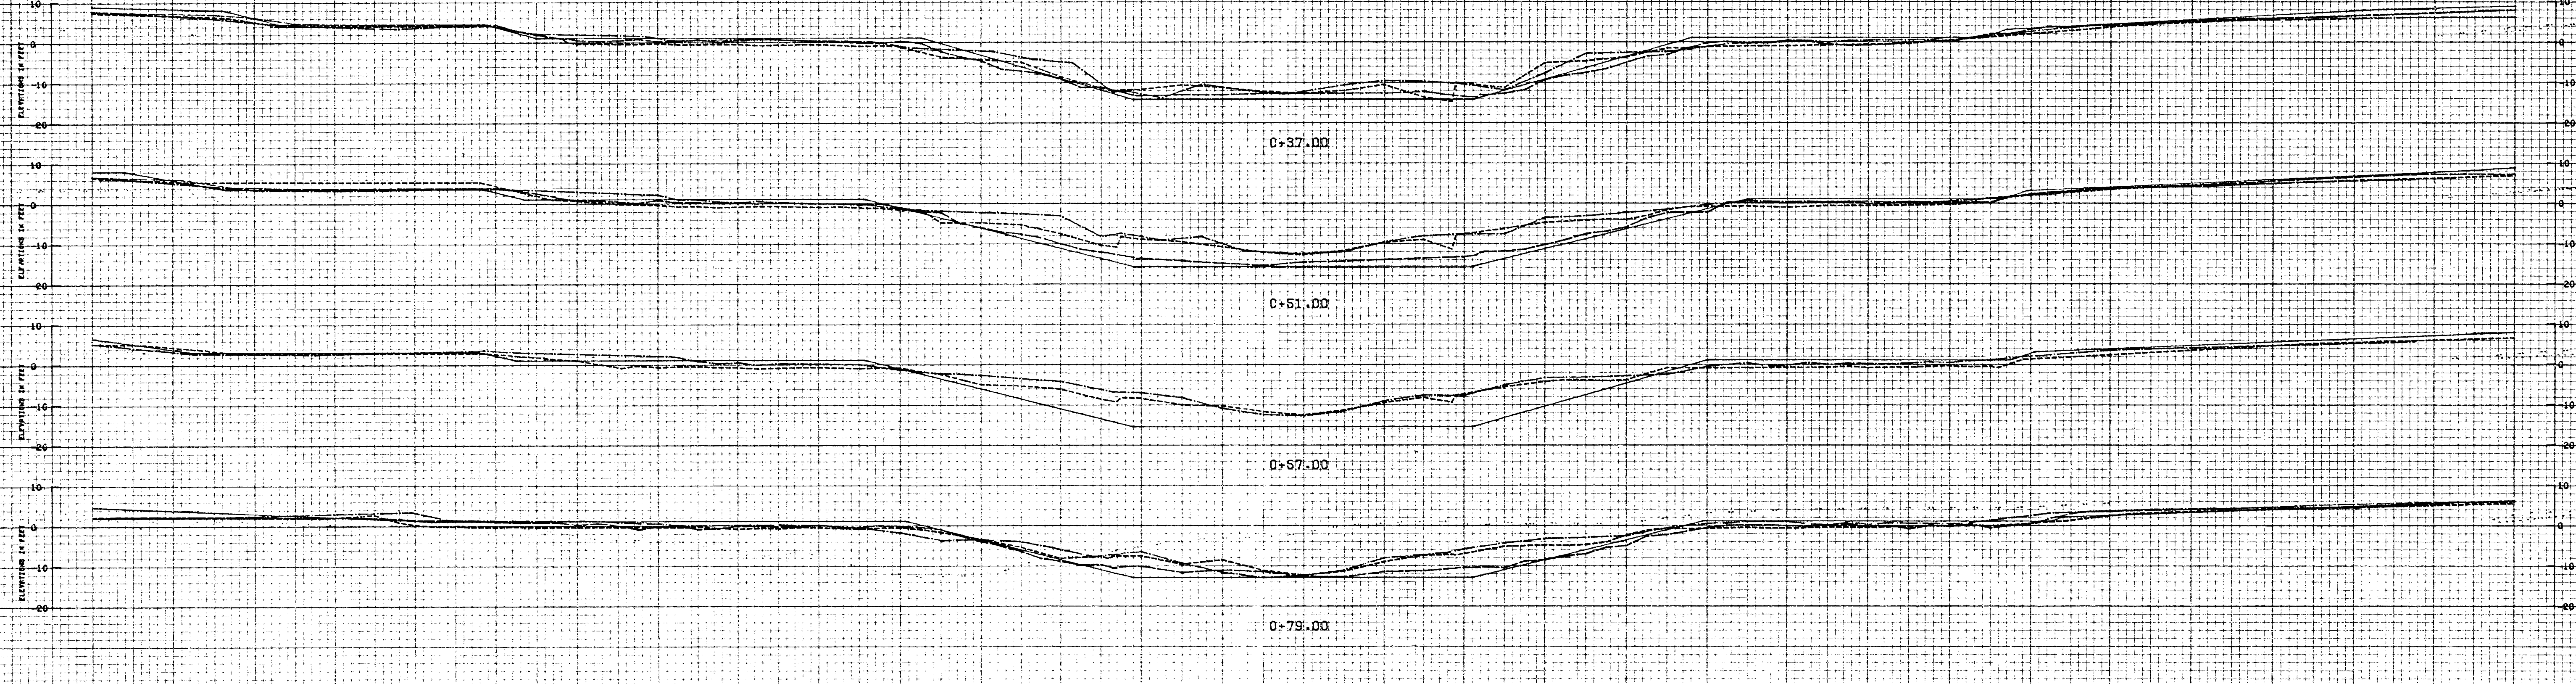
NEW ORLEANS TO VENICE, LA.
 HURRICANE PROTECTION REACH 2-1
 EMPIRE FLOODGATE - SOUTH APPROACH CHANNEL
 SCOUR SURVEY (73-78)
 U.S. ARMY ENGINEER NEW ORLEANS DISTRICT OFFICE
 SHEET OF SEPTEMBER 1978 TITLE NO.

d. Scour Survey. No scour problems were noted at the structure. Some minor siltation has occurred near the structure, but no action is required at the present.

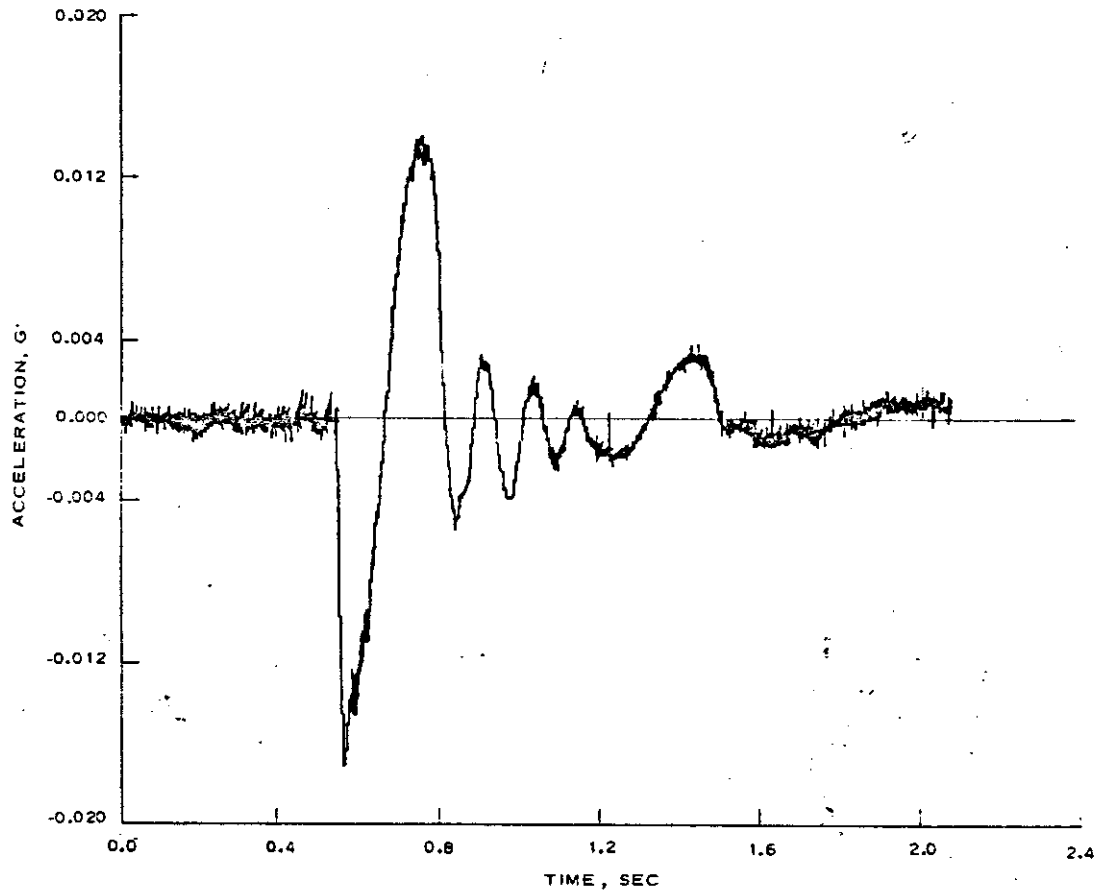
PLATE 5

15. A representative sample of the acceleration recordings is shown in Plate 4. The maximum accelerations during the study were observed during tests 19 and 26. The acceleration obtained during test 19 was examined to determine its magnitude and frequency. Plate 5 is an expanded playback of the acceleration over a 2.0-sec time period. The playback was further analyzed to obtain the frequency decomposition (Plate 6).
