STATE FIRE MARSHAL'S OFFICE

Firefighter Fatality Investigation

Volunteer Firefighter James McMorries

Howardwick Volunteer Fire Department

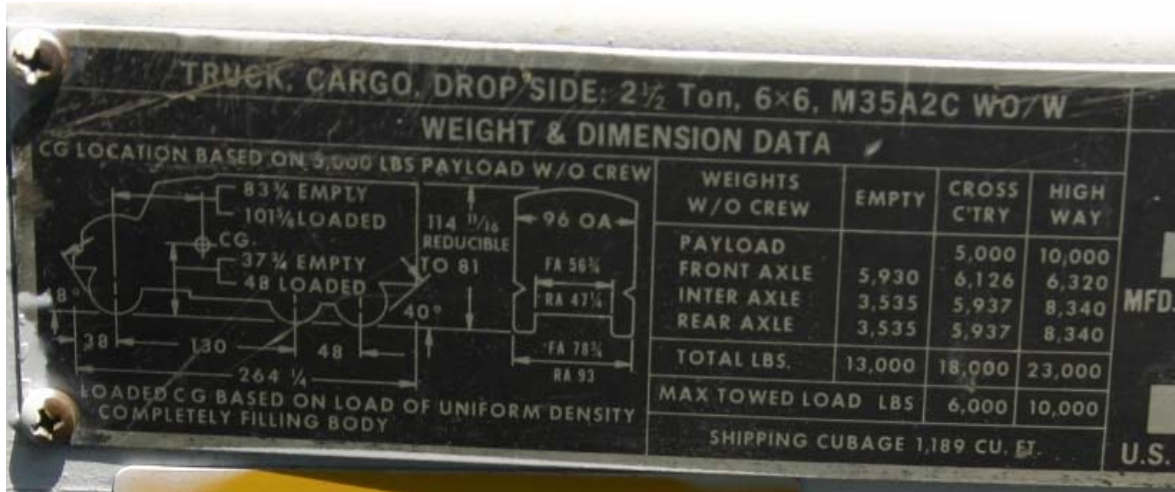
The overloaded vehicle with inadequate water tank baffles presented an extreme challenge to the driver to maintain control.

Recommendation: Any fire department acquiring a vehicle, chassis, or trailer not originally designed as firefighting apparatus should proceed with caution when converting equipment for use in firefighting. Fire departments should take into account factors such as the weight of tank water and equipment, center of gravity, load distribution, capacity of the drivetrain, tires, steering, and braking systems during fire apparatus construction.

Recommendation: All fire departments acquiring vehicles, chassis, or trailers should refer to all available manuals or documentation prior to commencing conversion or modification operations. Water tanks should be clearly marked with the tank capacity and full gross weight. Fire departments should install positive physical safeguards, such as overflow vents, to prevent vehicles from exceeding maximum permissible gross weight when fully loaded.
