STATE FIRE MARSHAL'S OFFICE

Firefighter Fatality Investigation

Investigation Number FY 07-02

Captain Kevin Williams
Firefighter Austin Cheek

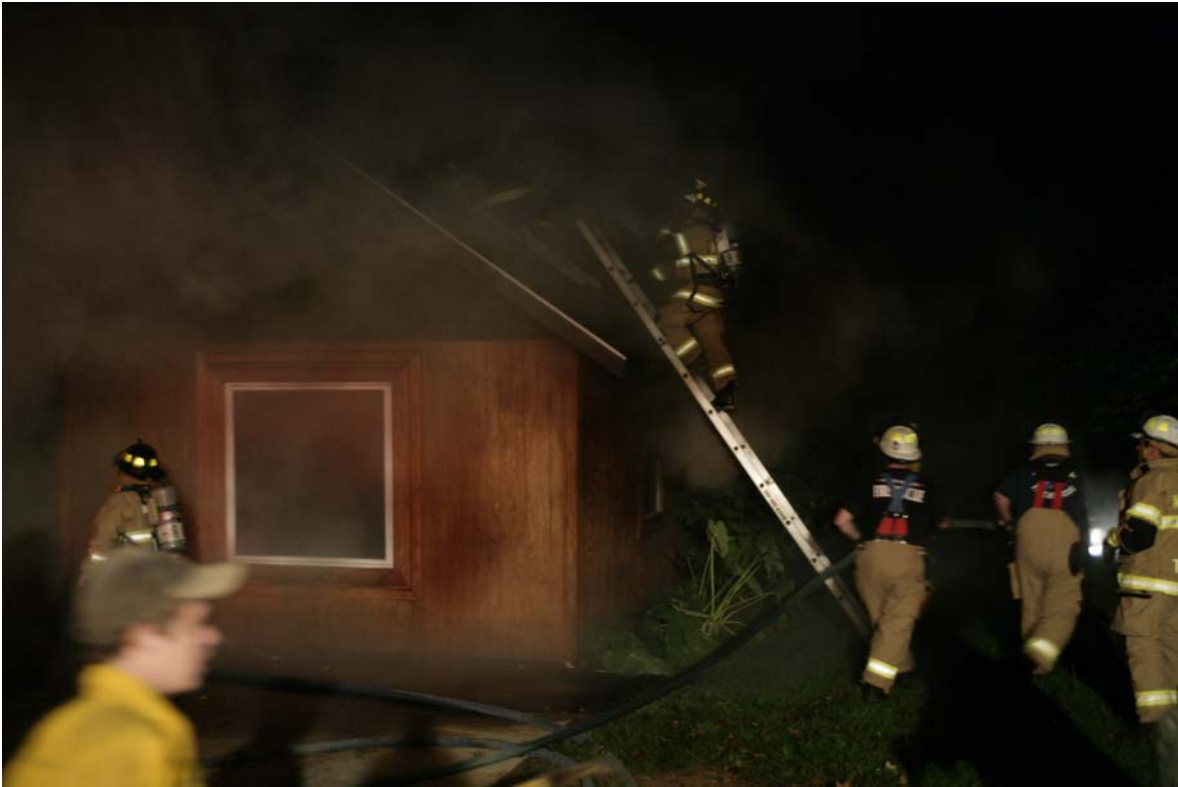
Several pictures showed Command moving from the front door to side “D” and firefighters staffing the hoseline while ventilation was attempted on the roof. At **02:20:31** IC Baldauf took the unmanned safety line from the front of the house and he and Chief Aarant passed the line to the roof ventilation team. Photos show that the roof ventilation team had the safety line.

At 02:20:31 Command and Asst. Chief Aarant pull the safety line to side “D” for the ventilation team. (Photo by Bullard FD)
