Line of Duty Death Investigation

Investigation Number 03-193-01

Firefighter Gary L. Staley

Texas Department of Insurance
Austin, Texas

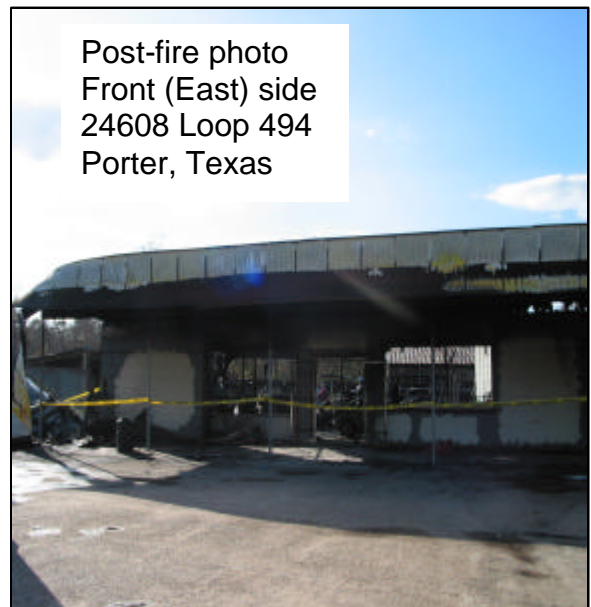
The business faces east and fronts onto Loop 494. The single-story building is of wood frame construction. Metal siding covers all areas except the concrete block façade on the front part of the building. The floor is a concrete slab. The roof in the front part of the building is a tar built-up roof with an overhanging canopy. The roof in the remainder of the building is corrugated metal installed over wood joists supported on metal columns. There is a rear overhanging roof protecting an open storage area enclosed with chain link fencing. There are several additions to the original building.

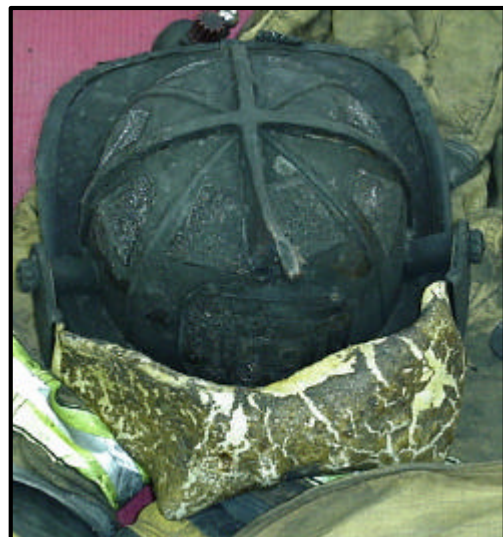
became disoriented and escaped the building with serious burns. All three were wearing full NFPA-compliant protective ensembles and SCBA. The helmets of the two most seriously burned firefighters, Chapa and Haynes, showed evidence of extreme heat exposure, with face shields burned and deformed, but helmet shells, although burned, were intact.
