DEFENSE NUCLEAR FACILITIES SAFETY BOARD

RECOMMENDATION 95-1 TO THE SECRETARY OF ENERGY
pursuant to 42 U.S.C. § 2286a(5)
Atomic Energy Act of 1954, as amended.

Technical Report

INTEGRITY OF URANIUM HEXAFLUORIDE CYLINDERS

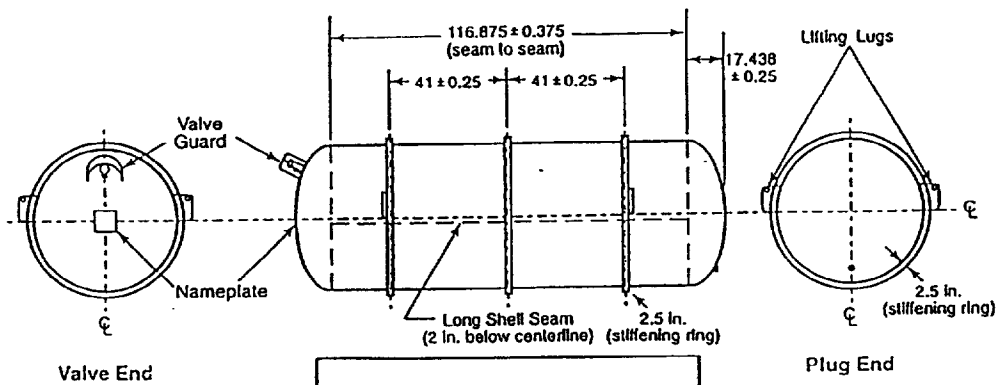
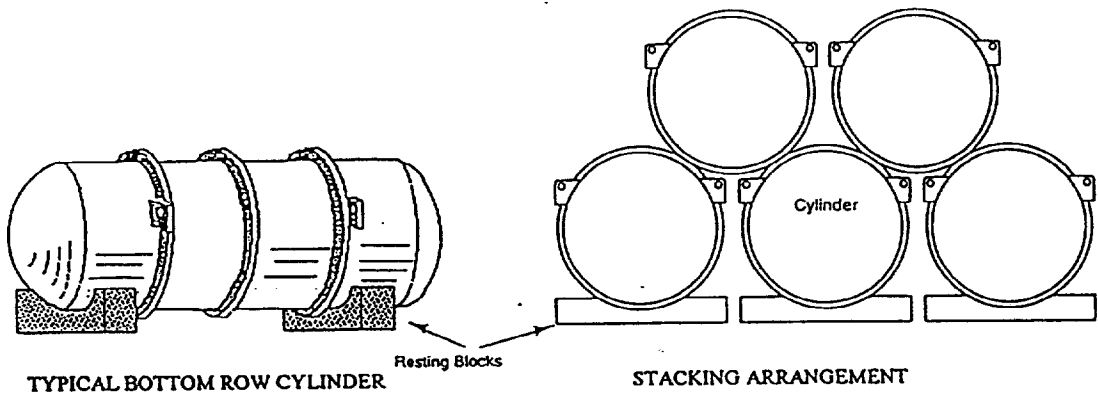
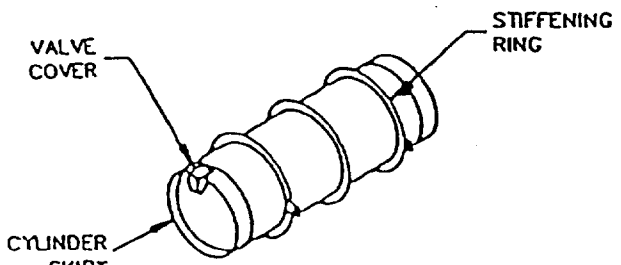
Various Cylinder Views
Figure 3

It does not appear that inspection methods, such as ultrasonic thickness measurements, are consistently being used in a manner that will provide needed information about the extent and rate of cylinder corrosion. For example, thickness measurements made on cylinders at K-25 were not correlated with the actual storage history of the cylinders (e.g., ground contact versus non-ground contact, or surfaces formerly on resting blocks). Also, ultrasonic measurements of the cylinders at K-25 and the bottom row of cylinders at Paducah were typically limited to spots that visually appeared to be the most corroded. Views and stacking arrangements of typical cylinders are shown in Figure 3.
