Explosion and Aftermath: The Causes and Consequences of the Disaster

Chapter Four

The Macondo Well and the Blowout

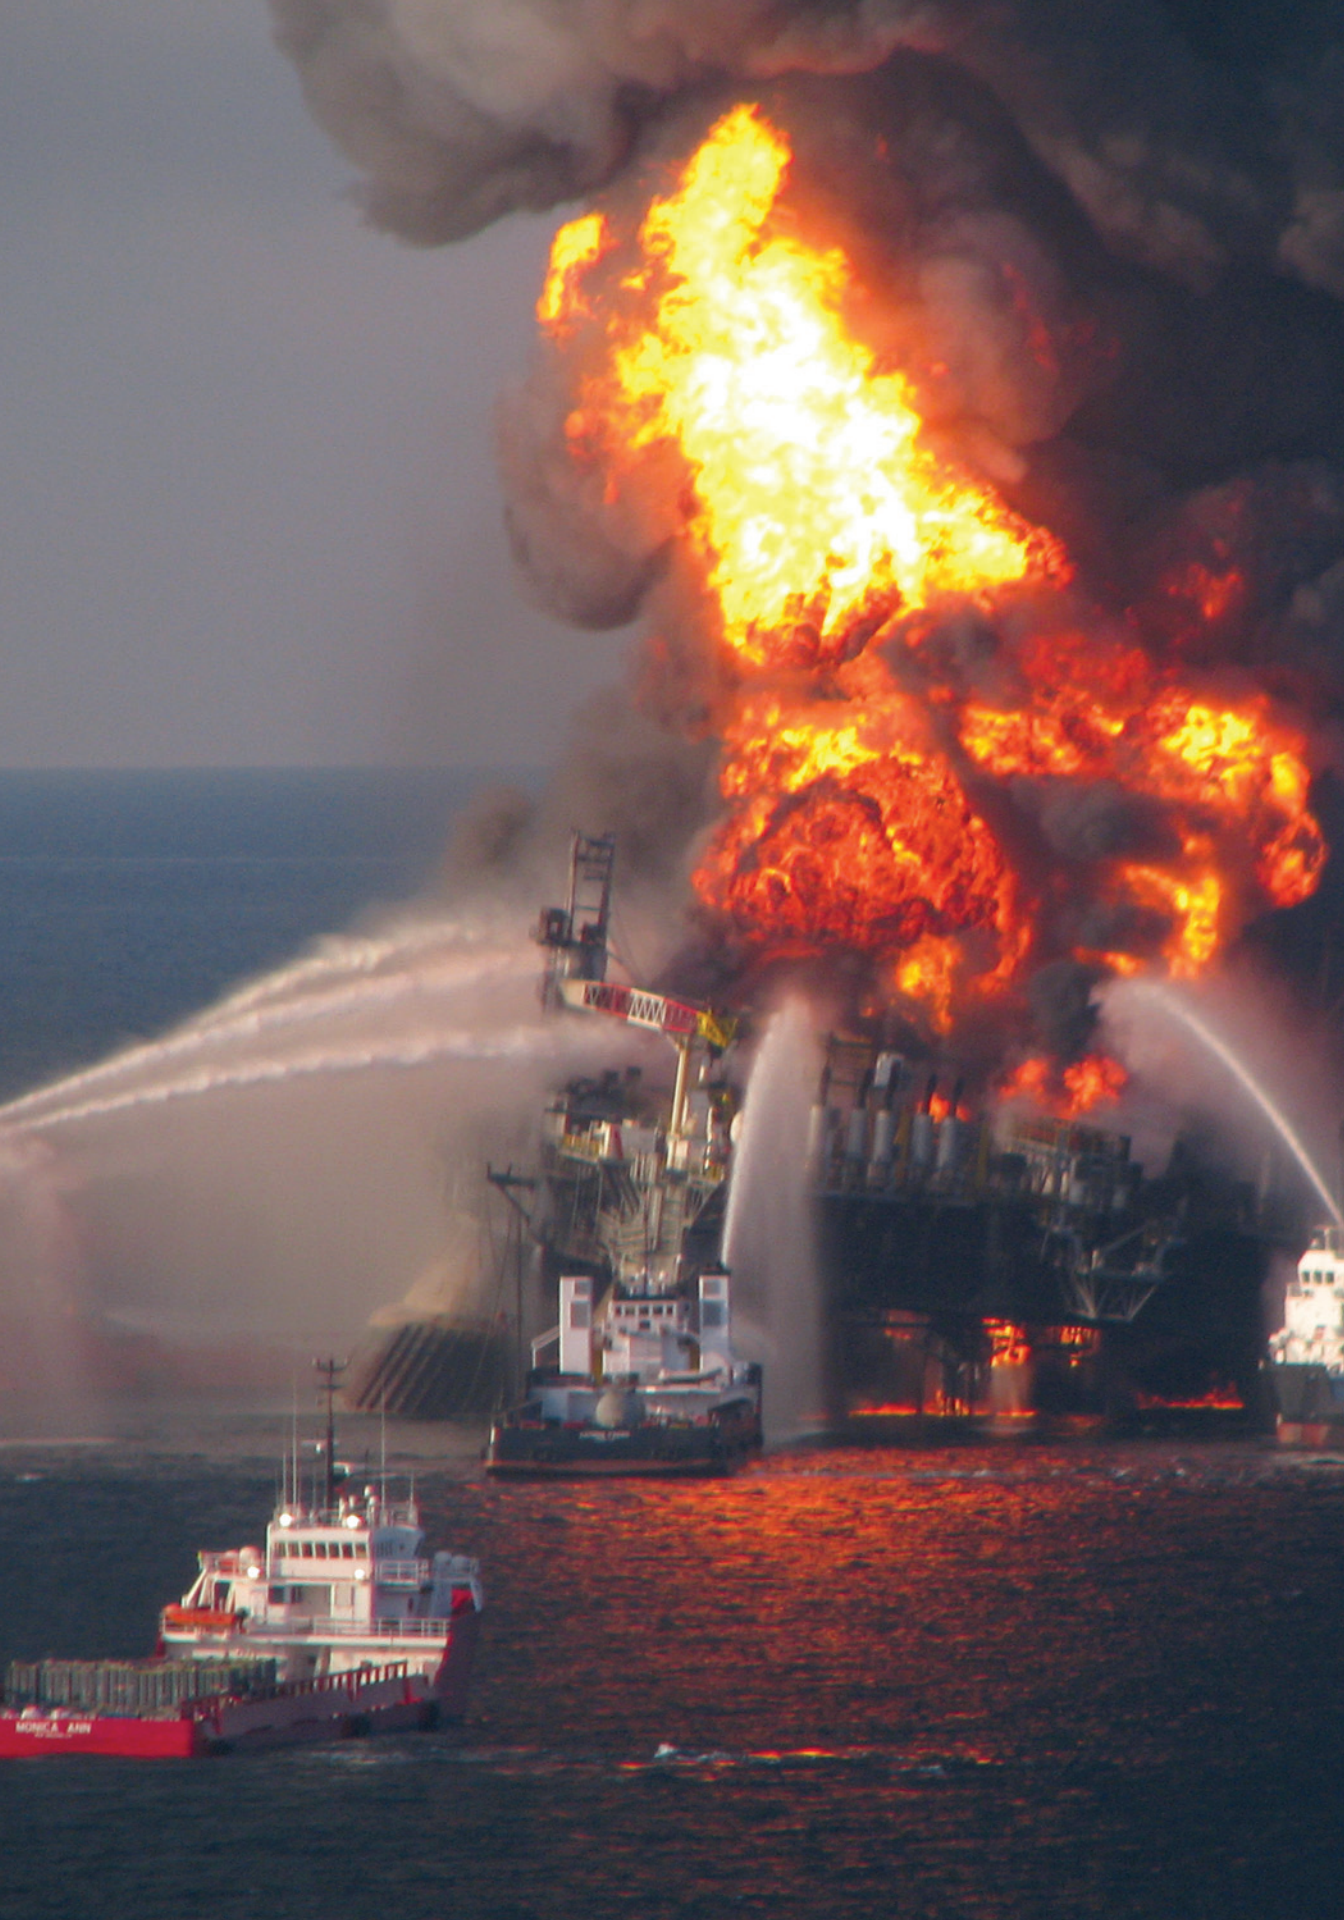
< U.S. Coast Guard photo

Fighting a losing battle, fireboats pour water onto the doomed rig in the hours after the Macondo well blowout. The tragic loss of the *Deepwater Horizon* at the close of the complex drilling project resulted from a series of missteps and oversights and an overall failure of management.
