# HIGHWAY ACCIDENT REPORT

MULTIPLE-VEHICLE COLLISION  
FOLLOWED BY PROPYLENE CARGO-TANK  
EXPLOSION, NEW JERSEY TURNPIKE, EXIT 8

SEPTEMBER 21, 1972

REPORT NUMBER: NTSB-HAR-73-4

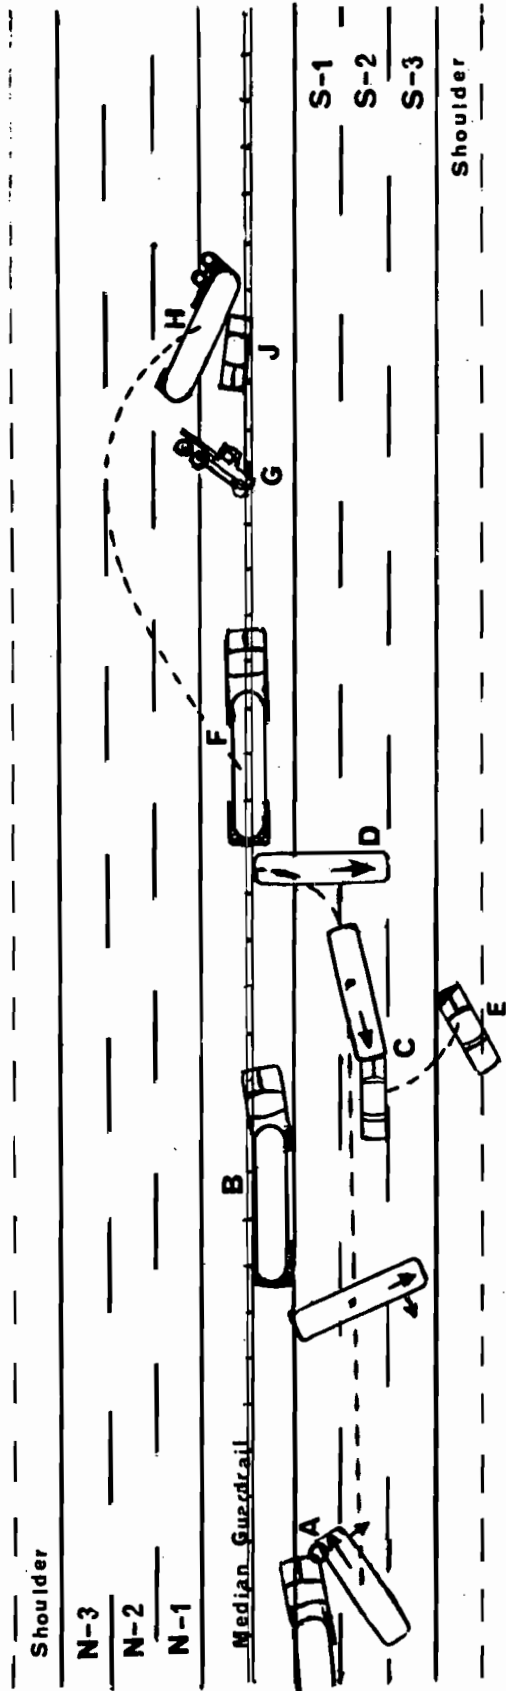
At 8:25 p.m., on September 21, 1972, a Greyhound bus with no passengers was en route from New York to Philadelphia on the New Jersey Turnpike at about 50 m.p.h. in the outermost (right-hand) southbound lane 1/ north of the Hightstown exit (Exit 8) in a light drizzle. The busdriver said that because a car ahead of him suddenly slowed down, he swerved left into lane S-2 to avoid it. A southbound tractor-semitrailer (cargo tank), operated by Matlack, Inc., of Lansdowne, Pa., and carrying propylene, was overtaking and passing the bus when the bus swerved directly into its path, and the truckdriver was unable to avoid a collision. The right front of the tractor struck the left front of the bus just forward of the left front wheel. The tractor scraped the median guardrail, and fire erupted from the damaged left-side fuel tank. The tractor-semitrailer then overrode and flattened about 200 feet of median guardrail. At that time, the truckdriver was apparently thrown from his seat. The tractor-semitrailer jackknifed into the northbound lanes, rotated clockwise about 200°, and was struck by a northbound 1972 Dodge hardtop. The cargo-tank semitrailer overturned onto its left side and came to rest with its rear resting on the raised median and with its front in lane N-1. 2/ (See Figure 1.) The Dodge was jammed between the tank and the median guardrail; its two occupants were killed.

- A Probable point of impact
- B Truck scraped guardrail
- C Veh.-3 struck bus
- D Final position of bus
- E " " " veh.-3
- F Truck overrode median rail
- G Tractor overturned
- H Cargo tank "
- J Veh.-4
