**PROPANE TRUCK COLLISION WITH
BRIDGE COLUMN AND FIRE
WHITE PLAINS, NEW YORK
JULY 27, 1994**

HIGHWAY ACCIDENT REPORT

**Adopted: November 14, 1995
Notation 6479A**

**NATIONAL
TRANSPORTATION
SAFETY BOARD**

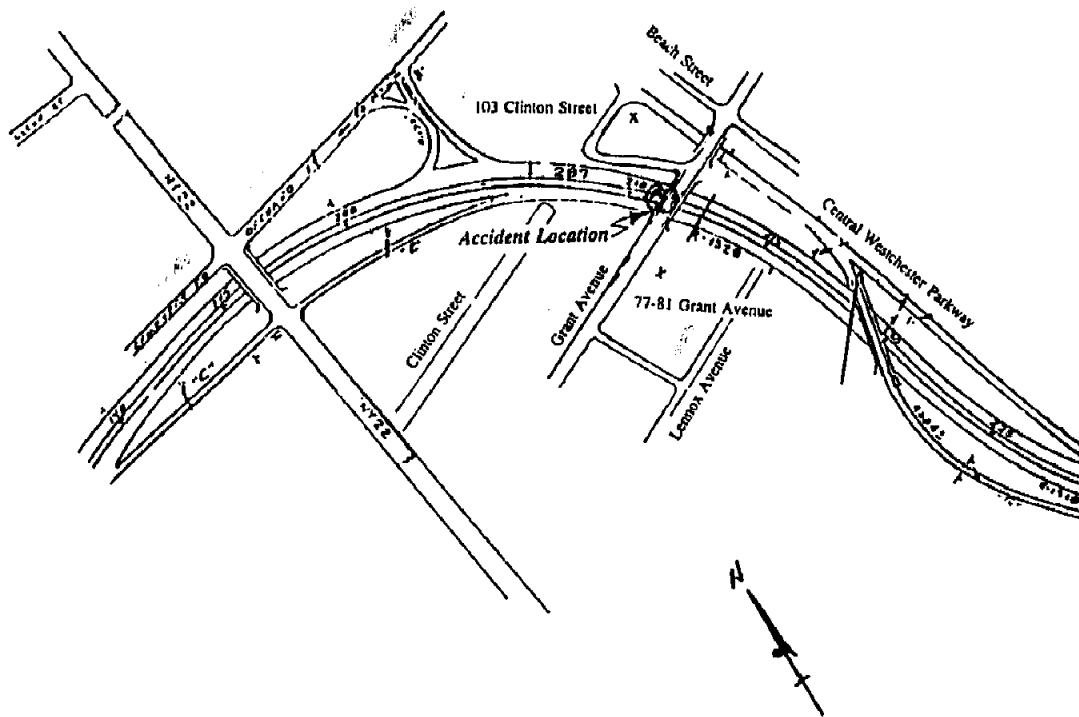
Figure 11. - Plan view of accident site

Highway Description -- The accident occurred on a 1,550-foot-radius (centerline radius) curve to the right on a 2.26-percent downgrade. (See figure 11.) The curve was 2,246 feet long and had 250-foot-long spiral transitions at each end. The centerline of the Grant Avenue bridge was 1,750 feet from the beginning of the curve. The bank or superelevation for the curve was +0.06 (percent). At the accident site the left shoulder slope was approximately -0.02 and the embankment foreslope approximately -0.16.

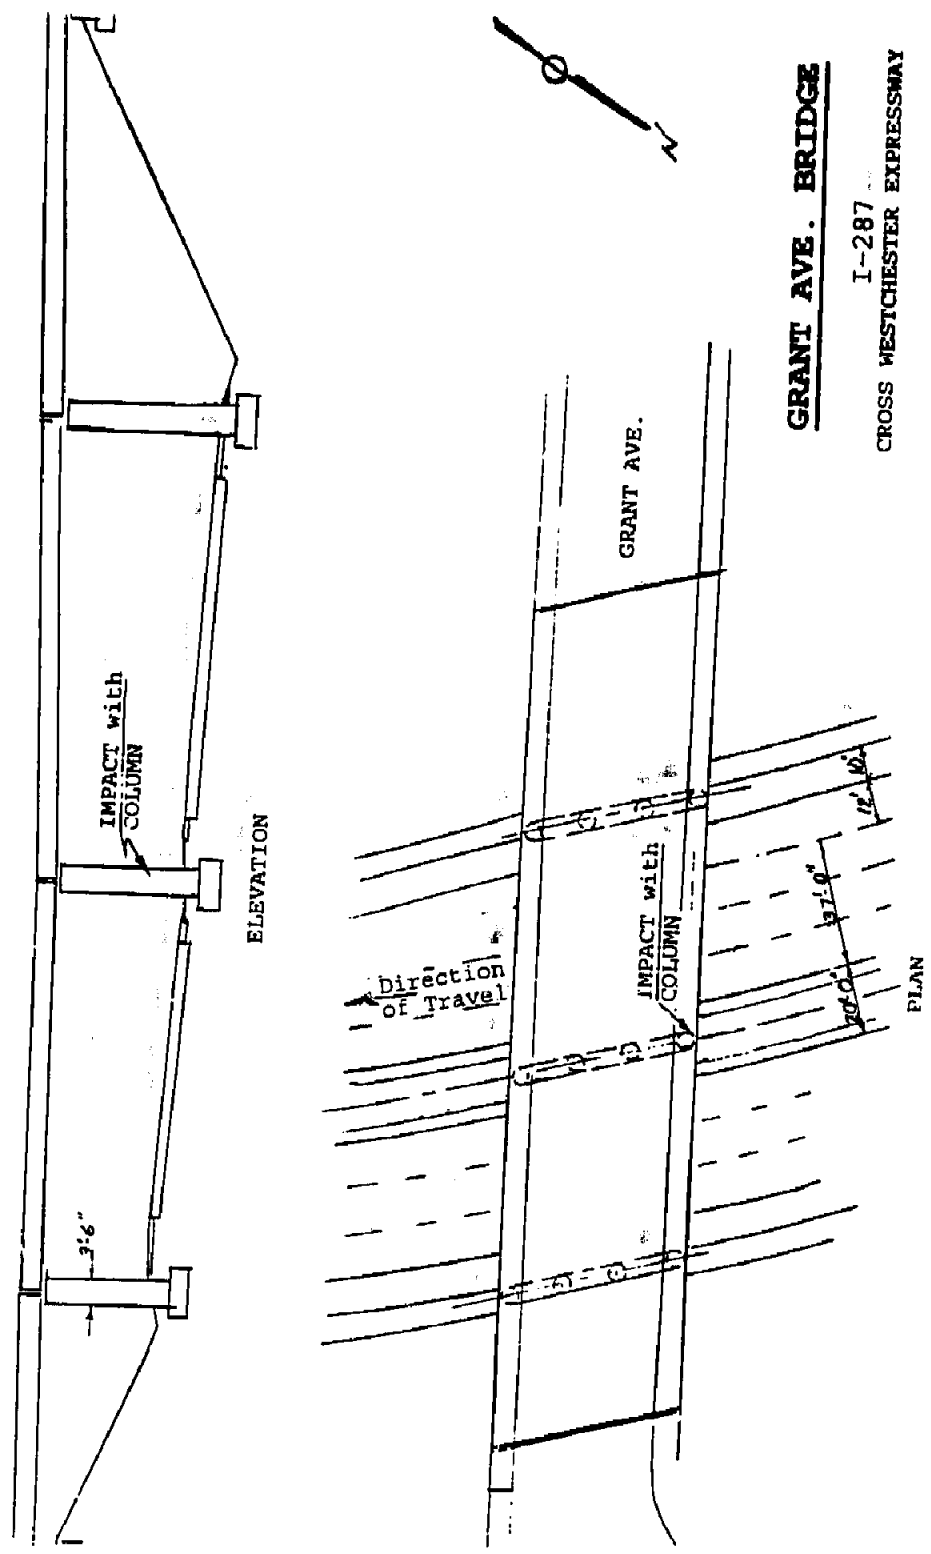
Figure 13.--Schematic of Grant Avenue overpass

Grant Avenue Overpass -- The bridge was a steel girder structure consisting of four simply supported³⁷ spans of eight girders each and was supported by three piers and two abutments. The reinforced concrete deck was 54 feet wide. The bridge was 232 feet long and formed an angle of 76 degrees with I-287. Each pier consisted of four 3 1/2 foot diameter reinforced concrete columns connected by a reinforced concrete pier cap. The columns were built along a straight line, and each rested on an isolated spread concrete footing. The faces of the 14-foot-2-inch center pier columns were 8 feet from the traveled way. (See figure 13.)

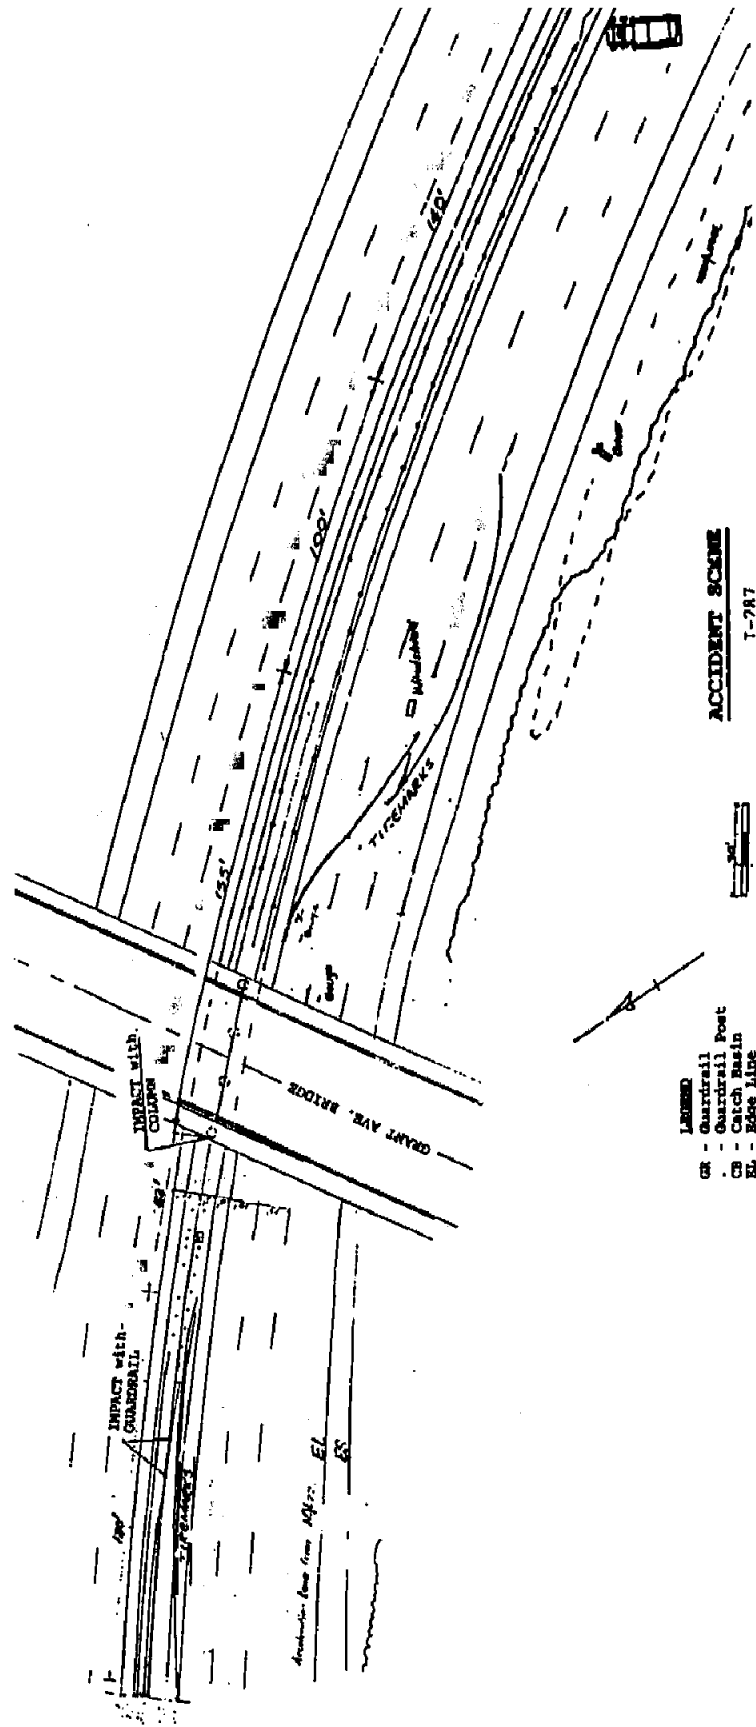
Figure 14.--Accident scene

Postaccident Physical Evidence -- Safety Board investigators documented 130 feet of tiremarks in the eastbound lanes of I-287. The marks began approximately 200 feet in front of the bridge column in the left lane and continued to the shoulder and foreslope of the drainage ditch. Near the end of the 130 feet, the marks started curving back to the roadway. The marks left the traveled way (across the pavement edge line) and the shoulder at an angle of 5 degrees. (See figure 14.)
