NATIONAL TRANSPORTATION SAFETY BOARD

HIGHWAY ACCIDENT REPORT

**MULTIPLE VEHICLE CROSSOVER ACCIDENT
SLINGER, WISCONSIN
FEBRUARY 12, 1997**

**Adopted: July 24, 1998
Notation 6832B**

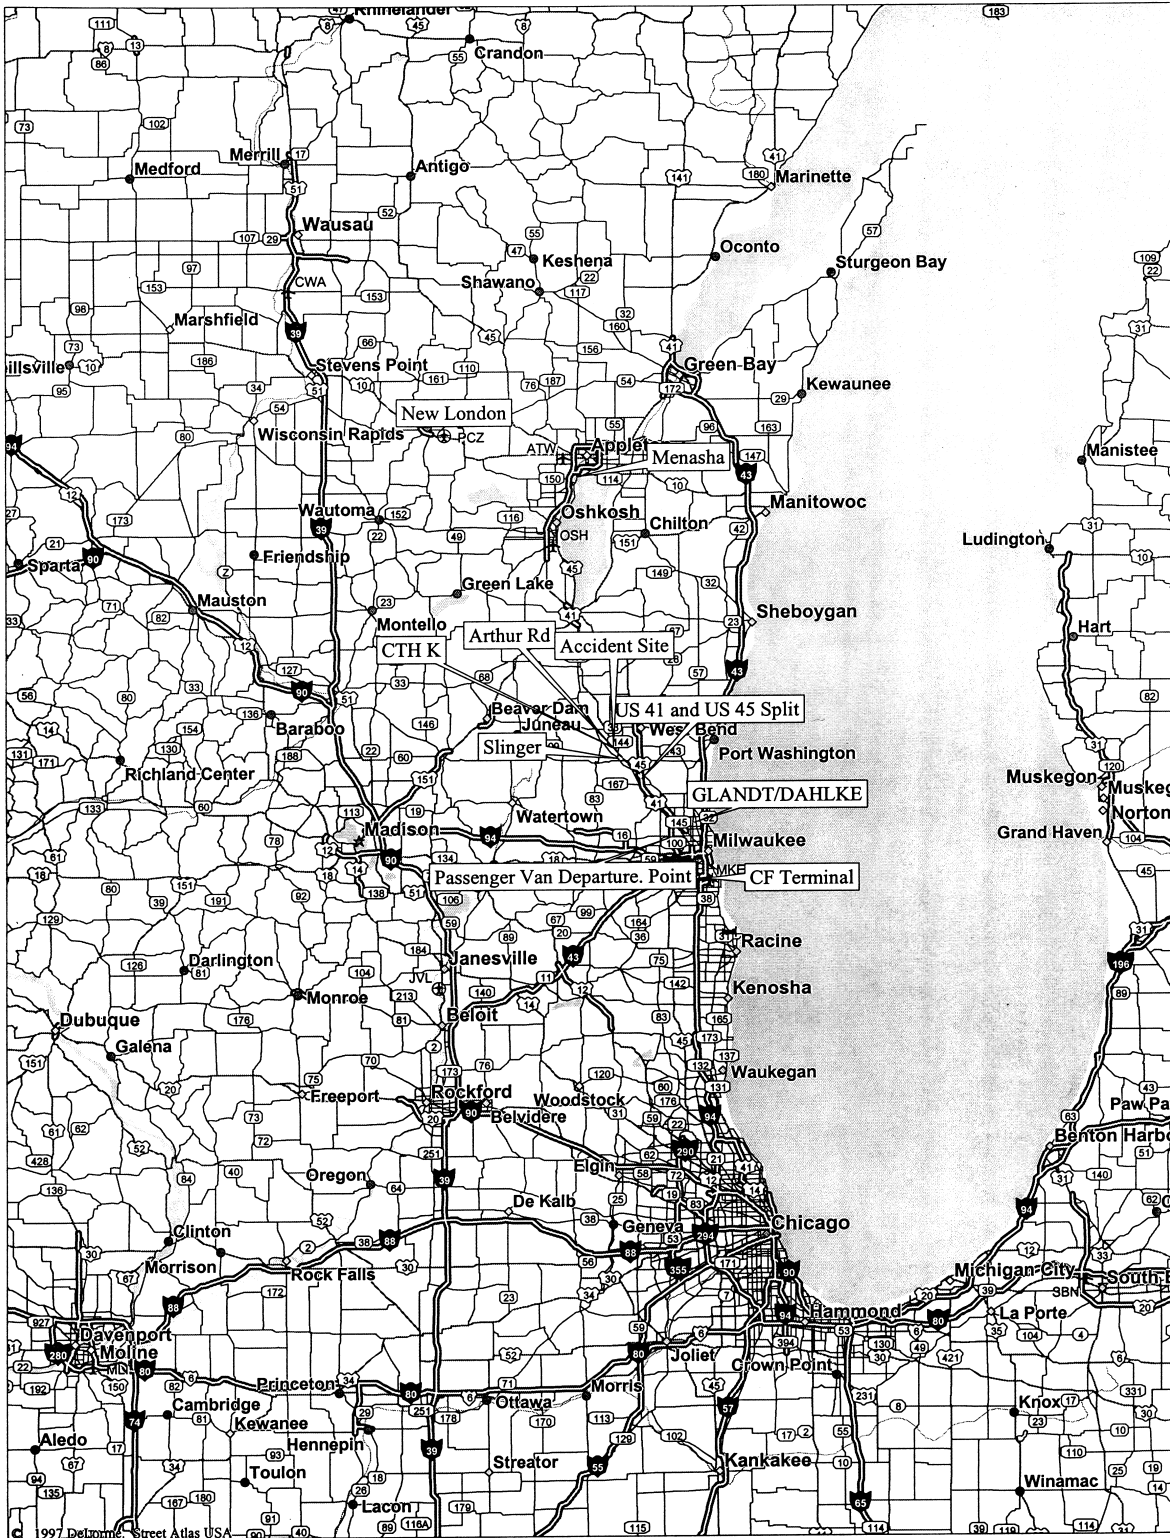
Figure 4 -- General accident area and reference points

The accident occurred in the north- and southbound lanes of US 41 at milepost 67.9 in Washington County, just south of CTH K. (Refer to figures 4 and 5.) US 41, a principal rural arterial, runs north from Milwaukee through Wisconsin to Michigan and was originally constructed in the late 1950s as a two-lane road. Two more lanes were added in the late 1960s, and the four-lane roadway was upgraded to freeway standards in 1994. Before the upgrade, the intersection of US 41 and CTH K was at-grade with stop signs on CTH K. After the upgrade, US 41 became a limited access highway with a diamond interchange at CTH K.

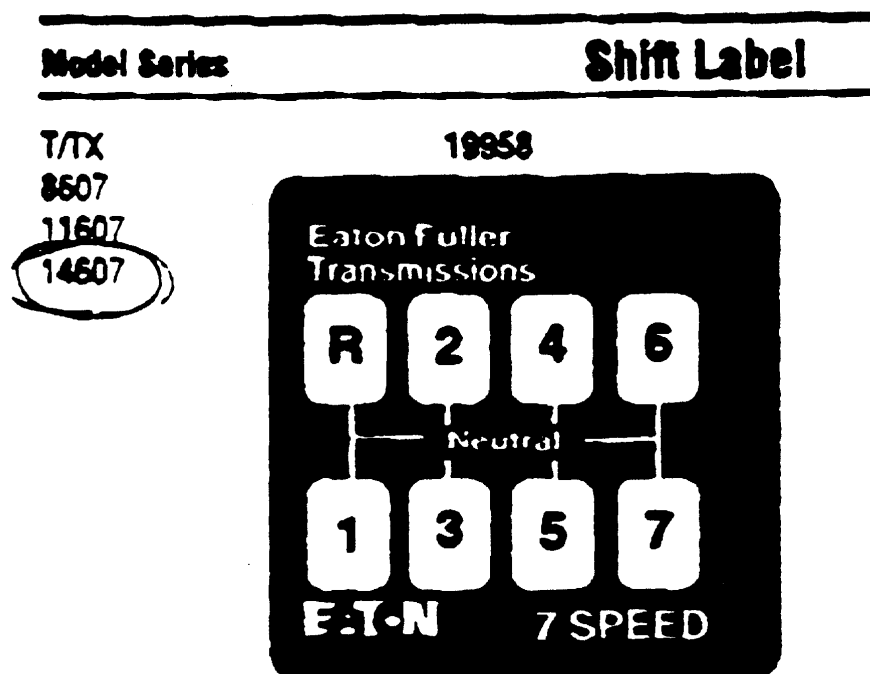
Figure 11 -- Gear box diagram

move forward from the 7th gear position to the 6th gear position. (See figure 11 for the gear diagram.) In addition, in order to achieve the speed of 60 mph necessary to pass the passenger van as occurred in this circumstance, the truck would have to have been in 7th gear. Based on the foregoing information, the Safety Board concludes that, although the doubles truck was found in 6th gear after the accident took place, it had been traveling at the upper limits of the calculated speed estimate of 43 to 58 mph, and therefore it had been in 7th gear.
