**Passenger Vehicle Median Crossover  
and Head-On Collision  
With Another Passenger Vehicle  
Linden, New Jersey  
May 1, 2003**

**Highway Accident Report**

NTSB/HAR-06/02

**NTSB/HAR-06/02  
PB2006-916202  
Notation 7754  
Adopted February 7, 2006**

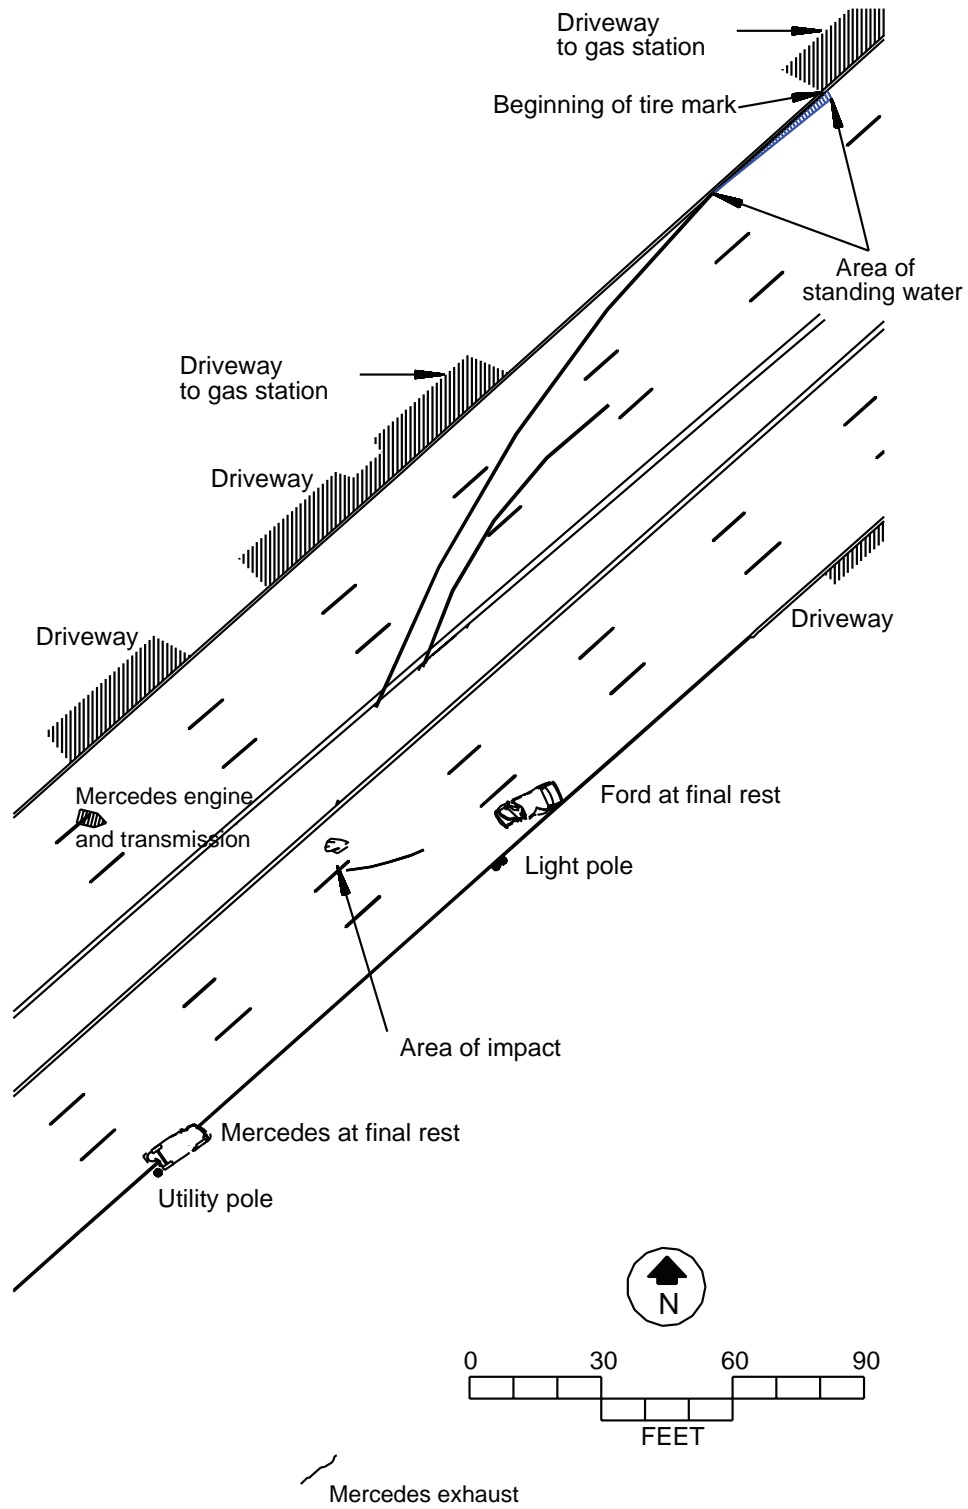
Figure 1. Linden, New Jersey, accident scene.

Near milepost (MP) 41.4, the Mercedes, traveling 48 to 62 mph,<sup>1</sup> hit the curb on the west side of the road and swerved to the left. The Mercedes crossed the other two southbound lanes; mounted and crossed an 11.5-foot-wide, 6-inch-high raised concrete curb median; and entered the northbound lanes, where it collided head on with a 1986 Ford Taurus (Ford) traveling in the left northbound lane. The Mercedes rolled up and over the Ford and landed on its roof. The Mercedes slid approximately 80 feet across the northbound lanes and struck a wooden utility pole next to the east side of the roadway, where it came to rest straddling the right northbound lane and the grassy area to the east of the roadway. Following the collision, the Ford remained upright, rotated about 163 degrees counterclockwise, and slid about 50 feet, where it came to rest in the right northbound lane. (See figure 1.)

LPD officers noted that, upon arriving at the accident scene, they observed a puddle of standing water, 2 to 3 feet at the widest part, which extended about 35 feet in the right southbound traffic lane adjacent to the north driveway of the gas station. (See figure 1, top-right corner of diagram.) A drop inlet located north of the puddle and intended to drain that area did not function as designed because it was no longer at the lowest point in the gutter, allowing a pool of water to collect. Variances in the thickness of the asphaltic concrete surface quite likely occurred the last time the roadway was resurfaced. The LPD accident report indicated that the puddle could have caused the vehicle to hydroplane.<sup>79</sup> However, the Safety Board's analysis of the physical evidence shows that hydroplaning was not a factor in the accident sequence.

The Mercedes driver drove about 3.35 miles in the southbound lanes of U.S. 1 in Linden before the accident. Near MP 41.4, as indicated by the tire marks, the vehicle was traveling between 48 and 62 mph,<sup>80</sup> hit the curb on the west side of the road, swerved to the left, crossed the other two southbound lanes, mounted and crossed the 11.5-foot-wide, 6-inch-high raised curb median, and entered the northbound lanes, where it collided head on with a 1986 Ford. As the Mercedes crossed over the raised center median, the vehicle had rotated about 71 degrees counterclockwise from its original orientation in the right southbound traffic lane. (See figure 1 for a diagram of the accident scene.)
