Ceiling Collapse in the Interstate 90 Connector Tunnel

Boston, Massachusetts

July 10, 2006

Highway Accident Report

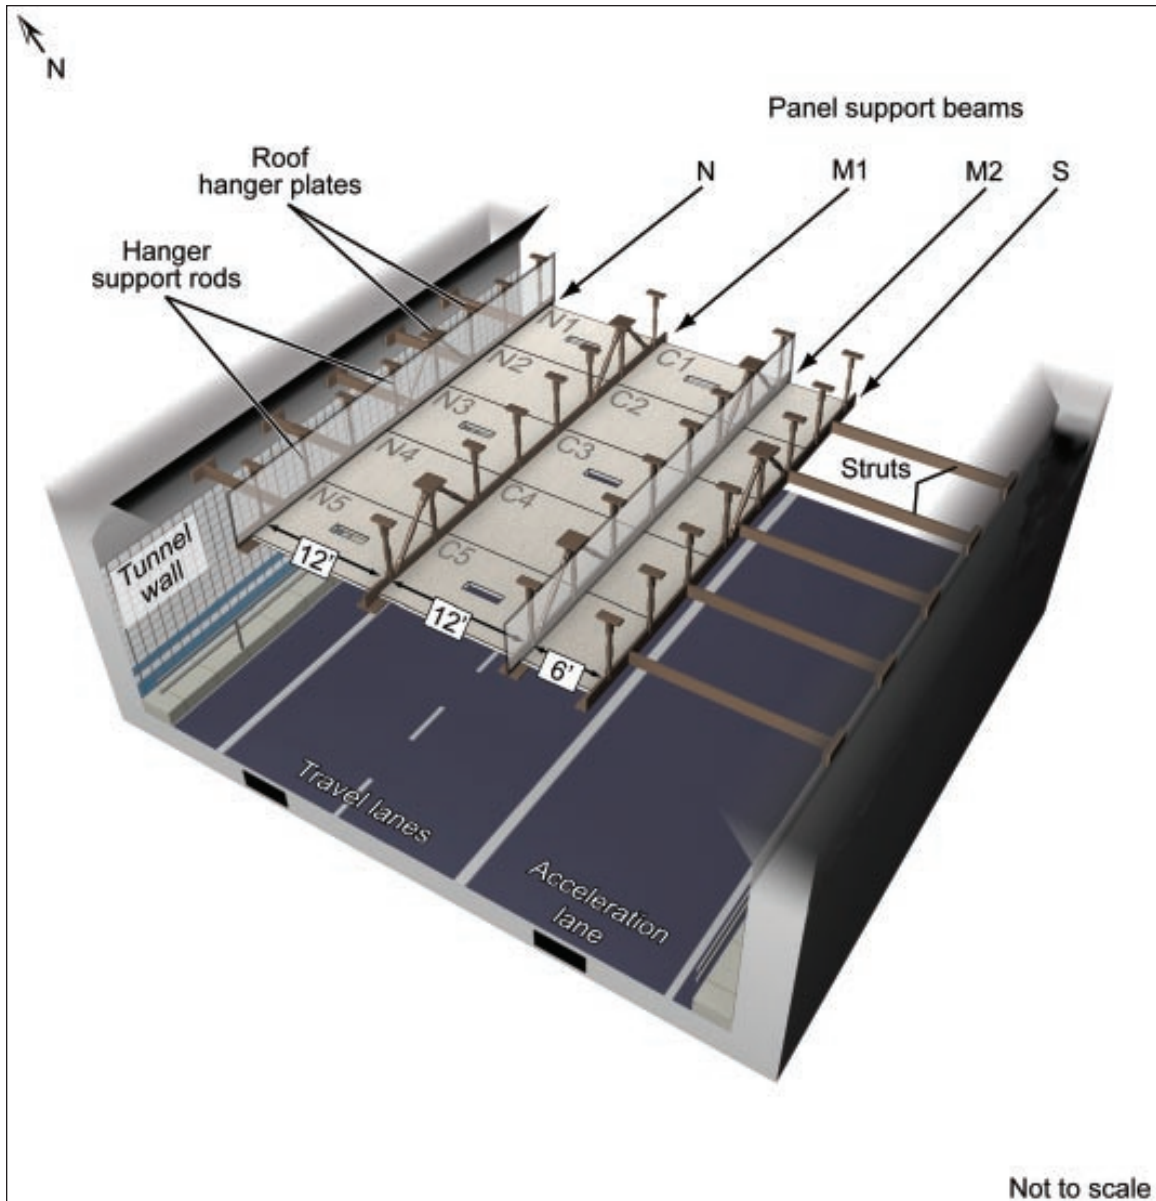
Figure 5. Overview of the support structure for the accident ceiling module. Panels and support beams show alphanumeric designations that were assigned during postaccident reconstruction.

Supporting the 15 concrete panels of the accident module were 4 steel support beams oriented parallel with the roadway—1 on the north side, 1 on the south side, and 2 toward the middle. The beam to the north (designated “N” by investigators) supported only the north ends of the five large panels in the north row. The first beam to the south (designated “M1”) supported both the south ends of the northern row of panels and the north ends of the center row. The next beam (“M2”) supported both the south ends of the large center panels and the north ends of the row of smaller 6- by 8-foot panels. The south beam (“S”) supported only the south ends of the smaller panels.

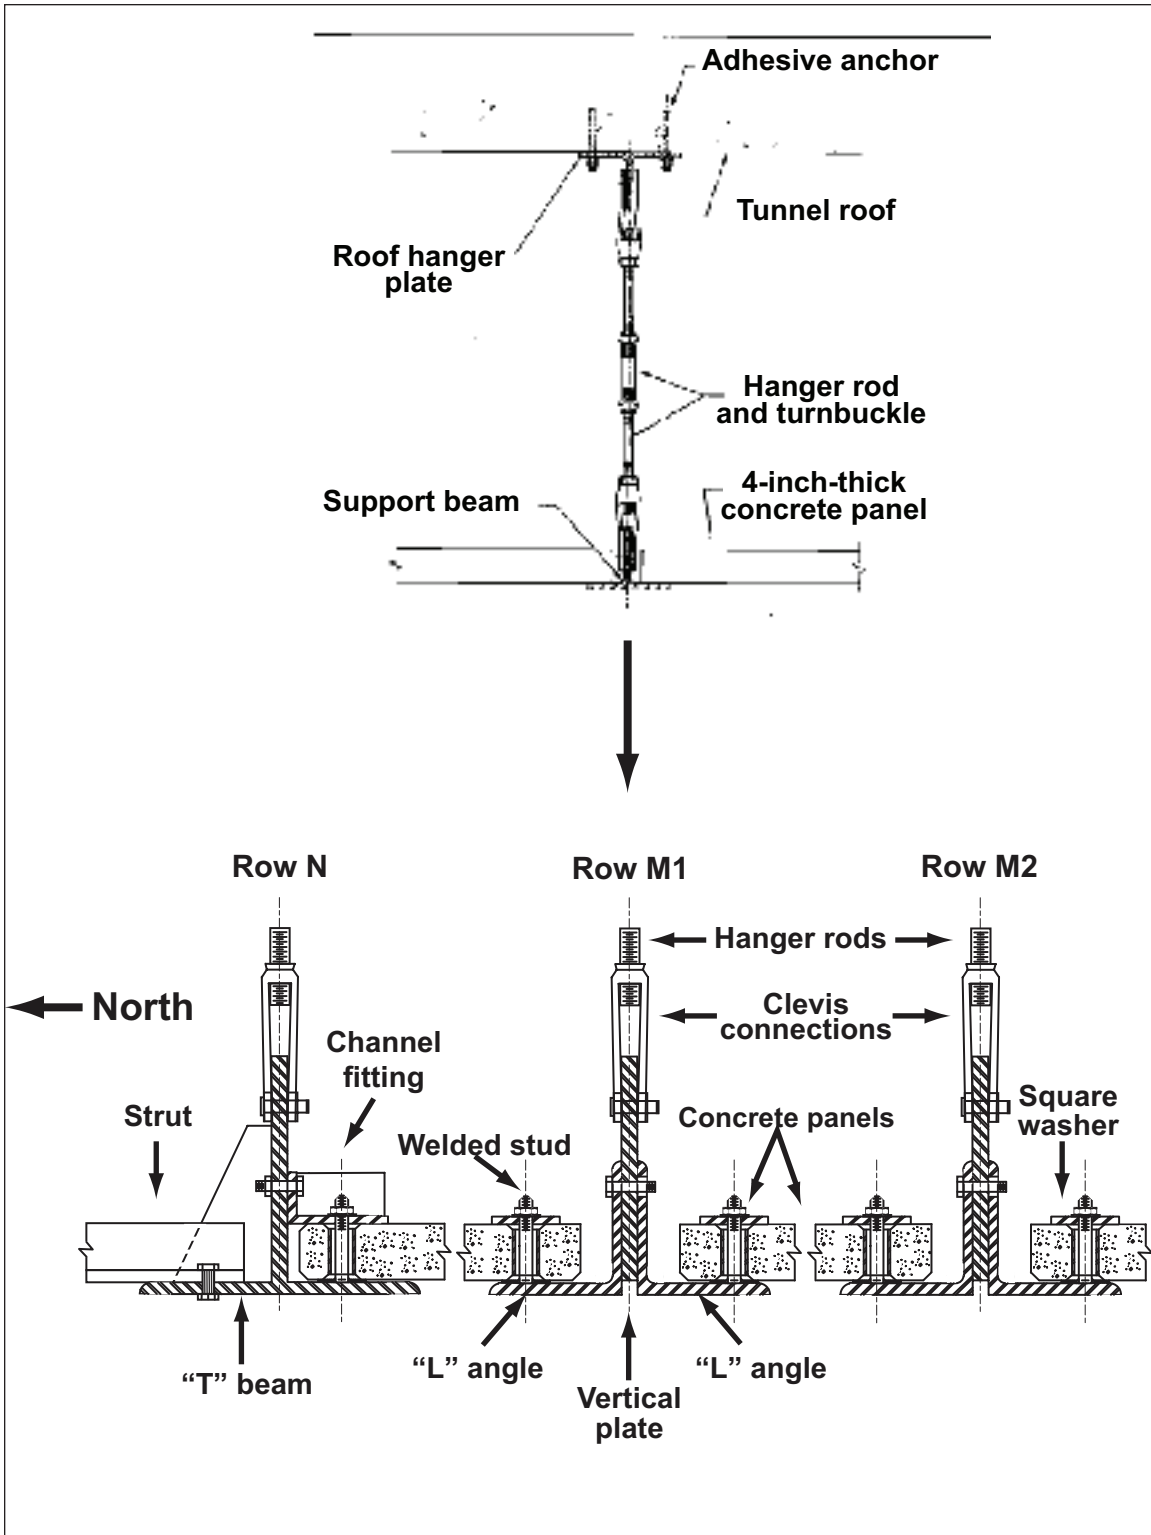
Each beam was supported by eight vertical hanger rods attached by clevis connections to the support beam at the bottom and to the roof hanger plate at the top. (See figure 6.) In addition to the vertical support rods, angled (diagonal) hanger rods at several locations prevented movement of the ceiling system in the longitudinal direction (parallel to the travel lanes). Metal struts extending from the tunnel walls to either side of the ceiling module prevented transverse movement.

Figure 6. Cross section of the I-90 tunnel ceiling showing support beam and concrete panel connections (looking east, not to scale).

The rotation of the north row of panels was initially somewhat restricted by the channel fittings that attached the tops of the welded studs to the N beam. (Refer to figure 6 for a detail of this type of connection) As the panels continued downward, the concrete began to fracture around these attachments, greatly reducing resistance to additional rotation of the north panels. As the M1 beam continued to drop, the degree of rotation between the concrete panels and the support beams also increased, causing the welded studs at the south end of the

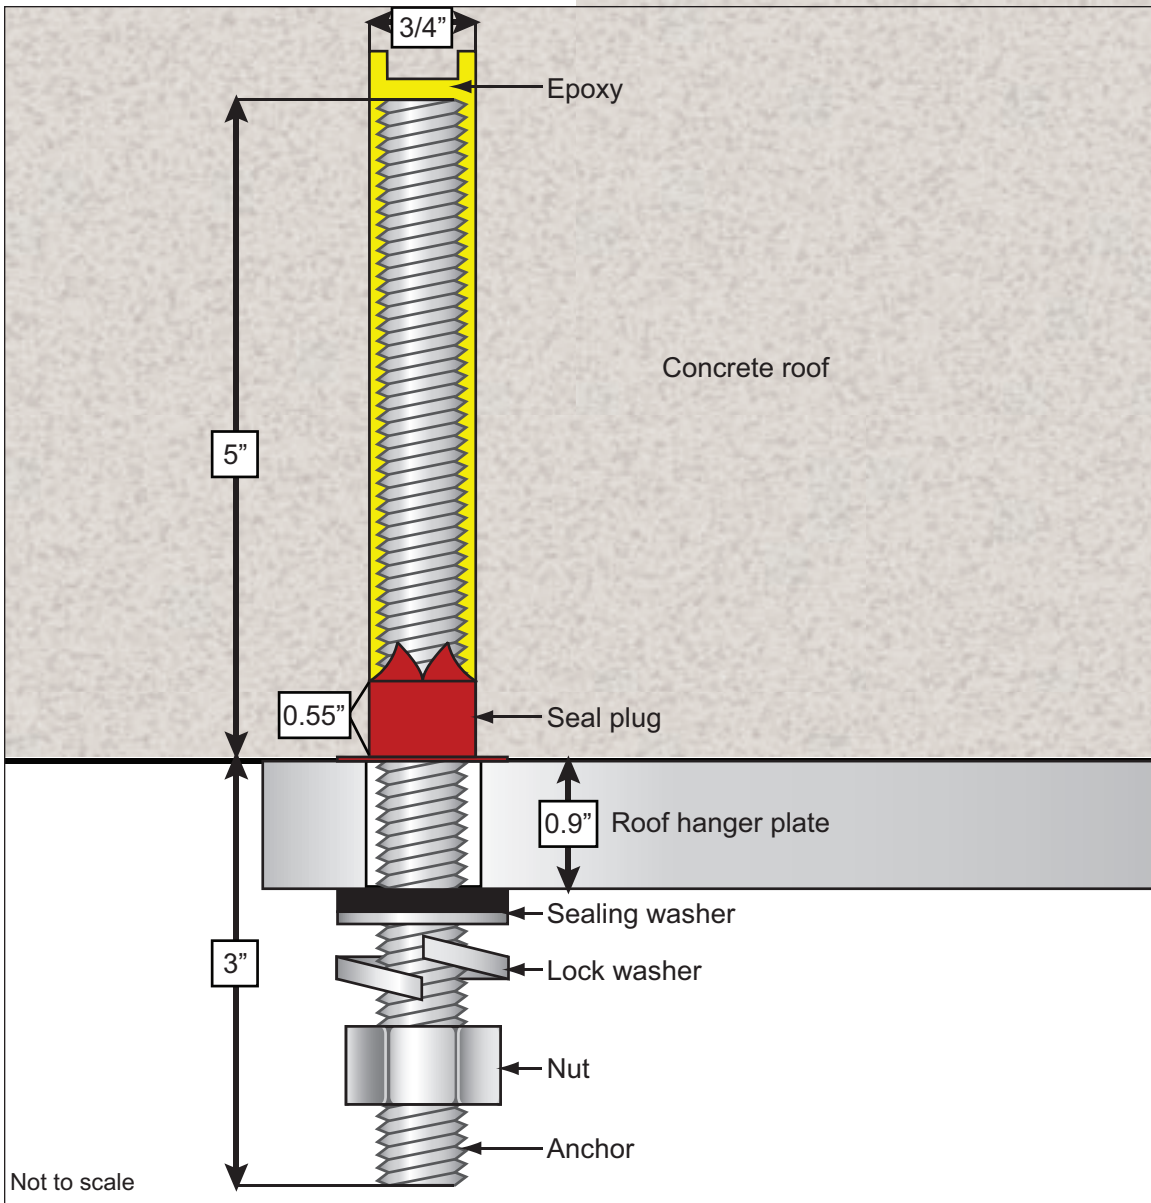
Two adhesive anchors (see figure 7) secured each of the 26 roof hanger plates (of the accident module) to which only vertical hanger rods were attached. Four anchors were used to secure the six roof hanger plates (two each for beams M1 and M2 and one each for beams N and S) that had both vertical and diagonal rods. Thus, beams N and S were each secured by 18 anchors, while beams M1 and M2 each used 20 anchors. The entire module was supported by 76 anchors. For reasons that will be discussed later in this report, the 200-foot-long D Street portal was the only section of the CA/T tunnel system to have a ceiling of this particular design supported solely by adhesive anchors.

Figure 7. Typical adhesive anchor and roof hanger plate assembly.
