National Transportation Safety Board  
Washington, DC 20594

**Highway Accident Brief**

**Accident Number:** HWY-06-MH-013  
**Accident Type:** Rear-end chain-reaction collision  
**Location:** State Route 121, near Lake Butler, Florida  
**Date and Time:** January 25, 2006, 3:25 p.m. eastern standard time  
**Vehicles:** 1996 Thomas Built school bus  
1993 Pontiac Bonneville sedan  
2004 Freightliner truck tractor and 1998 Wabash box trailer  
**Owners/Operators:** Union County, Florida, School District  
Private owner  
Crete Carrier Corporation  
**Fatalities/Injuries:** 7 fatalities  
5 serious injuries  
6 minor injuries

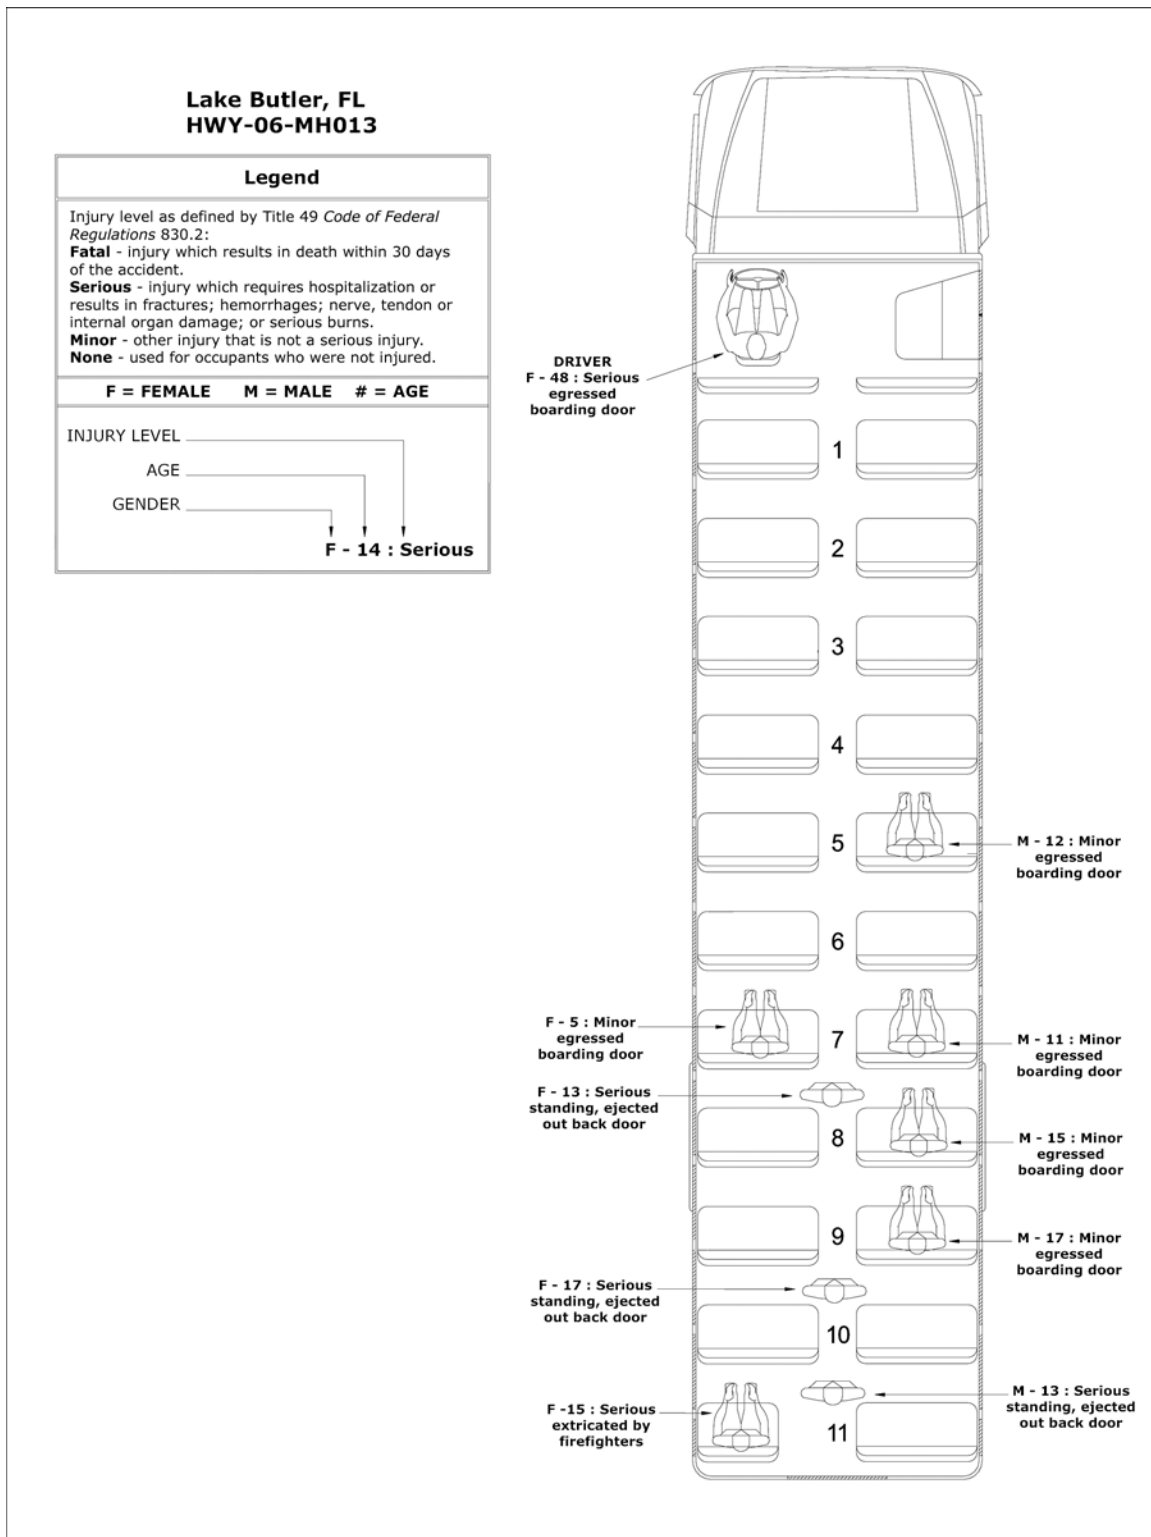
All seven occupants of the Pontiac were killed. Three of the nine students on the school bus were ejected from the rear of the vehicle and landed on highway pavement, seriously injured. One other student sustained serious injuries and was extricated from the bus by firefighters. The school bus driver, who was wearing a lap shoulder belt, also sustained serious injuries. Five

students and the truck driver received minor injuries. The students who had been discharged from the bus just before the accident were not injured. Figure 1 shows the seating chart for the school bus, and table 1 provides injury information.

**Figure 1.** Seating chart, Union County school bus.
