**Capsizing of U.S. Small Passenger Vessel *Lady D*
Northwest Harbor, Baltimore, Maryland
March 6, 2004**

Marine Accident Report

NTSB/MAR-06/01

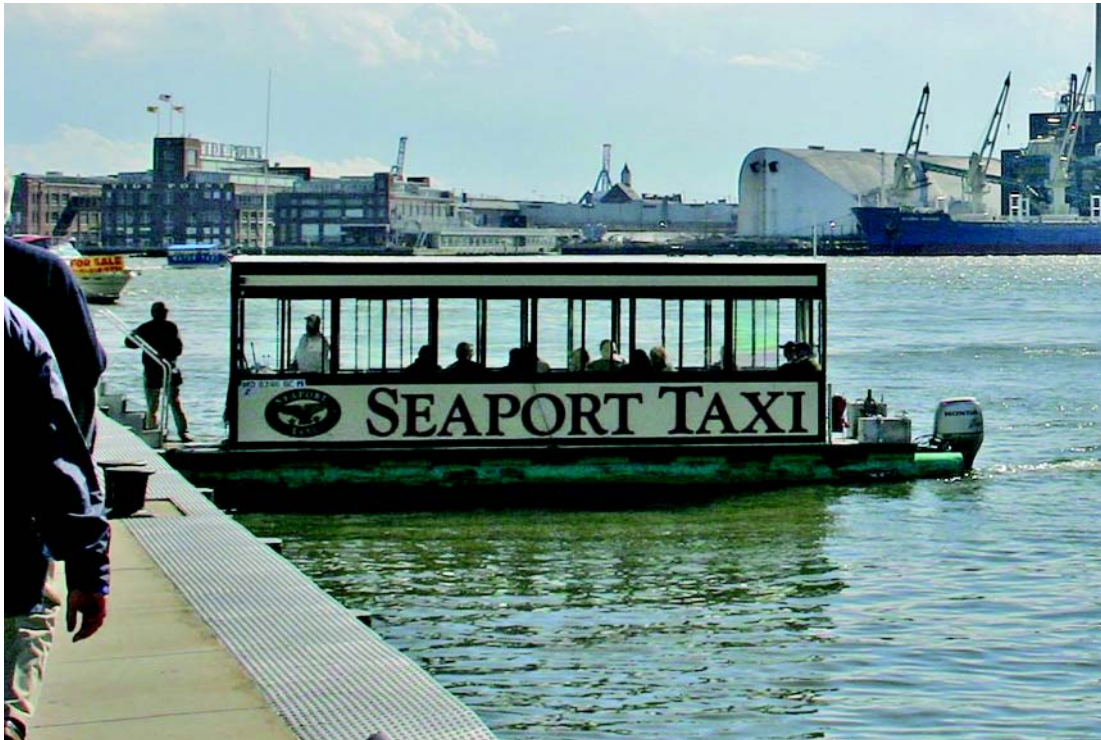
Figure 2. The U.S. small passenger vessel *Lady D* (above), an 8-foot-wide by 36-foot-long commercial pontoon boat, was certificated by the U.S. Coast Guard to carry 25 people. The process by which the *Lady D*'s allowable load was determined is discussed in the "Vessel Information" section of this report.

The *Lady D* had 12 slider windows, six along the port side of the vessel and six along the starboard side. (See figure 2.) Each slider window had one 24-inch-wide fixed sash and one 24-inch-wide sliding sash. One passenger said that he kicked on the window to get it to open. Another passenger said that he tried to open a window, but it seemed to be locked.¹⁰ He then noticed that the man next to him slid a window to the side to open it, whereupon he slid open his own window. He said that by this time, he could not see anything in the murky water. He felt a "sensation," but was not sure whether it was water pushing against him or whether "the window just ... caved in...." He then felt his way out of the boat. A female passenger also stated that while swimming down in the overturned deckhouse to find an exit, she felt and pushed on a window, only to have it "float away," which led her to believe that it was no longer attached to the boat.

Vessel Construction and Design. The vessel's pontoons, hull, and deckhouse (figure 2) were constructed of marine-grade aluminum. The hull consisted of two cylindrical pontoons connected by an I-beam framework and deck structure. The pontoons were constructed in seven sections, with a transverse bulkhead between each section. The deckhouse structure measured 24 feet 1/2 inch long and 7 feet 8 inches wide and had a canopy that measured 7 feet high at the sides and 7 feet 6 inches at the peak.¹⁷ The sides of the deckhouse each had a waist-high bulkhead, above which were six slider windows having one fixed sash and one sliding sash. Each window sash measured 42 inches high and 24 inches wide.

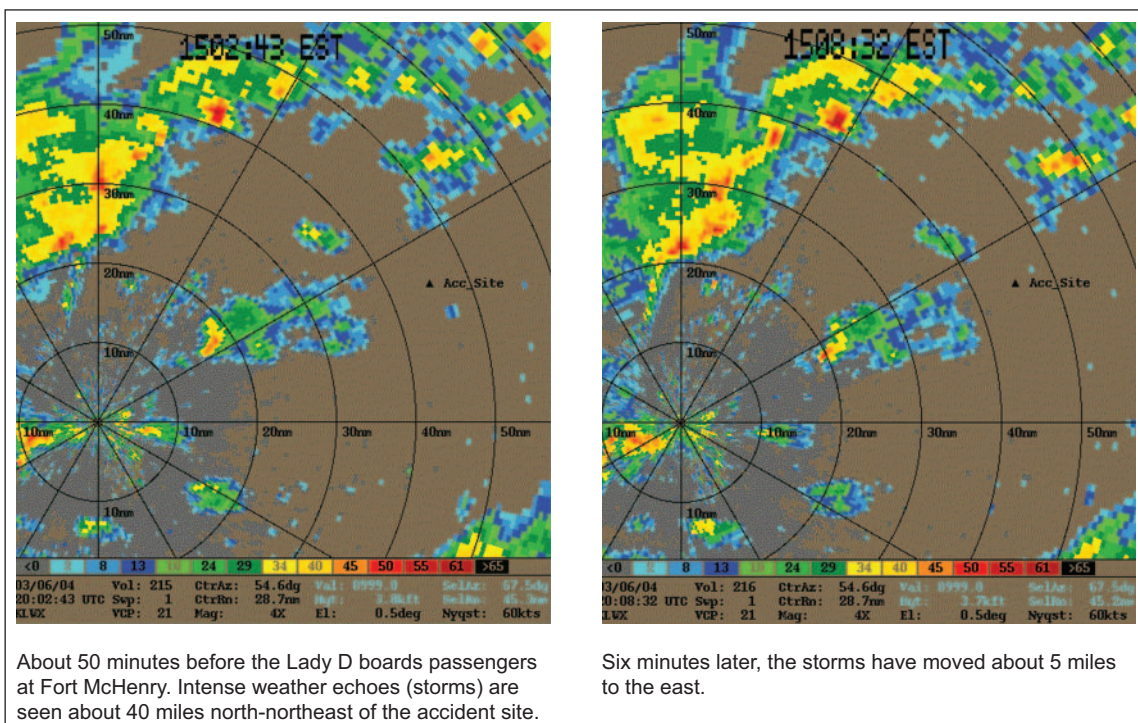
Figure 4. WSR-88D, or Doppler weather radar, shows detailed images of precipitation (snow, rain, hail) and other phenomena, including air motions within a storm. The images above show weather radar echoes, some of which are intense to extreme, moving to the east. The colors noted on the bottom of the images relate to weather radar echo intensities (in decibels of Z [dBZ], where Z = energy reflected back to radar). The colors blue to yellow indicate intensity ranges from weak, moderate, to strong, and the colors orange to red indicate ranges from very strong, intense, to extreme.

According to the radar operator at the Baltimore-Washington weather forecast office, he was receiving few aircraft soundings to the west of the cold front, which might have alerted him to increasingly unstable conditions. In addition, he did not recall his office's weather processing system generating a "meaningful" radar alarm that might have alerted him to a significant change. He later advised NWS officials who conducted an independent investigation that he had expected the storm to dissipate as area spring storms had typically done in the past.

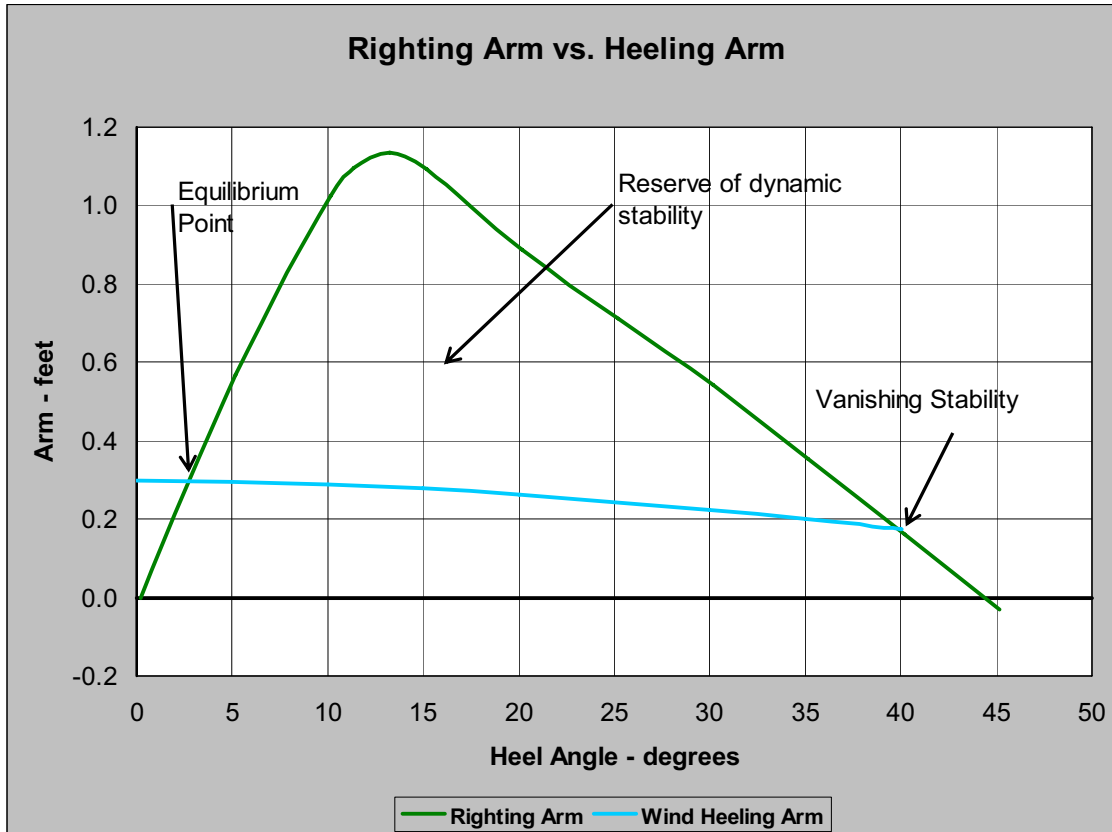
Figure 6 Righting Arm versus Wind Heeling Arm

Wind heeling arm curves are usually plotted on the same graph as a vessel's righting arm curve (Figure 6). The righting arm and wind heeling curves show important information about a vessel's intact stability in wind. The first intersection between the righting arm curve and the wind heeling arm curve is the equilibrium point. The angle of this intersection is how far the vessel would be heeled by a steady wind. If the wind heeling arm exceeds the vessel's righting arm the vessel will capsize. The second intersection point between the two curves is the point of vanishing stability in for the vessel at that wind speed. A steady wind heels a vessel over and reduces the amount of righting energy that is available to counteract environmental variables such as wind gusts or waves. The area between the two curves is called by naval architects the vessel's "residual righting energy". It is the vessel's reserve of righting energy that is available to counteract dynamic heeling forces. Stability criteria for ships that use the concept of righting energy usually do not consider the full area under the righting arm curve, but rather use only a portion of it, such as the area to the angle of maximum righting arm, the angle of downflooding, or a specified angle in degrees. This approach is conservative because it builds in an unspecified

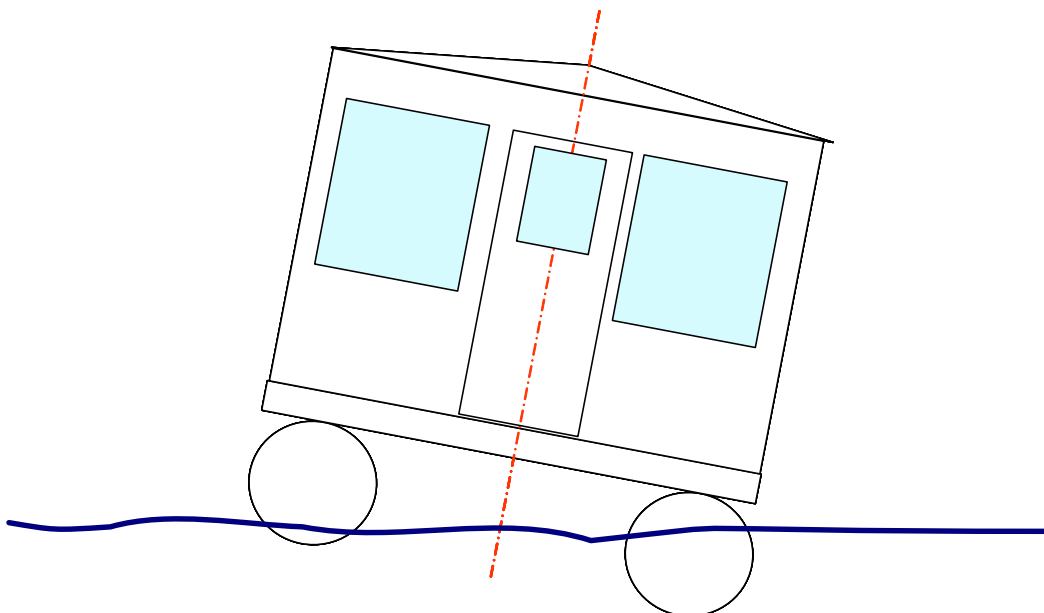
Figure 10 Sketch of LADY D in the Heeled Condition

The impact of a 40-knot steady wind on the intact stability of the LADY D as loaded on the day of the accident is shown in Figure 9. This figure shows the “residual righting arm” for the vessel, which is the difference between the righting arm for the vessel and the wind heeling arm. The figure shows that a steady 40-knot wind would heel the vessel over to a 6.1 degree angle in calm water. Figure 10 is a sketch of the vessel looking at the bow in the heeled condition. The pontoon on the opposite side from the wind is deeply submerged and has little reserve buoyancy left to counteract any additional heeling forces. At an angle of slightly less than 22 degrees of heel, the vessel has no more righting energy and there is nothing to prevent the vessel from capsizing. Any additional external force (such as a gust of wind or a wave hitting the boat), a rapid maneuver by the boat’s captain, or a shift in the boat’s center of gravity due to passenger movements would be enough to capsize the vessel. At this wind speed there is very little margin remaining in the vessel’s intact stability to counteract any additional heeling forces.
