**Rupture of a Railroad Tank Car Containing  
Hazardous Waste  
Freeport, Texas  
September 13, 2002**

**Hazardous Materials  
Accident Report**

**NTSB/HZM-04/02**

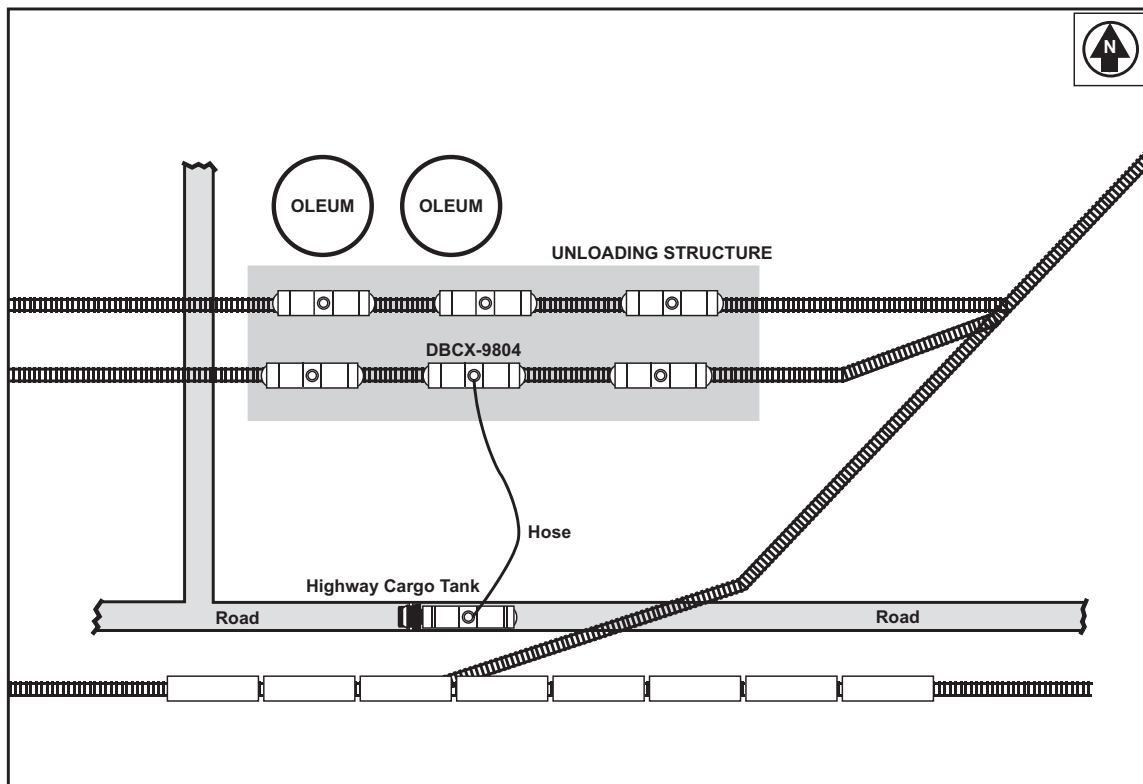
**Figure 2.** Schematic drawing of Freeport facility transfer area showing the highway cargo tank, railroad tank car DBCX 9804, unloading hose, and oleum tanks.

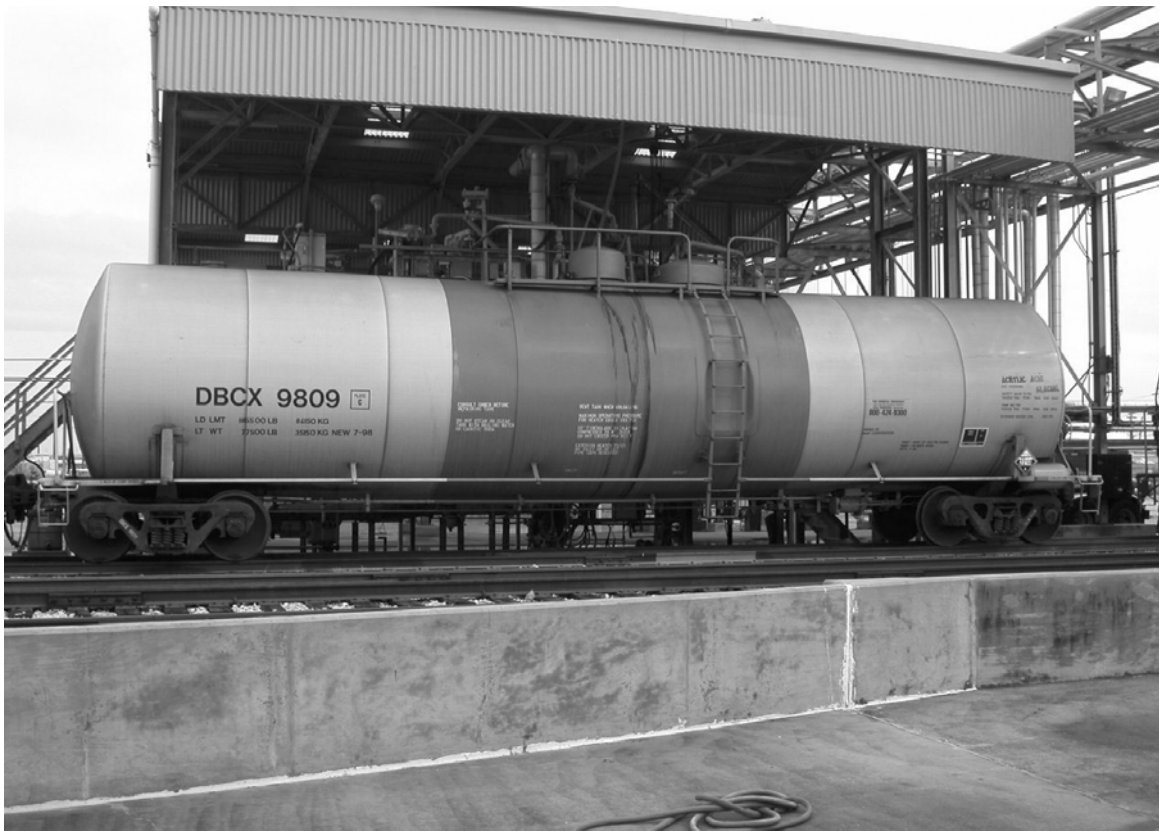
**Figure 4.** Undamaged tank car comparable to DBCX 9804.

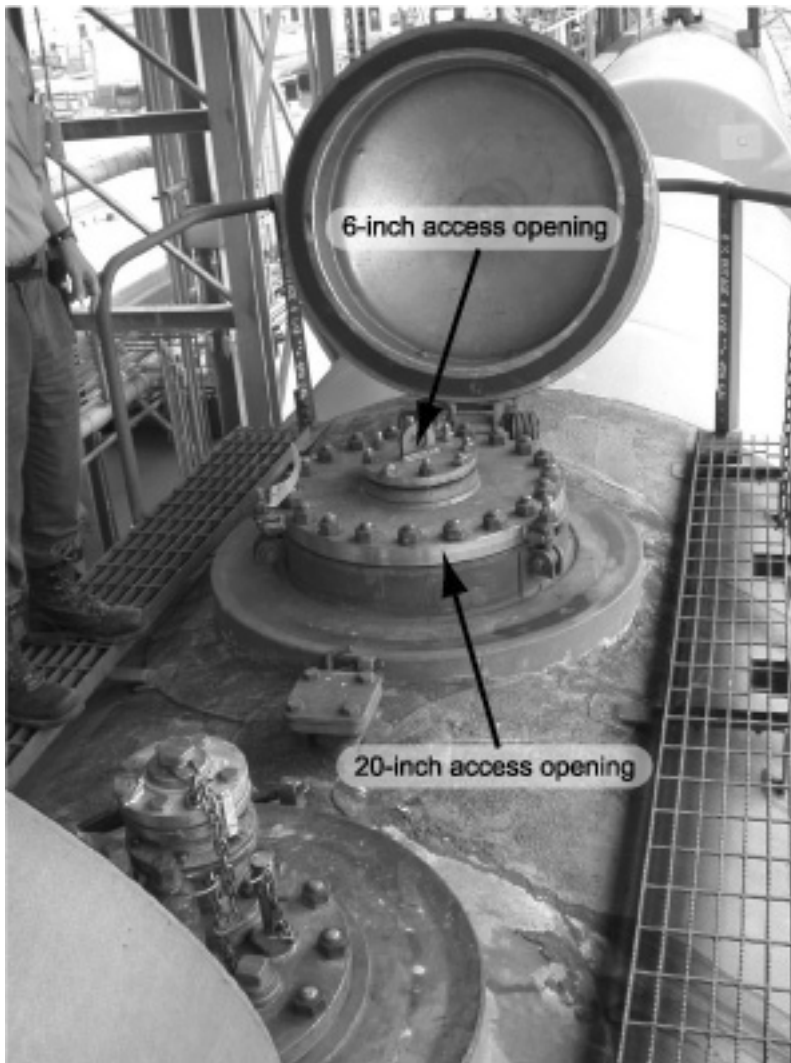
**Figure 5.** Photo showing interiors of two dome housings of tank car comparable to DBCX 9804. Housing to the right contains 6-inch access opening and 20-inch access opening.

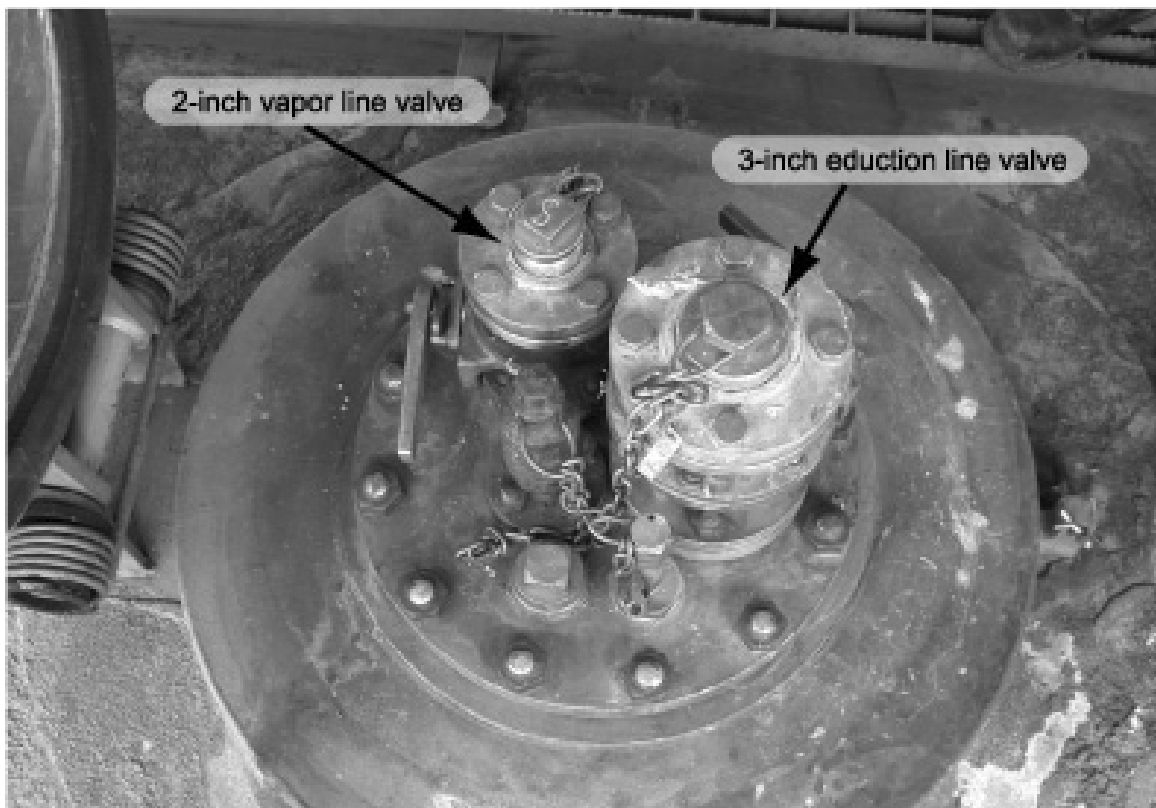
**Figure 6.** Housing of second dome on tank car comparable to DBCX 9804.
