609TH IRAQI NATIONAL GUARD
BATTALION GARRISON
THI QAR GOVERNORATE, IRAQ

SIGIR PA-06-056
JULY 25, 2006

SUBJECT: Report on Project Assessment of the 609th Iraqi National Guard Garrison,
Thi Qar Governorate, Iraq (Report Number SIGIR-PA-06-056)

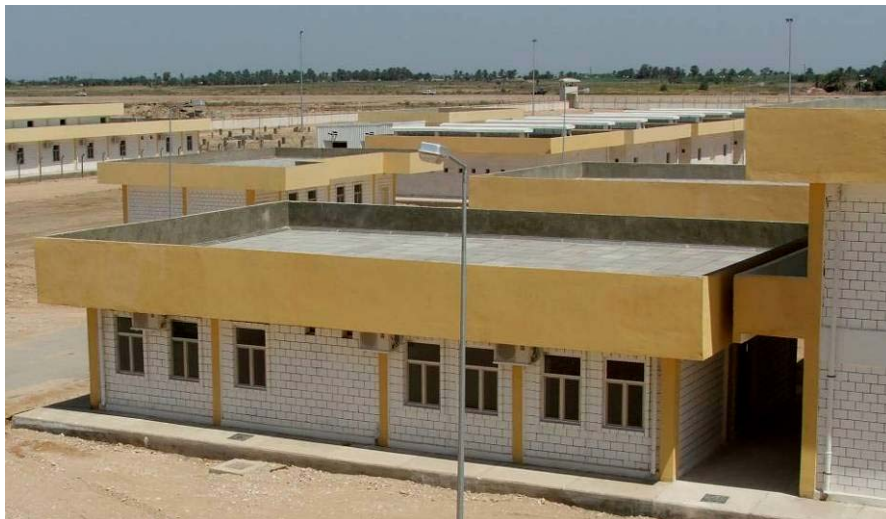
The 609th ING Battalion garrison buildings were designed with the same architectural style. The majority of the buildings are reinforced concrete structures infilled with exterior masonry walls. Site Photo 1 shows the style of construction that was utilized at the 609th ING garrison.

Site Photo 1. Buildings at the 609th ING Battalion Garrison

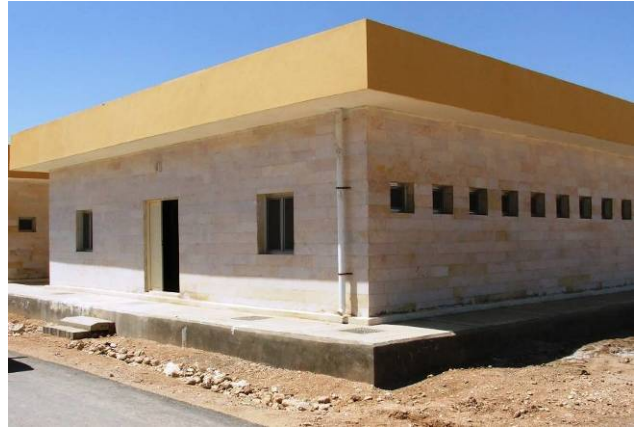
Site Photo 8. Completed shower and toilet building

Based on the review of the design and our observations, the shower and toilet buildings and interior finishes appeared to be constructed as designed. However, similar to the barracks buildings, on some of the doors, there were gaps between the exterior door and the doorframe as seen in Site Photo 9. As noted earlier, the USACE PE, subsequent to this site visit, instructed the contractor to correct the problem and the contractor agreed to install weather stripping and door sweeps.

In addition to the doors, we found the floor tile in many areas needed cleaning. According to the USACE PE, this had been a continual problem and it had been

listed as a deficiency on the USACE Quality Assurance Representative's deficiency tracking log. Additionally, in some areas, particularly near the walls or corners of the showers or water closets, we found the quality of workmanship associated with the ceramic floor tile grouting to be poor. Site Photo 10 provides an example of grouting workmanship, showing excess material left on the floor tile and dirty grout. One factor affecting the quality of workmanship, especially with finish work activities, was the requirement to utilize local labor. The USACE PE informed us that in order to maintain good relations with the local Iraqi leaders, the contractor was compelled to hire local labor, the majority of which were unskilled. The use of unskilled labor on this project directly influenced the quality of workmanship.

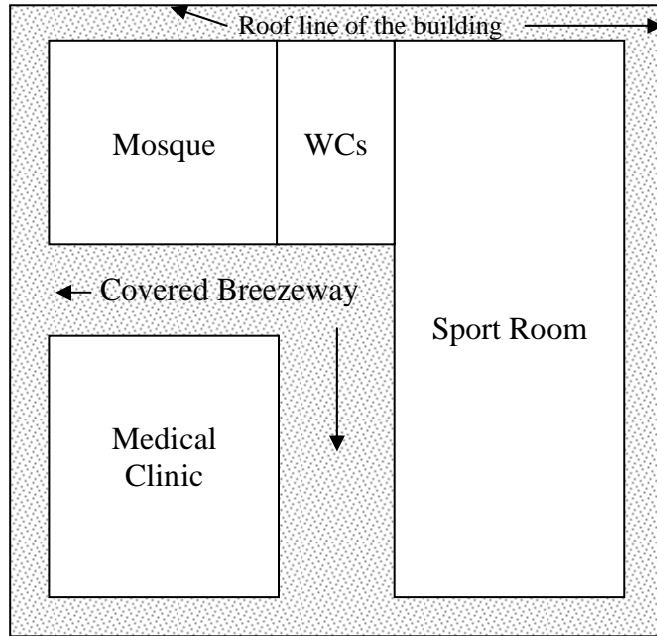
These three facilities were co-located in the same structure under one roof, although the medical clinic was separated from the other two by a covered breezeway. Diagram 1 provides the layout of the facilities. In addition to the three facilities, the building contained a lavatory with eastern style toilets and a separate hand wash area similar to the type of hand wash stations in the shower and toilet buildings.

Diagram 1. The layout of the sport room, lavatory, mosque, and medical clinic

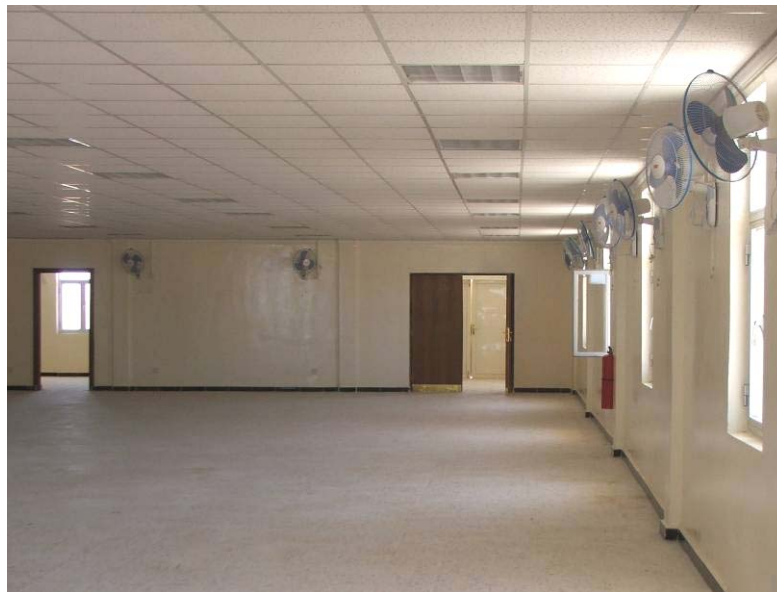
The design for the 11.8 m x 30 m sport room, which included an office and a storeroom, required plastered and painted walls and ceilings, terrazzo floors, aluminum frame windows, wood interior doors, and metal exterior doors. The original design required window air conditioning units, but the air conditioning units were de-scoped from the project prior to construction. Site Photo 14 shows the sport room. In the absence of air conditioning, the contractor had placed fans along the walls. In addition, instead of a plastered and painted ceiling, the contractor installed a suspended acoustical ceiling after requesting and receiving approval from the USACE Area Office. Based on our observations of the sport room construction, the facility as constructed, met the requirements of the design.

Site Photo 14. Sport room with adjoining office and store room

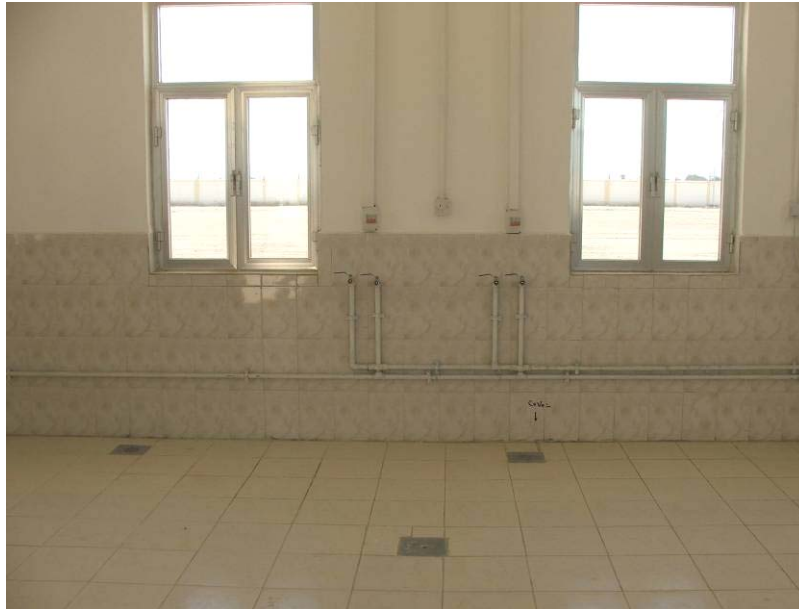
The washers and dryers were not part of the scope of work and were to be provided by the Iraqi military. The laundry's required interior finishes included ceramic tile floors, ceramic tile walls (on the lower half with the upper half plastered and painted), as well as plastered and painted ceilings. Site Photo 16 shows the interior of the laundry, including some of the piping, connections and power outlets for the washers. Our observations indicated the laundry construction satisfied the design requirements.

Site Photo 16. Interior of the officer laundry

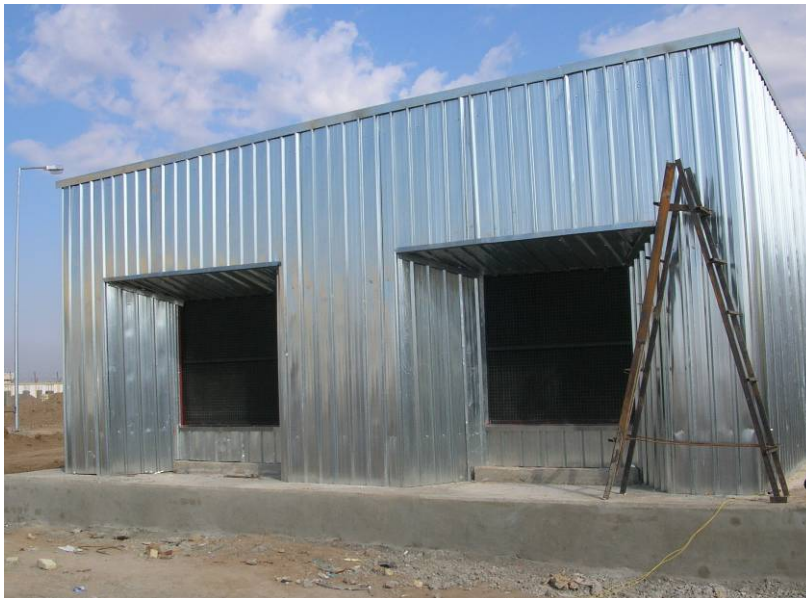
The design required housing the two generators in a reinforced concrete structure with sand lime block-walls similar to the others constructed at the garrison. However, with the shift in site generator locations, a decision was made by USACE to use a pre-engineered metal building to house the generators instead of the reinforced concrete structure. Site Photo 17 provided by USACE, shows the metal building while under construction prior to painting.

Site Photo 18. Generator building while under construction (Photo provided by USACE)

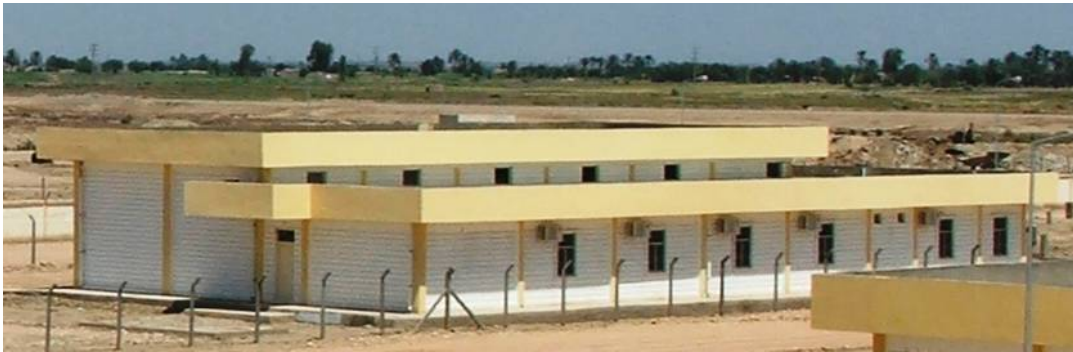
Site Photo 19. Logistics building

We did not find any noticeable deficiencies during our tour of the facility. The construction of the logistics building appeared to meet the requirements of the design.
