**REHABILITATION OF THE MANSOUR
PUMP STATION**

SUSTAINMENT ASSESSMENT

**SIGIR PA-07-111
JANUARY 24, 2008**

SUBJECT: Report on the Rehabilitation of the Mansour Pump Station in the Al Amerea area of Baghdad, Iraq (Report Number SIGIR PA-07-111)

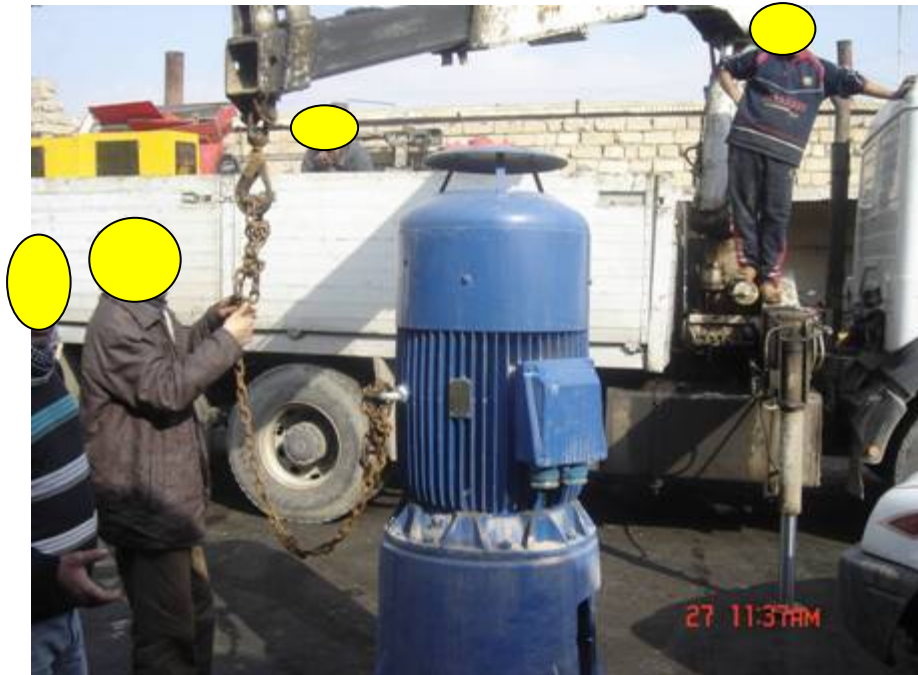
The USACE contract file lacked documentation that the contractor installed the government-provided 350 mm vertical pump. Several QC reports mentioned the completed installation of the 350 mm vertical pump; however, there were no photographs provided to support this claim. The QC reports documented the delivery of the new motor for the 350 mm vertical pump (Site Photo 5), but there were no photographs of the actual contract-required vertical pump.

**Site Photo 5. Delivery of the new motor for the 350 mm vertical pump.
(Photo courtesy of USACE)**

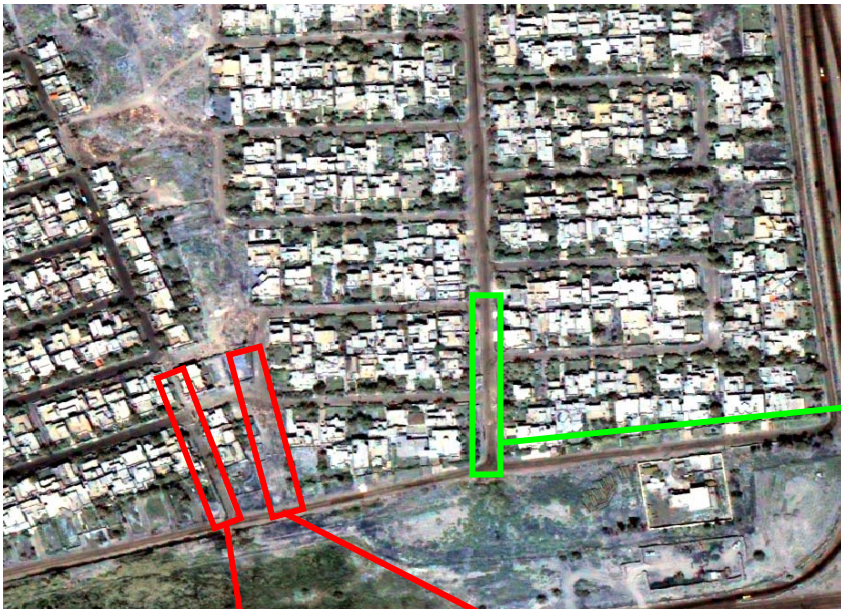
During our first site visit, we identified streets in the Al Amerea area with backed up sewer water and streets with no sewer water back up (Aerial Image 2 and Site Photos 9-11). While we conducted our site visit, a concerned resident of the area angrily complained about the backed up sewer water on his street.

**Aerial Image 2. Overview of the Al Amerea area
(Provided by Digital Globe 2007 ©)**

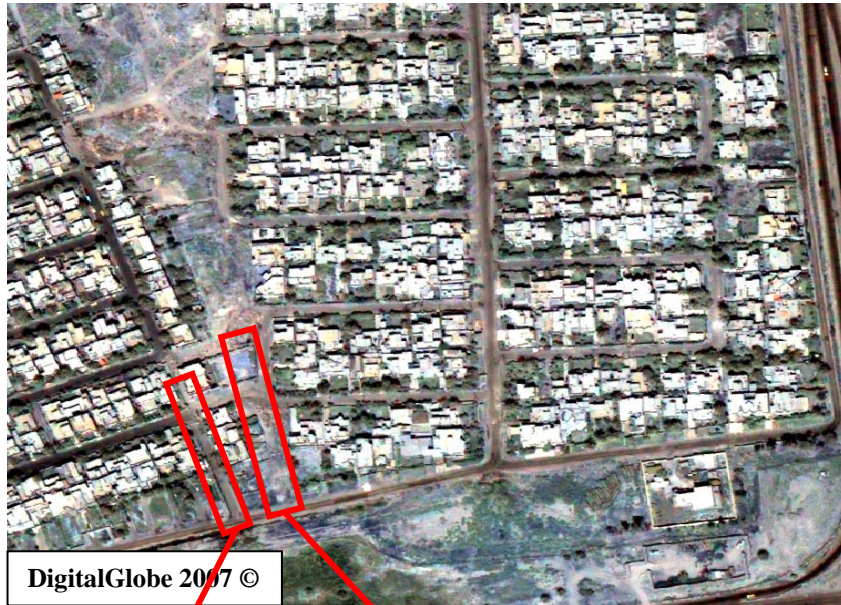
In an effort to determine if backed up sewer water was still affecting the Al Amerea area, we conducted a second site visit. The streets we previously identified with backed up sewer water were dry (Aerial Image 3 and Site Photos 12 and 13).

Aerial Image 3. Overview of the Al Amerea area with the previously flooded section highlighted.

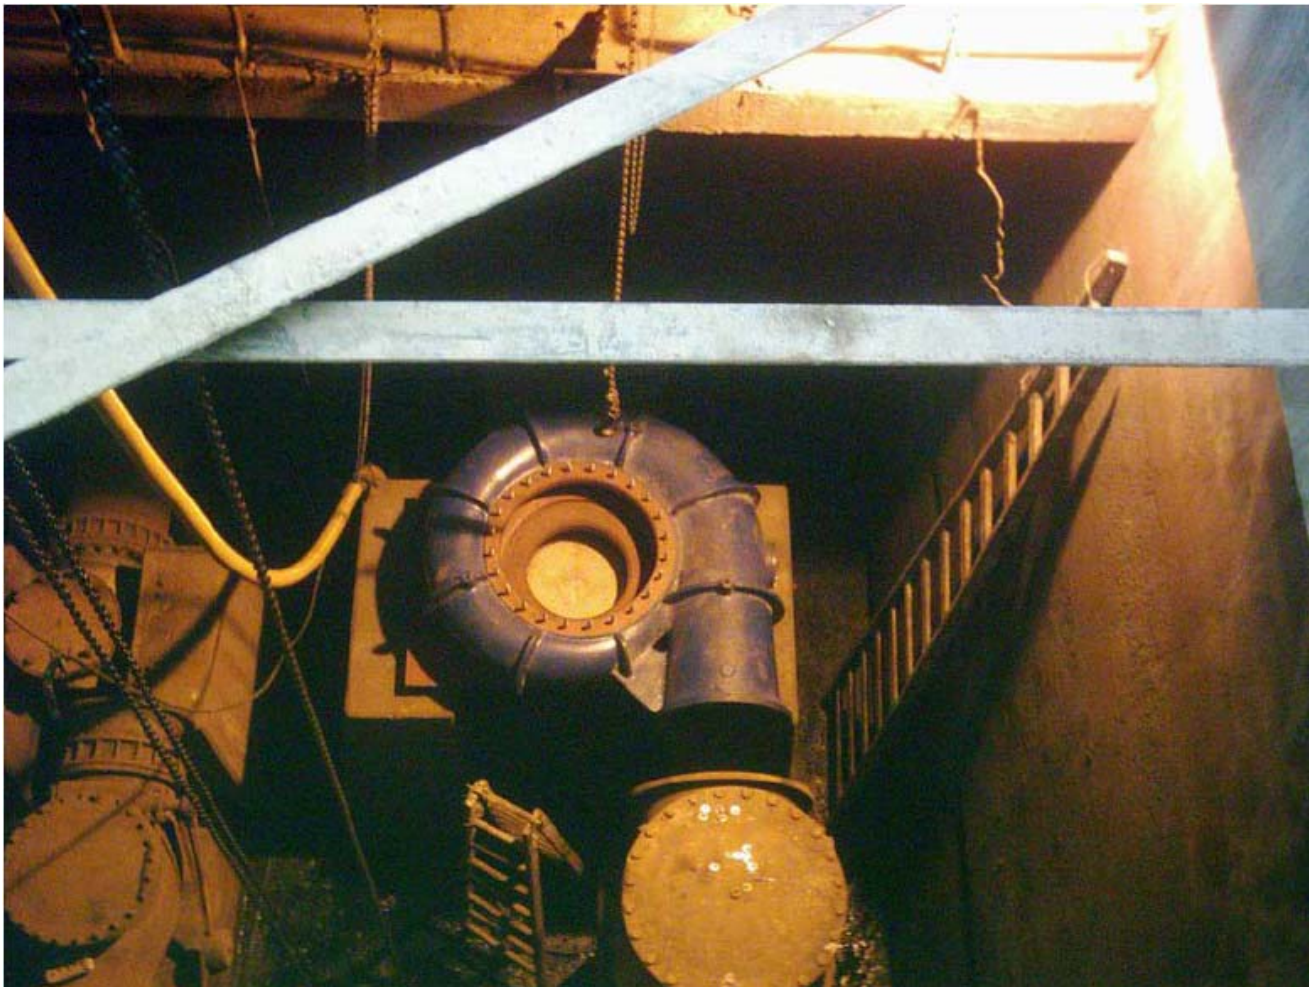
Phase 2 contract file documentation showed photographs of the installation of the four vertical pumps. For instance, Site Photo 21, which shows the installation of the 800 mm vertical pump, came from a daily QAR report.

Site Photo 21. Photograph from daily QA report documenting contractor progress installing the 800 mm vertical pump (Photo courtesy of the USACE)
