**REPAIR OF THE AL GHAZALIYAH
G-7 SEWAGE LIFT STATION**

UNDER THE COMMANDER'S EMERGENCY RESPONSE PROGRAM

BAGHDAD, IRAQ

**SIGIR PA-07-118
JANUARY 25, 2008**

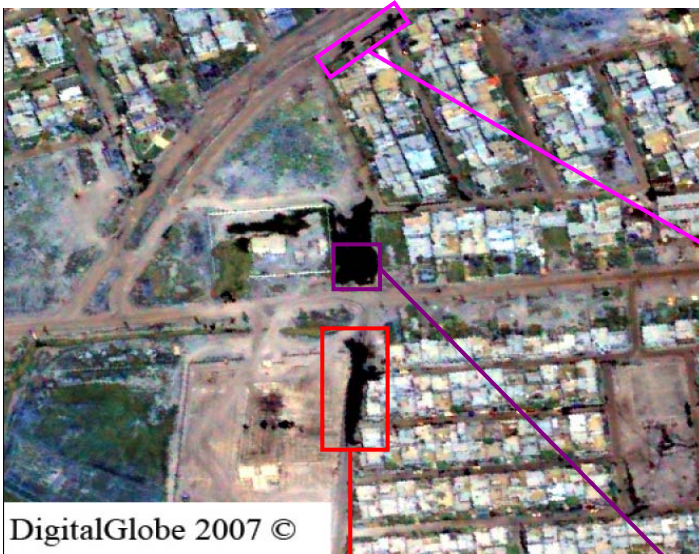
Aerial Image 3. Streets surrounding the G-7 lift station

During both site visits, SIGIR identified several streets in the Al Ghazaliyah area with backed-up sewer water (Aerial Image 3 and Site Photos 3-5).
