SARWARAN PRIMARY SCHOOL
UNDER THE COMMANDER'S EMERGENCY RESPONSE PROGRAM
ERBIL, IRAQ

SIGIR PA-08-120
APRIL 21, 2008

SUBJECT: Report on Project Assessment of the Sarwaran Primary School, Erbil, Iraq (Report Number SIGIR PA-08-120)

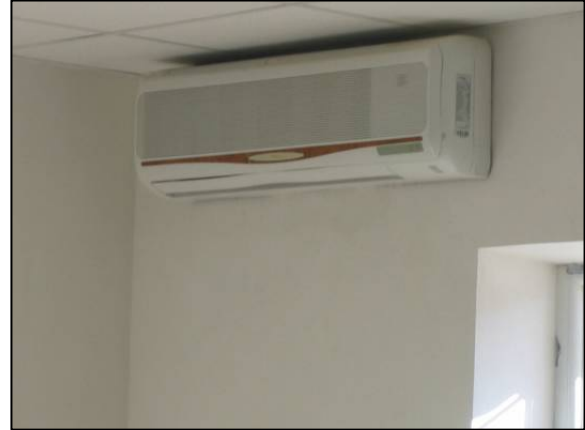
The hallways and classrooms were completed with tiled floors, plaster walls, and incandescent lighting. Two split air conditioning/heating units were installed in each room. We tested a sample unit and it functioned properly. Site Photos 6 and 7 show the hallway and a split air conditioning unit.

Site Photo 7. Split air conditioning unit

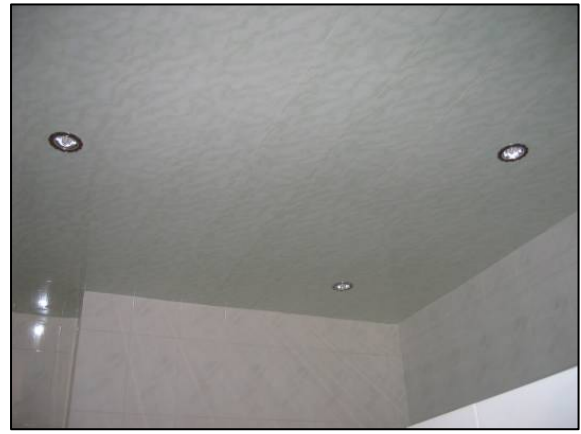
we noted that a web site for the sink brand (www.chiniam.ir) was an Iranian site. Site Photos 10 through 13 show the bathroom fixtures and ceiling.

Site Photo 11. Bathroom ceiling

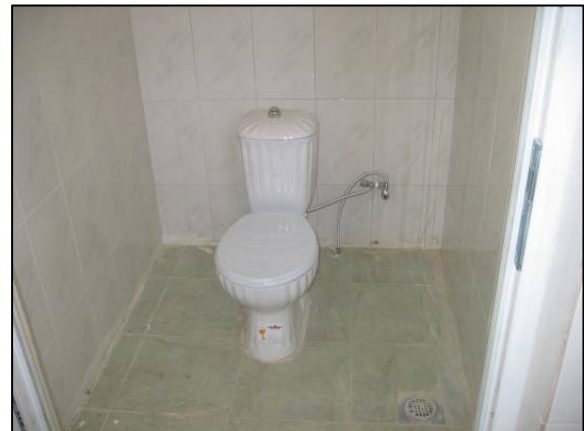
Site Photo 13. Western toilet

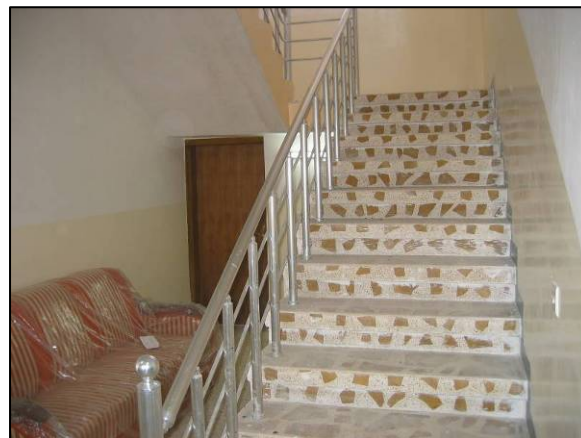
Windows were installed and functioned properly. Tiled stairways were guarded with stainless-steel railings that were adequately secured. The slope and step dimensions were adequate. Classroom title signs were installed on the outside of each classroom. Site Photo 14 shows the stairway and railing.

Site Photo 14. Stairway and railing
