**RAMADI 132-KILOVOLT SUBSTATION
RAMADI, IRAQ**

**SIGIR PA-08-153
JANUARY 27, 2009**

SUBJECT: Report on Ramadi 132-Kilovolt Substation in Ramadi, Iraq
(SIGIR Report Number PA-08-153)

Ramadi 132-Kilovolt Substation Ramadi, Iraq

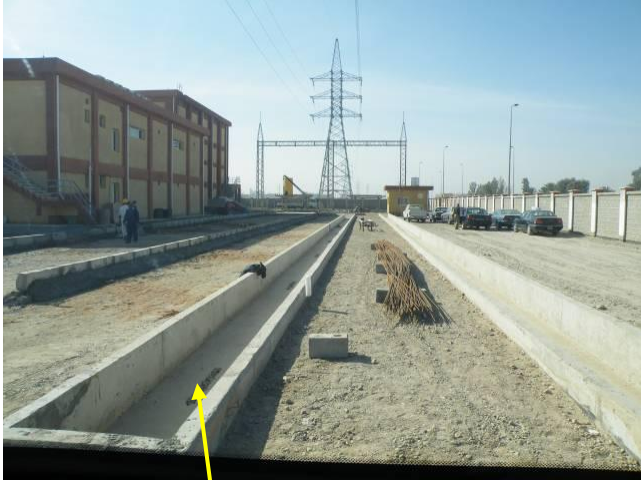
Site Photo 7. Cable trenches

The design required through-wall ducts and trenches for 132-kV feeder cables, 132/33/11 transformer cables, 33-kV feeder cables, and 11-kV feeder cables (Figure 4). The concrete cable trenches appeared to be well constructed and monolithic (Site Photo 7). For the wet season, the interior of the cable trenches has French drains (Site Photo 8). The cable trench proceeds up to the building (Site Photo 9), and the exterior wall of the substation has conduit installed to allow for the passage of cables from the transformer cables to enter the interior of the substation and for the feeder cables to exit the building (Site Photo 10).

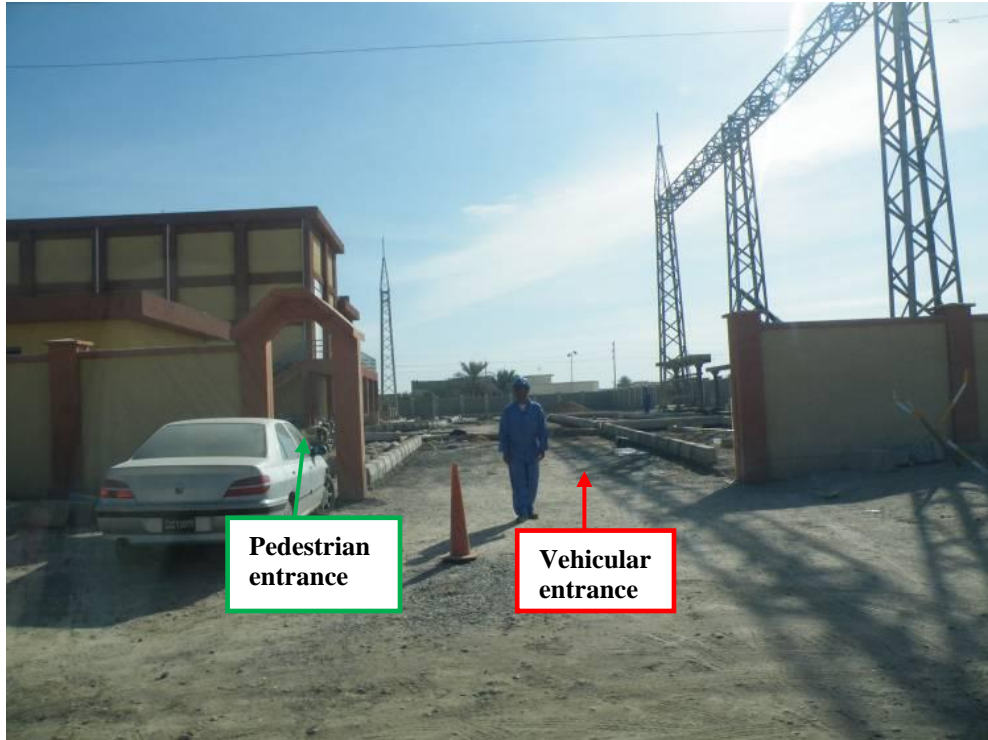
Site Photo 17. Pedestrian and vehicular entrances

Since the project was reportedly 88% complete, the substation is still under construction in various areas. The contract required the vehicular and pedestrian entrance gates to be made of steel construction. Currently the contractor has not completed the vehicular entrance or pedestrian gates (Site Photo 17). In addition, the contract stated that the contractor would provide external access roads. When the site assessment team toured the Ramadi 132-kV Substation, the roads were still a work in progress (Site Photo 18).

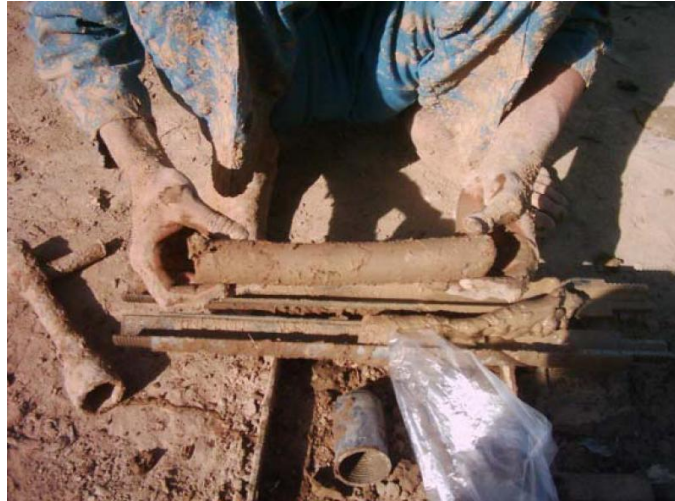
Site Photo 21. Split spoon sample (Courtesy of USACE)

Throughout the project, the contractor conducted daily, weekly, and monthly meetings to review applicable specifications, drawings, submittals, and testing before the start of definable activity on the project. The contractor maintained QC reports, which included descriptions of the day's activities and work performed, workers present, major equipment present, weather conditions, and significant events or concerns for the areas of the Ramadi 132-kV Substation project. In addition, the QC reports had records of tests, inspections, re-work, or deficiencies identified throughout the day. For example, the QC report, dated 15 February 2007, showed the soil investigation tests being conducted (Site Photo 21). In addition, the contractor provided the borehole results for the soil investigation. However, the contractor did not record the results of all concrete or cable tests taken, both passing

and failing, on the QC reports for the dates taken. There is no mention, on the few test results provided, the location where the tests were taken and the sequential control number identifying the test.
