**MISSAN SURGICAL HOSPITAL**  
**UNDER THE ECONOMIC SUPPORT FUND**  
**AL AMARAH, IRAQ**

**SIGIR PA-08-165**  
**SIGIR PA-08-167**

**JULY 16, 2009**

## Missan Surgical Hospital

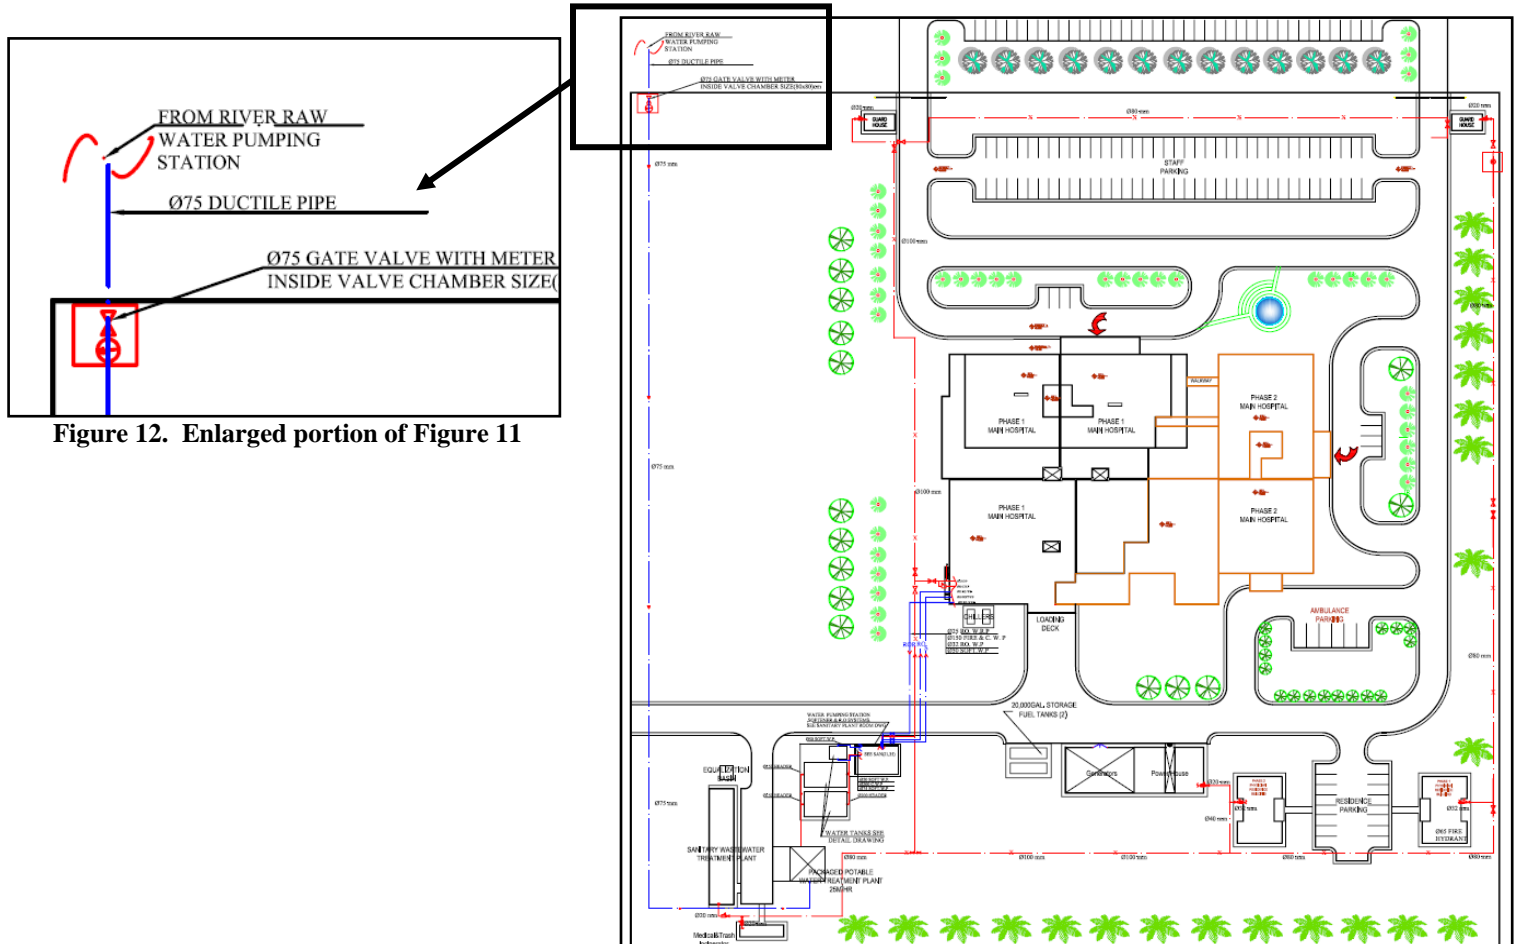
Further, when placed together, the two designs clearly show a lack of detail and cohesion. For example, the SOW required two water lines – one for water processing and one for fire suppression. The “River Intake 6-5 River Intake (1)” design identified only the 150 mm water line; while the “site-maissan Water(27) WATER FIRE(27)(1)” design only identified the 75 mm water line (Figures 10-12). Also, since the security wall has already been constructed, the contractor will now have to excavate under it in order to route the water lines under the wall. In addition, the exact location of the river intake has yet to be determined; instead GRS AAO stated it will be “located approximately where the Tigris [River] and Al Kahla [River] intersect.”

Figure 12. Enlarged portion of Figure 11

Figure 11. Contractor's water site plan (Courtesy of GRS)

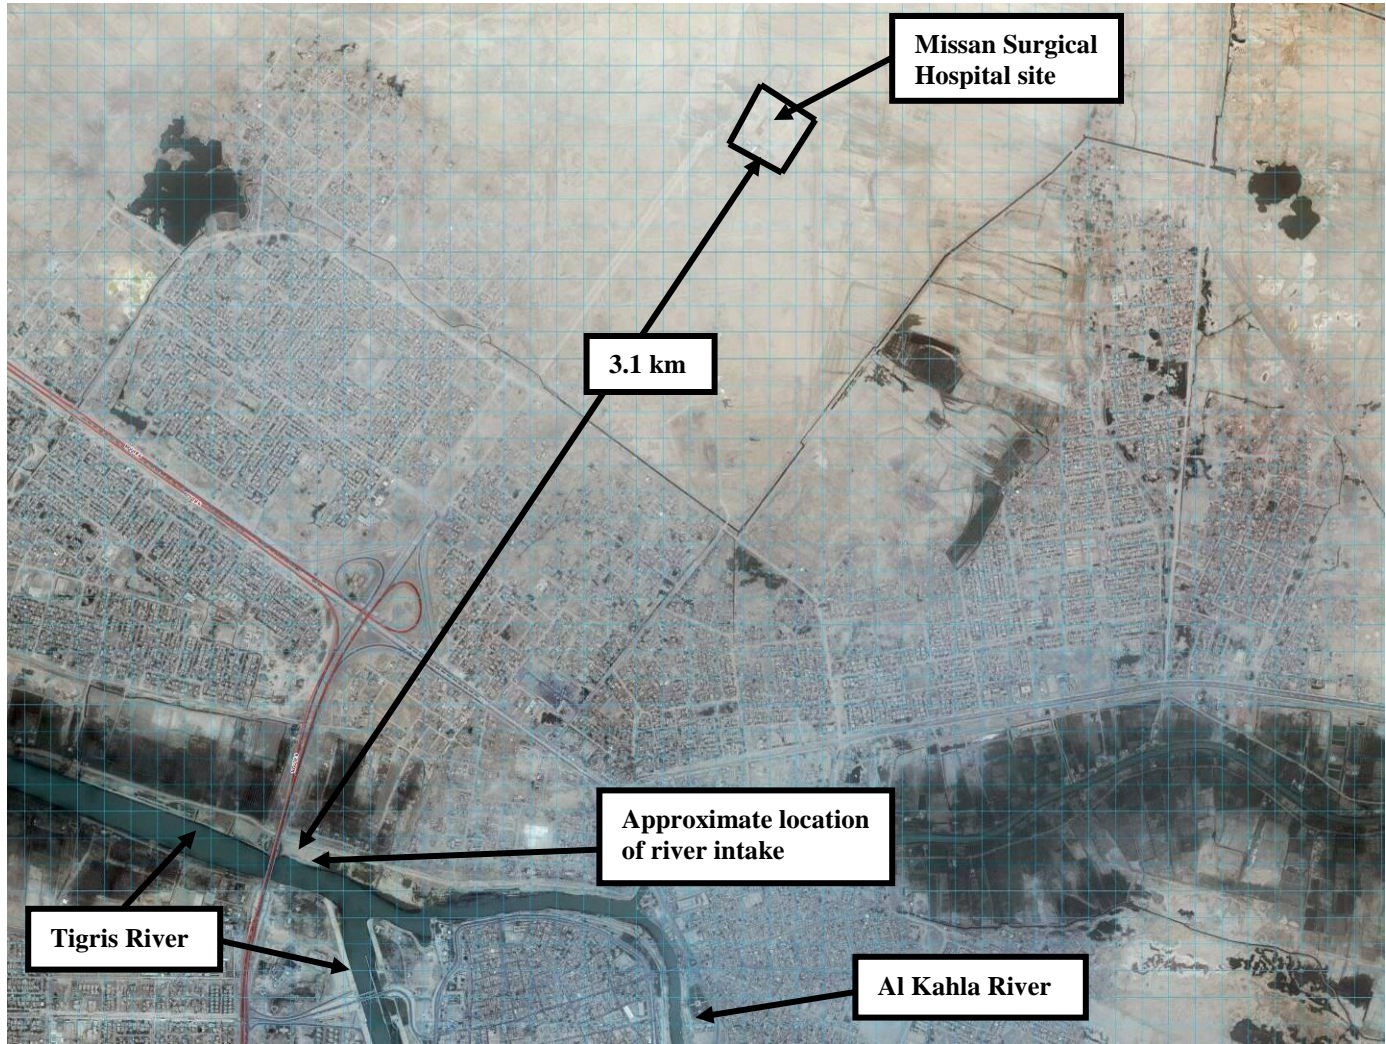
Of particular concern to SIGIR is the lack of the defined route from the river intake to the hospital. According to GRS, the current plan is to place the river intake near the intersection of the Tigris and Al Kahla Rivers and then run the water lines to the hospital site. However, this would require the contractor to excavate and lay two pipe lines a total of 3.1 km through a significant portion of the city of Al Amarah (Figure 13). In a previous SIGIR Inspections report of the Falluja Wastewater Treatment Plant, SIGIR documented significant delays and serious security issues due to the fact the contractor had to excavate and lay pipe through the city.

Figure 13. Aerial view of the water lines to be run from the river intake to the hospital site  
(Courtesy of the National Geospatial-Intelligence Agency)

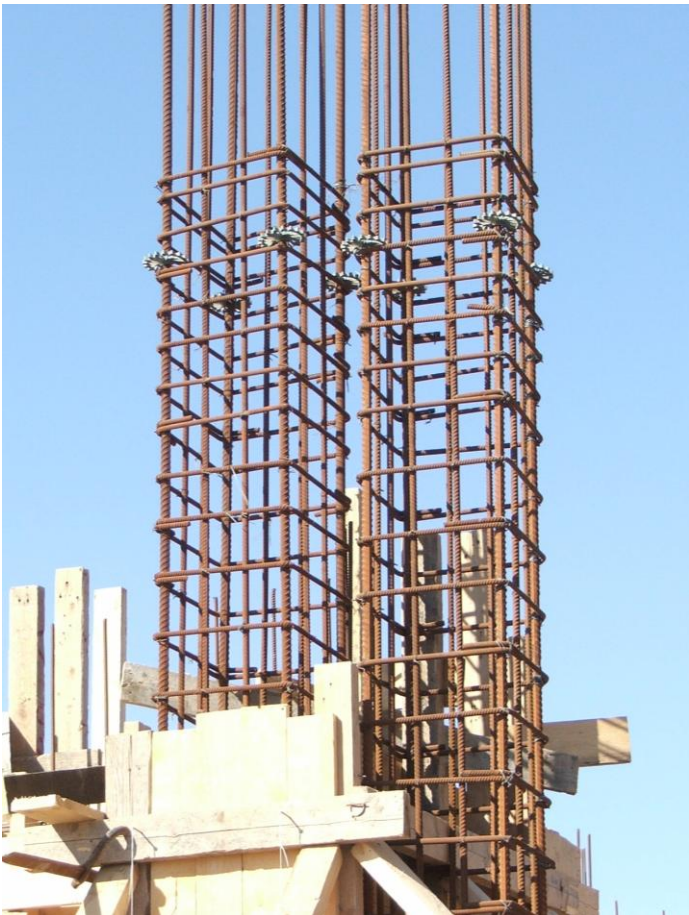
SIGIR noted that in several locations double, and in one case, triple columns were being constructed (Site Photo 14). These columns were not identified on the original URS Corporation drawings for the 80% design for Phase I and a 15% design for Phase II; however, there are indications of multiple columns on the construction contractor's design drawings.

Site Photo 14. Double column forming
