OFFICE OF THE SPECIAL INSPECTOR GENERAL FOR IRAQ RECONSTRUCTION

**SECURE DOCUMENT STORAGE FACILITY  
BAGHDAD, IRAQ**

**SUSTAINMENT ASSESSMENT**

**SIGIR PA-08-166  
OCTOBER 20, 2009**

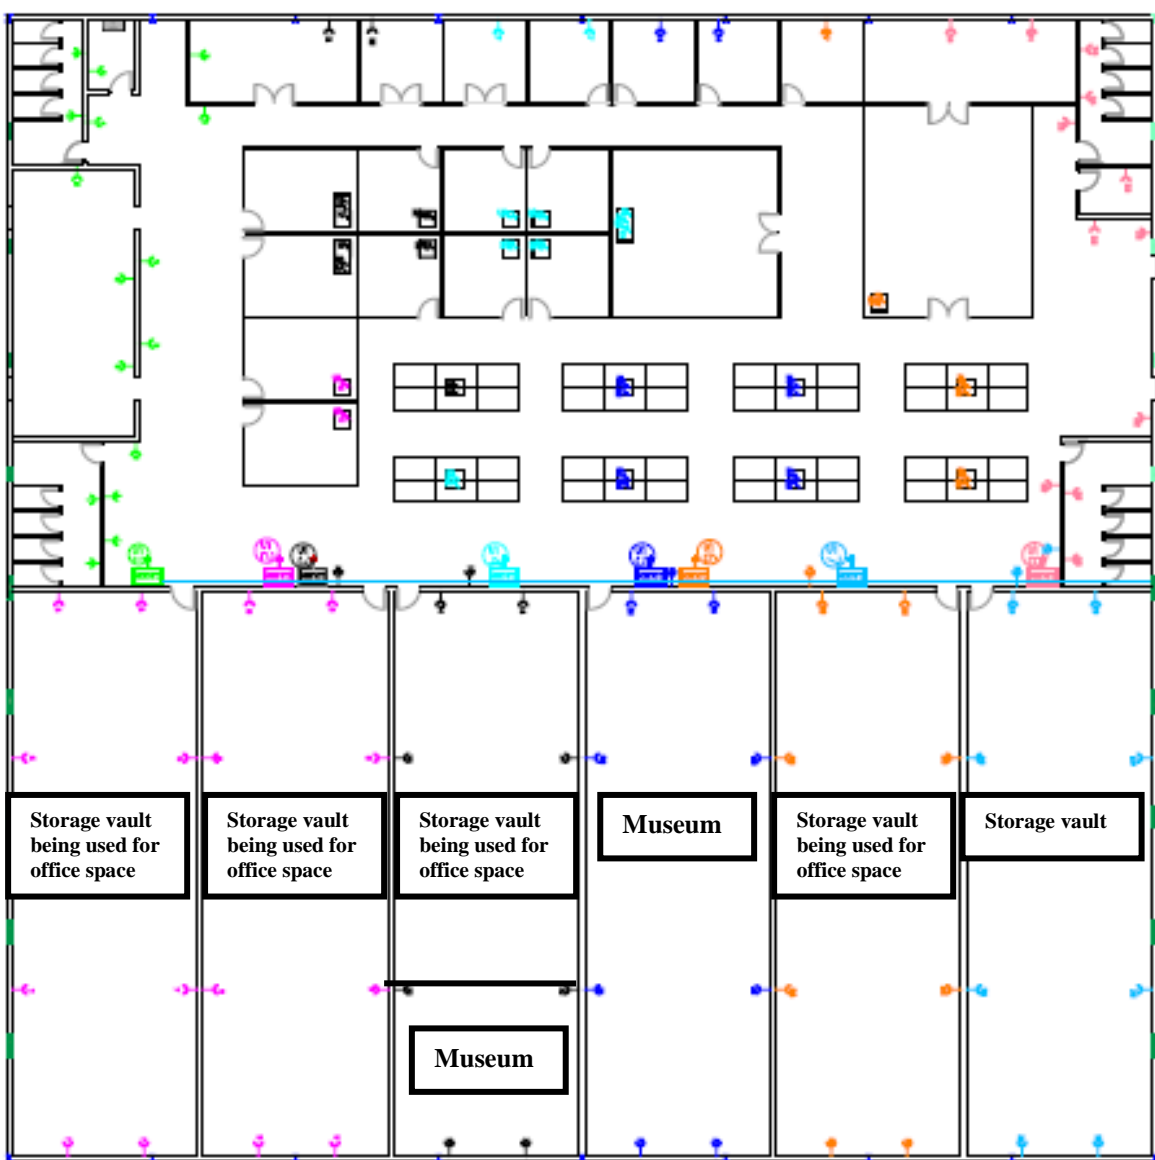
Figure 5. Interior layout of the SDSF (Courtesy of GRC)

The SOW required that half of the 2,500m<sup>2</sup> building would consist of storage vaults to safely and securely maintain critical paperwork and evidence to be used at upcoming criminal trials. The SOW also required four 12.5m x 25m storage vaults with masonry walls and concrete ceilings. However, a July 2006 MFR stated that “both the customer and the contractor have agreed that 6 storage rooms instead of the specified 4 storage rooms would provide more functional space.” As a result, the final design and construction comprised six storage vaults (Figure 5).

The SDSF facility manager stated that the IHT has remodeled the other five storage vault rooms to accommodate the additional personnel. For example, three complete storage vault rooms and part of another have desks and chairs for IHT personnel (Figure 5).

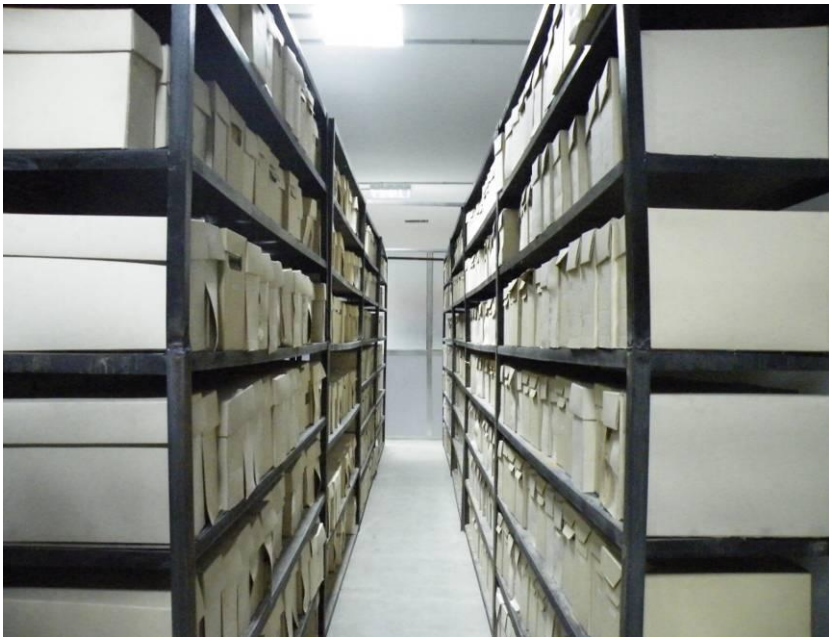
Site Photo 4. Documents stored within the SDSF storage vault room

transferred incrementally to the SDSF. The storage vault rooms were rectangular shaped with only one entrance/exit door. The SDSF facility manager showed SIGIR the one vault room that is currently storing all of the facility’s evidence. This room consisted of metal shelving units filled with boxes of documents (Site Photo 4). According to the SDSF facility manager, the U.S. Department of Justice and the Federal Bureau of Investigation assisted IHT representatives with the proper handling of evidence. For example, each document received is given a unique record identifier number and a computer barcode (Site Photo 5).

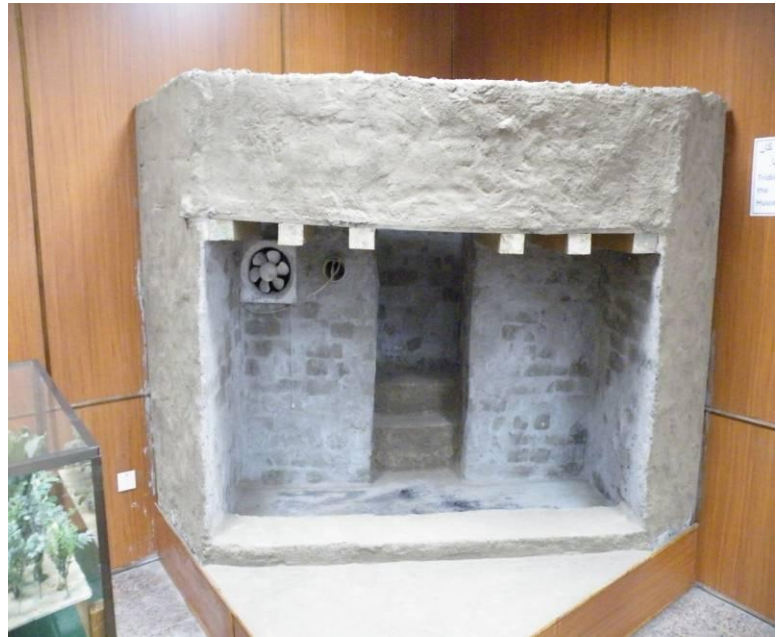
Site Photo 7. Life-size replica of the spider hole where Saddam Hussein was found

The museum also displays a model of the farm house and spider hole where Saddam Hussein was captured by Coalition forces in December 2004 (Site Photo 7).
