**MUJARRAH CANAL BRIDGE  
RAMADI, IRAQ**

**SIGIR PA-09-170  
JULY 14, 2009**

## Mujarrah Canal Bridge

### Summary of Report: PA-09-170

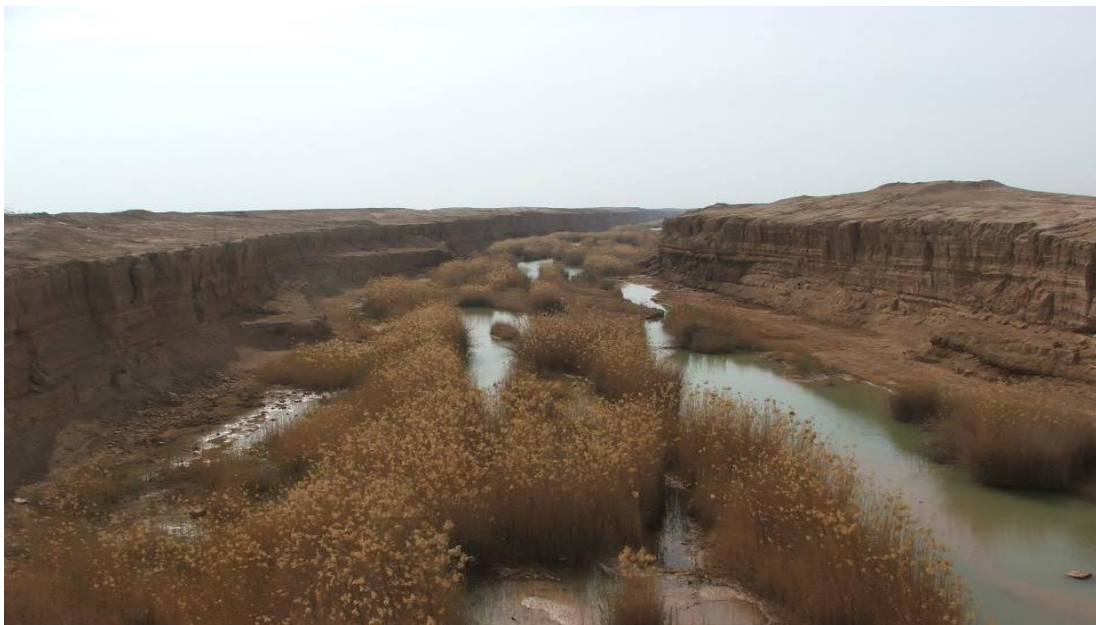
The general topography surrounding the site is level, with no significant changes in elevation. The Mujarrah Canal is the only significant topographic feature in the vicinity, connecting Lake Habbaniyah immediately to the north with Lake Razzazah, approximately 12 kilometers to the south. The canal near the structure is approximately 12 meters (m) deep, with near-vertical sides. The underlying geology appears to be highly erodible, resulting in the deep, approximately rectangular, channel geometry (Site Photo 1).

**Site Photo 1. Looking downstream from the Mujarrah Canal Bridge**

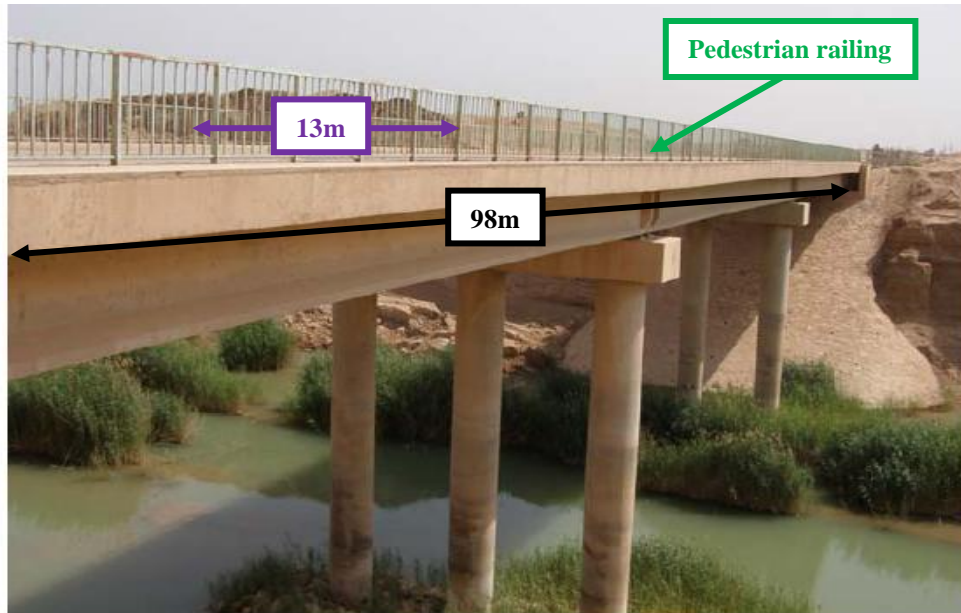
Constructed in 1983, the Murrajah Canal Bridge is a three-span structure, 98m long and 13m wide (Site Photo 2). A reinforced-concrete deck carries a two-lane, 9m-wide cart way, with 2m-wide pedestrian walkways along both sides of the bridge. The cart way is covered with a bituminous asphalt wearing surface and is separated from the walkways by concrete curbing. The cart way has metal pedestrian railing along the outside edge of the walkways. At the end of each girder, pre-molded expansion joints accommodate movement and protect the bearing seats from runoff and debris accumulation.

Site Photo 2. Mujarrah Canal Bridge prior to VBIED damage (Courtesy of GRC)

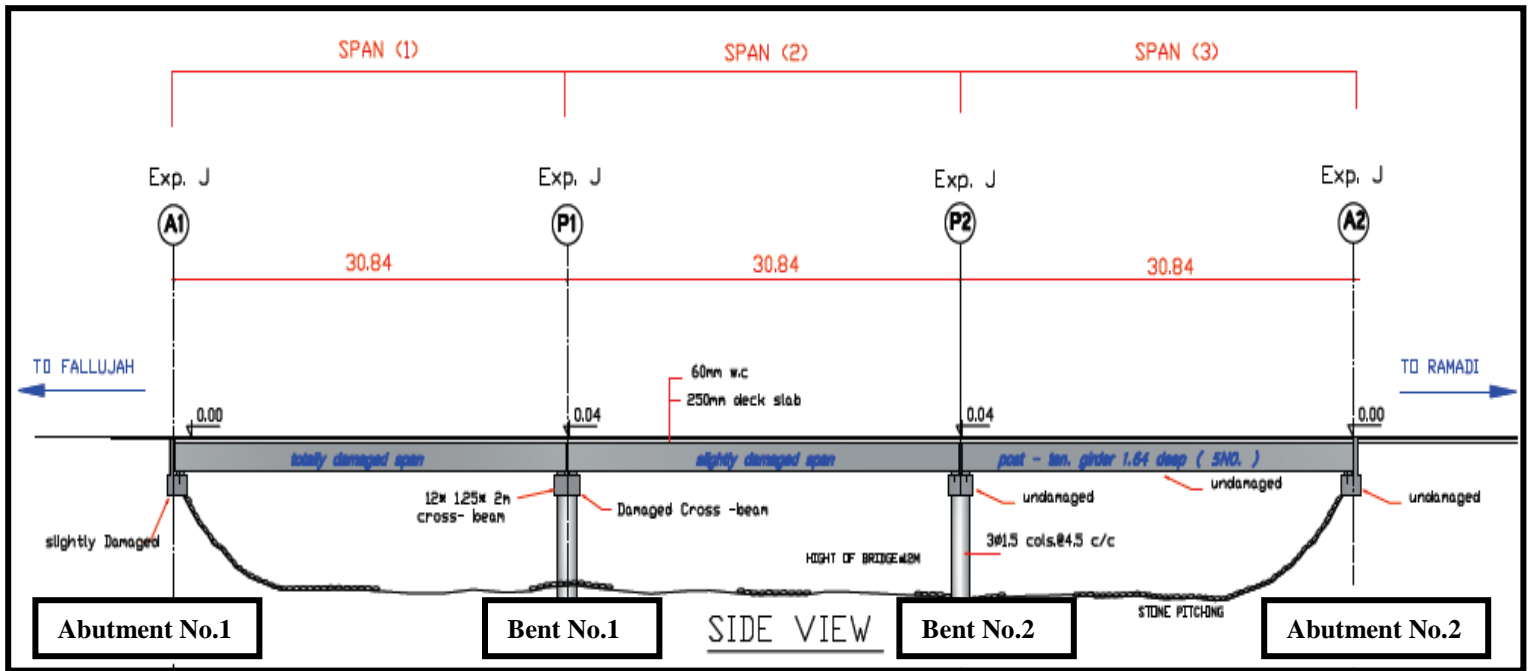
The GRC Falluja Resident Office provided SIGIR with the contractor's generated design package. The contractor's site survey identified all degrees of damage to the existing bridge (Figure 2).

Figure 2. Bridge elevation view (Courtesy of GRC)

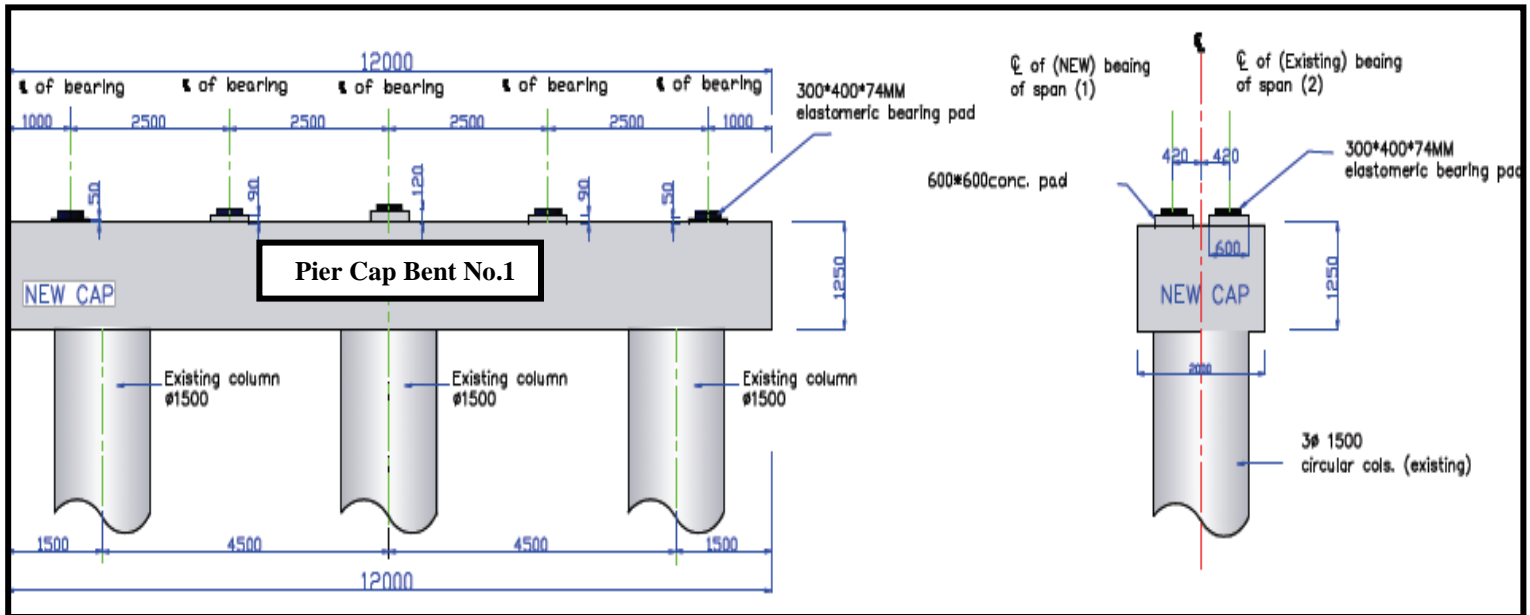
The contractor's generated drawings contained specific information about the temporary jacking and support of the existing structure, construction of the post-tensioned concrete beams and reinforced-concrete deck, and other project features (Figure 3).

Figure 3. Typical Bent elevation and section (Courtesy of GRC)

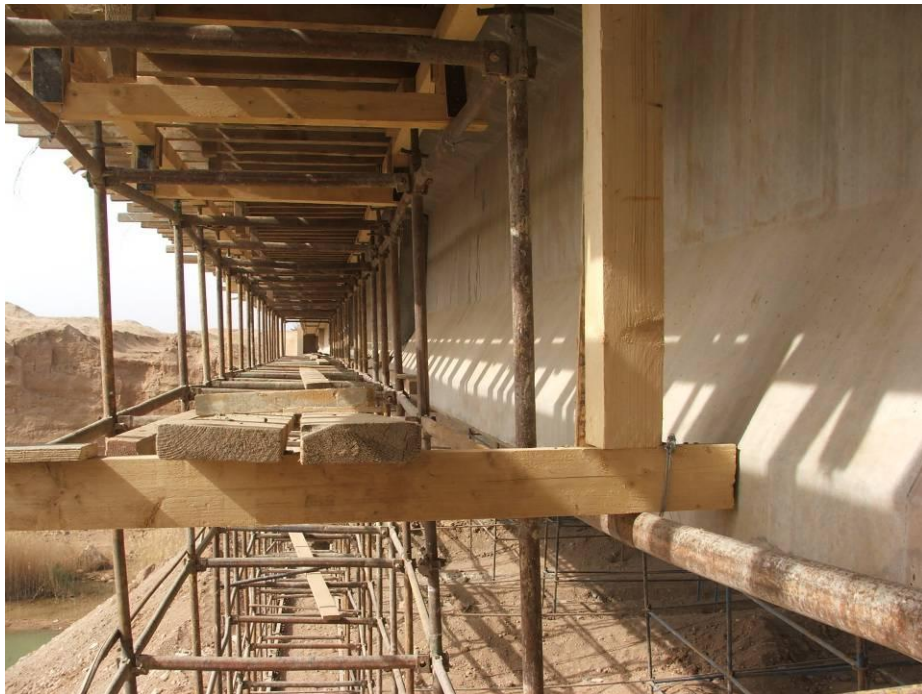
constructed on scaffolding, supported from the fill placed beneath the structure (Site Photo 8.)

**Site Photo 8. Falsework for forming concrete deck overhang**
