ABU GHRAIB DAIRY
ABU GHRAIB, IRAQ

SIGIR PA-09-172
JANUARY 14, 2010

Abu Ghraib Dairy

Summary of Report: PA-09-172

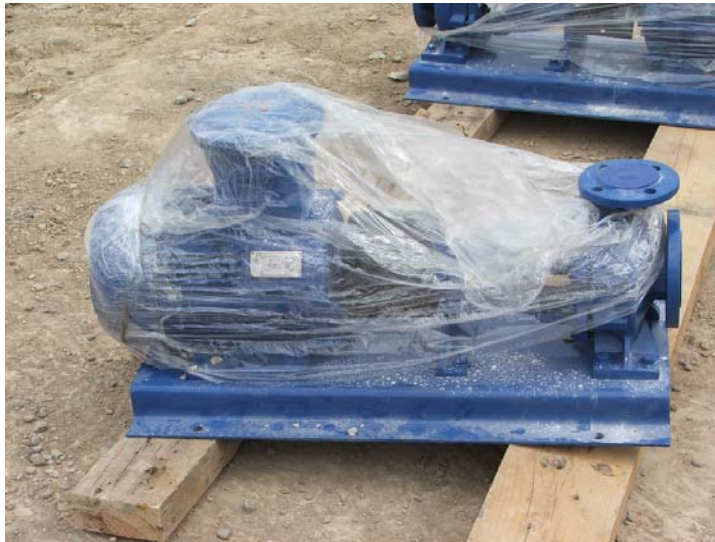
Pumps were on site awaiting installation (Site Photo 14). According to the contractor, they are fuel oil transfer pumps, which will be placed in the pump vault²² between the two fuel oil tanks.

Site Photo 14. Pumps for fuel oil transfer

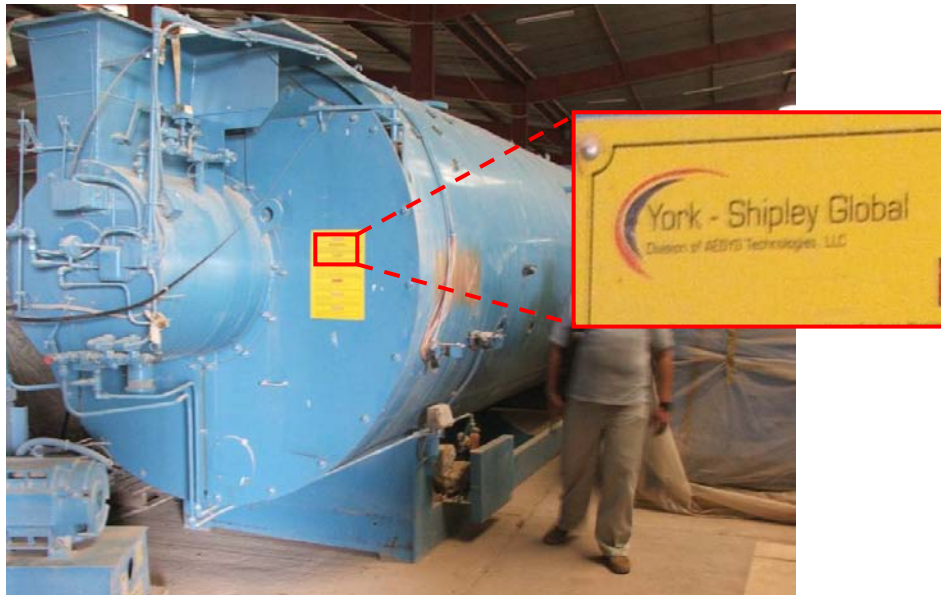
With the exception of one large piece of equipment already located inside the newly constructed facility, the milk processing and packaging equipment is stored inside a leaking warehouse²³ near the Abu Ghraib Dairy (on the Ministry of Industry and Minerals compound). SIGIR toured the warehouse and found most of the equipment in its original packaging and appeared to be in good condition. One of the pieces of equipment sustained some damage due to either improper storage or handling (Site Photo 16). SIGIR was able to identify several pieces of equipment with visible nameplates (Site Photo 17), and the remainder of the equipment was labeled with shipping labels.

Site Photo 17. Dairy production equipment

²³ It had recently rained and SIGIR observed a noticeable amount of water on the floor and on the equipment.

SIGIR also recommends that the TFBSO continue to work with the Director General of the Abu Ghraib Dairy to determine the status of any missing equipment and spare parts and the award of the contract to install and commission the milk line equipment.
