HANFORD BX-FARM LEAK ASSESSMENTS REPORT

February 2011

Prepared for the U.S. Department of Energy
Office of River Protection

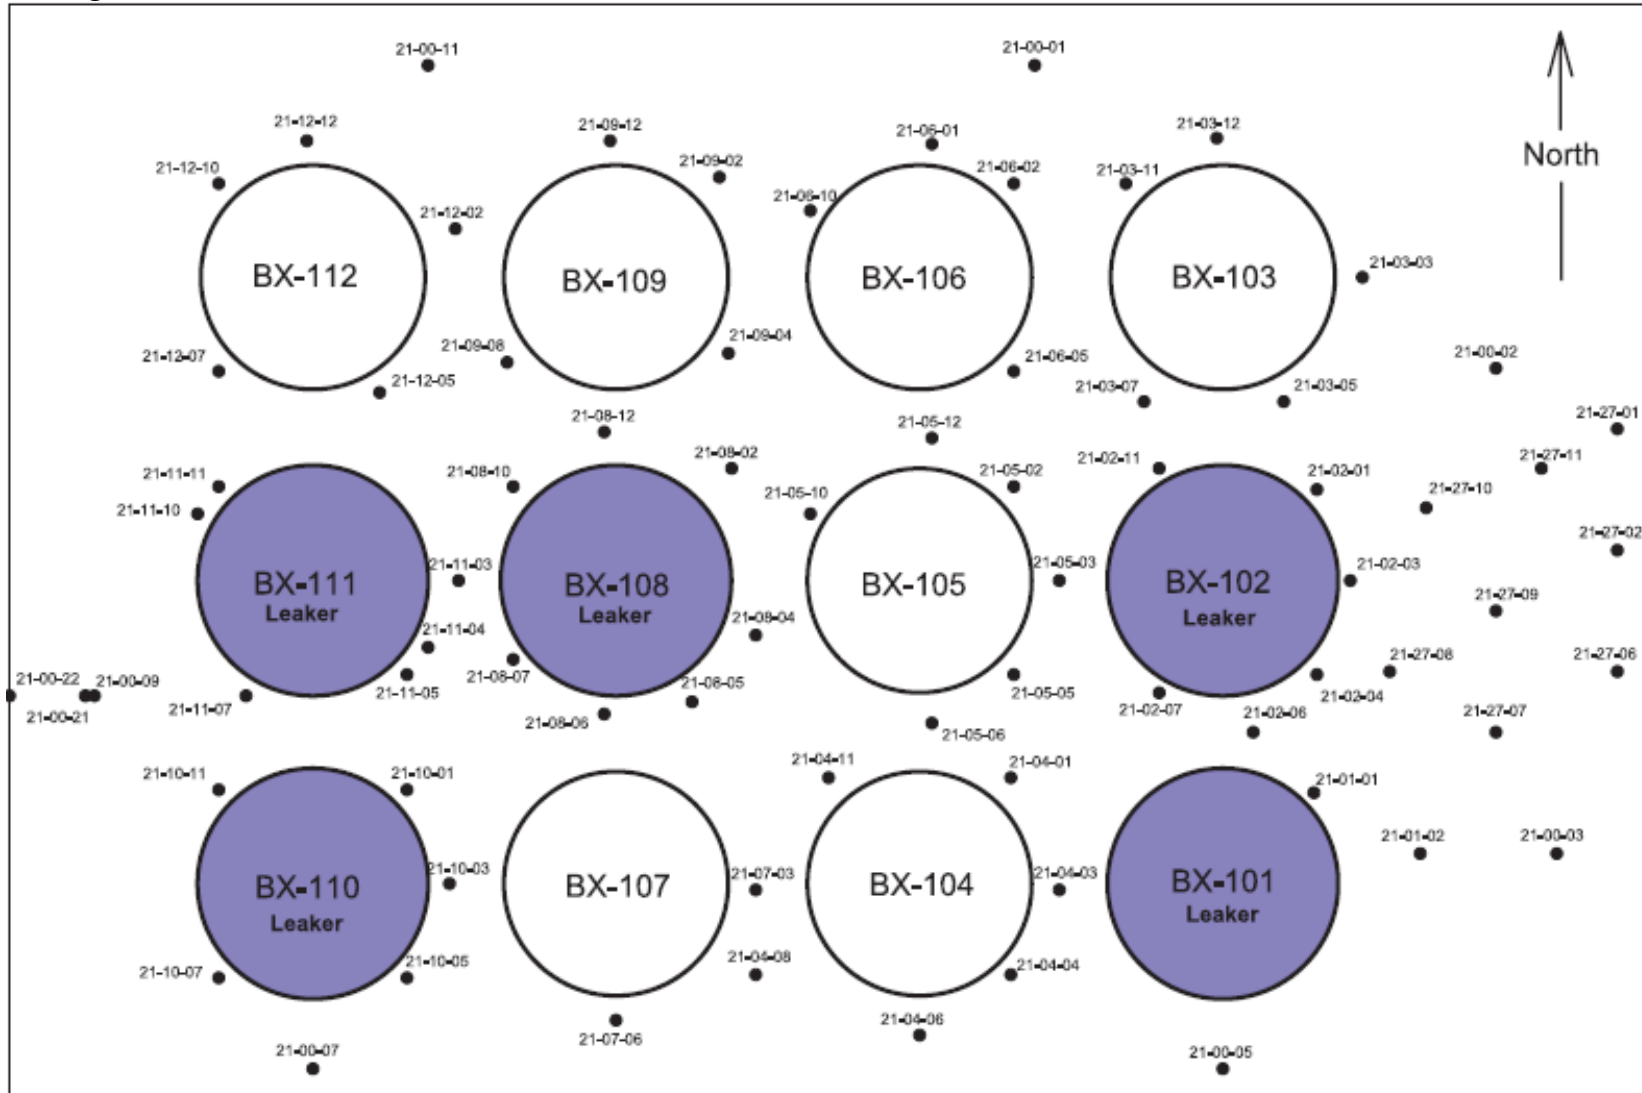
Figure 3-3. 241-BX Farm Tanks and Drywells

Note: Tanks marked “**Leaker**” are confirmed or assumed leakers per HNF-EP-0182, *Waste Tank Summary Report for Month Ending December 31, 2009*, Rev. 261

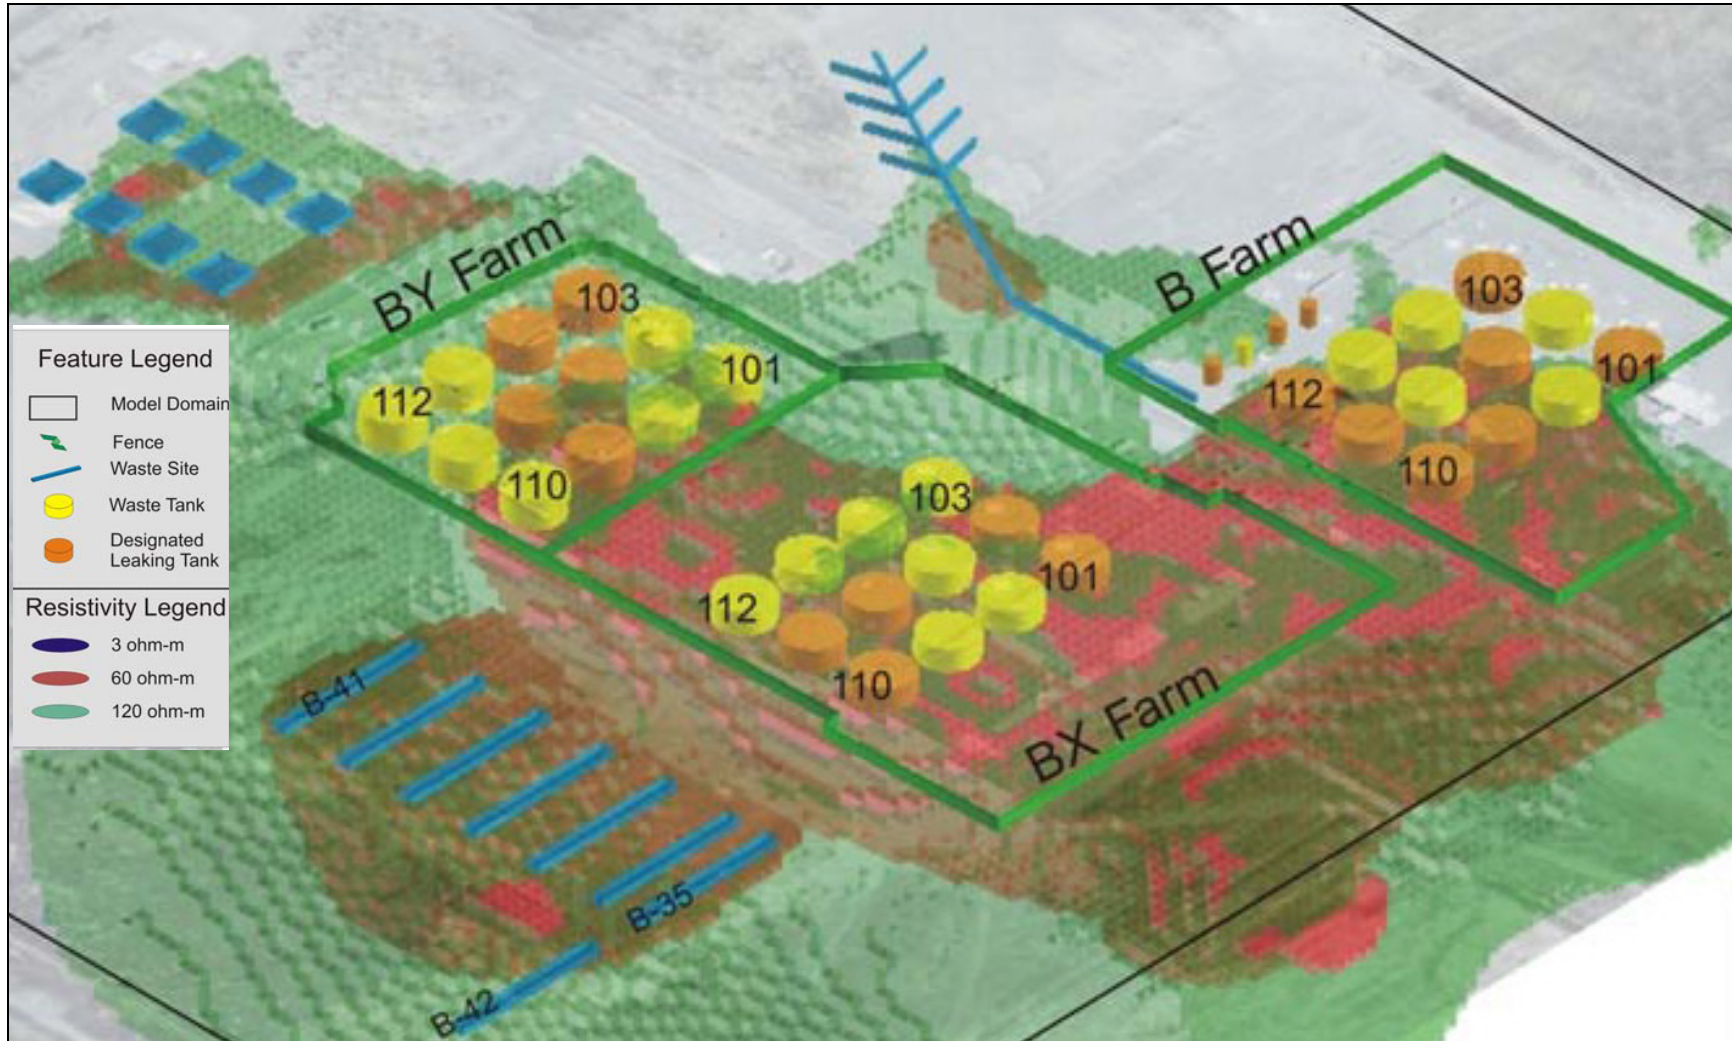
Figure 3-5. 241-BX Tank Farm Surface Geophysics Exploration Results

Surface Geophysical Exploration was deployed in Waste Management Area (WMA) B-BX-BY in October 2006 (RPP-34690, *Surface Geophysical Exploration of the B, BX and BY Tank Farms at the Hanford Site*). Figure 3-5 shows 60 and 120 ohm-m three-dimensional resistivity results in B-, BX- and BY-Farm for surface electrodes and well-to-well resistivity surveys with electrical connections to and between surface electrodes, tank farm drywells and groundwater monitoring wells. It is difficult to identify a specific tank leak source within BX-Farm based on these results. However, consistent with tank farm leak histories presented in this report the results indicate low resistivity regions near tanks BX-101, BX-102, BX-108, BX-110 and BX-111. Resistivity is the opposite of conductivity; thus, highly conductive zones have low resistivity. Low resistivity regions are also observed near tanks BX-104 and BX-107 and to the north of tank BX-112 (probably from releases in BY-Farm). Infrastructure obstructions and other physical features appear to have impacted the ability to observe clearer well-to-well and three-dimensional resistivity anomalies in the soils around WMA B-BX-BY.

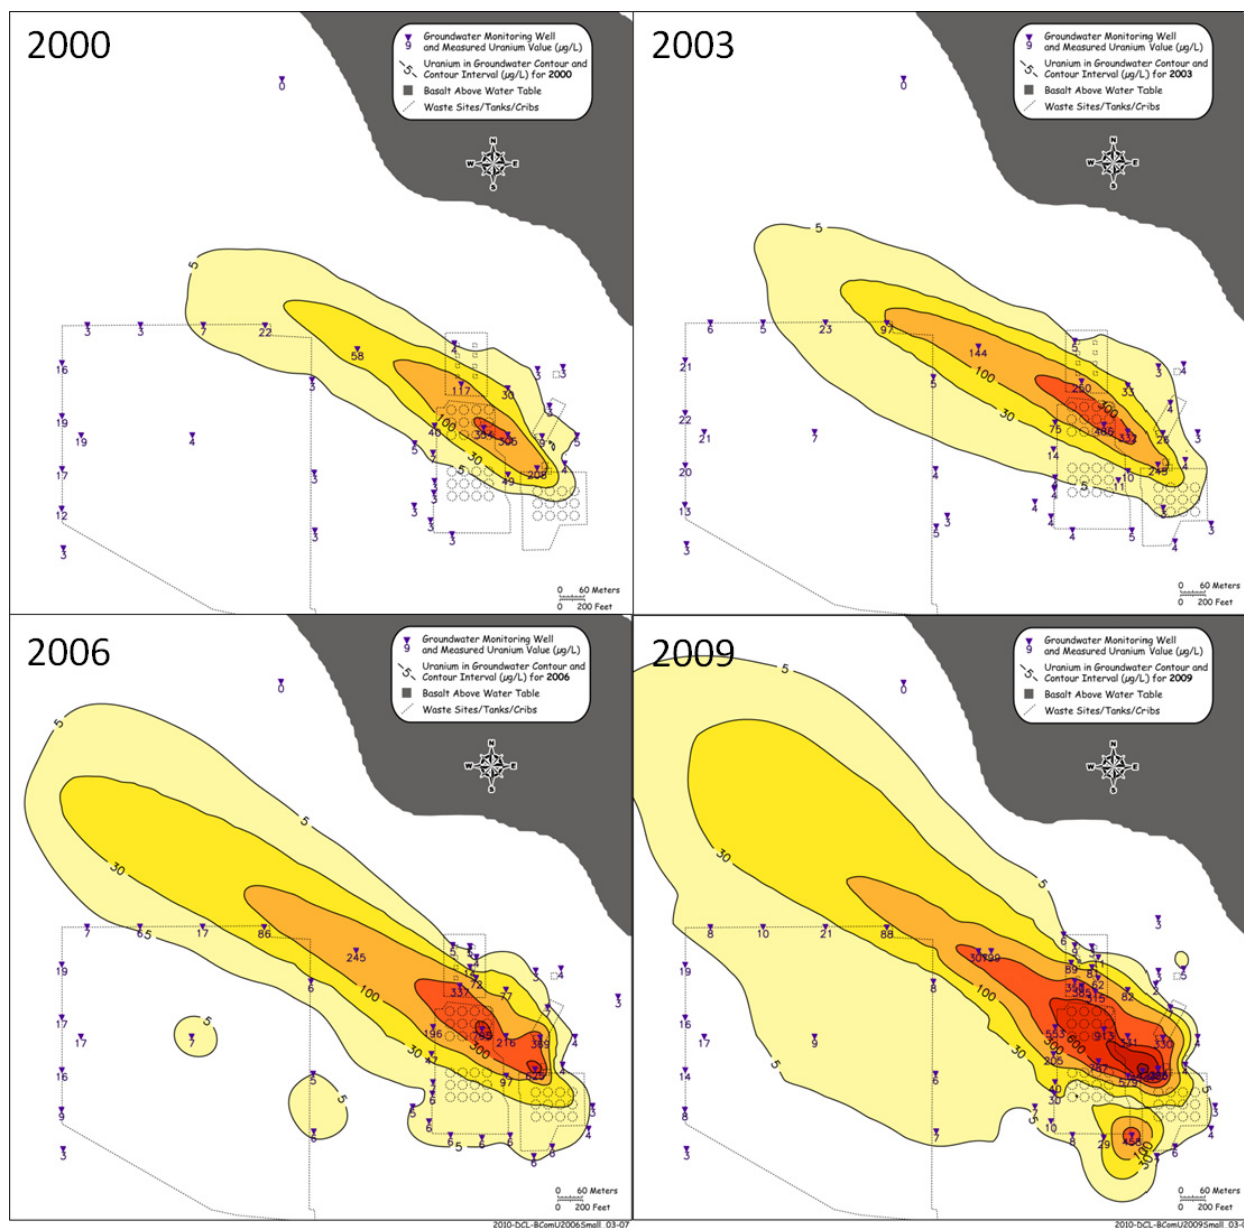
Figure 3-7. Uranium Plume Distribution in the Unconfined Aquifer Underlying Waste Management Area B-BX-BY in 2000, 2003, 2006, and 2009

The nature and extent of uranium contamination in the aquifer underlying WMA B-BX-BY can only be discussed from the mid-1990s forward because of the lack of monitoring frequency in earlier years. However, it is known that groundwater was contaminated in 1956 with ^{137}Cs and ^{60}Co , and perhaps other radionuclides such as ^{99}Tc that were not measured at the time. This contamination is thought to have originated from the BY Cribs. In the mid-1990s low levels of uranium contamination ($< 30 \mu\text{g/L}$) were measured under much of WMA B-BX-BY. Since then, concentrations in the groundwater below WMA B-BX-BY have been increasing over the last decade, though the amount of uranium in the groundwater is thought to be small when compared to the mass of uranium estimated to be present in the vadose zone in this area. Snapshots of uranium groundwater plume evolution beginning in 2000 are shown in Figure 3-7. The snapshots show that the heart of the plume has been centered underneath the tank farms in the last decade. In 2003 the plume was centered at monitoring well 299-E33-9 in the eastern portion of BY-Farm. By 2006 a second maximum concentration area appeared at the northeast corner of B-Farm at monitoring well 299-E33-18. Finally, by 2009 this high concentration zone had grown and superseded the hot spot underneath BY-Farm. Currently, highest uranium concentrations are occurring at monitoring well 299-E33-343.

predominant source of the observed contamination. The isotopic composition of the uranium in groundwater more closely matches the composition of waste leaked from tank BX-102.

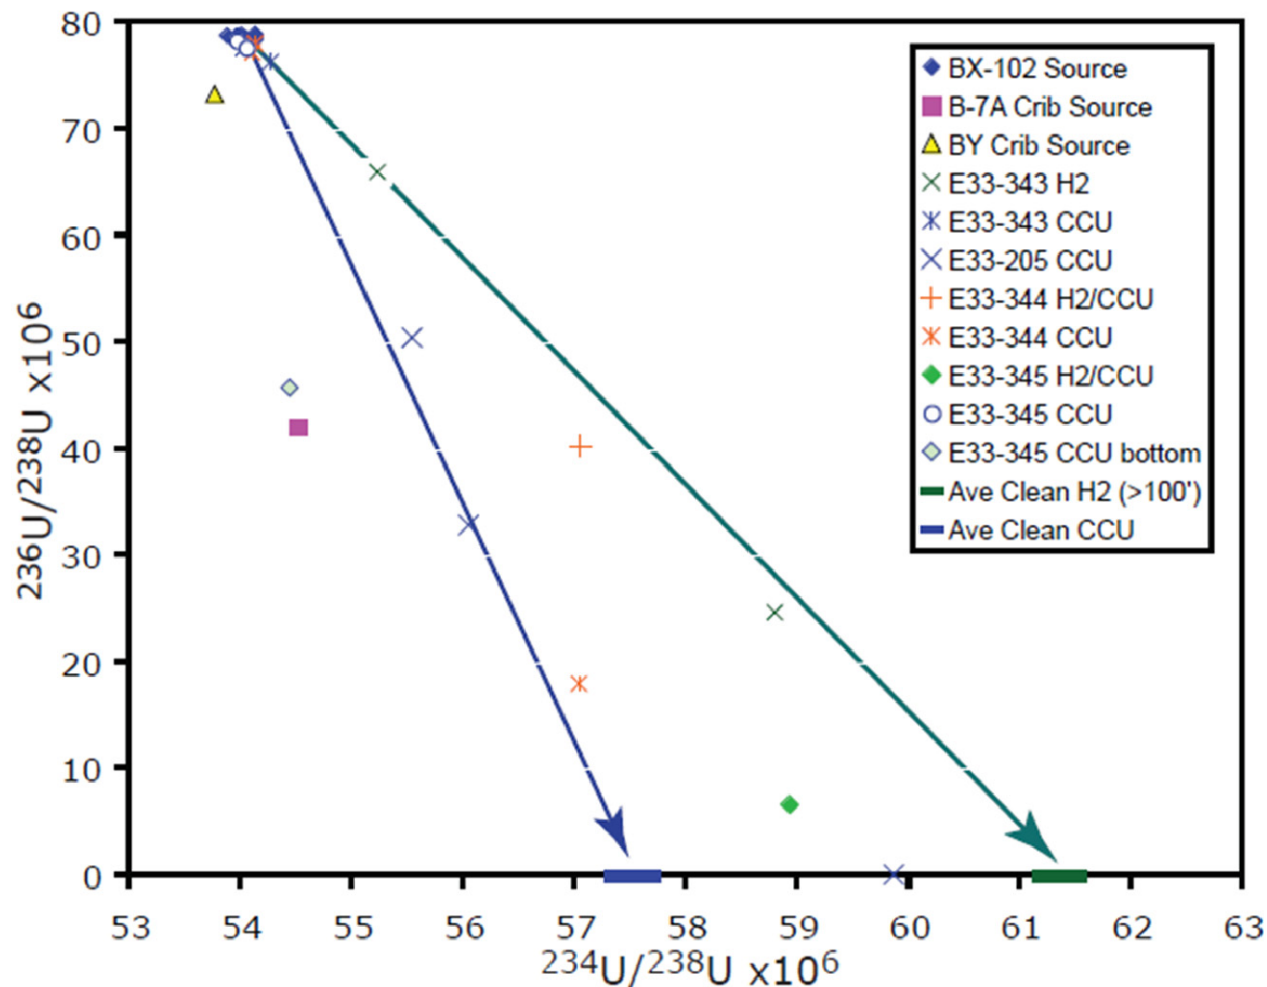
Figure 3-9. Uranium Isotopic Ratio Data for Subsurface Water Samples Taken at Waste Management Area B-BX-BY

The second type of information that supports the concept of the tank BX-102 metal waste leak as the primary source of uranium is uranium isotopic data measured in a variety of subsurface water samples from the vadose zone and the unconfined aquifer. Collectively, these data indicate that a unique isotopic signature can be assigned to the metal waste fluid, a signature which is found in most of the analyzed samples. A summary diagram of these data is shown in Figure 3-9.

In Figure 3-9 ^{236}U to ^{238}U ratios are plotted against ^{234}U to ^{238}U for water samples taken in the vadose zone and unconfined aquifer. In the upper left hand corner are the porewater samples taken from the intermediate depth vadose zone soils containing high concentrations of metal waste uranium. On the x-axis are the ^{234}U to ^{238}U ratios of uncontaminated water in the Cold Creek Silt Unit and the unconfined aquifer. Note that the ^{236}U to ^{238}U ratio is zero because ^{236}U is not naturally occurring. The lines drawn between the tank BX-102 water samples and the groundwater ^{234}U to ^{238}U ratios are mixing lines which indicate the potential changes in these ratios as various proportions of contaminated and uncontaminated waters mix. If ratios fall outside of the triangle formed by the two mixing lines then another source term is indicated. Figure 3-9 shows that only a few samples fall outside the mixing triangle, notably those near the BY and 216-B-7A cribs. These results are used to conclude that the tank BX-102 isotopic signature is distinguishable from the other plausible uranium sources and the one that matches most of the aquifer water. Currently, between the intermediate vadose zone and the Cold Creek Silt Unit, there is more uranium in the vadose zone than in the aquifer. Given this condition, the uranium contamination in the unconfined aquifer underlying WMA B-BX-BY is likely to continue for an indeterminate time span.

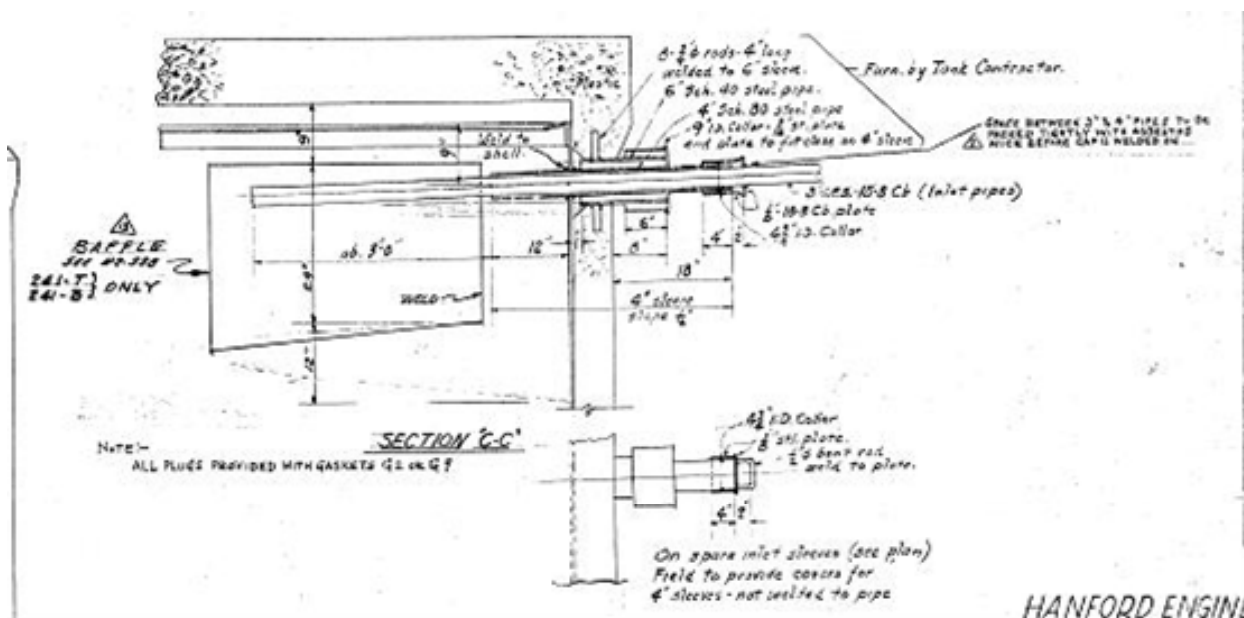
Figure 5-4. 20-Foot Diameter Single-Shell Tank Detail Showing Inlet Nozzles

Some of the inlet nozzles on the SSTs are spares and do not have installed process waste lines. A 4.5-in. diameter cover was to be placed over these 4-in. diameter spare inlet nozzles (Figure 5-4). However, some of the spare inlet nozzles are poorly sealed. Tank BX-102 was overfilled in February 1951 and waste was lost to the ground through the spare inlet nozzles (HW-20742, *Loss of Depleted Metal Waste Supernatant to Soil*). As part of the investigation into the waste loss from SST BX-102, spare inlet nozzles on several SSTs (specific tanks were not identified) were examined. This investigation revealed "... that some have blanks which are welded tight, some have wooden plugs driven into the spare nozzle covered by a cap and sealed with waterproofing, and some have caps covered with waterproofing membrane and then sealed in cement" (see HW-20742, page 5).

Based on the SST BX-102 waste loss investigation, waste may have been similarly lost to the ground in other locations in the BX-Farm if SSTs were filled above the height of the spare inlet nozzles (17-ft 4-in. [~547,500 gal]). If waste losses occurred, small waste losses from the spare inlet nozzles for SSTs BX-101, BX-104, BX-107, and BX-110 may have been contained and channeled along the concrete beams that support the process waste lines connecting to the inlet nozzles (Figure 5-3).

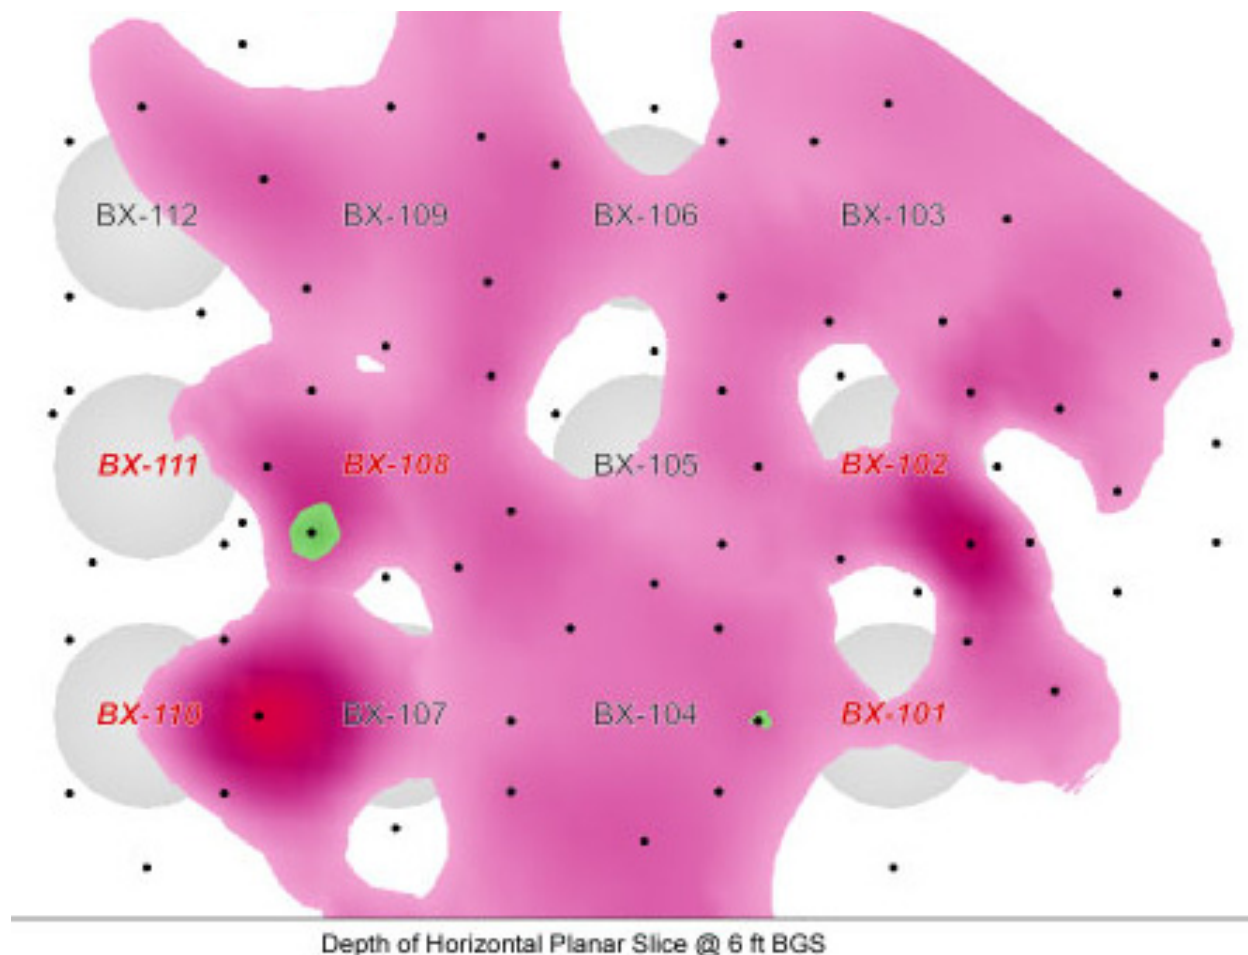
Figure 5-5a. Visual Based on Drywell Logging Activity @ 6 feet in 241-BX Tank Farm

Figures 5-5a to 5-5e are cross section visualizations based on SGLS drywell measurements. The figures show ^{137}Cs activity at <100 pCi/g throughout the upper 9 ft of BX-Farm and hot spots near tanks BX-101, BX-102, and BX-110. Europium-154 (^{154}Eu) is observed near tank BX-108. At 24 and 43 ft ^{154}Eu , ^{60}Co , and antimony-125 (^{125}Sb) are observed near tank BX-101 and at 43 ft a ^{60}Co plume is shown emanating from tank BX-108. At 80 ft and 104 ft the plume from the southeast edge of tank BX-102 is shown to migrate to the northeast and uranium is observed. These observations are consistent with previous discussion for tanks BX-101, BX-102, BX-108, BX-110 and BX-111.

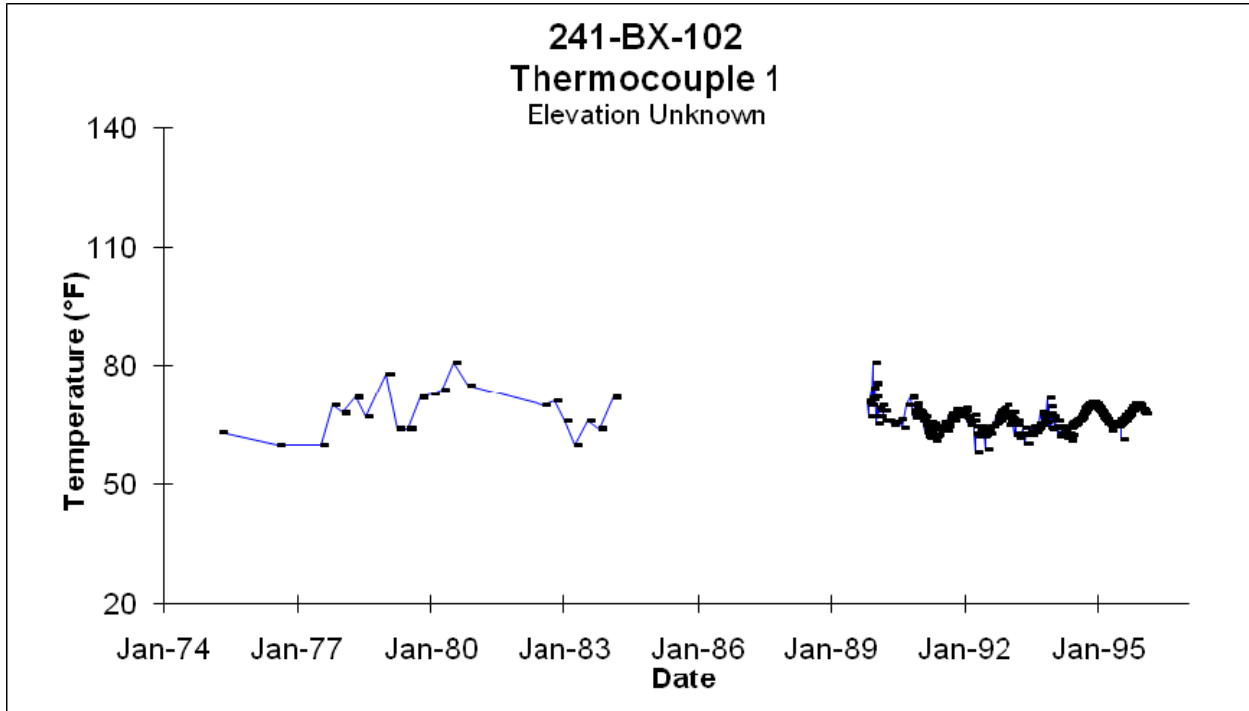
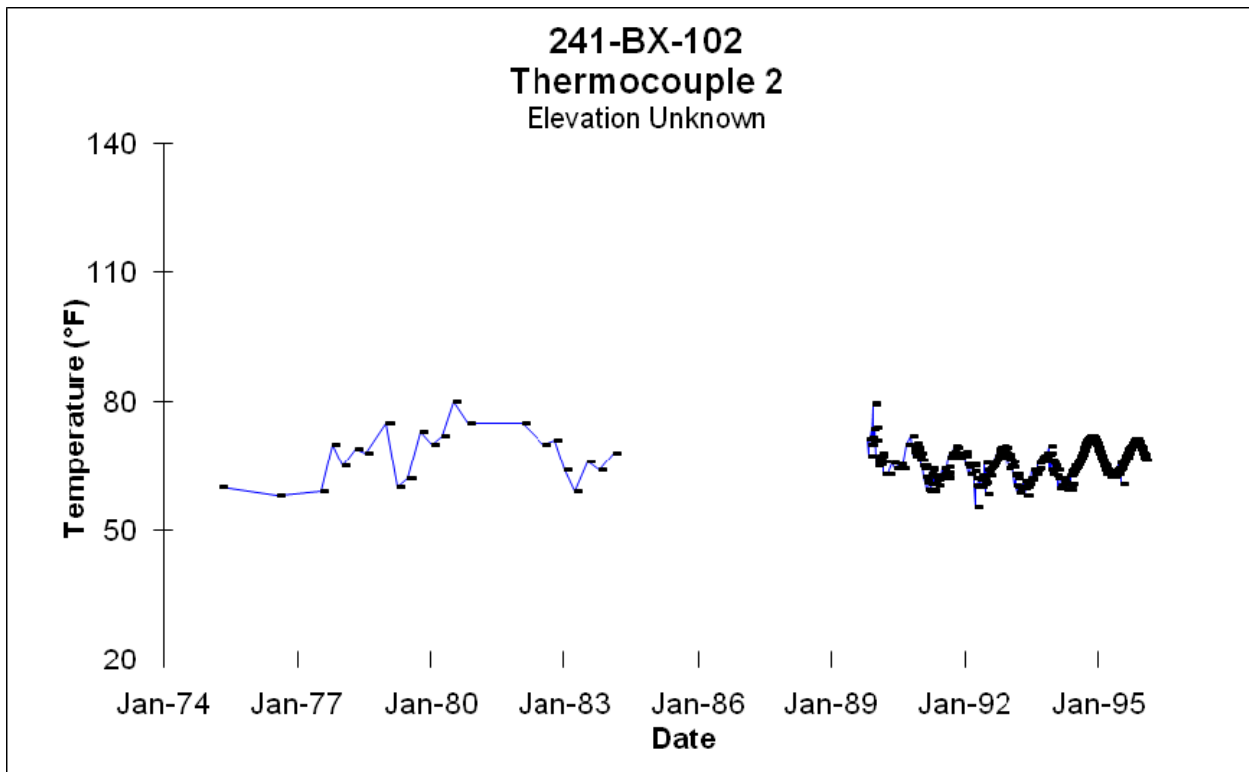
Figure B2-5. Tank 241-BX-102 Waste Temperature Measurements

No temperature measurements were found before 1974. As shown in Figure B2-5, between 1974 and 1995 the tank temperature ranged between 50 and 80° F indicating that the tank is a low heat tank. Tank temperature is being monitored by a single thermocouple tree.

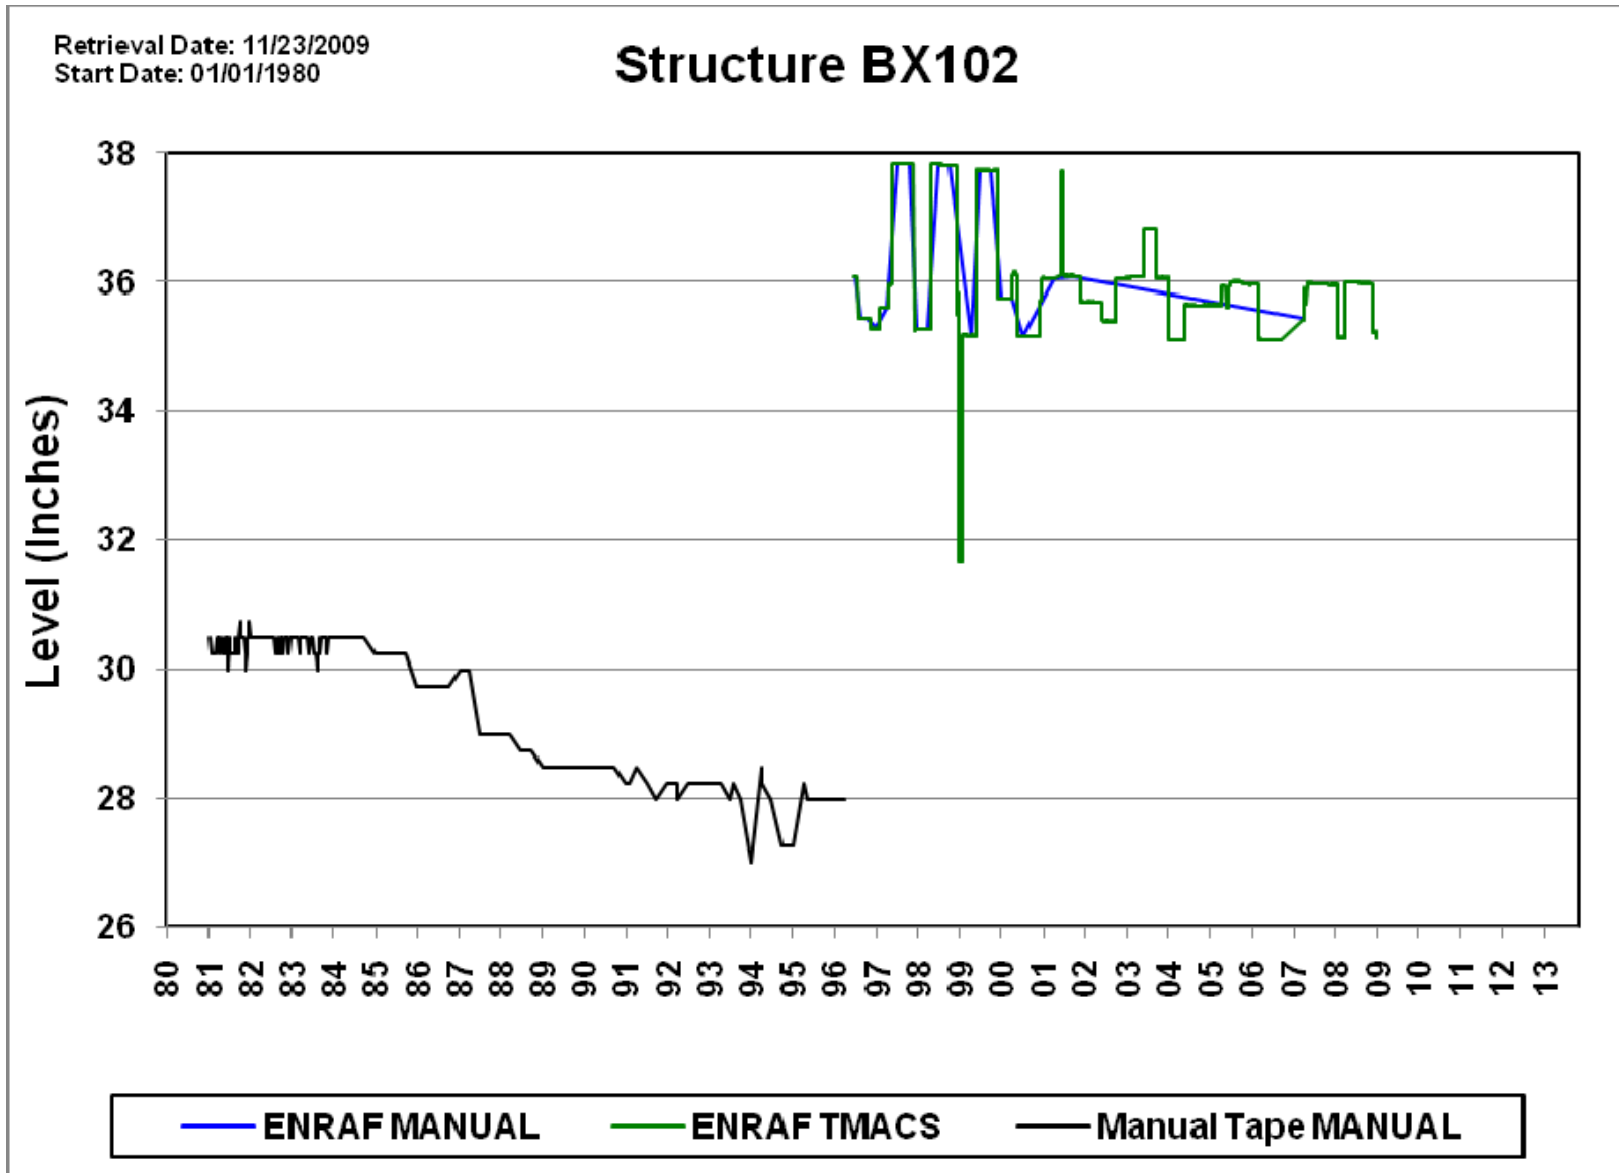
Figure B2-6. Liquid Level Measurements

Table B2-2 shows liquid level measurements from April 1975 to January 1987 (SD-WM-TI-356). Figure B2-6 shows liquid level plots from the tank surveillance monitoring system from 1974 to 1995. Increased liquid levels were observed in the late 1970s. A steady surface level decrease was observed in manual tape readings between 1981 and 1992, but the surface level gage was sitting on sludge solids after 1980. The manual tape was replaced with an ENRAF gage in 1996 and the liquid level baseline was shifted 12 in. (in Figure B2-6 a manual tape measurement of 28 in. measured from the top of the tank dish is equivalent to an ENRAF measurement of 40 in. measured from the bottom of the tank). The ENRAF measurements oscillated between 34 and 36 inches.

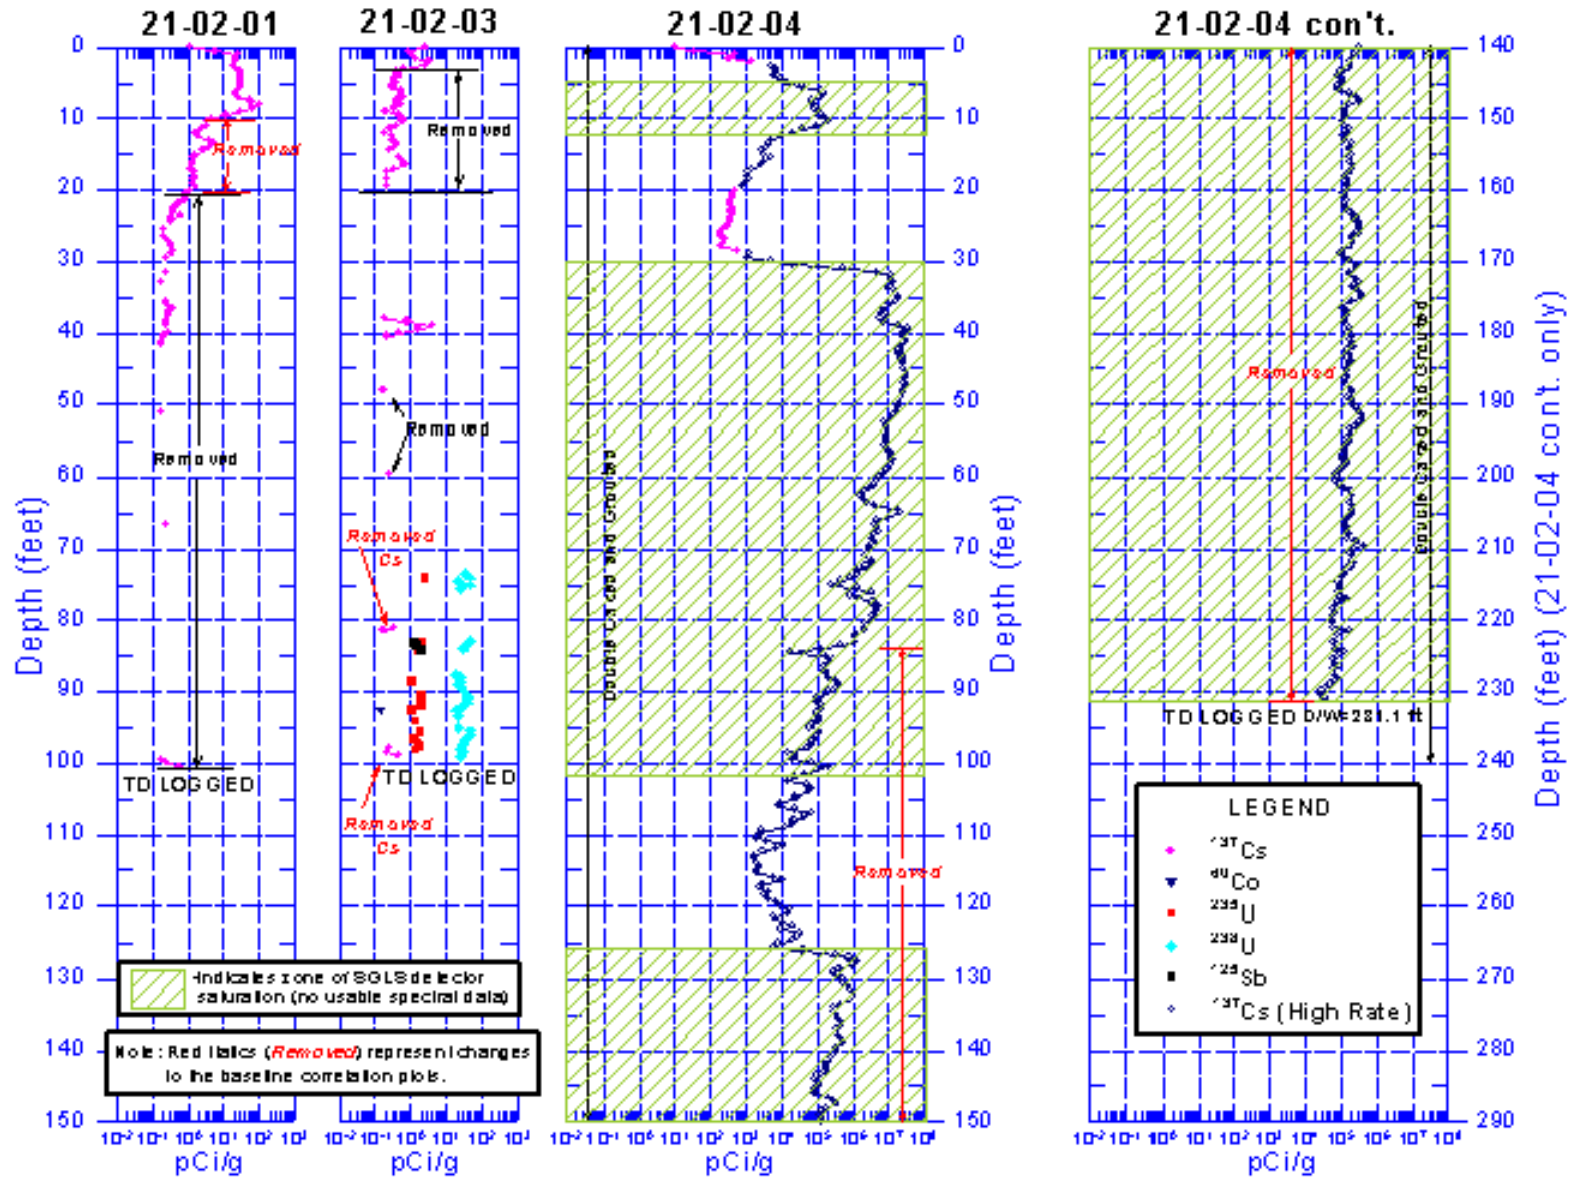
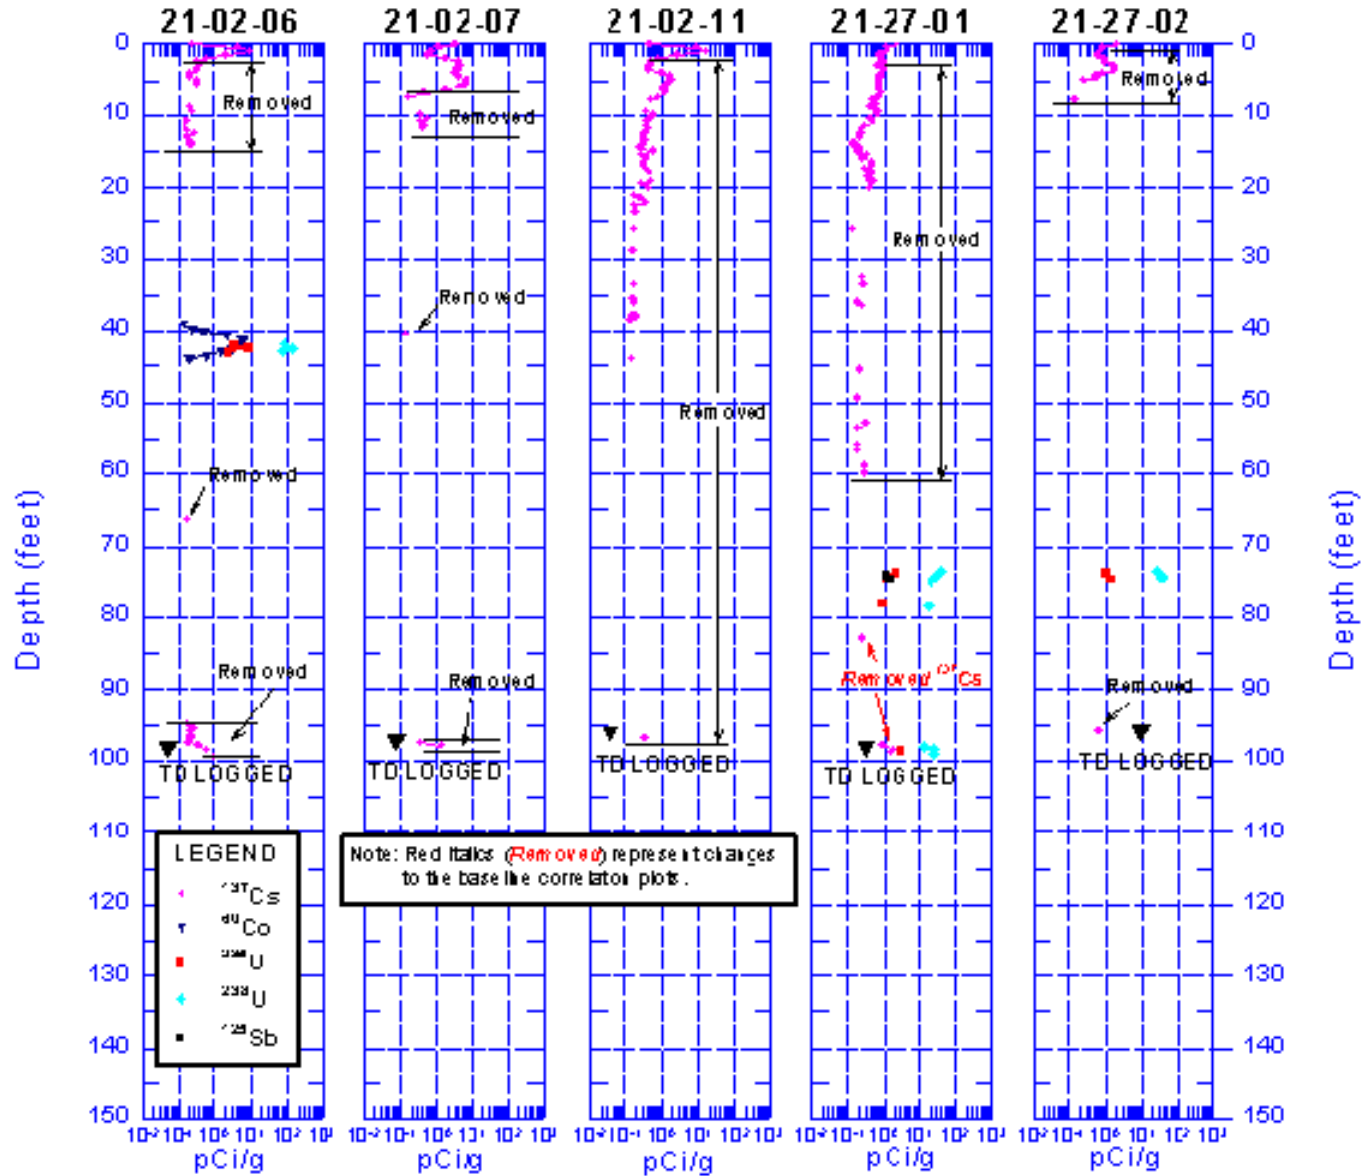
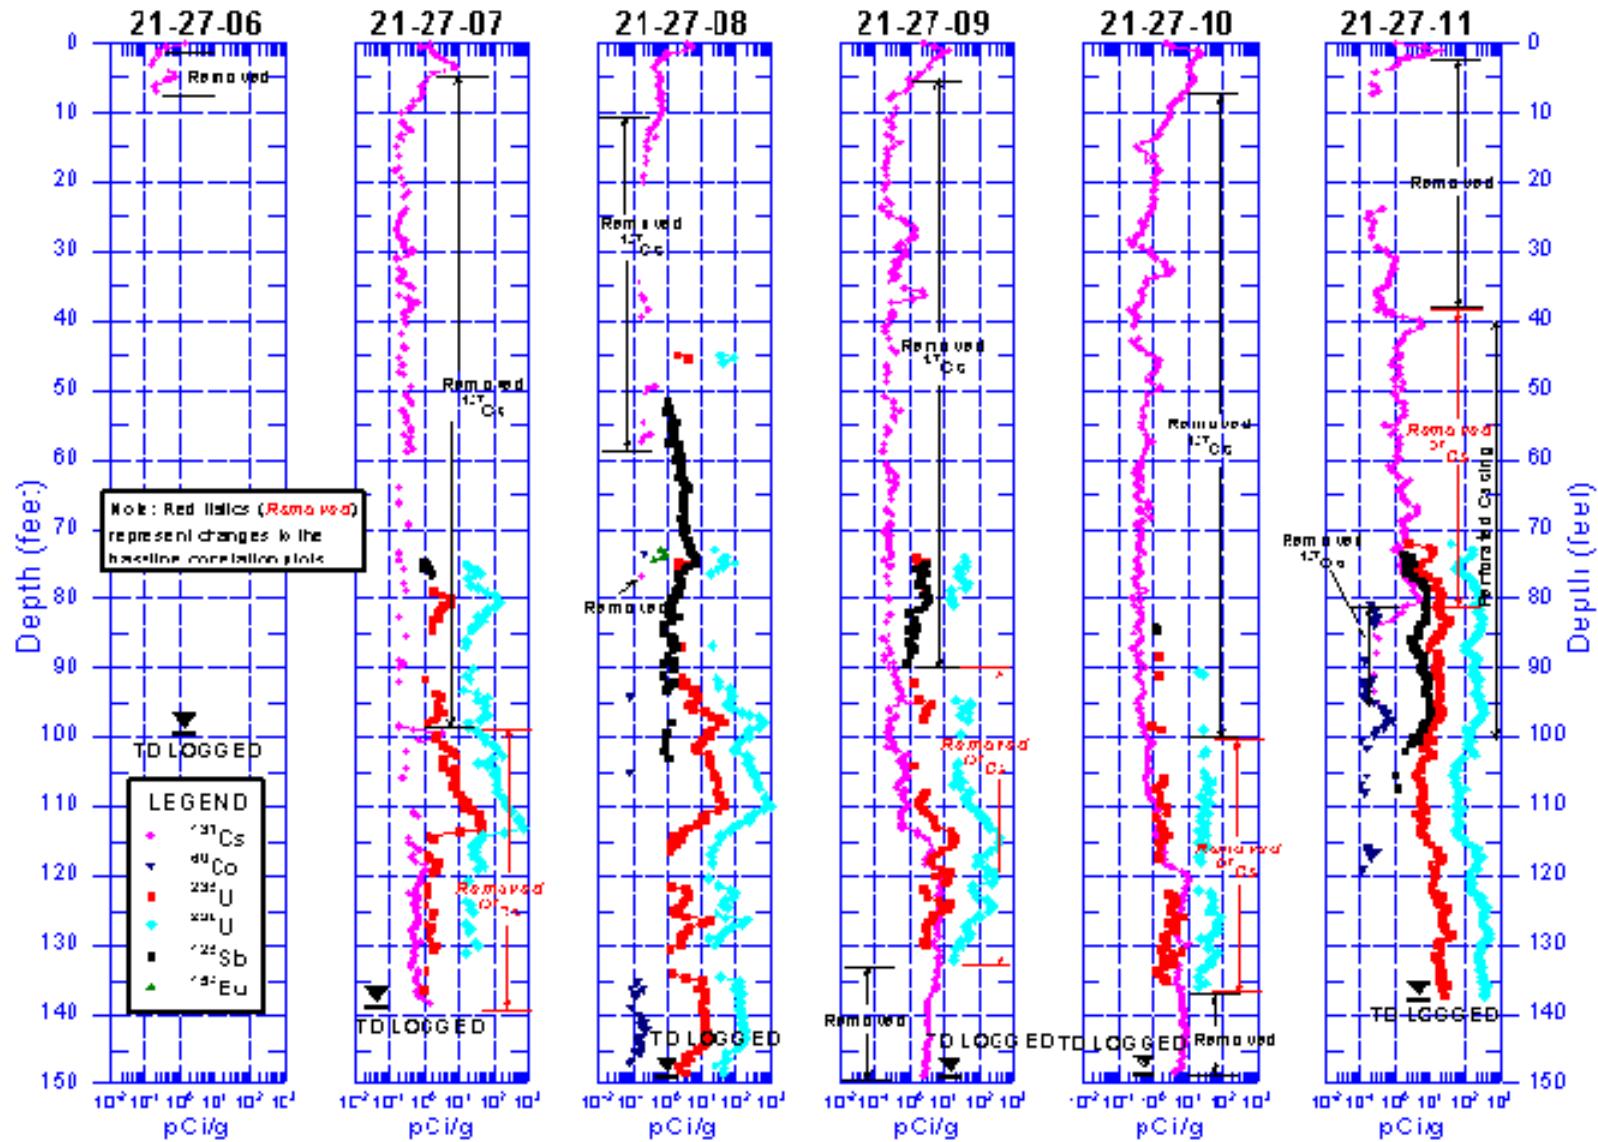
Figure B2-7. Spectral Gamma Logging System/High Rate Logging System Data (3 sheets)

observed in drywell 27 (now 21-02-04) at 1E8 pCi/g at 40 to 50 ft. This well is near tank BX-102, and like drywell 61 activity increases were attributed to leaks from the tank. Figure B2-7 shows 2000 SGLS logging results for drywells near tank BX-102 (GJ-HAN-19, *Vadose Zone Characterization Project at the Hanford Tank Farms Tank Summary Data Report for Tank BY-102*). Drywell 21-02-03, 21-02-04, 21-02-06, 21-27-01 and other 21-27 series drywells are discussed in the following sections.

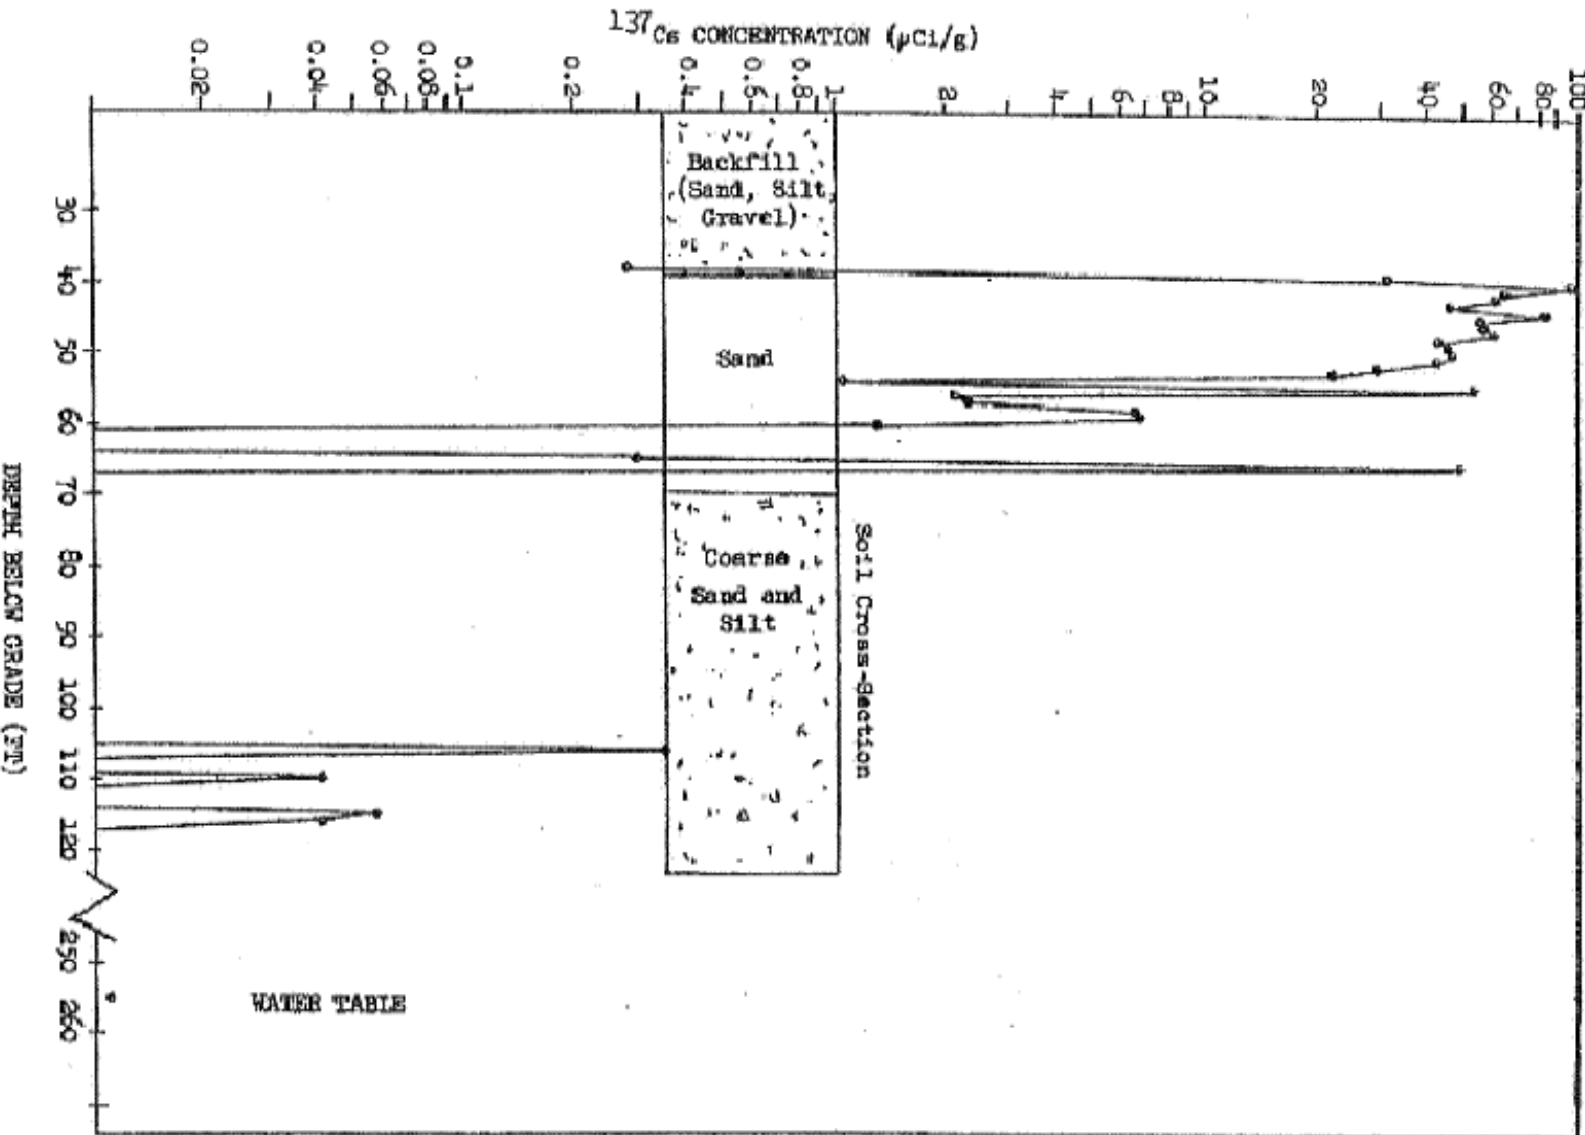
Figure B2-9. Drywell 21-02-04 Soil Sample Results

Drilling samples were collected every 5 to 10 ft from the ground surface to about 105 ft, every 1 ft from 105 to 122 ft, and every 5 to 10 ft from 122 ft to the bottom of the drywell (255 ft); Figure B2-9 shows the ^{137}Cs concentration data from lab analysis of the samples acquired during construction of this drywell (ARH-2035). The drilling samples are consistent with historical gross gamma log data from 1975 to 1994 (Figure B2-10) showing high gamma activity between 35 and 70 ft bgs. Spectral gamma logging system logs were obtained in 1997 and high rate logs in 2000 to a depth of 231 ft. Cesium-137 contamination was measured continuously from the ground surface to groundwater with a peak of ~ 1.5 pCi/g from 5 to 12 ft bgs and $> 1\text{E}7$ pCi/g from 32 to 65 ft bgs (Figure B1-7). Uranium appears to be masked by high activity ^{137}Cs in this drywell.

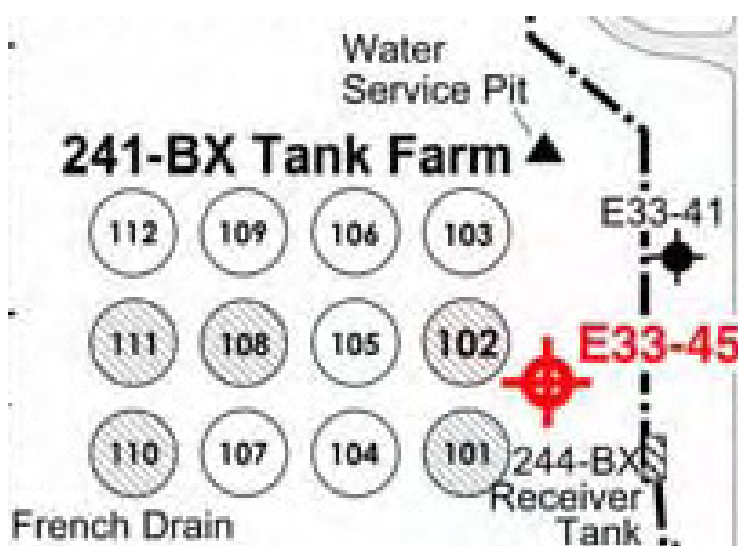
Figure B2-19. Drywell 299-E33-45 Location

Well 299-E33-45 was installed and samples collected between November 13, 2000 and January 25, 2001. This drywell was installed to a depth of 260 ft bgs and is located ~70 ft from the edge of tank 241-BX-102 at about the 4 o'clock position (Figure B2-19). A perched water zone was encountered at a depth of 227 ft within a silty-to-clayey silt zone. Groundwater was reached at a depth of 255 ft. Figure B2-20 shows gamma and neutron logging and sample moisture results (RPP-7921, *BX-102 Borehole Completion Report*) and Figures B2-21 and B2-22 show analytical results for samples collected from the drywell (PNNL-14083, *Characterization of Vadose Zone Sediment: Borehole 299-E33-45 Near BX-102 in the B-BX-BY Waste Management Area*). Logging results show peak total gamma activity between 130 and 150 ft bgs and moisture spikes at 72, 120, 168 and 220 to 240 ft bgs.
