HANFORD BX-FARM LEAK ASSESSMENTS REPORT

February 2011

Prepared for the U.S. Department of Energy
Office of River Protection

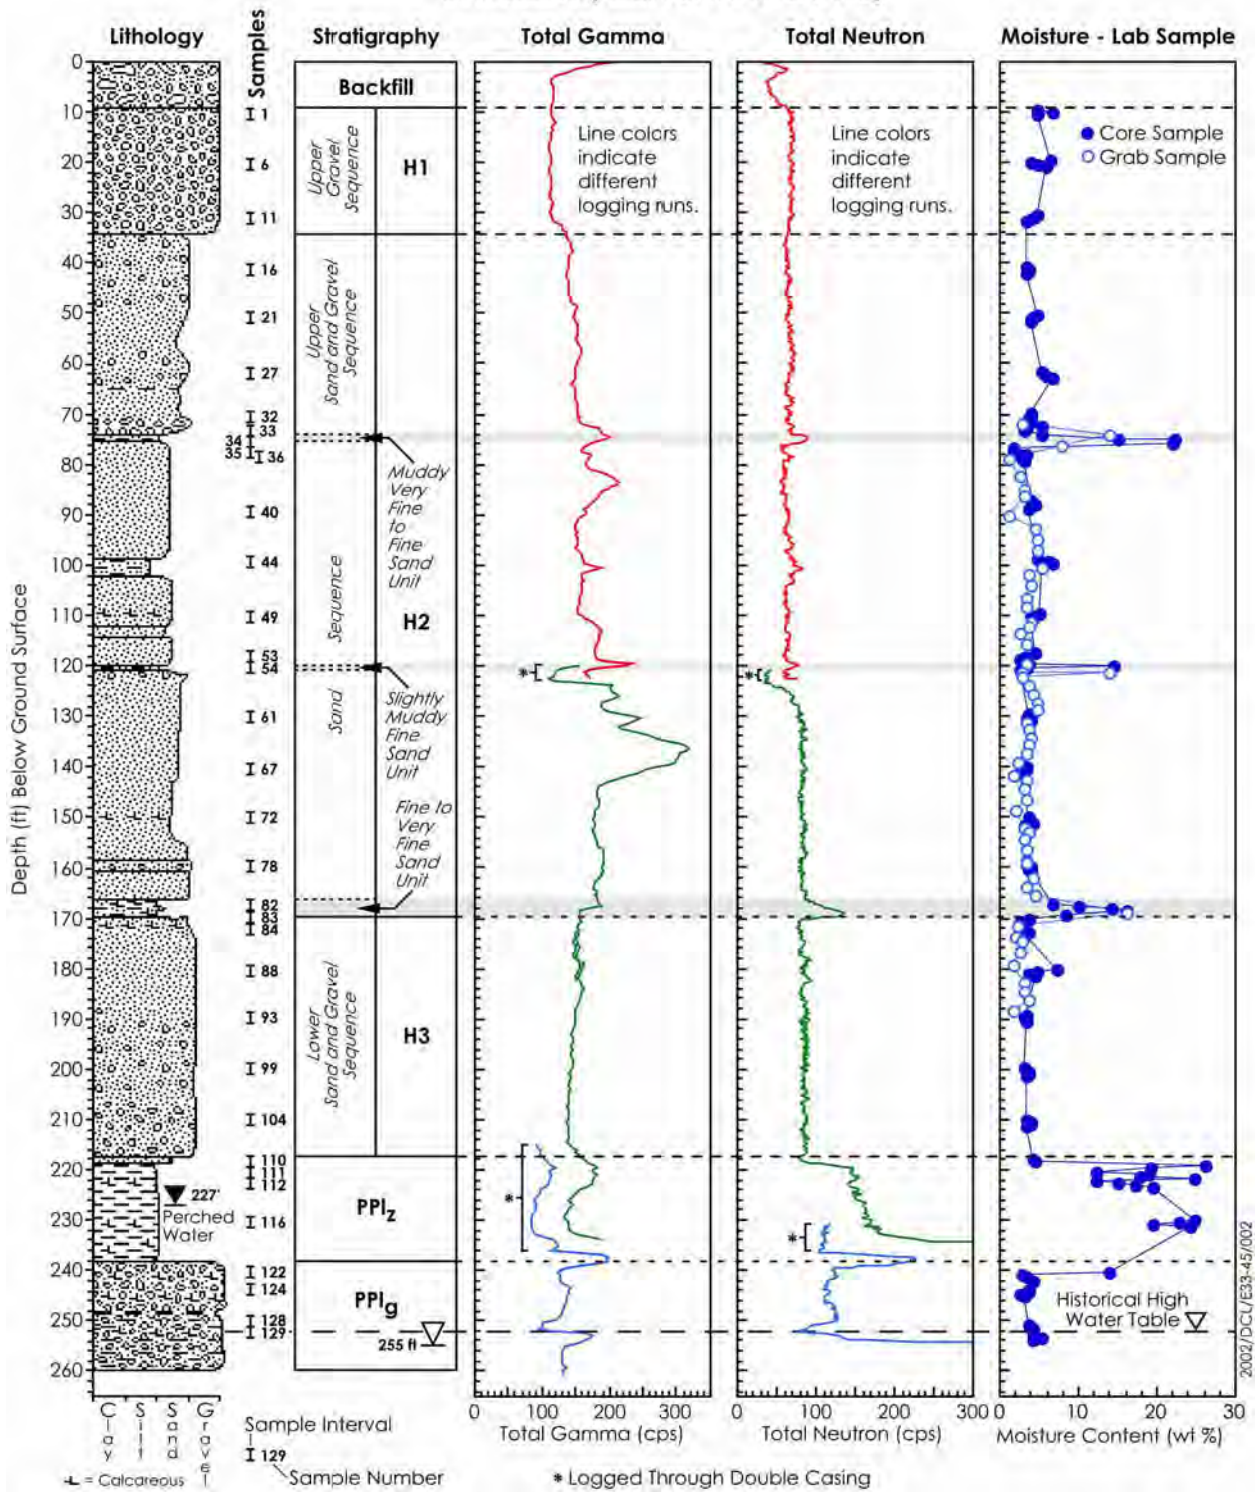
Figure B2-20. Drywell 299-E33-45 Logging and Lab Sample Moisture Results

Elevated moisture content, pH, electrical conductivity, sodium, uranium and technetium-99 (⁹⁹Tc) were found in drywell 299-E33-45 vadose zone samples to a depth of 170 ft bgs. In

general, the ratios of constituents found is consistent with an MW type and the contaminants are attributed to the 1951 MW loss from BX-102. The near horizontally bedded, northeasterly dipping sediment likely caused horizontal flow of the migrating contaminants. At drywell 299-E33-45, there are several fine-grained lenses at 74, 120, and 167 ft bgs that could have caused horizontal spreading of fluids. The 21-ft thick Plio-Pleistocene fine-grained silt/clay unit is also a horizontal flow conduit, as evidenced by the perched water zone between 227 and 232 ft bgs.

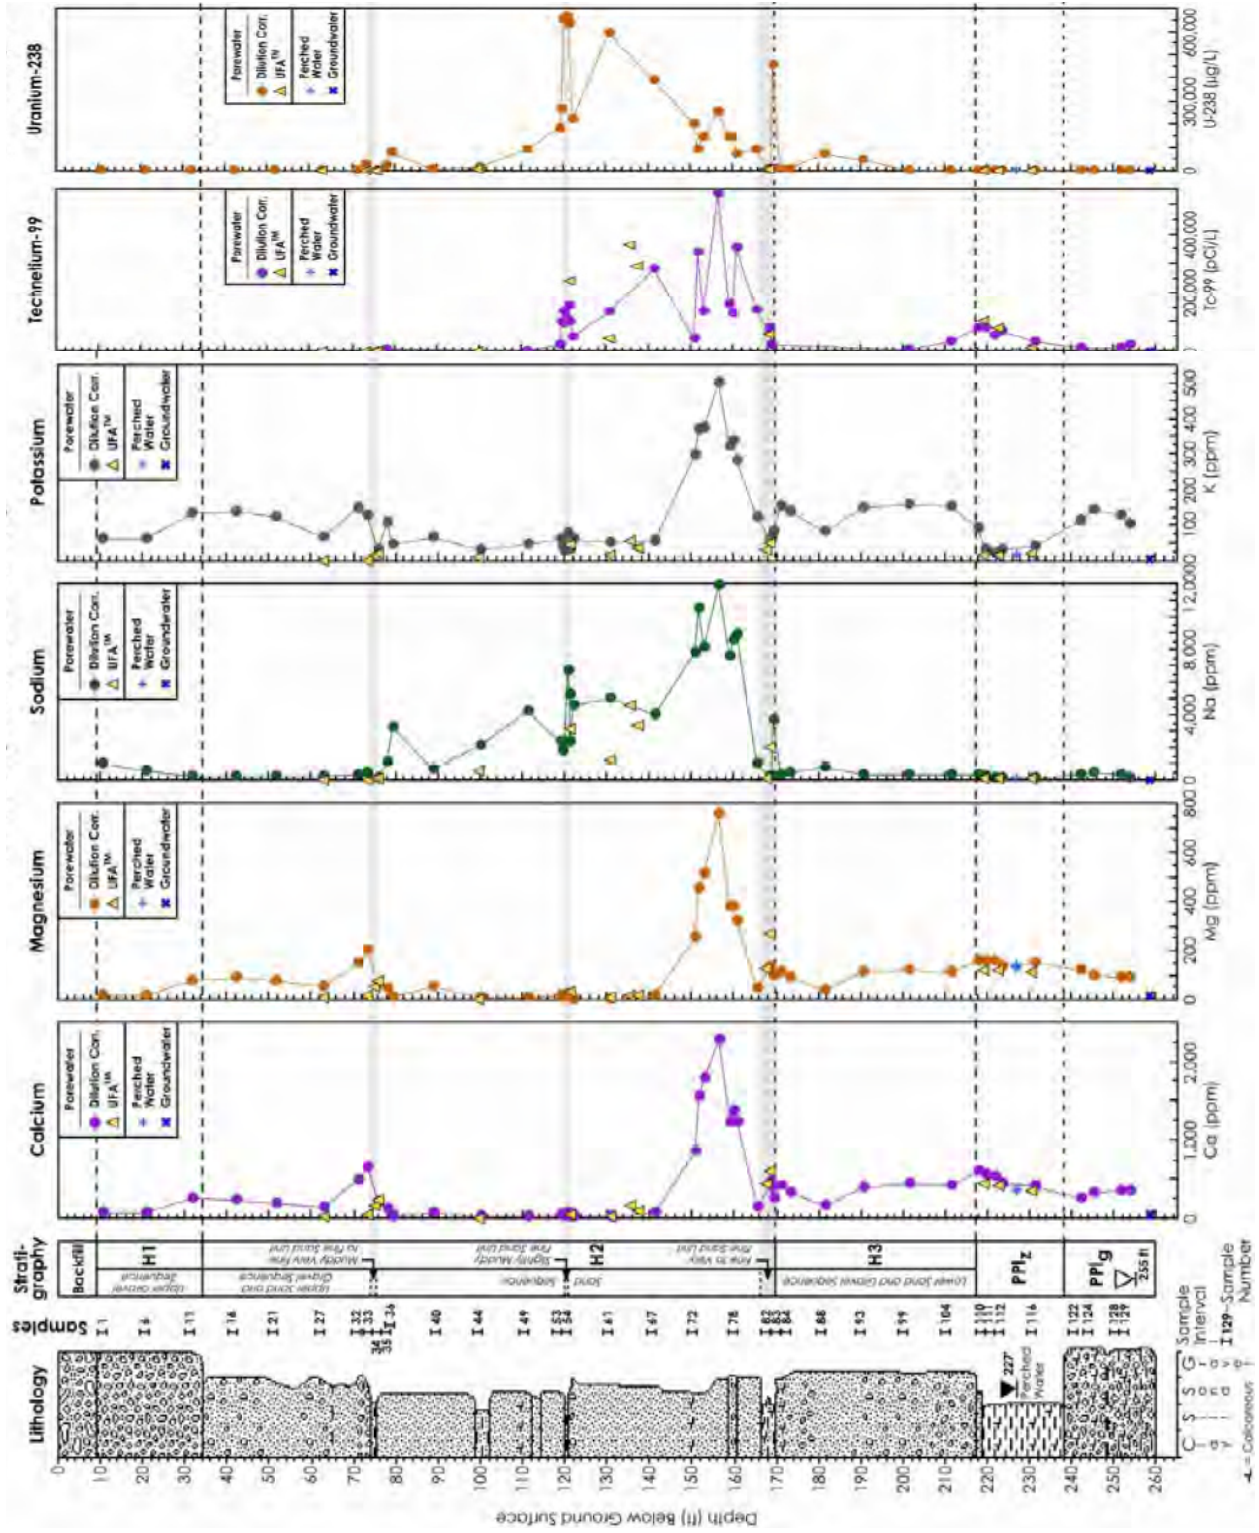
Figure B2-22. Drywell 299-E33-45 Cation, Technetium-99 and Uranium-238 Results

Elevated cation concentrations were observed throughout the drywell from about 10 feet bgs to 255 ft bgs. The bulk of the water-extractable cations are bounded between two thin fine-grained lenses at 120 ft bgs and 167 to 170 ft bgs.

Elevated concentrations of ^{99}Tc were found in the vadose zone samples between 120 and 167 ft bgs (within the middle sand sequence of H2). There appears to be a second less concentrated plume of ^{99}Tc between the H3 unit and the PPlz unit (220 to 235 ft bgs).

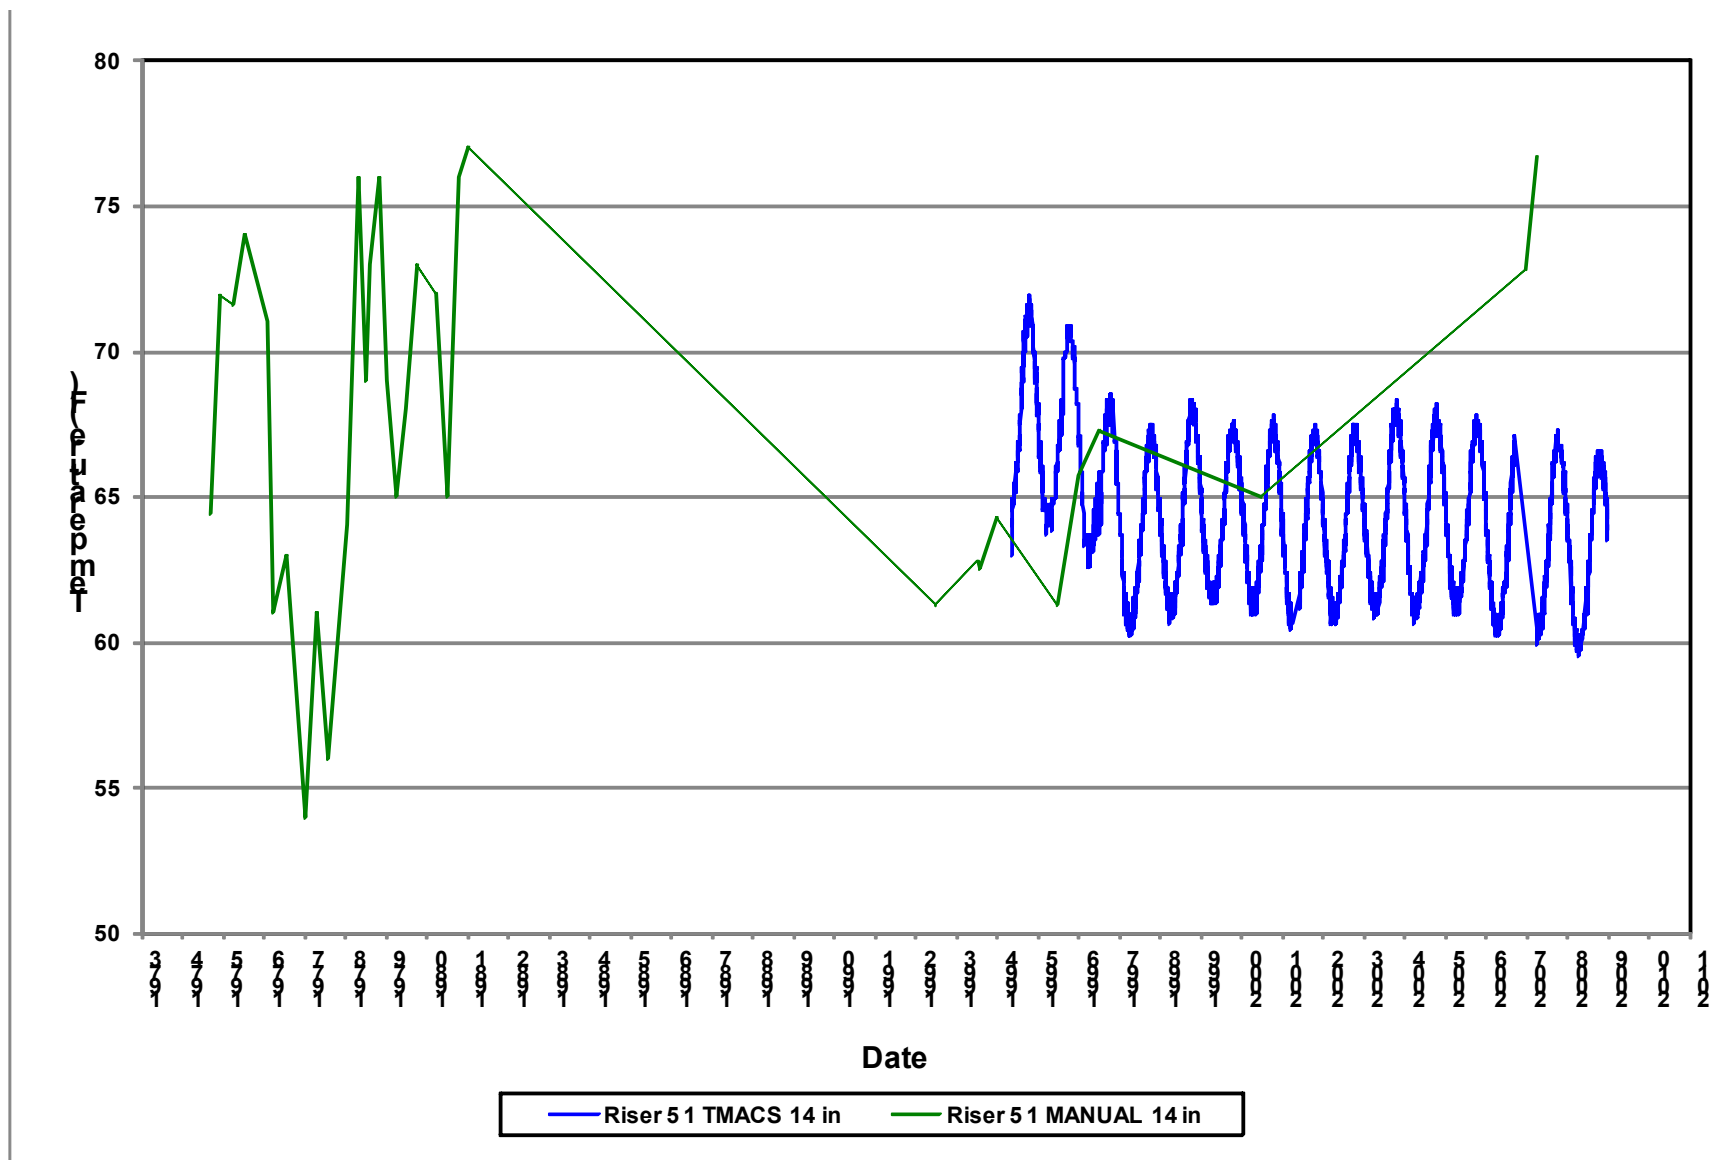
Figure B3-5. Tank 241-BX-108 Waste Temperature Measurements

No temperature measurements were found before 1974. As shown in Figure B3-5, between 1974 and 2009 the tank temperature ranged between 55 and 77°F and continues to vary seasonally between 60 and 67°F indicating that the waste temperature for tank BX-108 is low. Tank temperature is being monitored by a single thermocouple tree.

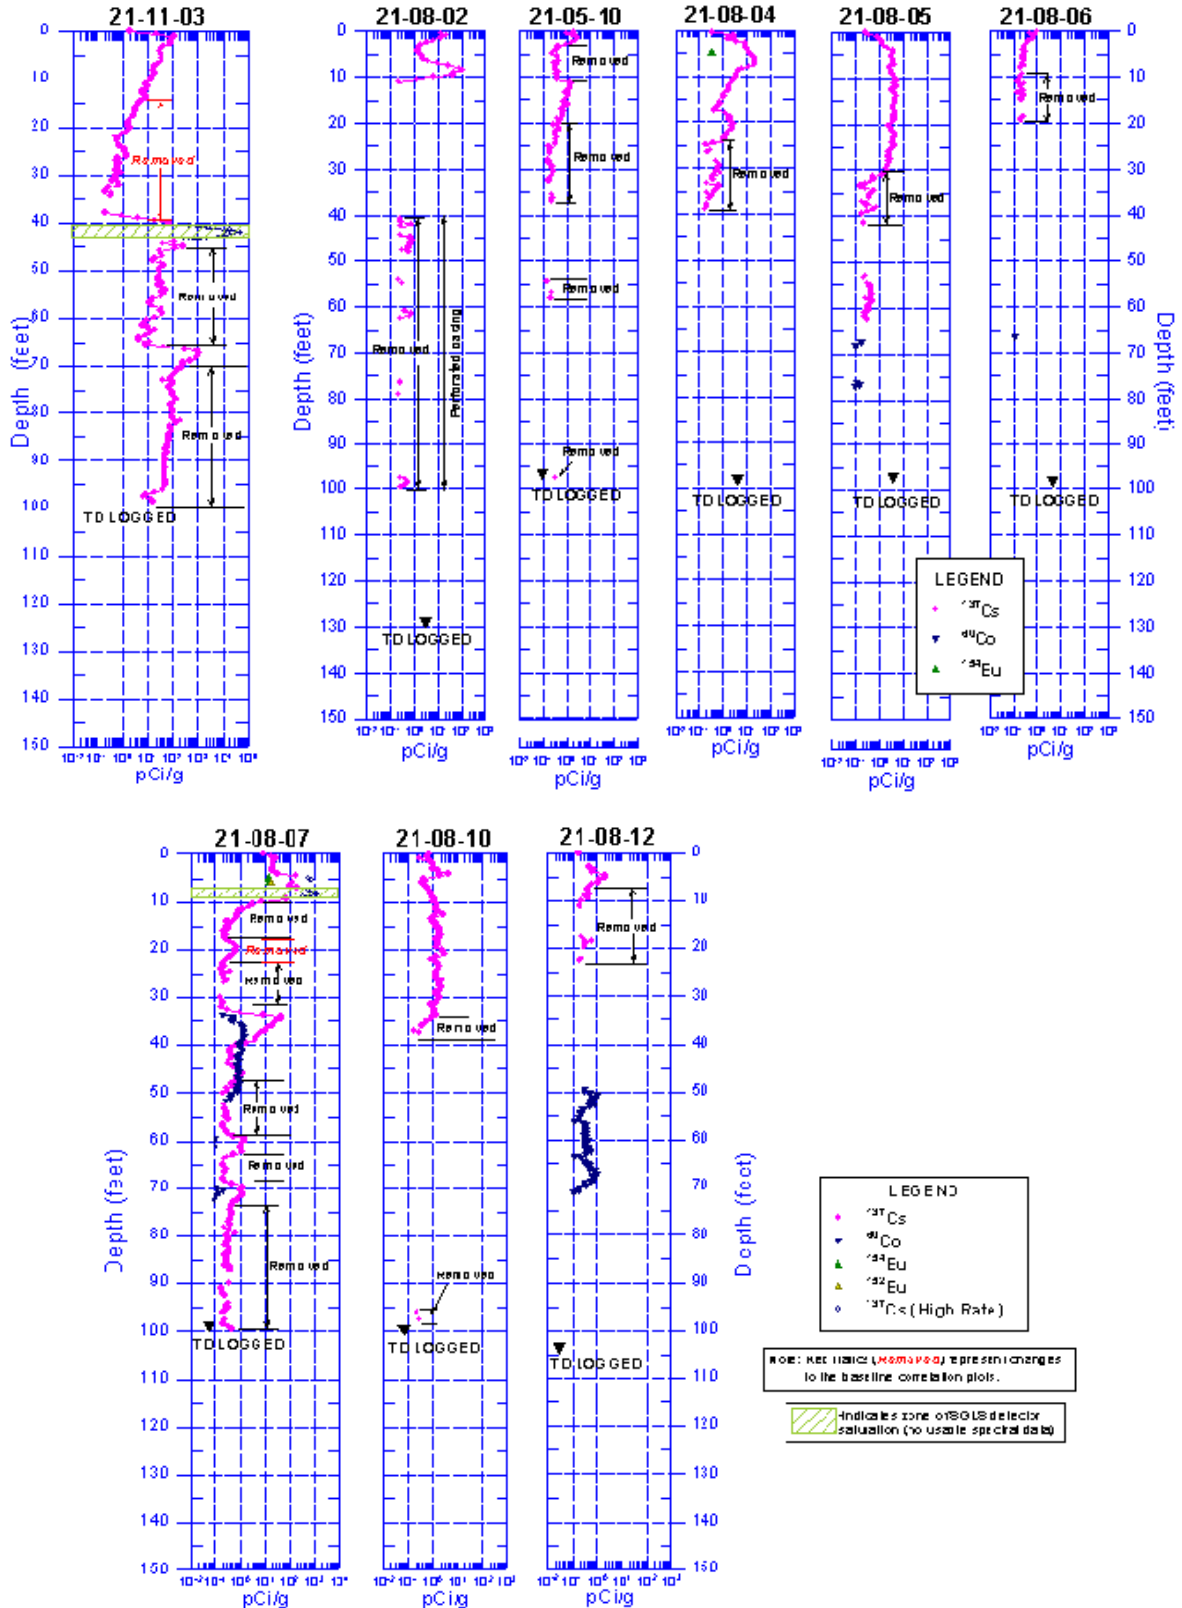
Figure B3-7. Spectral Gamma Logging System Data

Nine drywells surround tank BX-108 (Figure 3-3). Figure B3-7 shows SGLS results for these drywells. Of the eight, three show higher levels of contamination (21-08-07, 21-11-03 and 21-08-12). Historical total gamma and more recent SGLS results for these three drywells are described below. In addition, drywell 21-08-06 is described because historical activity in this well was attributed to a leak from tank BX-108.

The man-made radionuclides ^{137}Cs , ^{60}Co , ^{154}Eu , and ^{152}Eu were detected in this drywell in December 1997 SGLS measurements (Figure B3-7). Cesium-137 contamination was measured almost continuously from the ground surface to about 27 ft, except for a zone of high dead time from 8 to 8.5 ft. High rate logging system measurements in 1999 showed peak levels of ~1000 pCi/g ^{137}Cs from 5 to 8.5 ft. Lower levels of ^{137}Cs activity were measured almost continuously from 30 ft to the bottom of the logged interval (99.5 ft). Distinct peaks of ^{137}Cs contamination were detected at about 5 ft, 34 ft, from 60 to 63 ft, and 69.5 to 73 ft. Cobalt-60

contamination was detected continuously from 33.5 to 52 ft, almost continuously from 69.5 to 72.5 ft, and at 59.5 and 61 ft. Europium-154 contamination was detected at 5 and 6 ft, and ^{152}Eu contamination was detected at 6 ft.

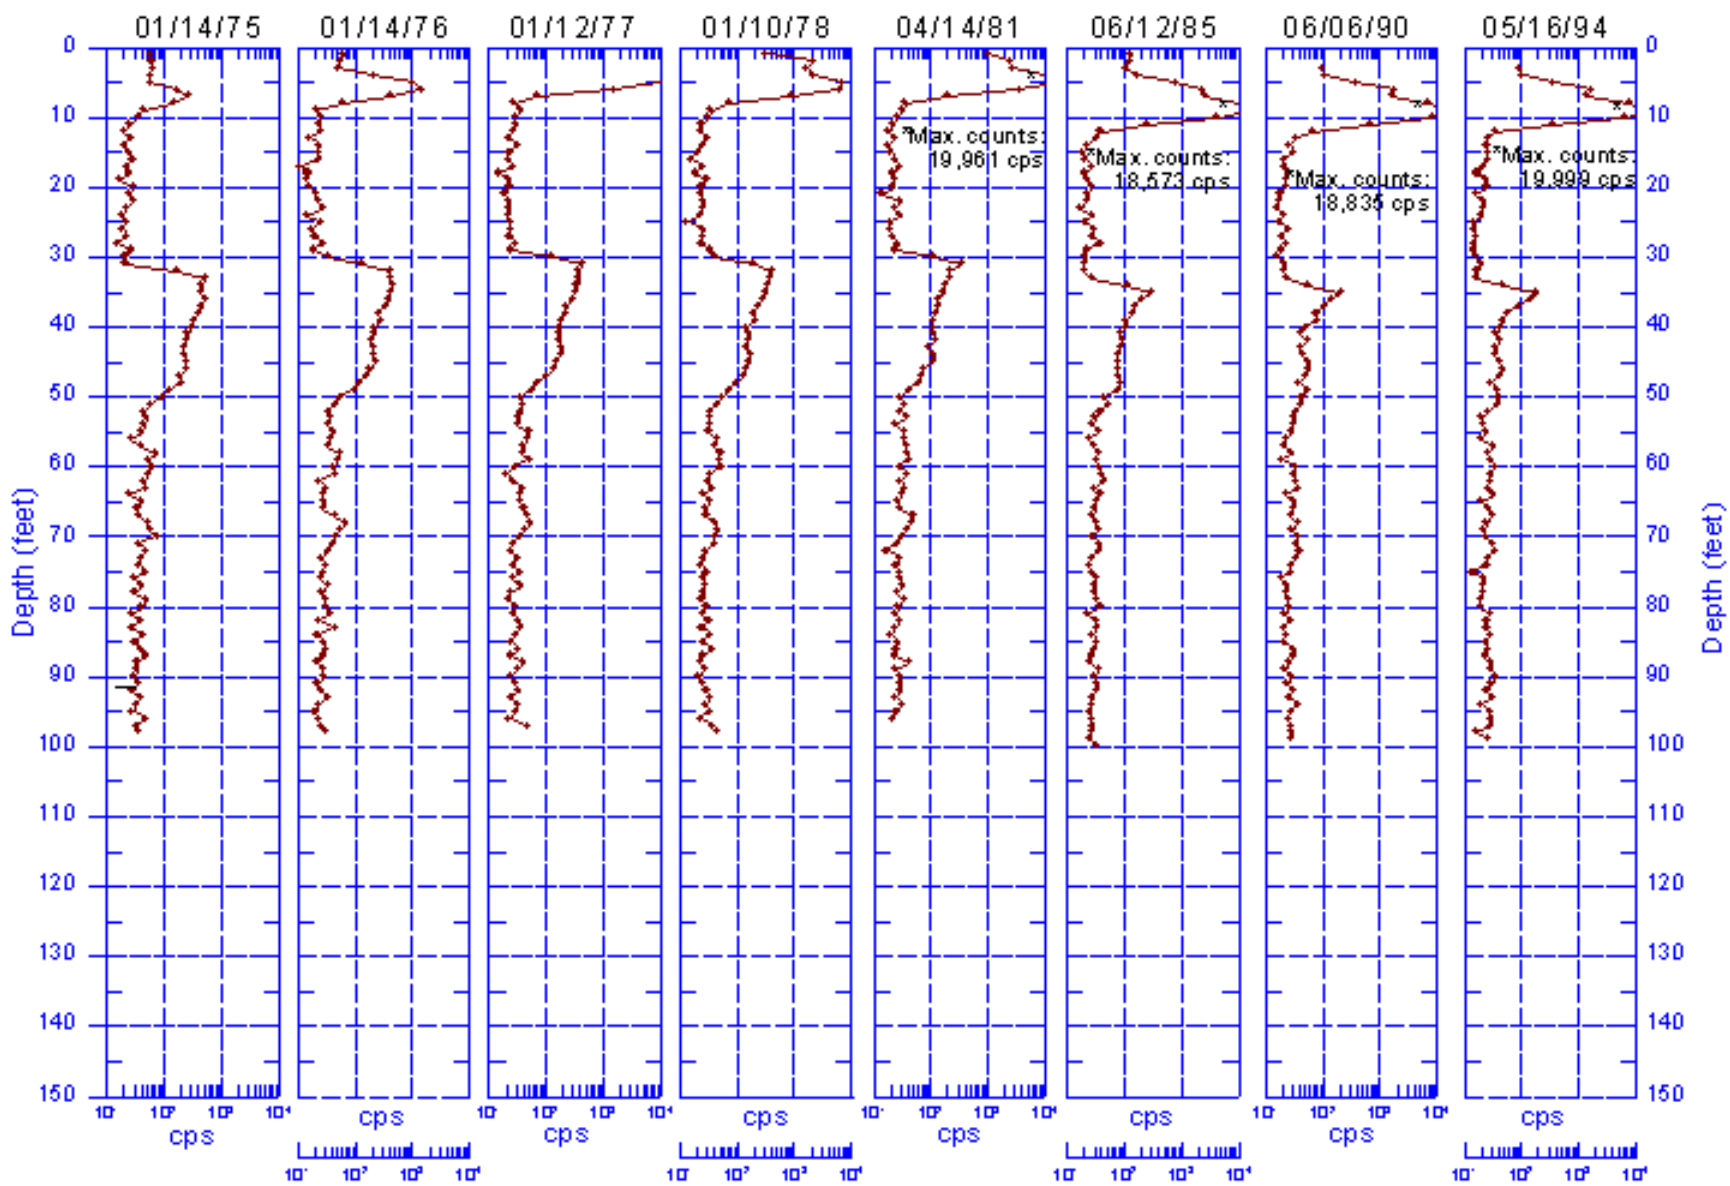
Figure B3-8. Historical Gross Gamma Logs for Drywell 21-08-07

The historical gross gamma log data from 1975 to 1994 (HNF-3531) were reviewed, as well as summaries of the historical gross gamma log data from 1972 to 1986 presented in SD-WM-TI-356 (Figure B3-8). Zones of anomalous gamma-activity are present in the historical logs from about 5 to 10 ft and about 31 to 50 ft. A zone of anomalous gamma-activity is present from about 5 to 10 ft on the earliest log available (January 14, 1975). The activity in this interval

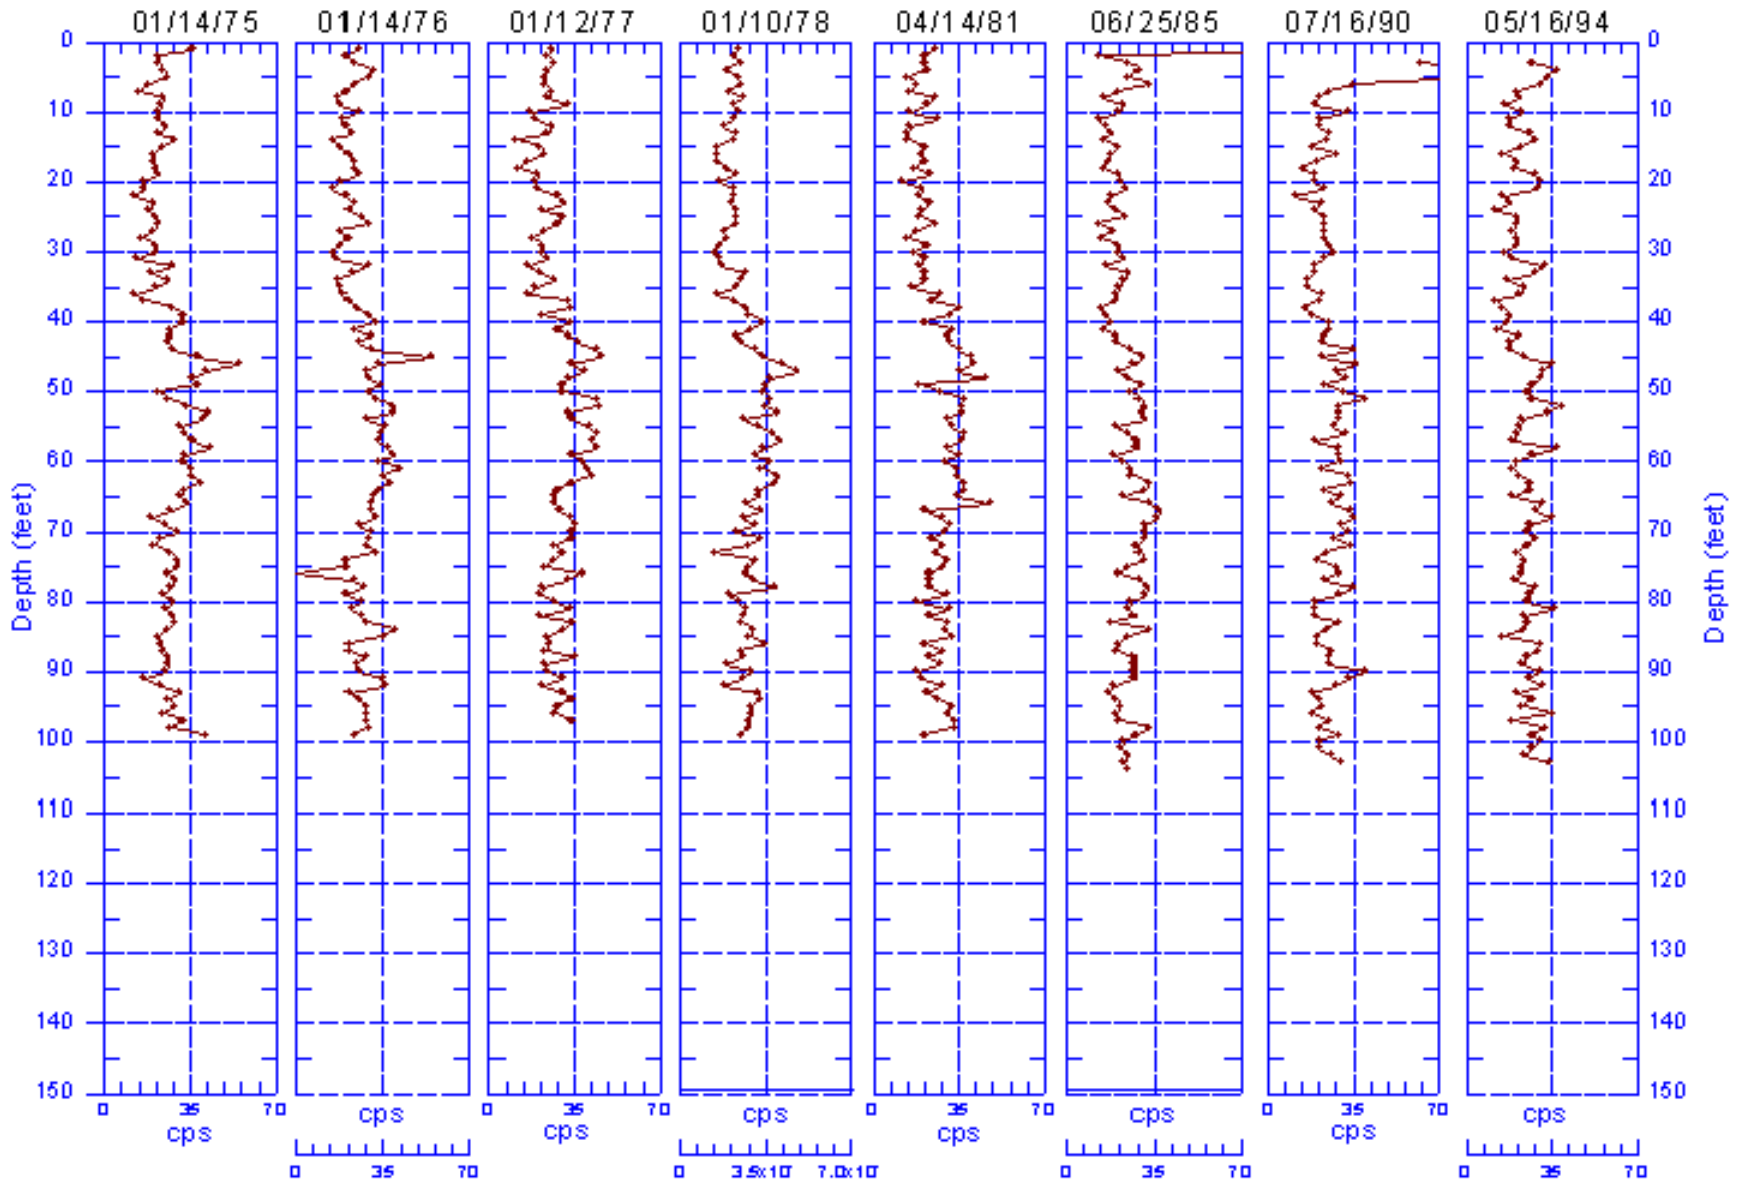
Figure B3-10. Drywell 21-08-12 Historical Gross Gamma (1975 to 1994)

Historical gross gamma log data from 1980 to 1989 (HNF-3531) and data summarized in SD-WM-TI-356 were reviewed (Figure B3-10). Anomalously high gamma-ray activity was present at a depth of about 46 ft in the earliest gross gamma log data (January 1975) available. This contamination appears to have moved downward about 4 ft between April and June 1982, apparently due to berm construction around the tank (similar to apparent downward contaminant movement observed in other drywells around tank BX-108 at this time).

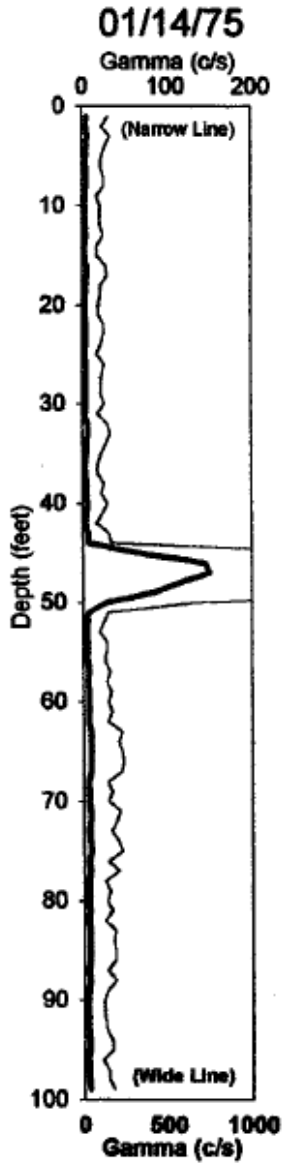
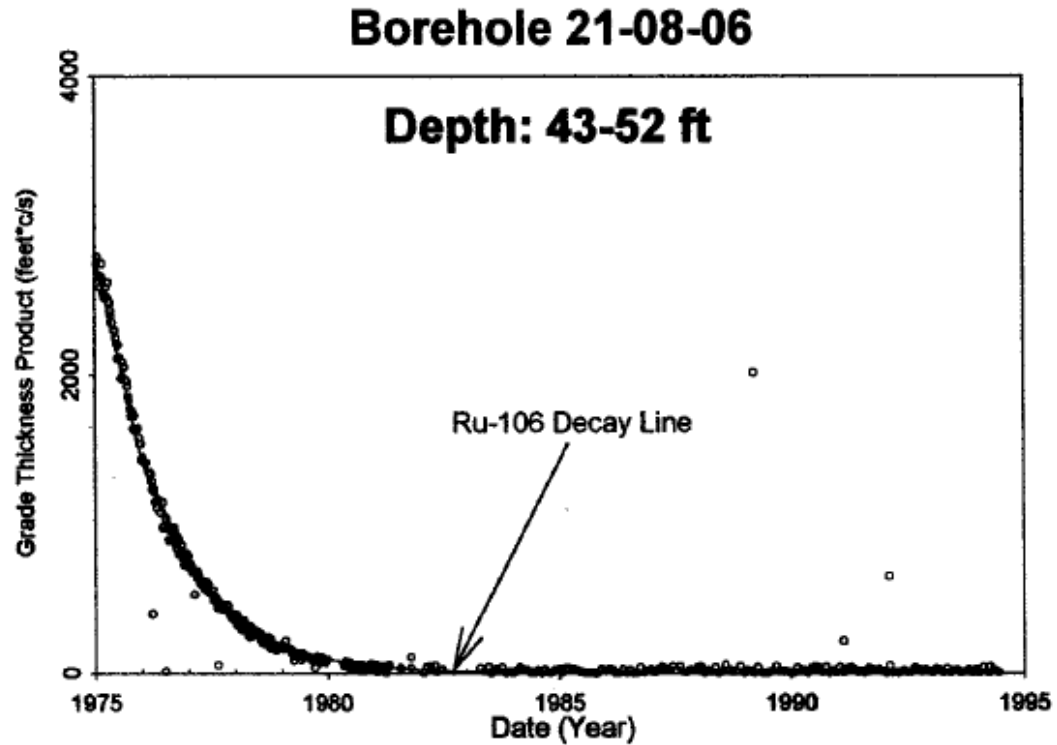
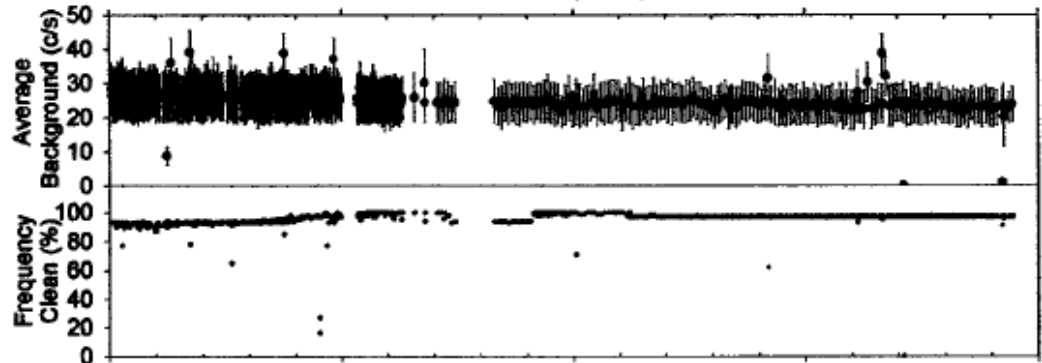
Figure B3-11. Historical Gross Gamma for Drywell 21-18-06 (1975 to 1994)

Drywell 21-08-06 is located approximately 4 ft from the south side of tank BX-108. It was given the Hanford Site designation 299-E33-151. This drywell was completed in January 1972 to a depth of 100 ft using 6-in. casing. Figure B3-11 shows gross gamma logs from 1975 to 1992. Anomalous gamma-ray activity was identified in the historical logs from about 44 to 51 ft in the earliest available historical log data (January 1975). SD-WM-TI-356 records a zone of anomalous activity at 48 ft as early as July 1972, the earliest data provided. The gamma-ray activity at about 48 ft decreased rapidly and reached near background activity levels by 1985. The decay of activity closely matches a decay curve for ^{106}Ru . In SGLS measurements, ^{137}Cs was detected in this drywell from surface to 20 ft bgs at less than 1 pCi/g.

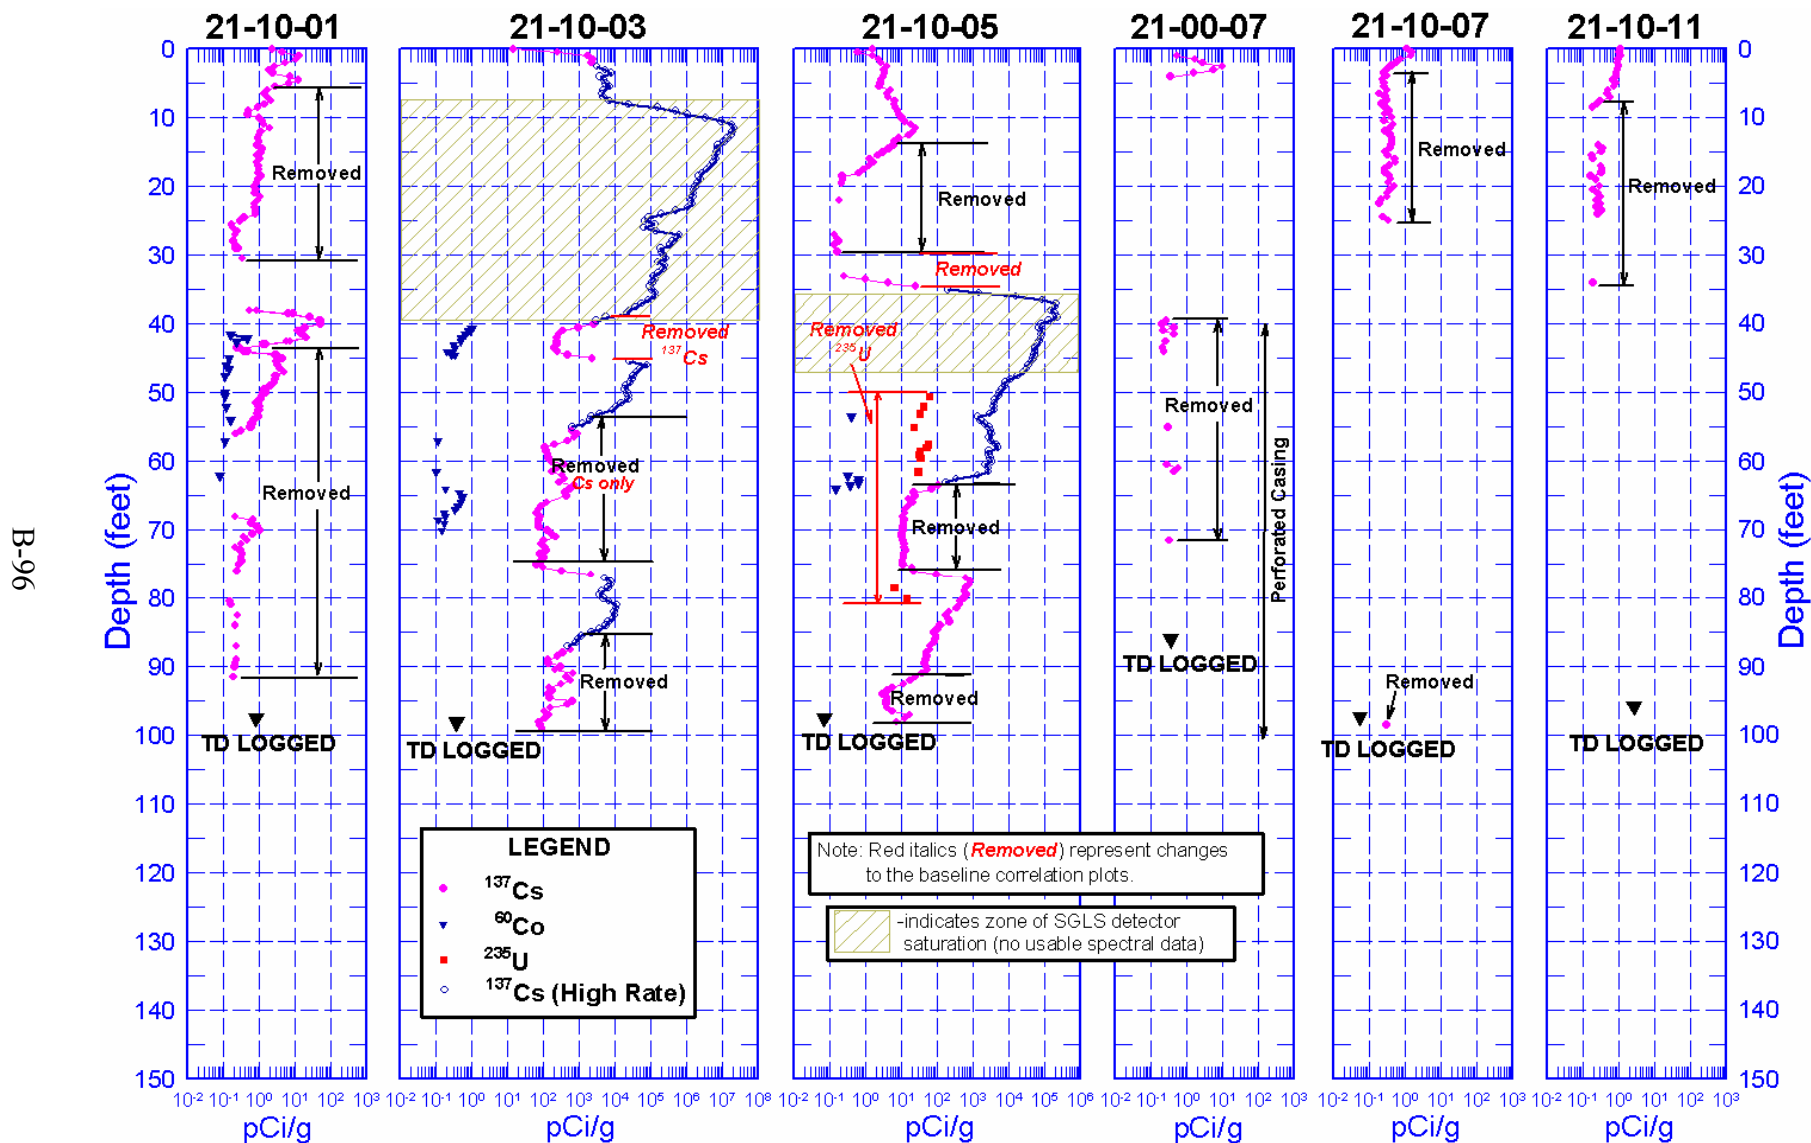
Figure B4-6. Spectral Gamma Logging System Data for Drywells Surrounding Tank 241-BX-110

The 1998 SGLS results (Figure B4-6) show ^{137}Cs contamination from the ground surface to a depth of about 29 ft at a peak of about 10 pCi/g, from 38 to 56 ft ranging up to 60 pCi/g, and from 68 to 75 ft at less than 1 pCi/g. Cesium-137 was also observed intermittently from 76 to 91 ft. The ^{60}Co contamination was detected intermittently from 41.5 to 62 ft at 0.1 to 0.5 pCi/g.

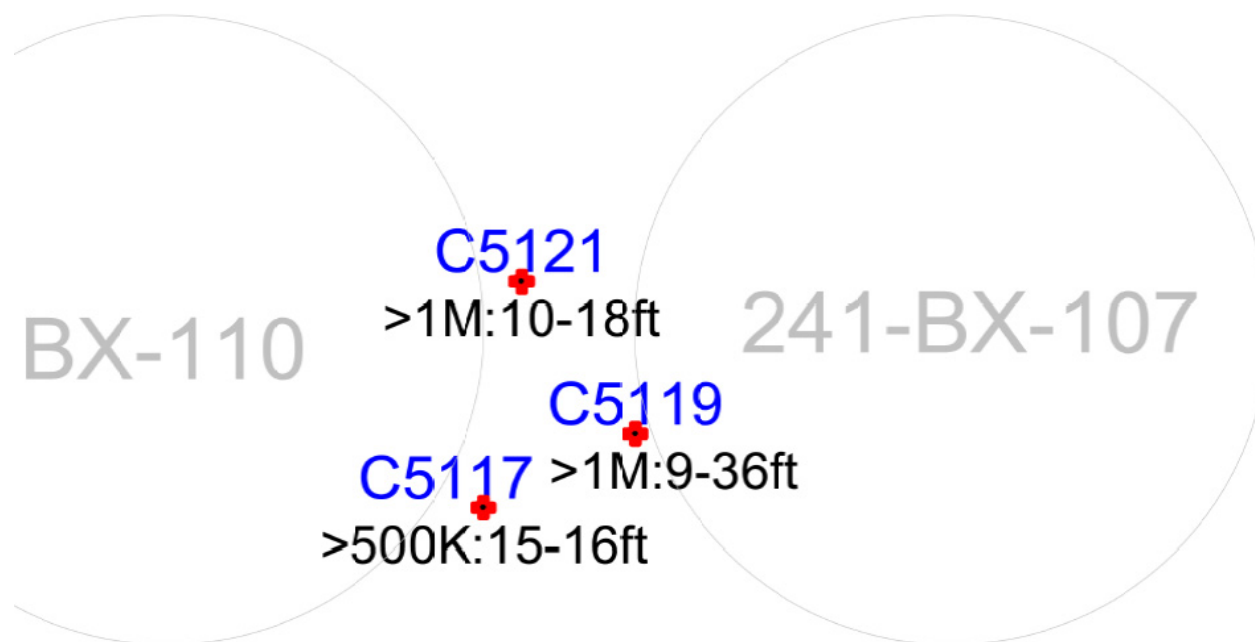
**Figure B4-10. Direct Push Logging Results near Tank 241-BX-110
(logging units pCi/g equivalent Cesium-137)**

Direct push measurements near tank BX-110 also showed high activity in small diameter push holes C5117, C-5119 and C-5121. Figure B4-10 shows the location of the holes drilled and peak logging results. The holes were too hot to obtain samples.

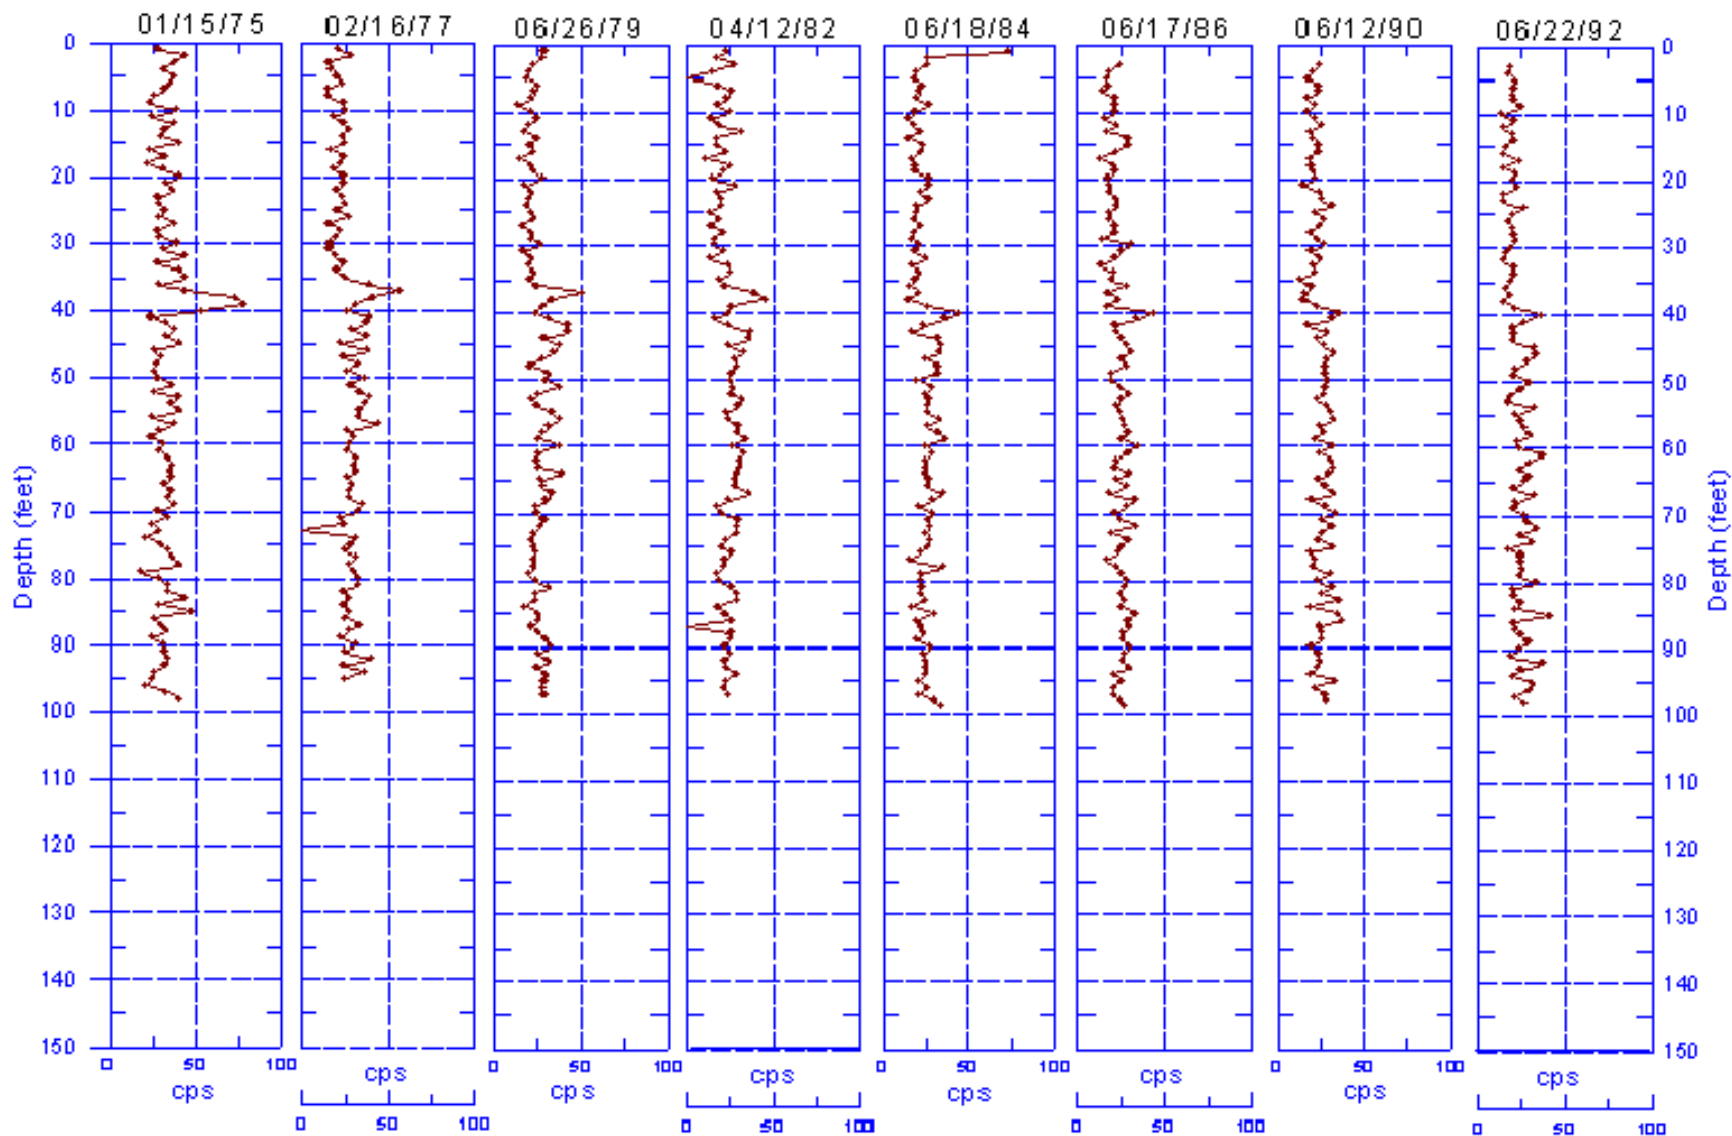
Figure B5-10. Drywell 21-11-07 Historical Gross Gamma (1975 to 1992)

Drywell 21-11-07 is located approximately 2 ft from the southwest side of tank BX-111. This drywell was drilled in September 1971 and completed to a depth of 100 ft using 6-in. casing. The total logging depth achieved by the SGLS was 98.5 ft. A peak SGLS ^{137}Cs value of 0.6 pCi/g was measured at about 40 ft. Historical logs (Figure B5-10) show peak gamma readings of about 75 cps in 1975. The 40 ft gamma peak decayed through 1990. In 1997 SGLS measurements less than 5 pCi/g ^{137}Cs was detected between the ground surface and 15 ft bgs and at 40 ft bgs and 0.1 pCi/g of ^{60}Co was detected at 45 ft bgs.

Historical gamma logs, spectral gamma logs, and direct push logs were also reviewed and discussed. The logs show near surface activity and peak activity from about 30 to 40 ft bgs in drywells 21-11-03 and 21-11-04. The logging data and historical information (see Section 6.0 text) indicates that multiple transfer line leaks or other near surface leaks in lines that run between tanks BX-110 and BX-111 occurred that may account for deeper activity in the drywells.

Although other potential sources are present, the high peak activity at 40 ft with lower near surface activity and little or no activity in drywells 21-11-03 and 21-11-04 indicates the potential for a tank leak.

Because the data suggests two potential sources (tank over flow and transfer line leaks) for activity near tank BX-111 in addition to a potential tank leak it is recommended that this tank be re-assessed per TFC-ENG-CHEM-D-42.

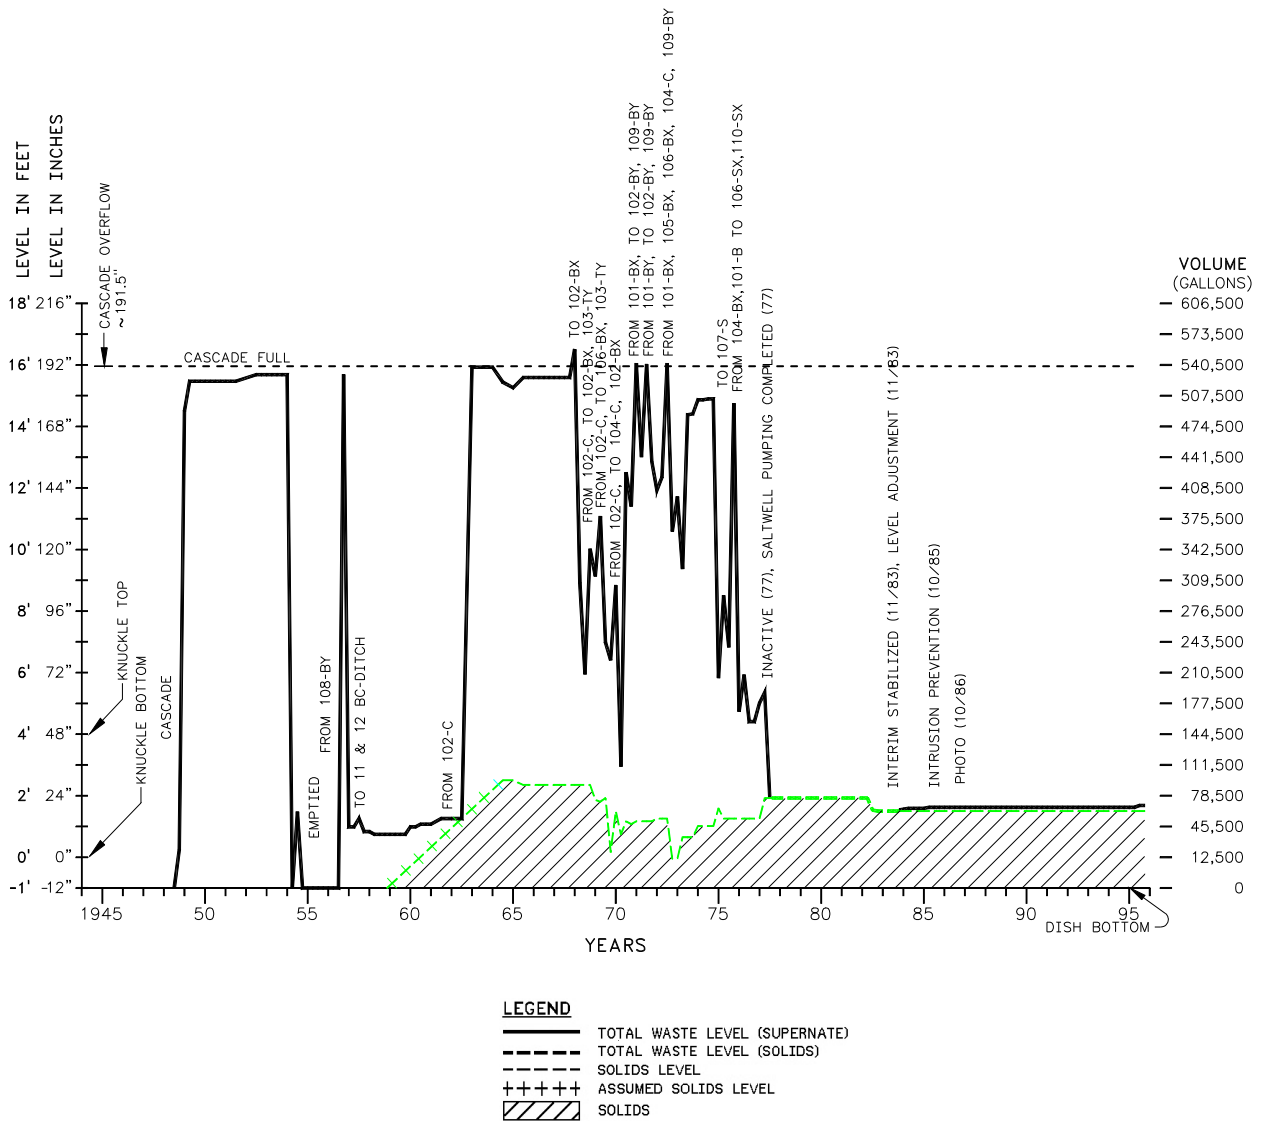
Figure C-1. Tank 241-BX-103 Waste Surface Levels

Surface level measurements have increased since January 1986, caused by a potential intrusion.

2010. As noted in Appendix B, a similar intrusion is also continuing in tank BX-101. In-tank videos of BX-103 taken in 2006 show dripping down the outside of riser 014. No liquid has been observed in tank pits or open pipelines to the pits. As of 2008, the intrusions were believed to be due to leaking seals between the riser and tank dome. The source of the intrusions is unknown, but may be a result of rainwater intrusions around one or more risers. No indications were observed as to unknown surface level decreases inside this SST. Tank BX-103 was filled to over 540 kgal in the mid-1960s and a maximum waste level of 542 kgal was reported in 1972. Figure C-1 shows quarterly tank waste surface levels since the tank first received waste. Figure C-2 shows liquid level monitoring data from SACS (Surveillance Analysis Computer System).
