HANFORD BX-FARM LEAK ASSESSMENTS REPORT

February 2011

Prepared for the U.S. Department of Energy
Office of River Protection

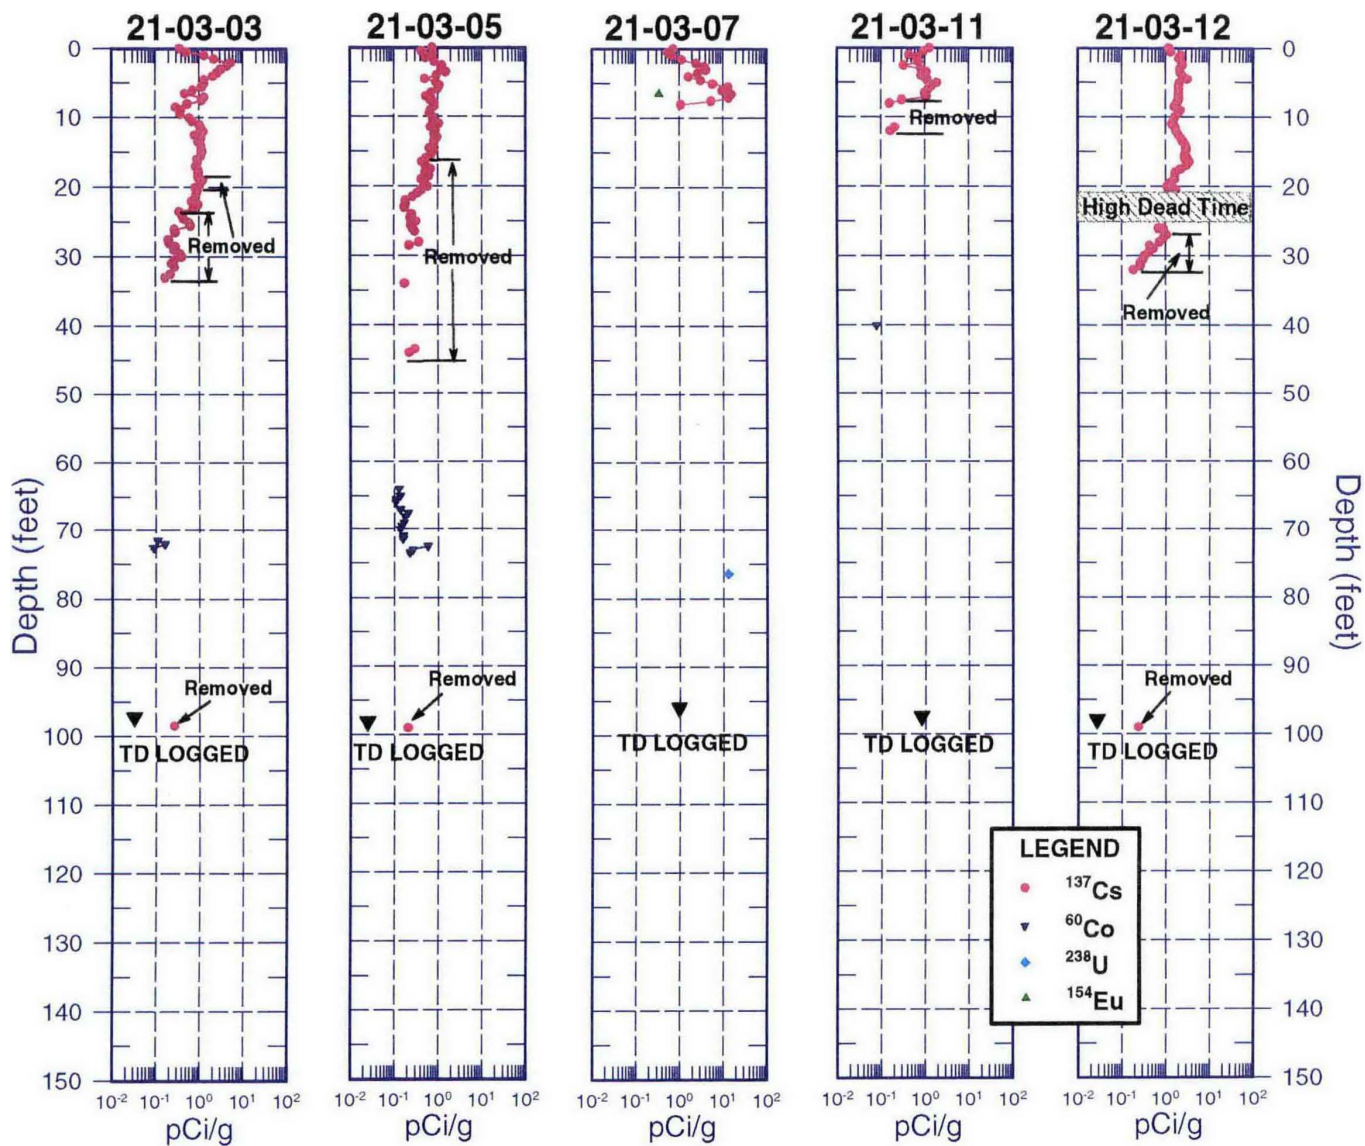
Figure C-3. 1997 Tank 241-BX-103 Spectral Gamma Logging Data

GJO-HAN-19, *Vadose Zone Characterization Project at the Hanford Tank Farms BX Tank Farm Report* shows that a plume of ¹³⁷Cs occurs on the north side of the tank to a depth of about 20 ft (Figure C-3) and concludes that this contamination most likely resulted from surface spills or leaks that migrated downward and some of the contamination may have resulted from dragdown during drilling. A high count-rate zone within this plume may represent a leak from the cascade line connecting tank BX-103 with tank 241-BY-101 in the BY Tank Farm. The thin interval of ⁶⁰Co below 0.2 pCi/g most likely resulted from releases from tank BX-102 or from a large surface spill that occurred between tanks BX-102 and BX-103 in 1951.

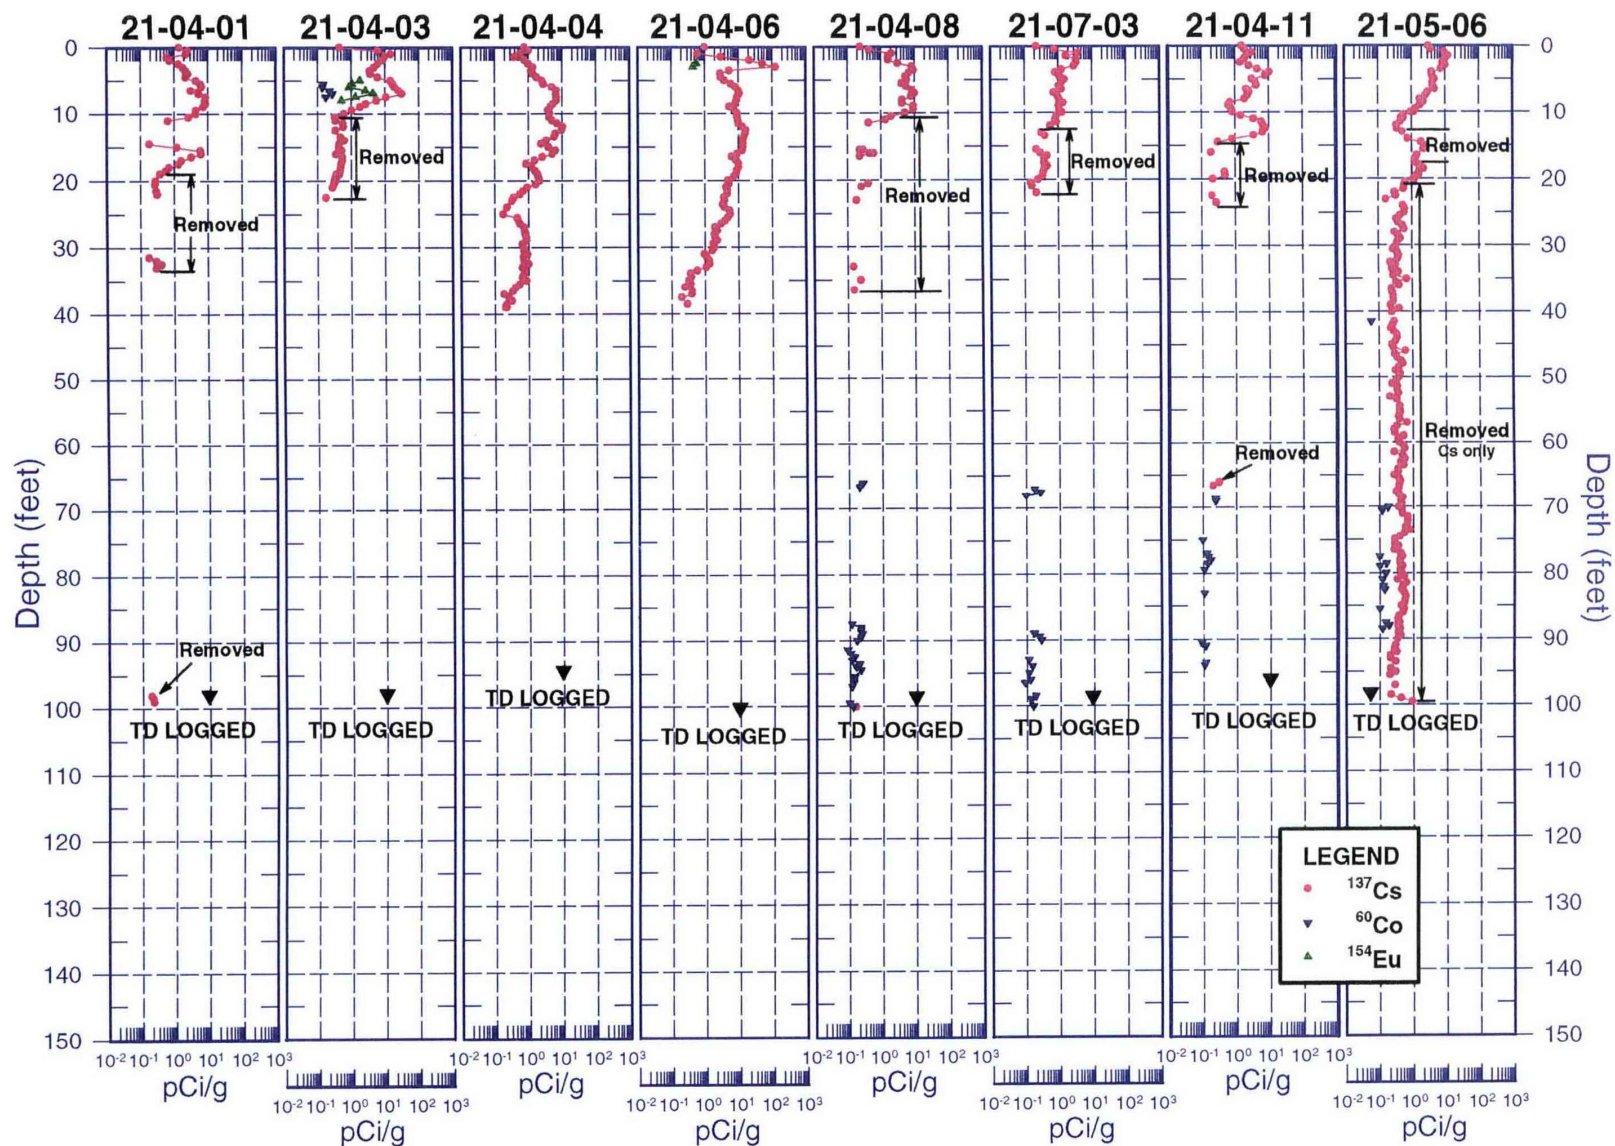
Figure C-6. 1997 Tank 241-BX-104 Spectral Gamma Logging Data

The geologic and historical information available from other sources did not identify any active leaks from tank BX-104. However, the data indicate that surface spills have occurred and subsurface contaminant plumes exist in the vicinity of the tank. The subsurface plumes shown in Figure C-6 are likely associated with releases from tank BX-102 (GJ-HAN-97, *Hanford Tank Farms Vadose Zone Tank Summary Data Report for Tank BX-104*).

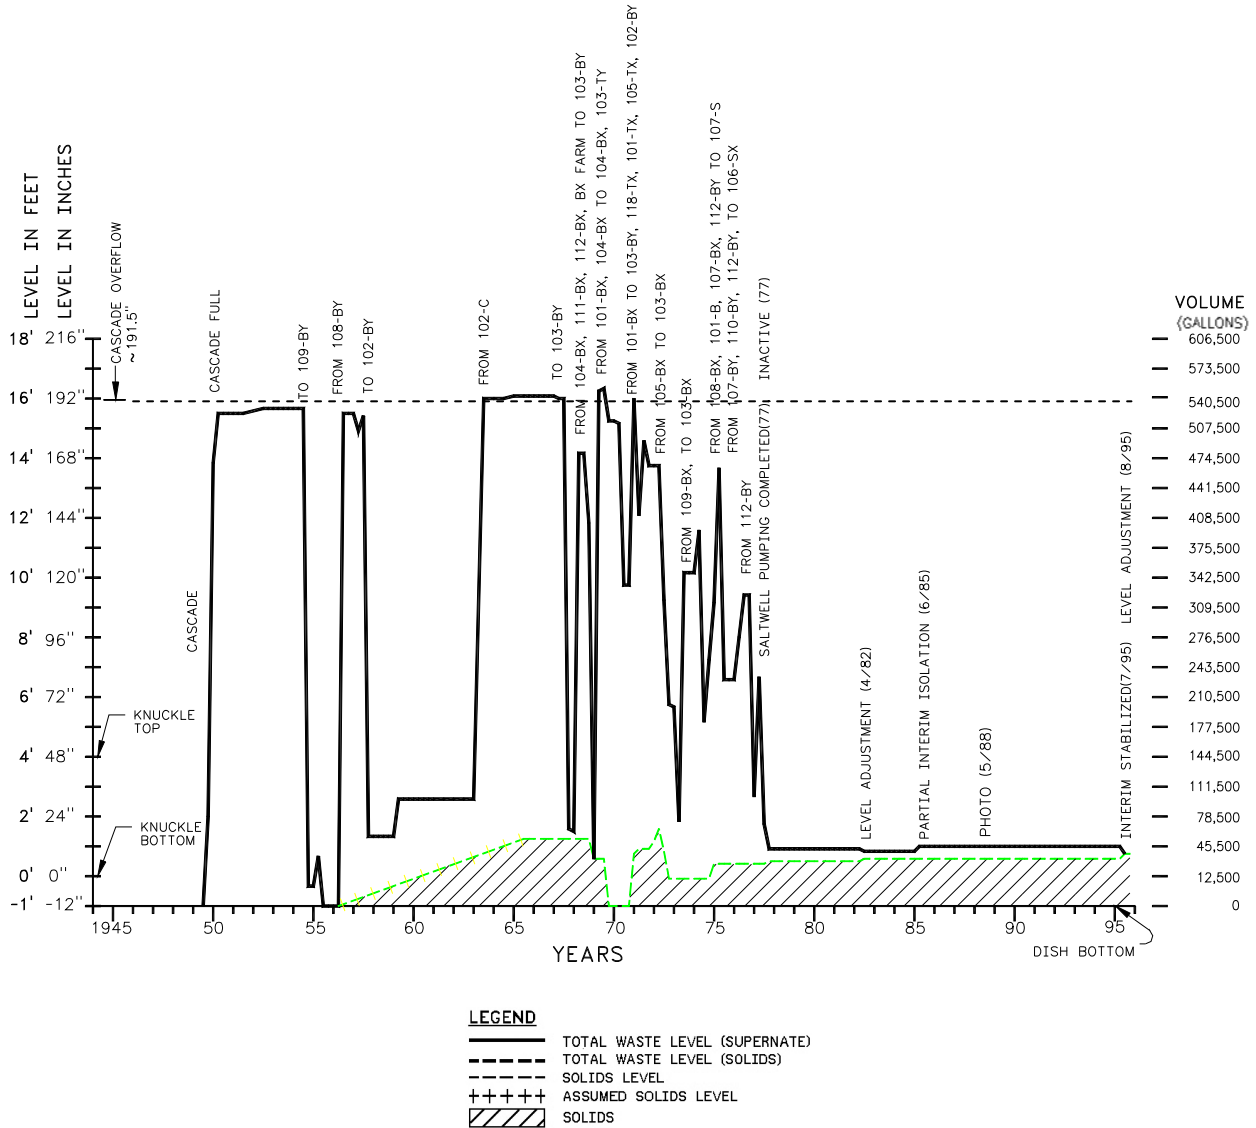
Figure C-10. Tank 241-BX-106 Waste Surface Levels

No basis was found as to unknown surface level increases. Tank BX-106 was filled to a maximum waste level of 541 kgal in 1963, remained well above 530 kgal waste volume through 1967 and again filled to 552 kgal in 1969.

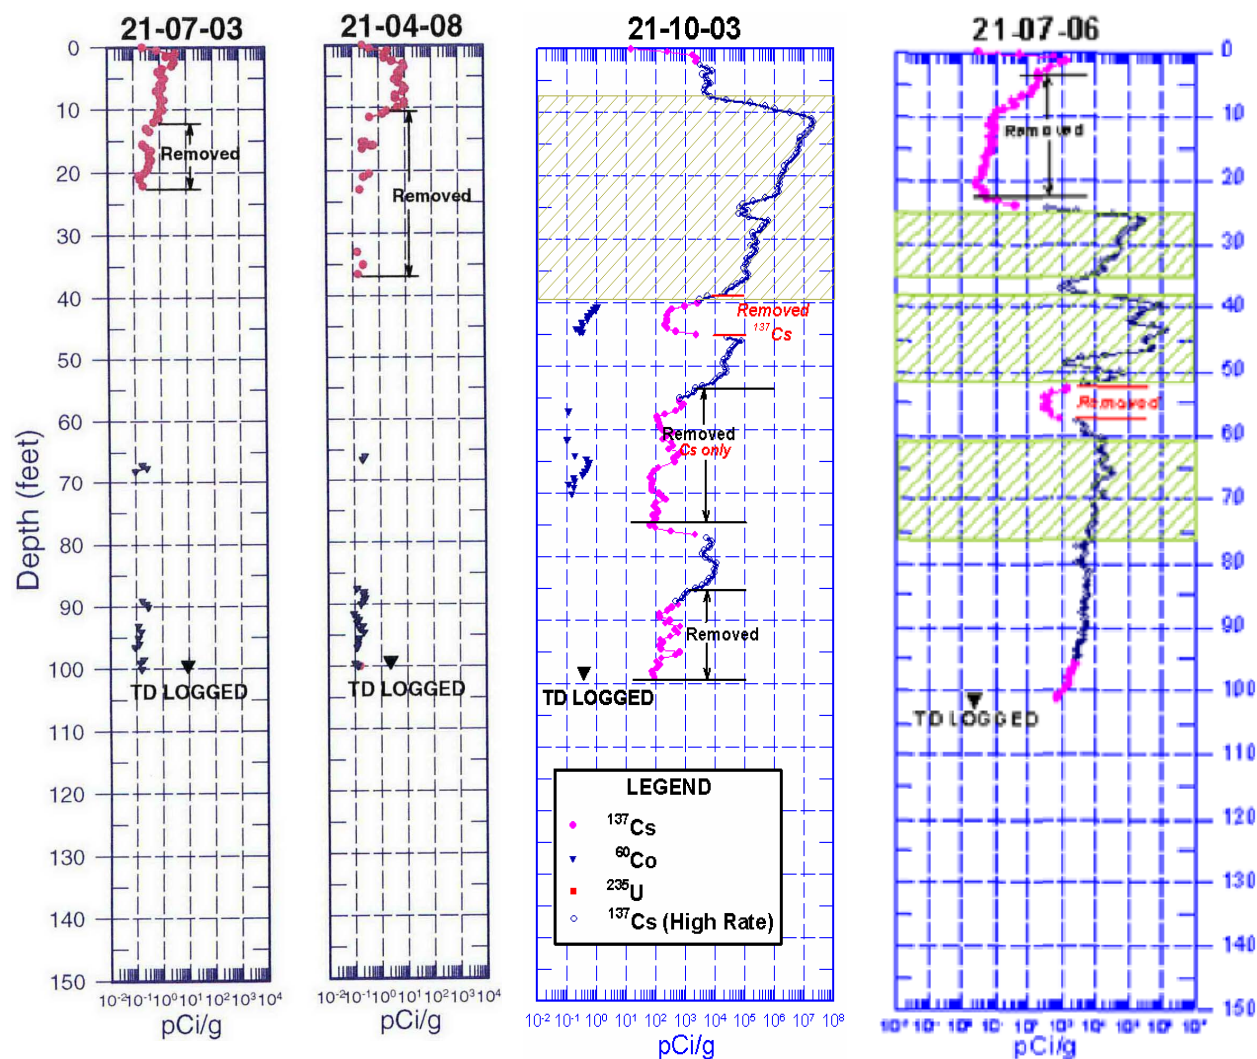
Figure C-15. 1997 Tank 241-BX-107 Spectral Gamma Logging Data

Document SD-WM-TI-356 stated that test drilling and auguring in 1974 indicated that the high-level activity in drywell 21-07-06 was associated with a transfer line leak (no specific information or data concerning this leak is available). GJ-HAN-100, *Hanford Tank Farms Vadose Zone Tank Summary Data Report for Tank BX-107* reports that historical information indicates that the sources of the contamination around this tank are surface spills and pipeline and/or tank leaks. Gross gamma-ray logs indicate drywells 21-07-06 and 21-10-03 showed zones of high dead times. Drywell 21-07-03 showed zones of contamination below the base of the tank (Figure C-15). The vertical extent of this contamination could not be determined. The source of this contamination could be a tank leak that originated at any of a number of tanks in the vicinity, or tank BX-107 itself.
