# NATIONAL TRANSPORTATION SAFETY BOARD

## PIPELINE ACCIDENT REPORT

Natural Gas Pipeline Rupture  
and Subsequent Explosion  
St. Cloud, Minnesota  
December 11, 1998

**NTSB/PAR-00/01  
PB2000-916501  
Notation 7178A  
Adopted July 11, 2000**

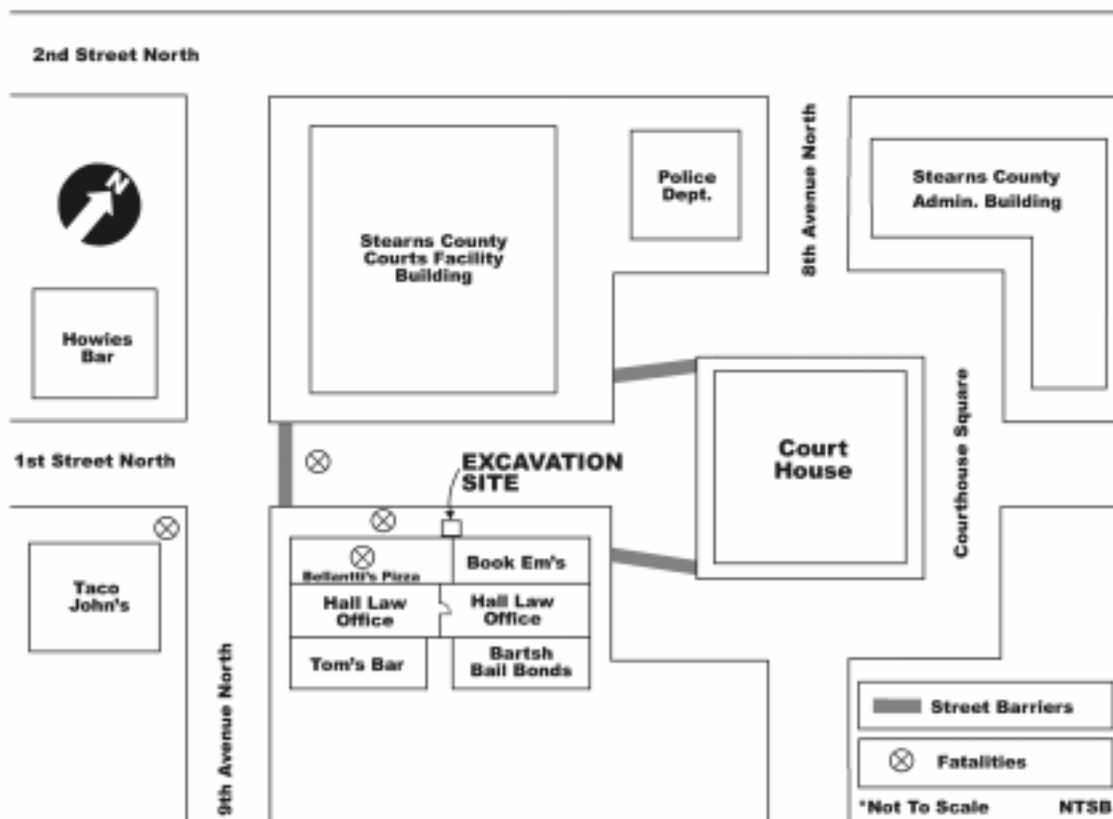
**Figure 1.** Accident Area

On December 11, 1998, a crew of four Cable Constructors, Inc., (CCI) workers was tasked with installing a utility pole support anchor<sup>1</sup> vertically through a concrete sidewalk in the city of St. Cloud, Minnesota. (See figure 1.) The anchor (figure 2) was being installed as part of a project by Seren Innovations, Inc., (Seren) to construct a fiber-optic communication system in the St. Cloud area. Sirti Ltd. (Sirti) had been hired to provide all engineering, design, drafting, mapping, licensing, permitting and specification development, and program management for the construction of the system, and CCI had been hired to perform the actual construction work.
