Highway Accident Report

Collision Between Amtrak Train 97 and Molnar Worldwide Heavy Haul Company Tractor-Trailer Combination Vehicle at Highway-Rail Grade Crossing in Intercession City, Florida, on November 17, 2000

**NTSB/HAR-02/02
PB2002-916202
Notation 7480
Adopted July 23, 2002**

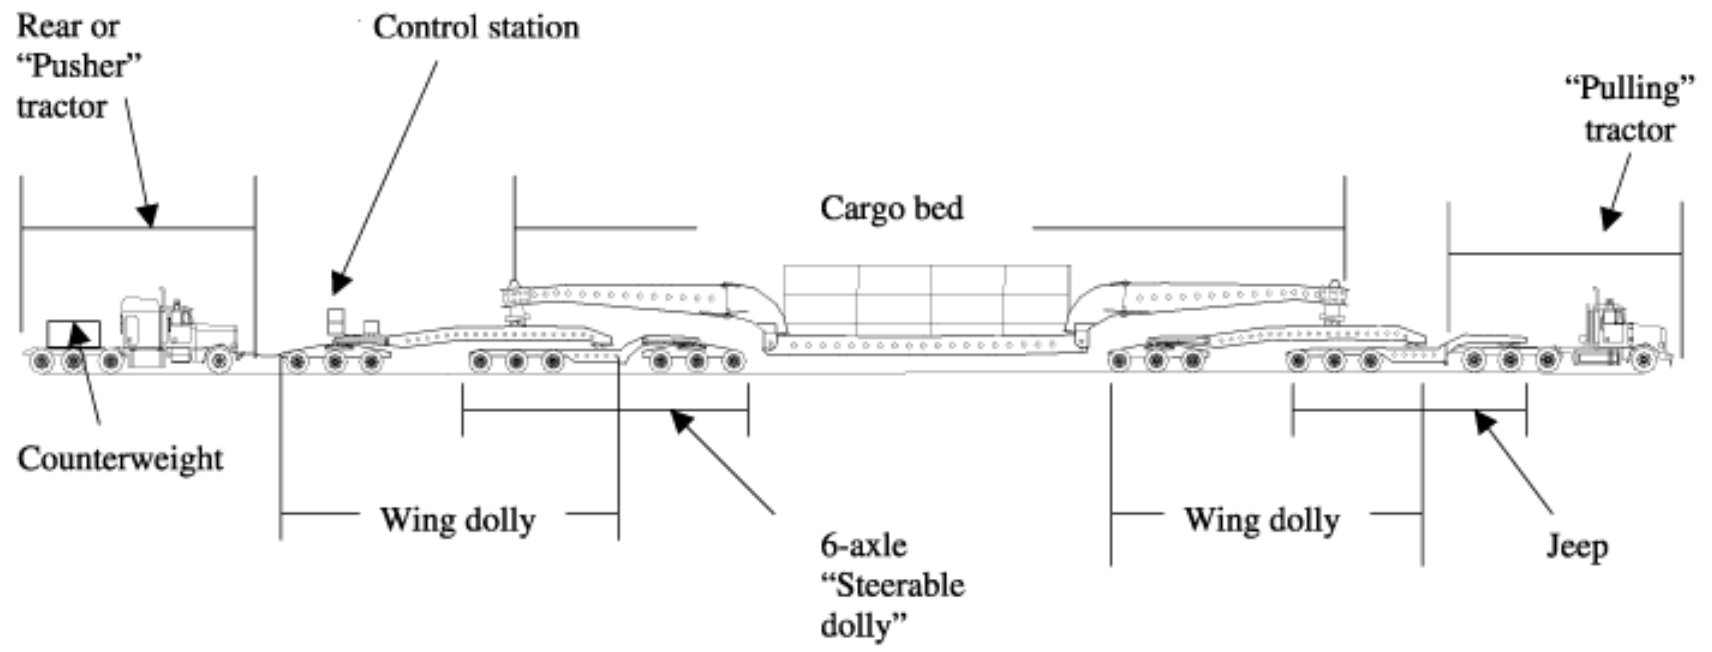
Figure 1. Diagram of accident vehicle.

The tractor-combination vehicle and load (see figures 1 and 2) measured 225 feet long, 15 feet 11 inches wide, and 13 feet 6 inches high; ground clearance was 8 inches; and gross vehicle weight was 380,420 pounds.² The load, valued at \$330,000, was being transported from Salt Lake City, Utah, to the KUA power plant. The truckdriver possessed specialized moving permits for the load that required escort vehicles (pilot cars). At the time of the accident, three private pilot cars were escorting the load. Additionally, KUA representatives were present at the site for the delivery of the condenser. The Amtrak train was bound from New York City to Miami, Florida, with 83 passengers and 4 crewmembers on board.

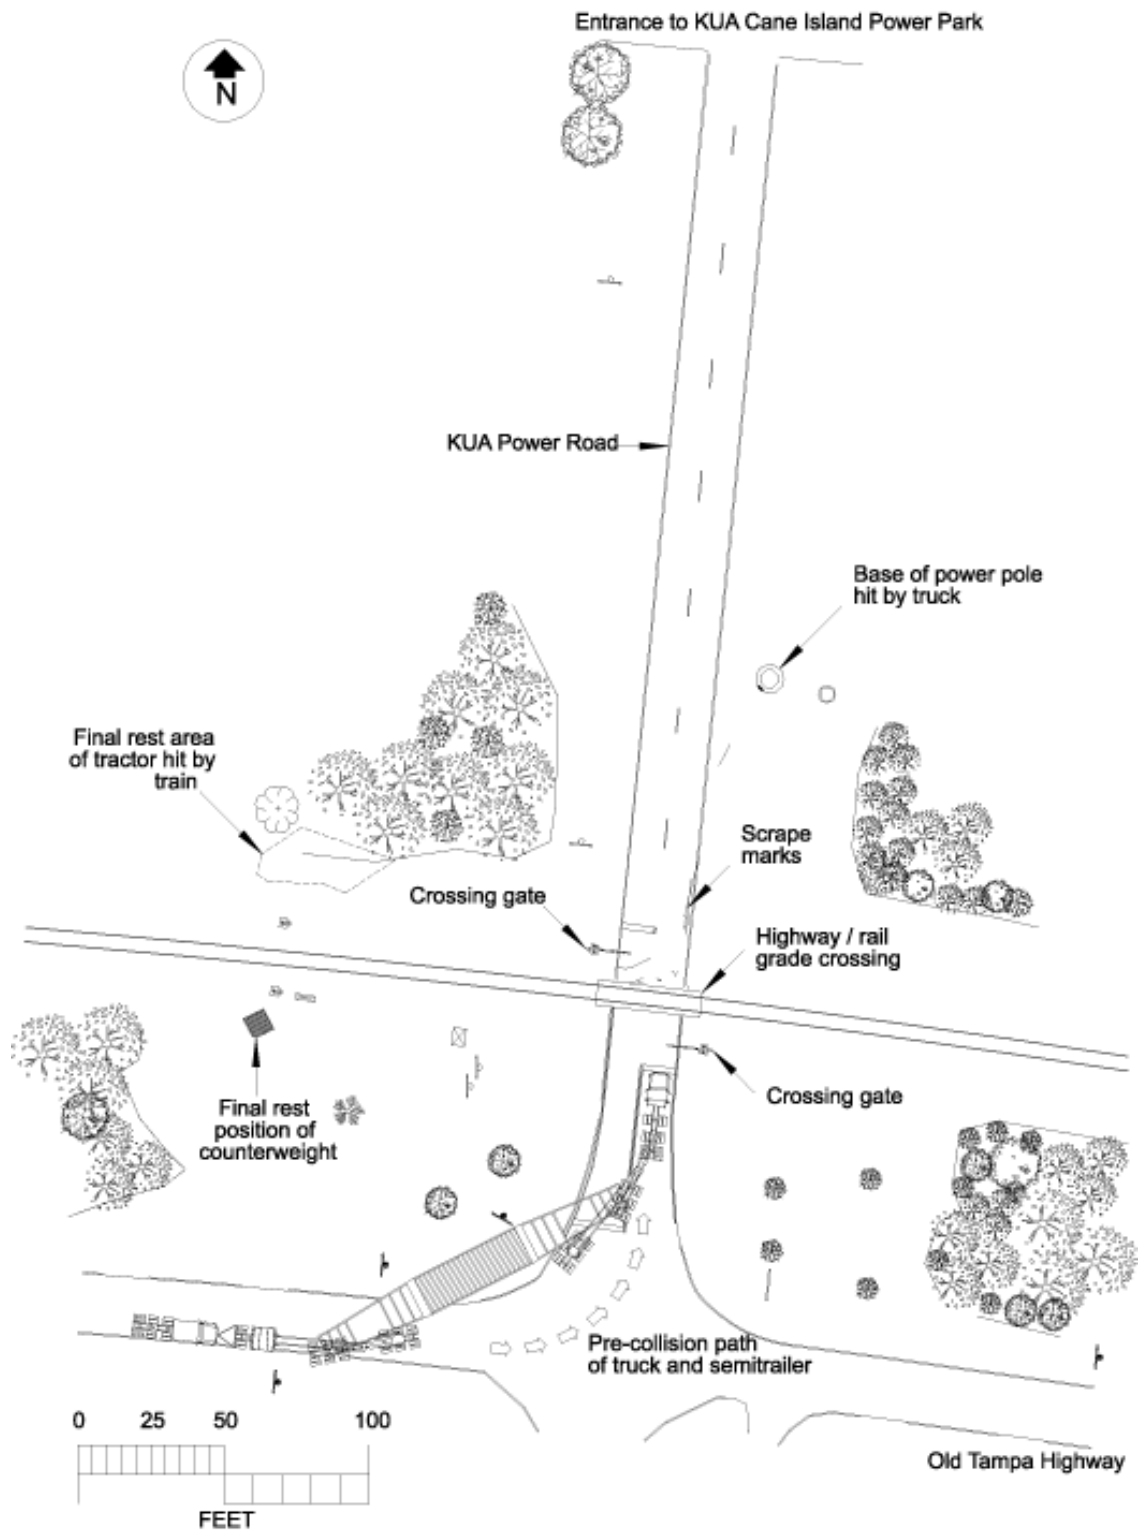
Figure 5. Schematic of accident site.

Just before the accident, the convoy (combination vehicle and three private pilot cars) was traveling eastbound on Old Tampa Highway and made a left turn onto the private roadway leading up to the KUA Cane Island Power Park. (See figure 5.) The truckdriver stated that to maneuver the vehicle over the highway-rail grade crossing, he stopped and adjusted the vehicle's cargo deck to its highest position (32-inch ground clearance from a normal 8-inch ground clearance). The truckdriver also stated that because of the combination vehicle's extensive length, the convoy spent a "considerable amount of time" in the intersection attempting to make the left turn. The unique configuration and length of the combination vehicle required an auxiliary operator who was responsible for steering the combination vehicle's rear. (A control station located at the trailer's rear [see figure 1] enabled the auxiliary operator to steer and to regulate the load's height.) The convoy stopped to avoid a guide wire for a utility pole in the southwest corner. The truckdriver had to back up and move forward while the auxiliary driver steered the trailer around the guide wire. Crewmembers also removed a stop sign located at the northwest corner of the intersection. (See figure 6.) Once the trailer was properly aligned, the truckdriver proceeded to cross the tracks without stopping.
