APPENDIX V  
MINE MAP  
ARACOMA ALMA MINE #1, MSHA ID No. 46-08801  
ARACOMA COAL COMPANY, INC.  
9 Headgate Longwall Belt Drive  
Area Fire Protection

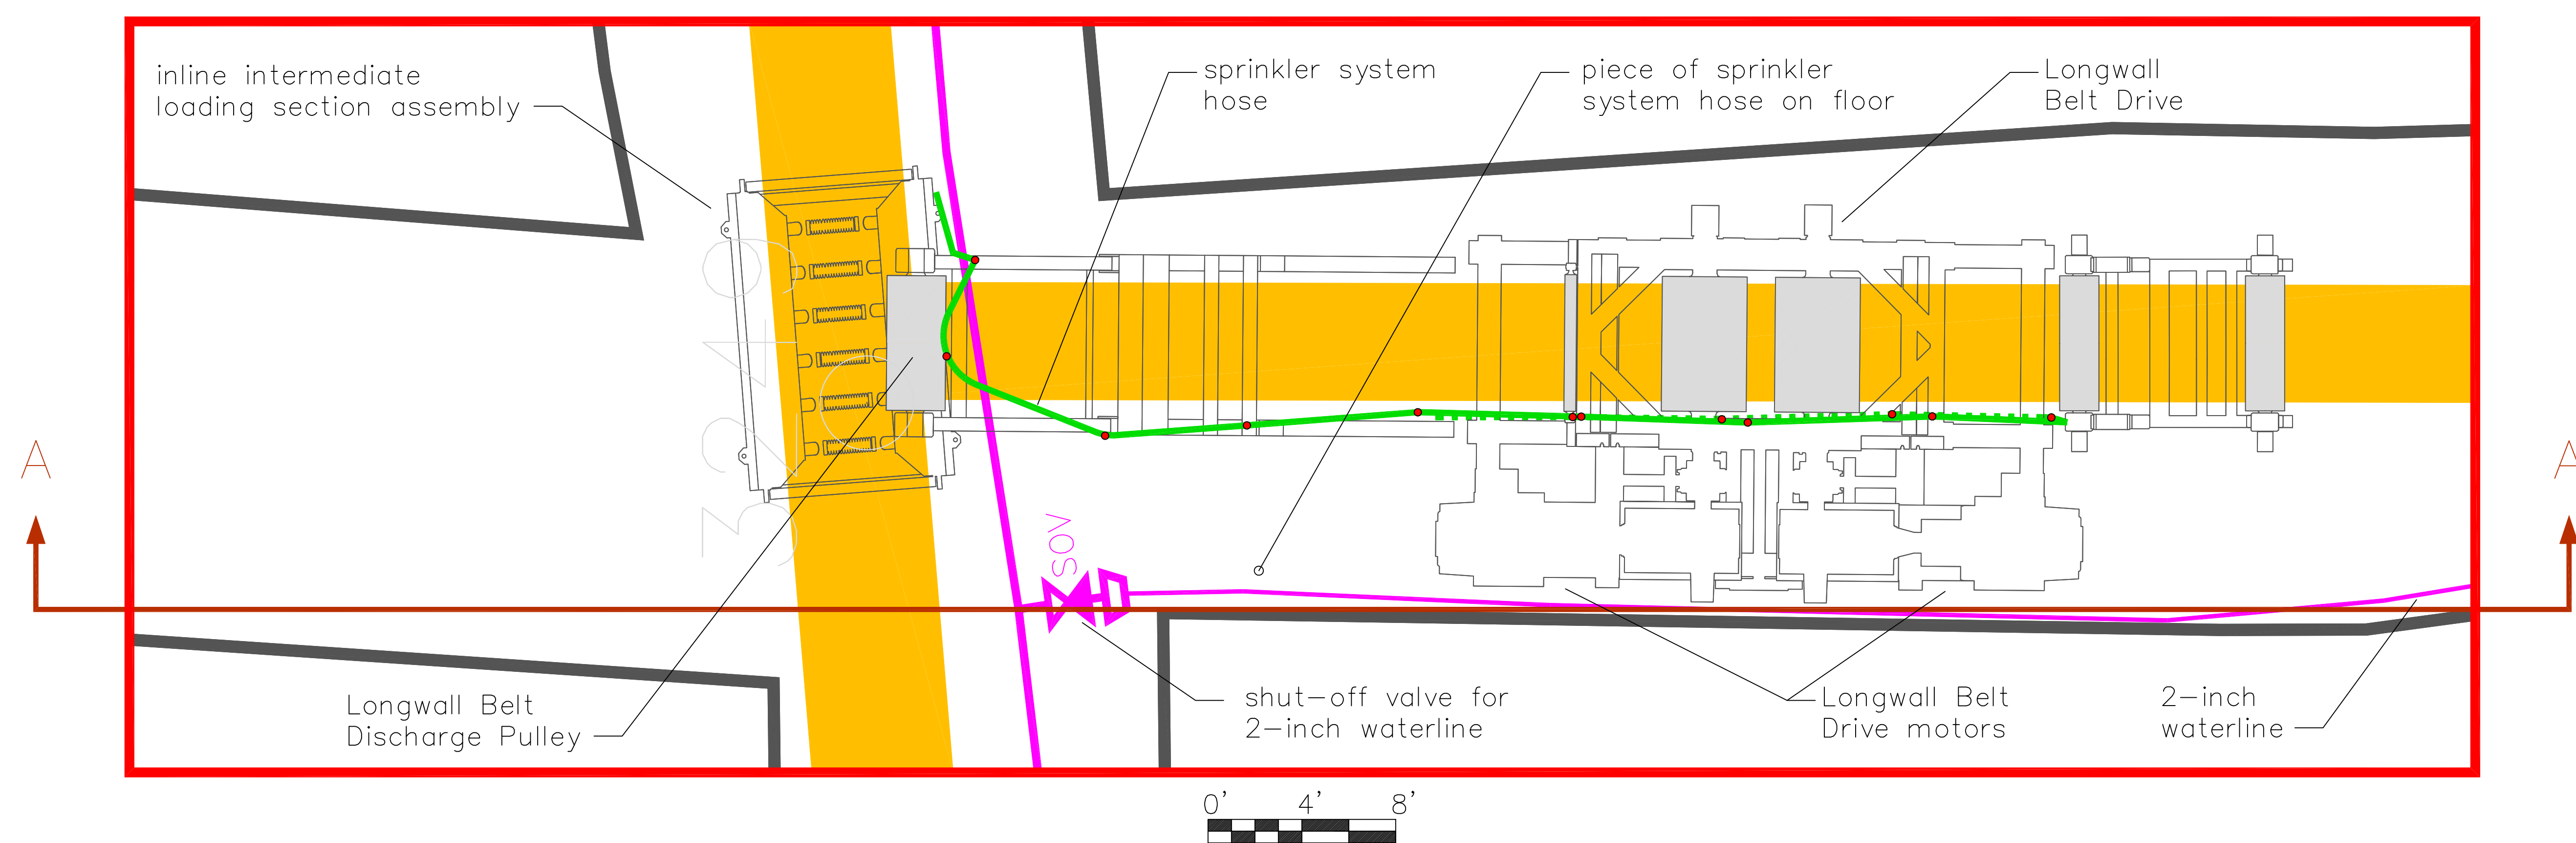
Detail Plan View of Longwall Belt Drive Area

Portions of the suspended belt structure shown in the Section A-A' side view was damaged by the fire and fell from the roof. The belt structure and other conveyor belt system components shown are depicted as similar to how they likely existed, based on information collected during the investigation, before the fire and is for demonstrative purposes only.

Waterline and other objects in the area of the fire were damaged. Approximate location of specific objects depicted as mapped and photographed for demonstrative purposes.
