Report of Investigation  
Fatal Underground Coal Mine Fire

U.S. Department of Labor  
Mine Safety and Health Administration  
2007

Aracoma Alma Mine #1  
Aracoma Coal Company, Inc.  
Stollings, Logan County, West Virginia  
I.D. No. 46-08801

Fatal Underground Coal Mine Fire  
January 19, 2006

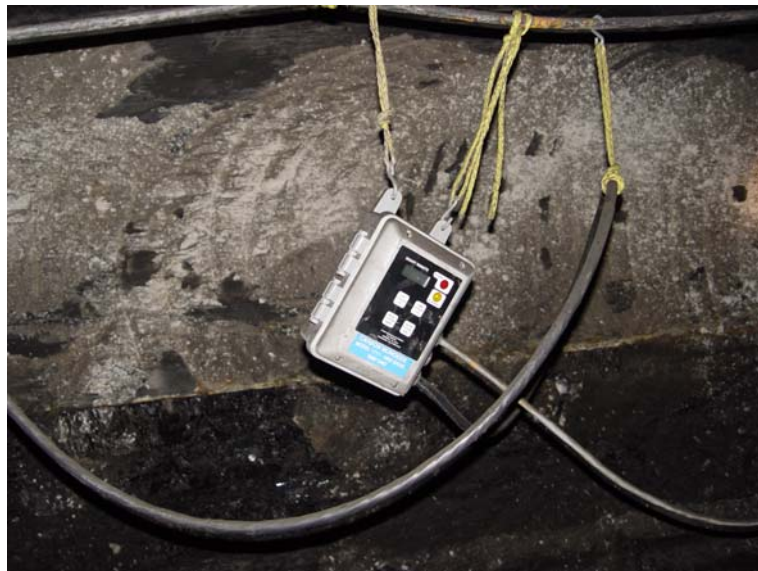
A Pyott-Boone AMS, Model 9500, was installed at the mine to measure carbon monoxide concentrations along the entire underground belt system. Approximately 44 carbon monoxide sensors were installed in the belt entries to provide early warning of a fire (Figure 9).

**Figure 9. Carbon monoxide sensor.**

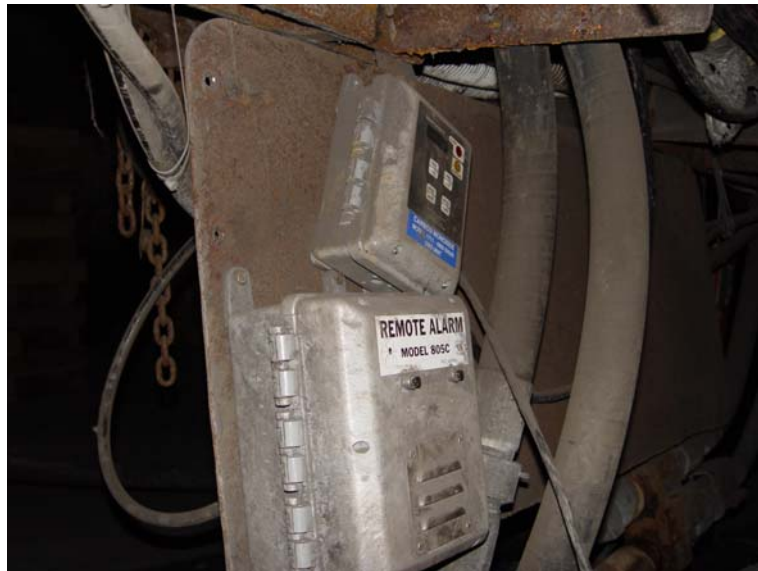
The locations of the CO sensors are shown in Appendix N. An alarm unit was installed underground at the longwall headgate to provide visual and audible signals in the event of a single CO alarm signal or alert signals from two consecutive CO sensors (Figure 10).

**Figure 10. Remote alarm unit in headgate area on longwall section.**

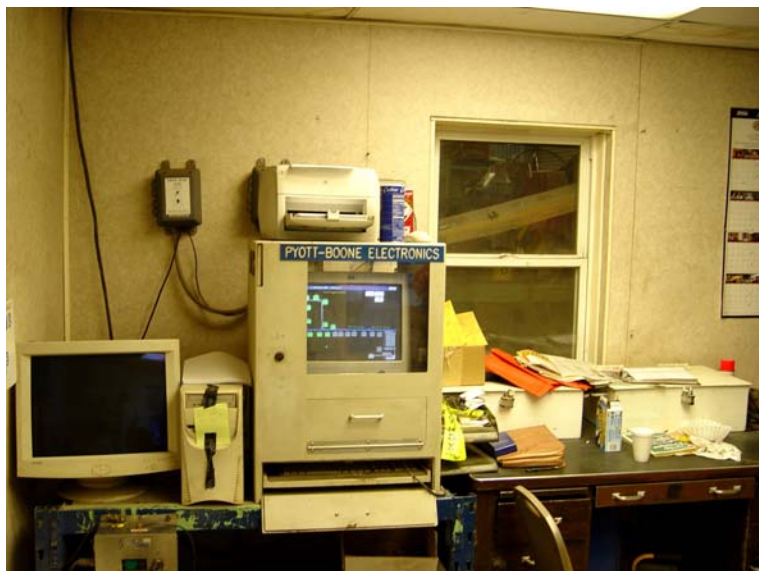
To function properly, the mine operator was required to program the AMS computer to respond to individual CO sensor signals so that specific CO sensors would automatically activate the appropriate alarm unit. The AMS computer, printer, visual display, and means of communication with underground locations were located in the dispatcher's office (Figure 11).

**Figure 11. AMS in dispatcher's office located in Box Cut on surface.**
