Report of Investigation
Fatal Underground Coal Mine Fire

Aracoma Alma Mine #1
Aracoma Coal Company, Inc.
Stollings, Logan County, West Virginia
I.D. No. 46-08801

January 19, 2006

Fatal Underground Coal Mine Fire
January 19, 2006

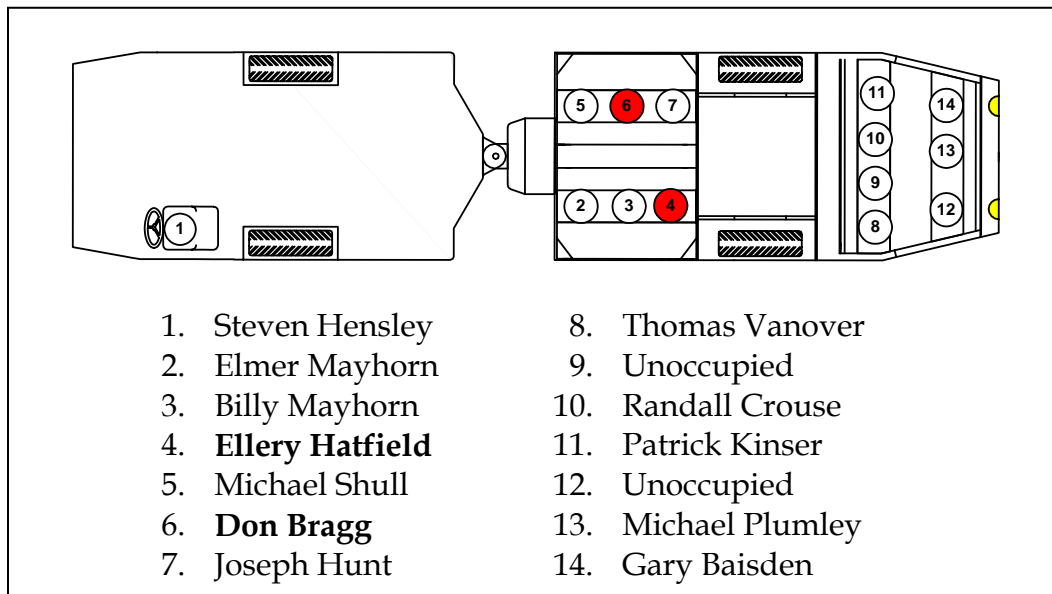
Figure 2. Seating arrangement of miners on 2 Section diesel mantrip

After boarding the mantrip, the entire 2 Section crew continued their evacuation, traveling out the No. 5 Entry of NEM. The locations where the miners were seated in the mantrip are shown in Figure 2.

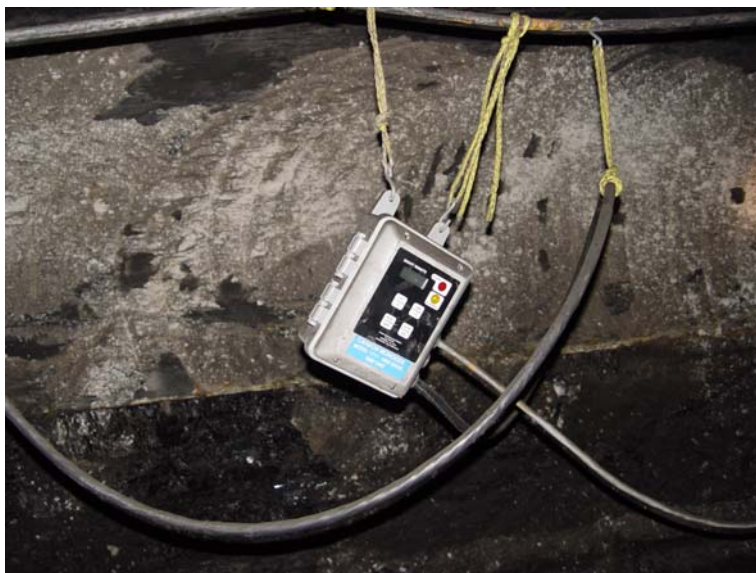
Figure 9. Carbon monoxide sensor.

A Pyott-Boone AMS, Model 9500, was installed at the mine to measure carbon monoxide concentrations along the entire underground belt system. Approximately 44 carbon monoxide sensors were installed in the belt entries to provide early warning of a fire (Figure 9).

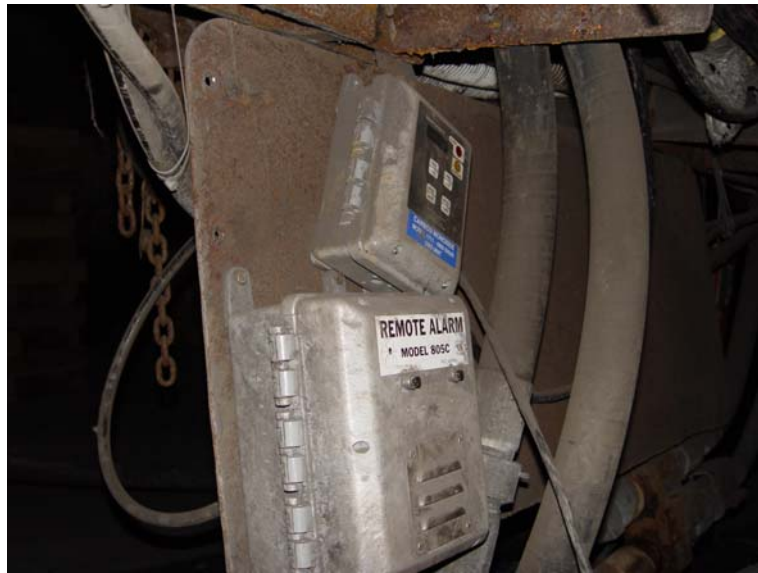
Figure 10. Remote alarm unit in headgate area on longwall section.

The locations of the CO sensors are shown in Appendix N. An alarm unit was installed underground at the longwall headgate to provide visual and audible signals in the event of a single CO alarm signal or alert signals from two consecutive CO sensors (Figure 10).

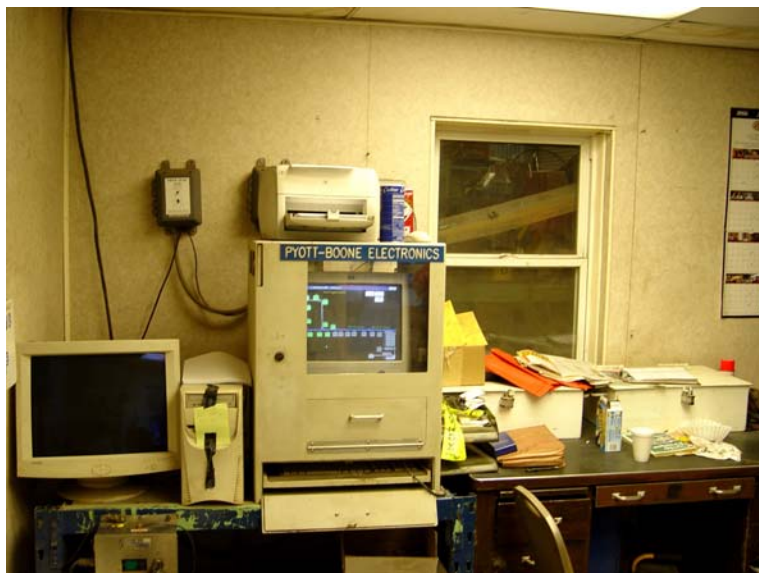
Figure 11. AMS in dispatcher's office located in Box Cut on surface.

To function properly, the mine operator was required to program the AMS computer to respond to individual CO sensor signals so that specific CO sensors would automatically activate the appropriate alarm unit. The AMS computer, printer, visual display, and means of communication with underground locations were located in the dispatcher's office (Figure 11).

The dispatcher's office was located on the surface in the shop area of the Box Cut, adjacent to the warehouse and the lamp room. AMS alert, alarm, and malfunction signals were received on the surface in the dispatcher's office. The AMS computer automatically generated a printed record of all alert, alarm, and malfunction signals. This printed record was identified as the AMS event log. Visual and audible AMS alert, alarm, and malfunction signals were provided through the AMS computer for the AMS operator in the dispatcher's office. As an additional means of providing audible and visual notification on the surface, a strobe light and horn were also installed in the open area of the Box Cut shop.
