# Department of Defense Legacy Resource Management Program

PROJECT NUMBER (05-170)

## **Long-Term Management Strategies for USS ARIZONA, A Submerged Cultural Resource in Pearl Harbor**

NATIONAL PARK SERVICE  
SUBMERGED RESOURCES CENTER

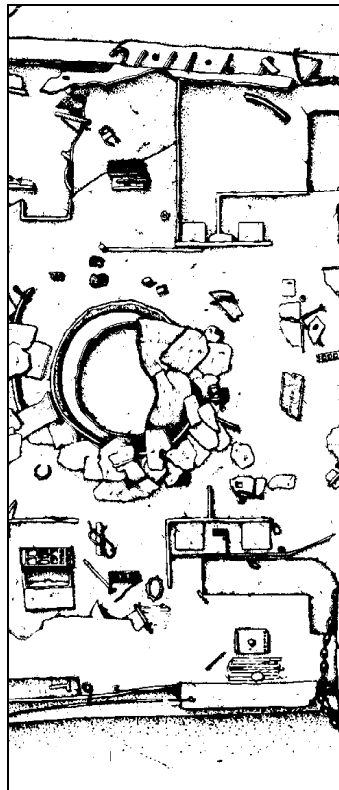
Acting *Arizona* Commander Homann (1942a:2, 1942b:2) who relied on survivors' interviews states in correspondence to the Chief, Naval Operations that "an early bomb hit down the stack and disrupted the fire main and bilge pumps." This is also listed by McClung in a report to the Salvage Engineer (McClung n.d.:1). One of the survivors was Lt CDR S.G. Fuqua, who reported a bomb had gone down the stack, and that it was not known "whether a torpedo hit the face plate of No. 4 turret indirectly" (Fuqua 1941:2). Divers investigating the uptake armor grating in the main deck as far as the wreckage would permit, and the grating was believed to be intact (Paine 1943:5), indicating no bomb went down the stack. Again, like the search for torpedo damage, no damage has been observed by NPS or Navy divers in the deck area around the stack. Based on material evidence, a bomb did not go down the stack and the fire pumps were disabled by the magazine explosion (Figure 3.7).

**Figure 3.7.** Detail of archeological map of *Arizona* depicting the stack area, with bow to the left (Drawing by NPS-SRC).

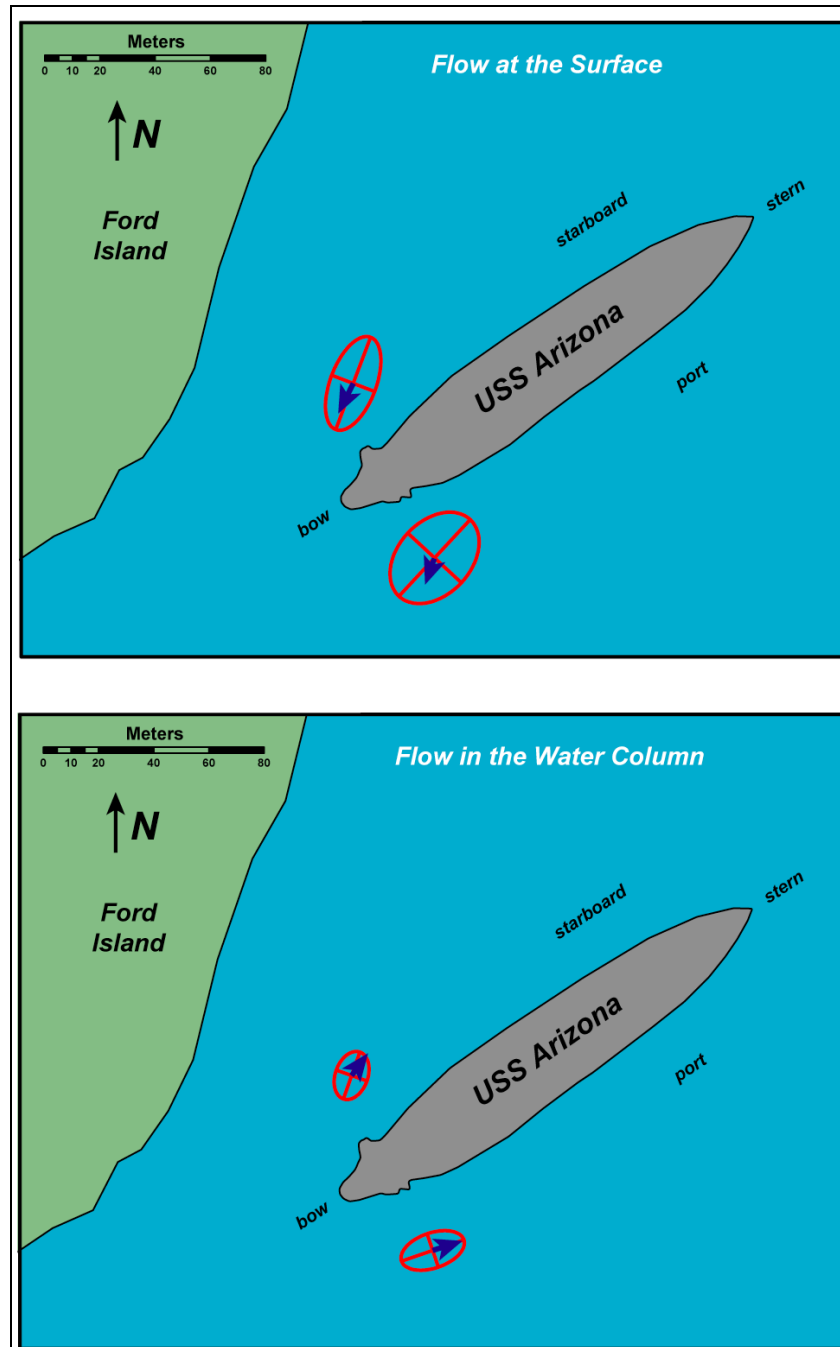
northeast or south-southwest, roughly parallel Ford Island's shoreline in the vicinity of the USS *Arizona*. Off the port side, however, the flow is predominantly oriented east-northeast or west-southwest, roughly parallel to the main trend of the East Loch of Pearl Harbor. These differences in orientation imply steering, not only by the bathymetry, but also by the USS *Arizona*'s hull (Figure 4.6).

**Figure 4.6.** The orientation of mean flow and its variability in the water column adjacent to the *Arizona*. **TOP:** Flow at the surface. **BOTTOM:** Flow in the water column. The red ellipses denote the magnitude of major and minor axes of variability in flow; the blue vectors denote the magnitude and direction of mean flow. Note that surface flow is stronger and oriented to the southwest while flow within the water column is weaker and is oriented to the northeast. Off the starboard side, the flow is predominantly oriented north-northeast or south-southwest, roughly parallel Ford Island's shoreline; off the port side, however, the flow is predominantly oriented east northeast or west-southwest, roughly parallel to the main trend of the East Loch of Pearl Harbor.

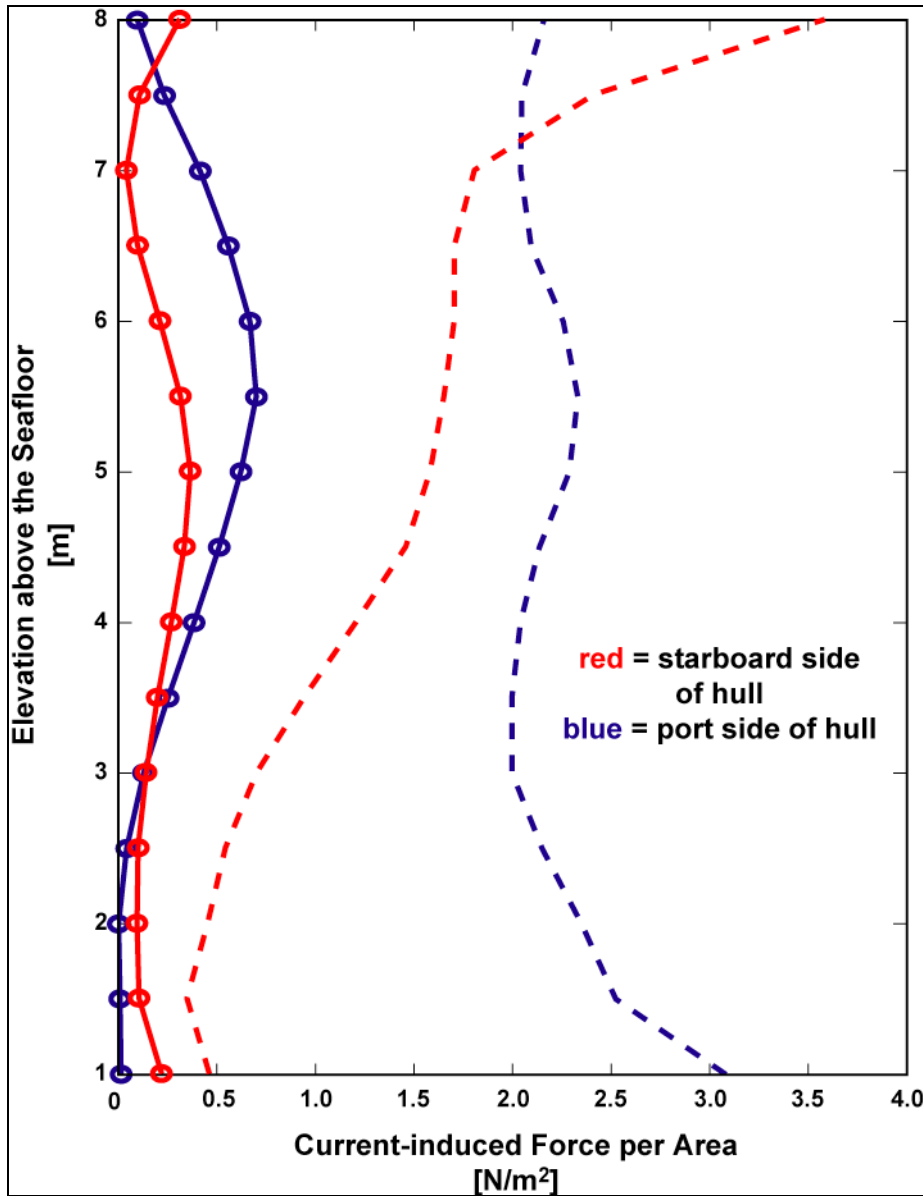
The differences in current speed, both vertically and from one side of the hull to the other, result in velocity shear, which, in turn, likely increases turbulence and mixing. The values of vertical shear varied from  $0.025 \pm 0.015$  1/s off the starboard (northwestern) side of the hull and  $0.038 \pm 0.023$  1/s off the port (southeastern) side of the hull. The shear was generally highest during the falling tides. The vertical velocity shear, by moving seawater of a given density, would impart a vertical variation in current-induced force on the hull. Seeing that seawater in Pearl Harbor has a density around  $1023 \text{ kg/m}^3$  (temperature~25 °C and a salinity~33 Practical Salinity Units, PSU, or parts per thousand), the mean current-induced force on the starboard (northwestern) side of the hull is  $0.175 \pm 0.131 \text{ N/m}^2$  and  $0.291 \pm 0.259 \text{ N/m}^2$  on the port (southeastern) side of the hull (Figure 4.7).

Figure 4.7. Vertical profiles of the current-induced force on the USS *Arizona*'s hull. Dashed lines are  $\pm 1$  standard deviation. Note that the force generally is at a maximum 6 m above the seafloor (4 m below the surface).

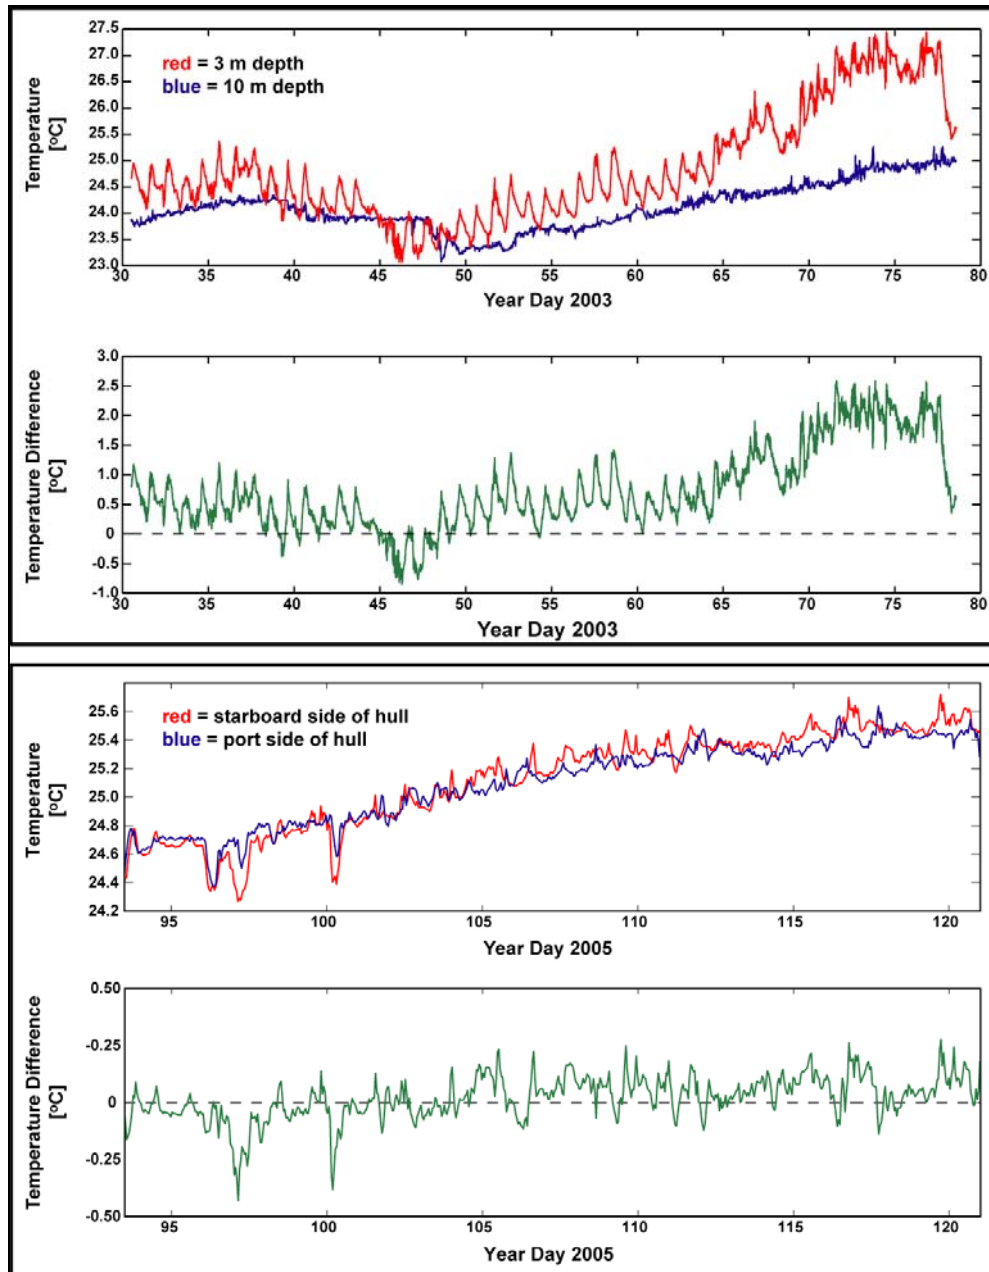
**Figure 4.9. Differences in water temperature around the USS *Arizona*. TOP: Near-bed (10 m) and near-surface (3 m) temperatures and the resulting thermal stratification. BOTTOM: Concurrent water temperatures off the port and starboard sides of the hull and the resulting thermal gradient. While both the port and starboard temperatures both follow the same long-term trends, note the greater fluctuations in water temperature off the starboard side; this likely results from less mixing of the water column off the starboard side.**

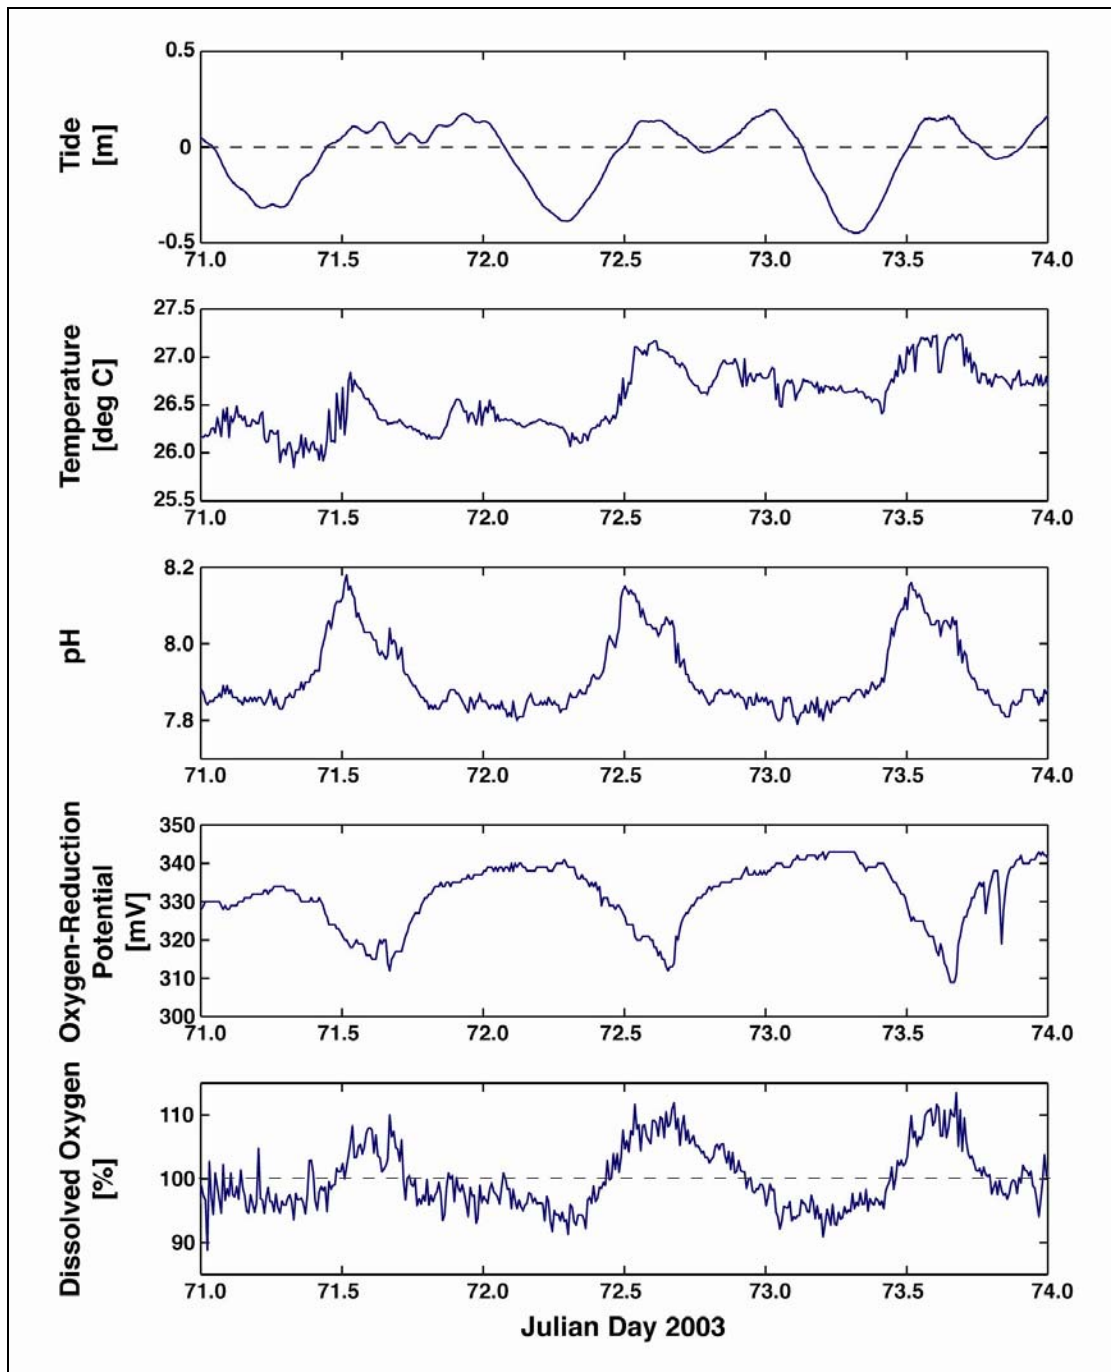
Over the period of study, the oxygen-reduction potential at the site along the 3-m isobath ranged between 150.0 mV and 397.2 mV, with a mean oxygen-reduction potential  $\pm$  one standard deviation of  $289.2 \pm 50.6$  mV. Oxygen-reduction potential had an *inverse* relationship with pH and the percentage of dissolved oxygen during the summer months, with oxygen-reduction potential decreasing during the daytime and increasing into the night, attaining its greatest values just before sunrise. However, during the winter months when temperature and salinity were more variable, oxygen-reduction potential had more variable *positive* relationship with pH and the percentage of dissolved oxygen, suggesting that changes in salinity due to precipitation and/or submarine groundwater discharge might be impacting the data (Figures 4.10 and 4.11).

Figure 4.10. Graphic illustrating positive correlation between tide, temperature, pH, and dissolved oxygen; and an inverse correlation with oxygen reduction potential on the USS *Arizona* over a several day period.

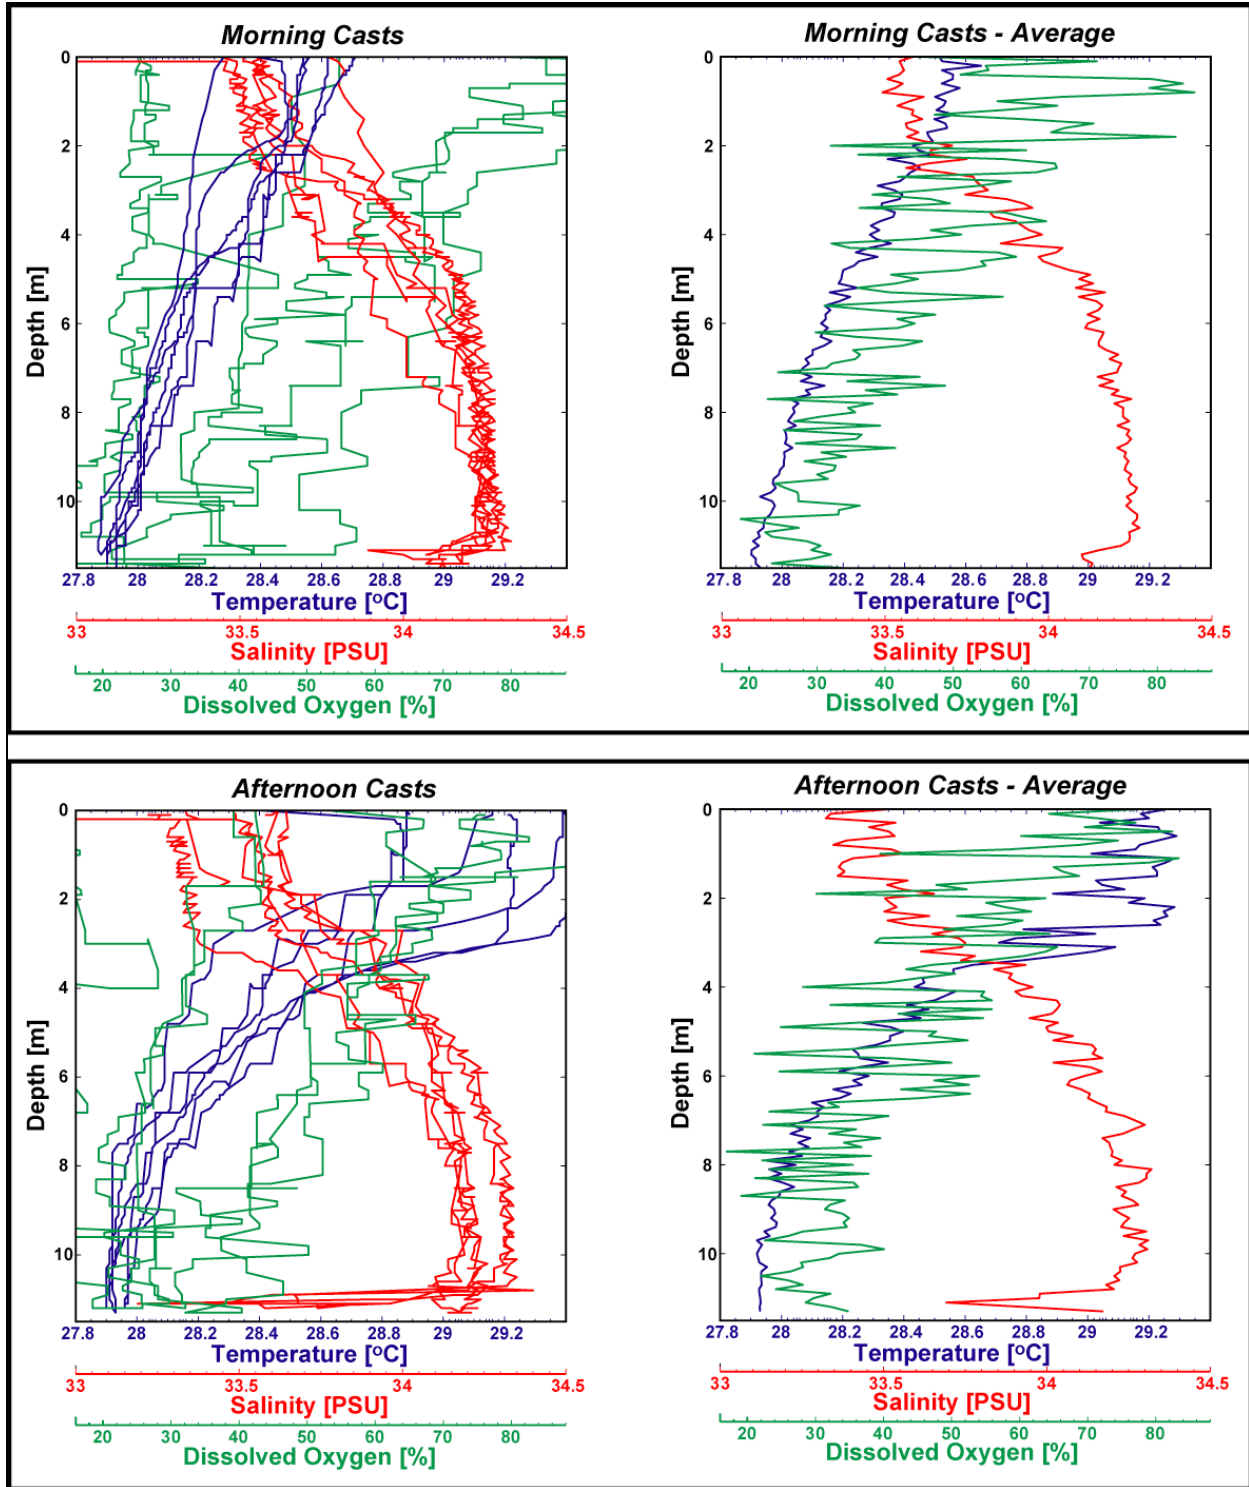
The temperatures during the vertical profiles taken in the early morning varied between 27.83 °C and 28.72 °C, with the near-surface temperatures on average roughly 0.74 °C warmer than the near-bed temperatures. The salinities during these profiles varied between 33.47 PSU and 34.38 PSU, with the near-surface temperatures roughly 0.79 PSU less saline on average than the near-bed salinities. The dissolved oxygen levels during these profiles varied between 15.3% and 91.2%, with the near-surface dissolved oxygen levels on average roughly 41.1% higher on average than the near-bed dissolved oxygen levels (Figure 4.12). The temperatures during the

vertical profiles taken in the late afternoon varied between 27.85 °C and 29.51 °C, with the near-surface temperatures roughly 1.32 °C warmer on average than the near-bed temperatures. The salinities during these profiles varied between 33.21 PSU and 34.35 PSU, with the near-surface temperatures roughly 0.91 PSU less saline on average than the near-bed salinities. The dissolved oxygen levels during these profiles varied between 11.7% and 104.4%, with the near-surface dissolved oxygen levels roughly 46.6% higher on average than the near-bed dissolved oxygen levels (Figure 4.12).

Figure 4.12. Vertical profiles of temperature, salinity and dissolved oxygen off the USS Arizona dock. These plots show how these parameters vary vertically from just below the water’s surface down to the sea floor and how the vertical variation in these parameters changes over the course of a day.
