CHAPTER 5

Steel-Hull Corrosion Analysis of USS *Arizona*

Donald L. Johnson, Brent M. Wilson, John D. Makinson, Robert De Angelis, William N. Weins, and James D. Carr

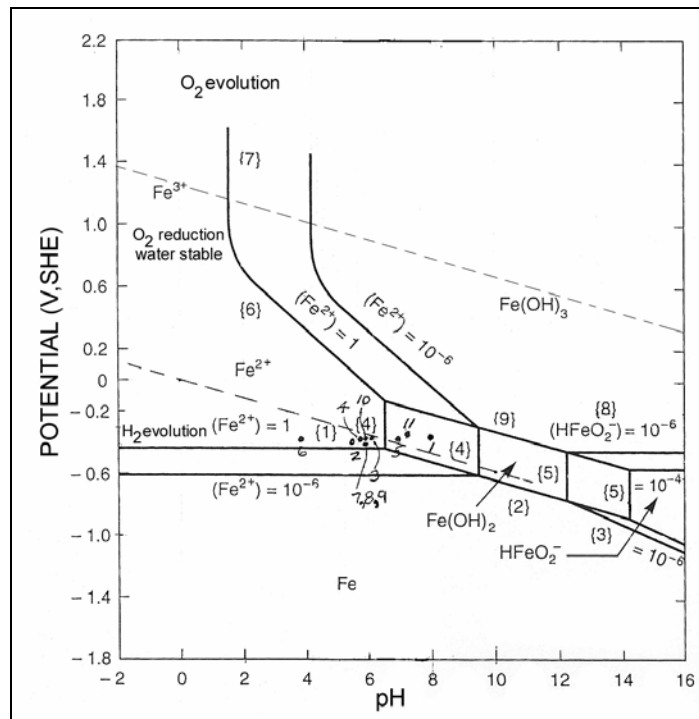
Figure 5.3. Pourbaix diagram for iron in water with E_{corr} / pH data taken on the USS Arizona, September 2000 (modified from Jones 1996:59).

E_{corr} /pH data from the 2000 field season is superimposed on the iron-water Pourbaix diagram in Figure 5.3. All of the points fall within the region of active corrosion because they appear in the area labeled Fe^{+2} , yielding iron ions in water solution. Note that the points are well below the region of Fe^{+3} stability, so ferrous ion (Fe^{+2}) dominates. Since the points appear to follow closely along the lower dotted line, the cathode appears to be dominated by equations [3] or [4]. Lower pH values observed at the steel/concretion interface suggests the cathode reaction involves hydrogen evolution, in addition to oxygen consumption, as observed by divers after the first penetration of the concretion.

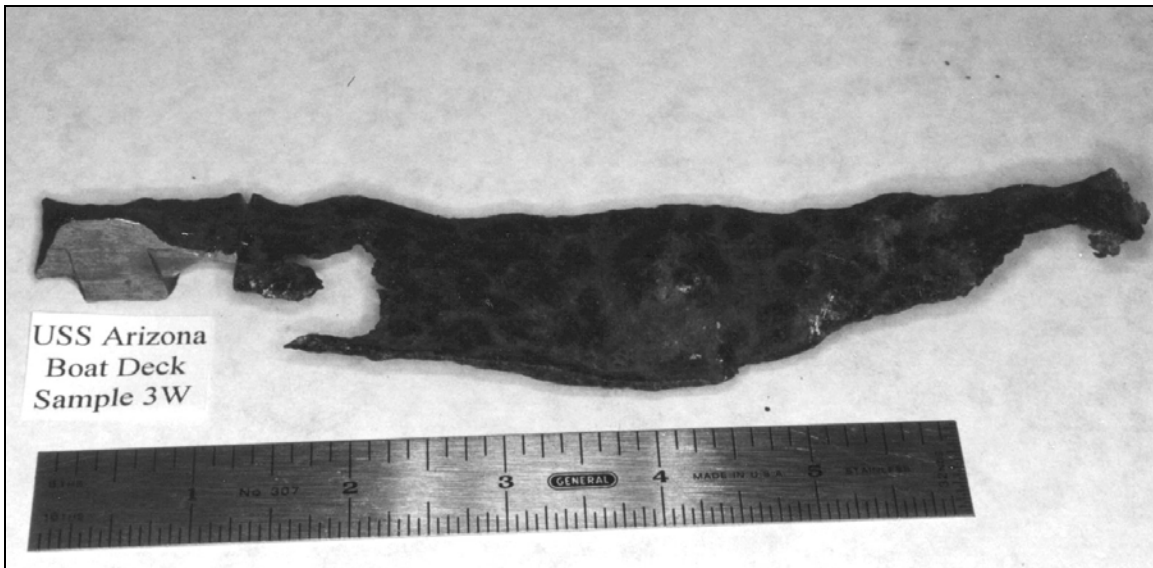
Figure 5.6. Sample W3, section with rivet in place from boat deck.

The microstructure of samples W1 and W3 are typical for the time period and operations when this vessel was built. The banded microstructure seen in sample W1 can affect the rate and mechanism of corrosion of the steel over a period of time, but is not expected to be a significant factor. The fact that the microstructure of the rivet and plate (Figures 5.5 and 5.6) are different indicates that at least this part of the ship did not see extremely high temperatures. If it had seen temperatures above 1,340 °F (727 °C), the steel would have gone through a phase transformation and the microstructures of the rivet and plate would have been similar on cooling. Since banding appeared in sample W1, samples WB2, WB3 and WB5 from September 1999 were sectioned for examination in both the longitudinal and transverse directions.

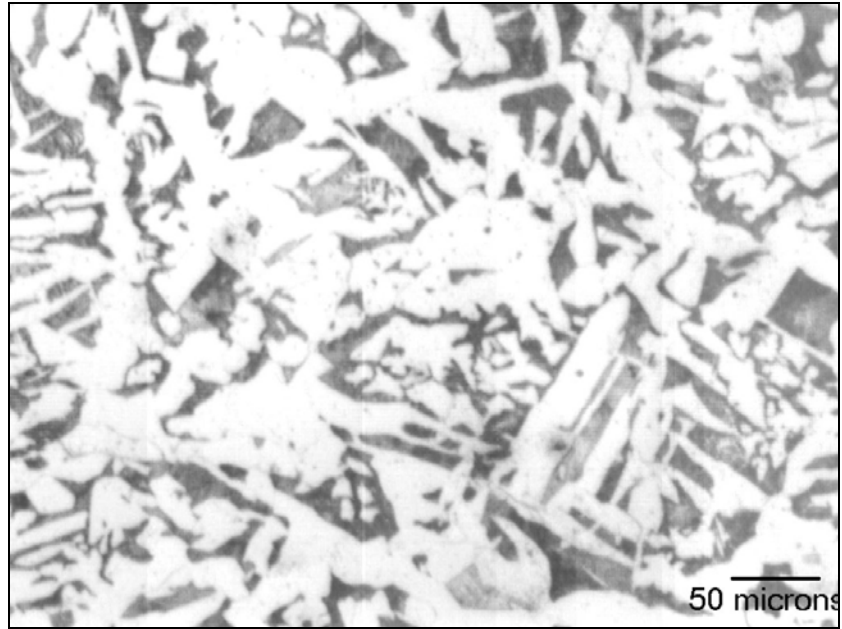
Longitudinal and transverse sections of main mast tripod sample WB2 show Widmanstätten ferrite with slight evidence of banding (Figures 5.11 and 5.12). Microstructures are consistent with carbon content between 0.2–0.25%. Grain size of this material was measured to be ASTM 7.3

Figure 5.11. Microstructure of mainmast tripod leg, sample WB2, longitudinal, 175X, 2% Nital etch.

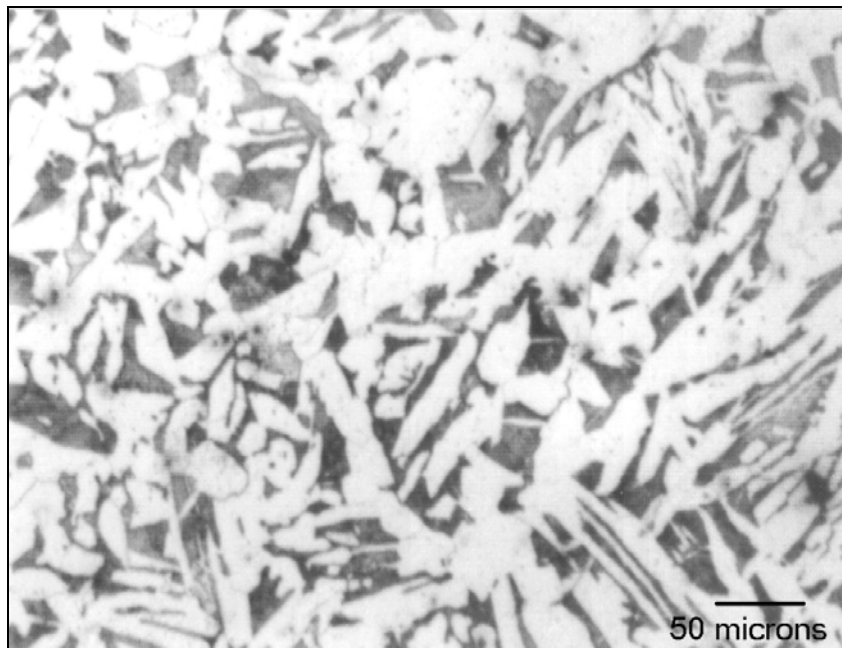
Figure 5.12. Microstructure of mainmast tripod leg, sample WB2, transverse, 175X, 2% Nital etch.

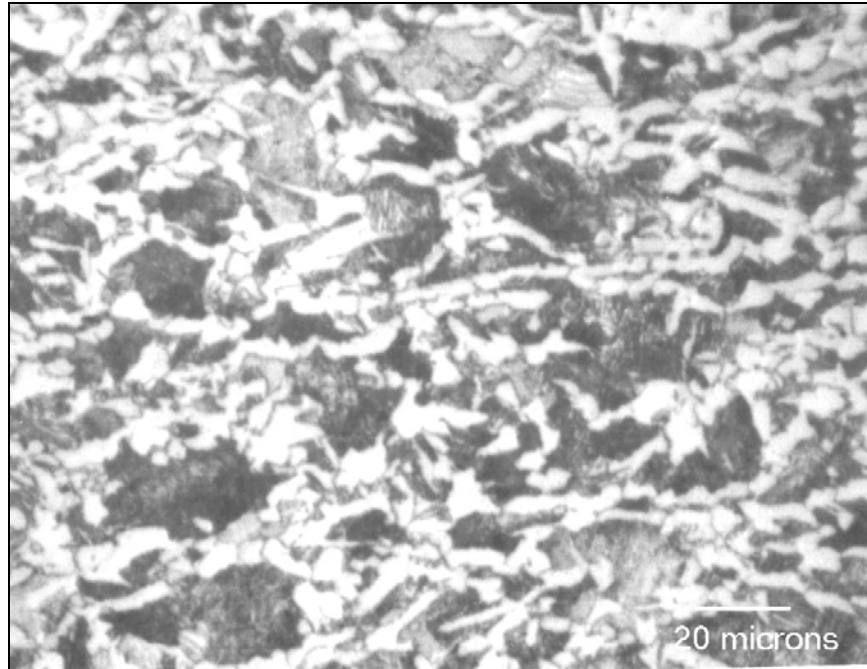
A longitudinal section of galvanized locker plate, WB3, has microstructure typical of medium carbon steel (Figure 5.13)(Table 5.2). Pearlite is resolved and grain size is finer than that of the much thicker walled mainmast. Galvanizing is still evident on the exterior of the plate. The reason for the use of medium carbon steel in this application is not clear, although this is believed to be an exterior panel in which medium carbon steel would offer some level of protection over low carbon grades. New York Navy Yard correspondence, however, does not identify galvanized sheet steel as being a medium carbon grade (New-York-Navy-Yard 1913).

Figure 5.13. Boat deck locker sample WB3, longitudinal galvanized section, 450X, 0.2% Nital etch.

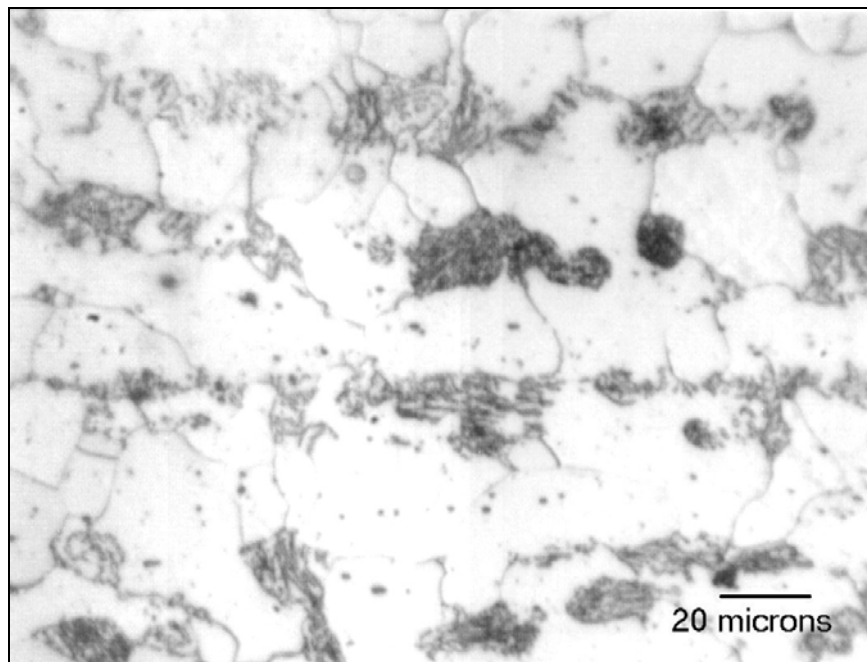
A longitudinal section of boat deck channel member WB5 shows elongated MnS inclusions and oxide particle alignment clearly evident and also pronounced banding (Figure 5.14).

Figure 5.14. Microstructure of boat deck channel, sample WB5, longitudinal, 450X, 2% Nital etch.

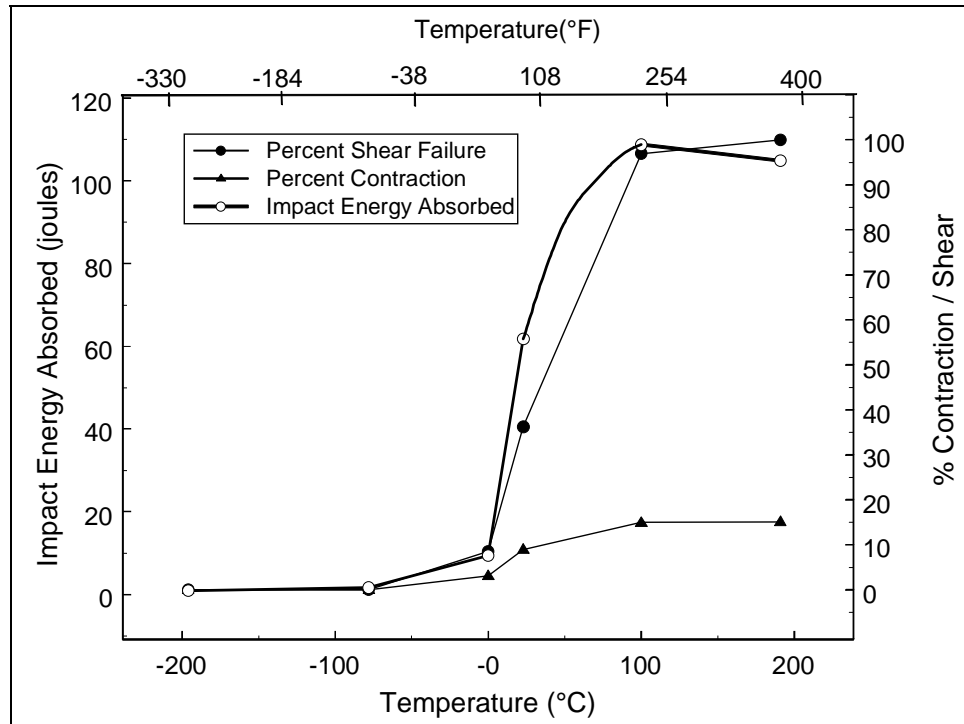
The carbon content has the largest effect and raises the ductile to brittle transition temperature as measured by (DBTT) by 25 °F (14 °C) for every additional 0.1%. Manganese lowers the transition temperature by 10 °F (5.5 °C) for every 0.1% added whereas P raises it by 13 °F (7 °C) for every 0.1% added. Transition temperature is lowered as the grain size decreases by $D^{-1/2}$. These factors will also raise the upper shelf energy in conjunction with a lowering of the transition temperature. Using these guidelines for the effects of C, Mn, P and grain size, it can be calculated that the DBTT for *Arizona* and *Titanic* steels compared to the A-36 steel, measured by the average between the upper and lower shelf energies, should vary predictably (Table 5.4)—note that the A-36 and USS *Arizona* materials have essentially identical S contents (0.037% and 0.039% respectively) and P contents (0.012% and 0.013% respectively) whereas *Titanic* material has higher contents of 0.069% S and 0.045% P. The differences in transition temperature as computed between *Arizona* steels and A-36 grade can be explained through the C, Mn, P and grain size, whereas the differences between *Titanic* and A-36 grades takes into account of the higher S content in order to explain the differences. This is a direct result of the use of acid open hearth steelmaking practices which understandably were state-of-the art at that time in Europe. The mainmast steel from *Arizona* was of the same general quality from the metallurgical aspect as was the modern A-36 grade, with the differences being noted that the DBTT data were obtained from the mainmast steel manufactured in the late 1920s when cage masts were replaced with tripods.

Figure 5.15. Charpy impact results plotted as temperature vs. energy absorbed, % shear failure, and % contraction for longitudinal steel samples taken from the mainmast of the USS Arizona.

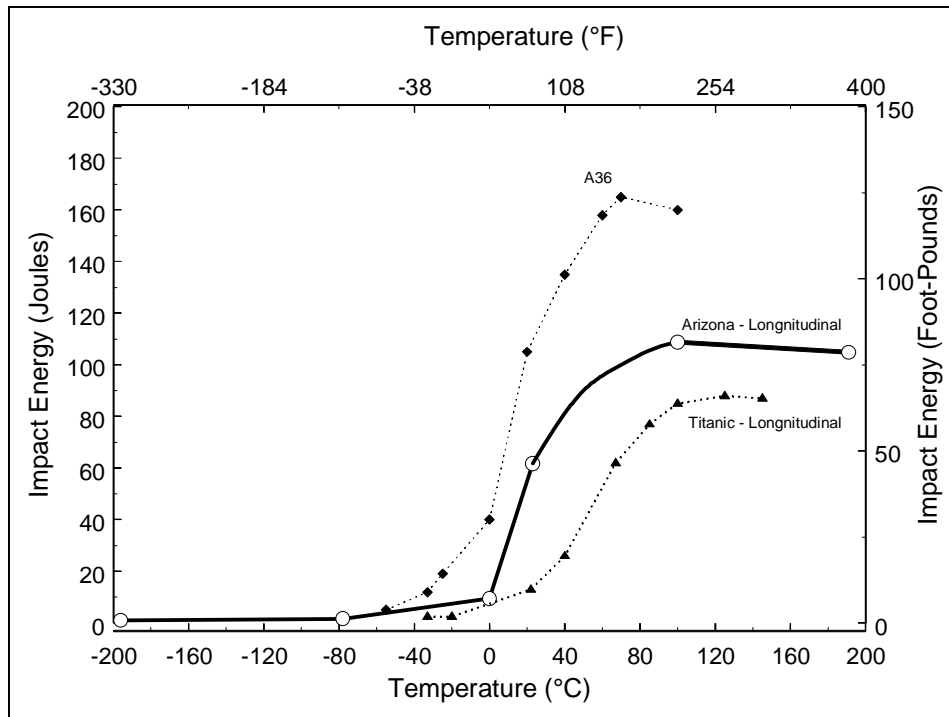
Figure 5.16. Charpy impact energy vs. temperature for longitudinal specimens from USS Arizona, HMS Titanic, and A36 steels.

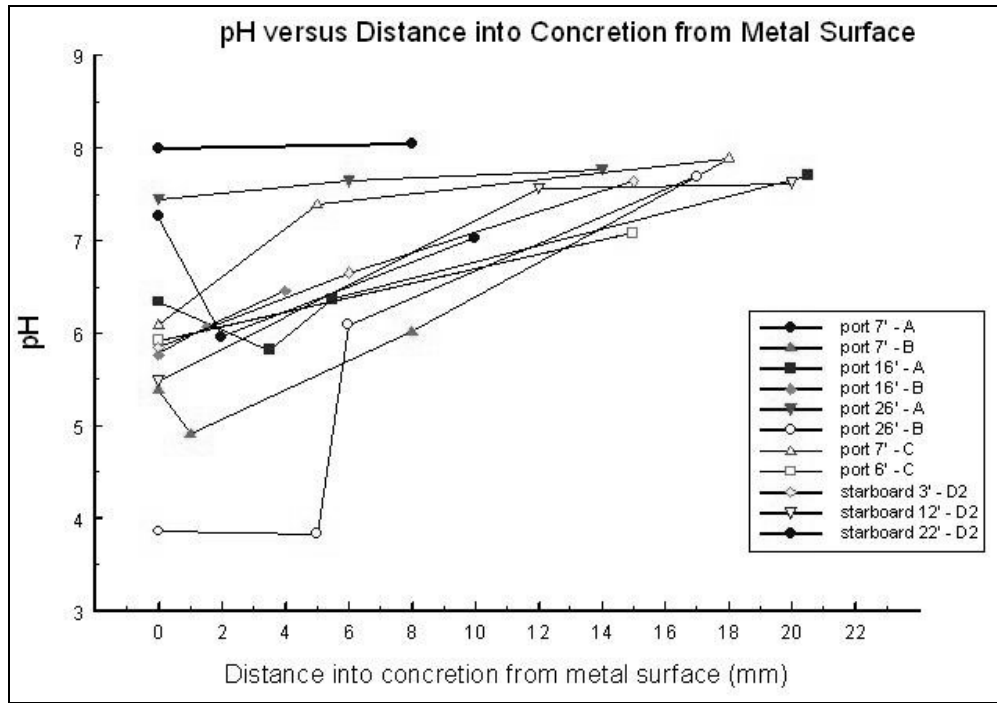
Data from the 2000 field season are tabulated (Table 5.7) and plotted in various graphs. A plot of pH vs. concretion depth shows that pH consistently decreases from a maximum at the exterior surface of the concretion to a minimum at the steel surface (Figures 5.21 and 5.22). The observation that pH decreases through the concretion from exterior to steel surface is consistent with reports on wrought and cast iron marine artifacts that note the cause for the decrease as similar to the crevice effect common in corrosion processes. Depletion of oxygen occurs as the concretion thickness increases and the low porosity of the concretion does not allow the oxygen to be replenished as fast as it consumed in the corrosion process (North 1976; North and MacLeod 1987). Chloride ions (Cl^-), with relatively high transport rates, migrate more rapidly than molecular oxygen through the concretion to the metal surface. The pH drops to as low as 4 at the metal surface as a result of hydrolysis reactions (equation [7]). The anodic reaction

Figure 5.21. Relationship between pH and concretion thickness, based on September 2000 data in Table 5.7.

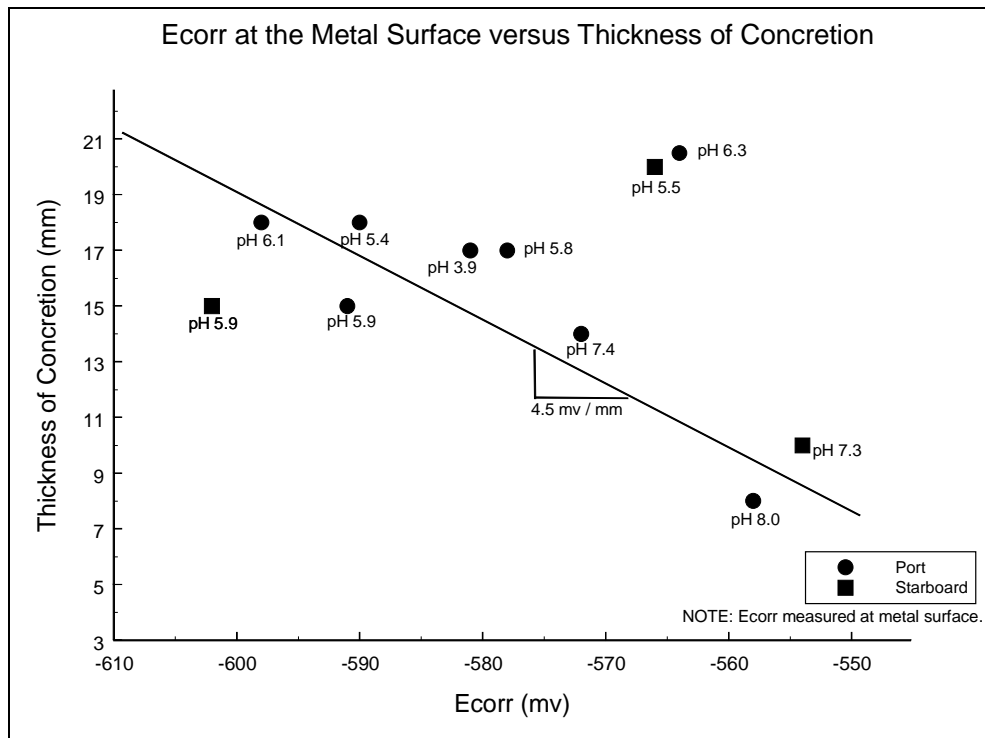
Figure 5.22. Relationship between E_{corr}, pH and concretion thickness, from data in Table 5.7.

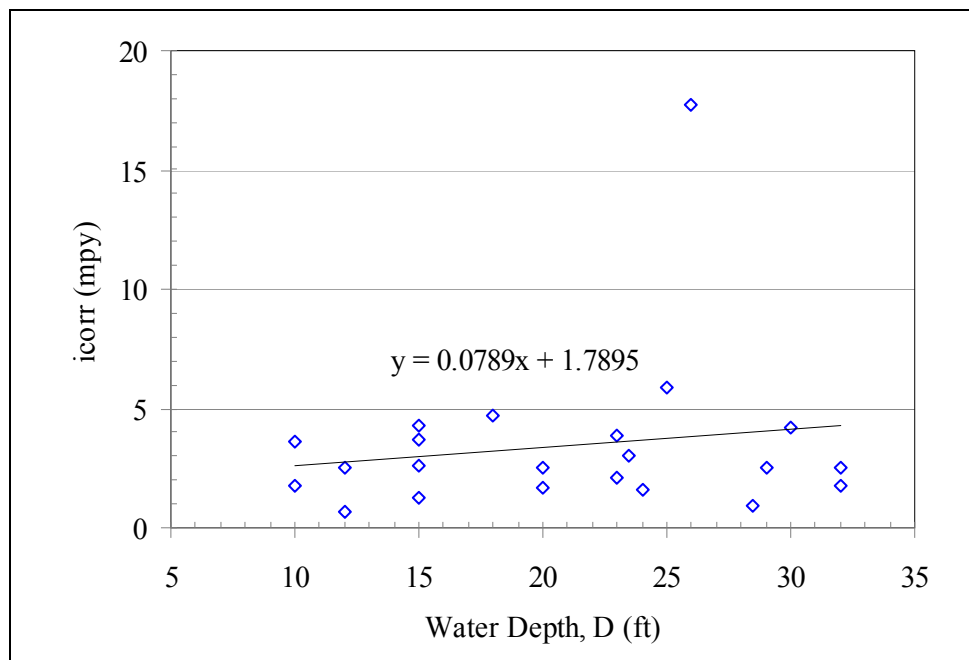
Computation of $i_{(\text{corr}, \text{IR drop})}$ for all of data in Tables 5.8–5.17, including E_{corr} values taken inside the concretion, resulted in a wide scatter of data. Figure 5.28 shows a plot of $i_{(\text{corr}, \text{IR drop})}$ as a function of water depth after eliminating internal E_{corr} readings obtained from 22 sites over the entire hull. The trendline shows increasing $i_{(\text{corr}, \text{IR drop})}$, just the opposite of i_{corr} obtained from metal samples taken from the hull. It is concluded that current distribution inside the concretion is complex and creates a voltage gradient across the concretion that cannot be related to i_{corr} in simple terms. Furthermore, the electrical resistivity of the concretion is not a constant as assumed in equation [15]. This observation is confirmed from x-ray diffraction results showing that the concretion is not homogeneous.

Figure 5.28. i_{corr} (IR Drop across concretion) as a function of water depth.

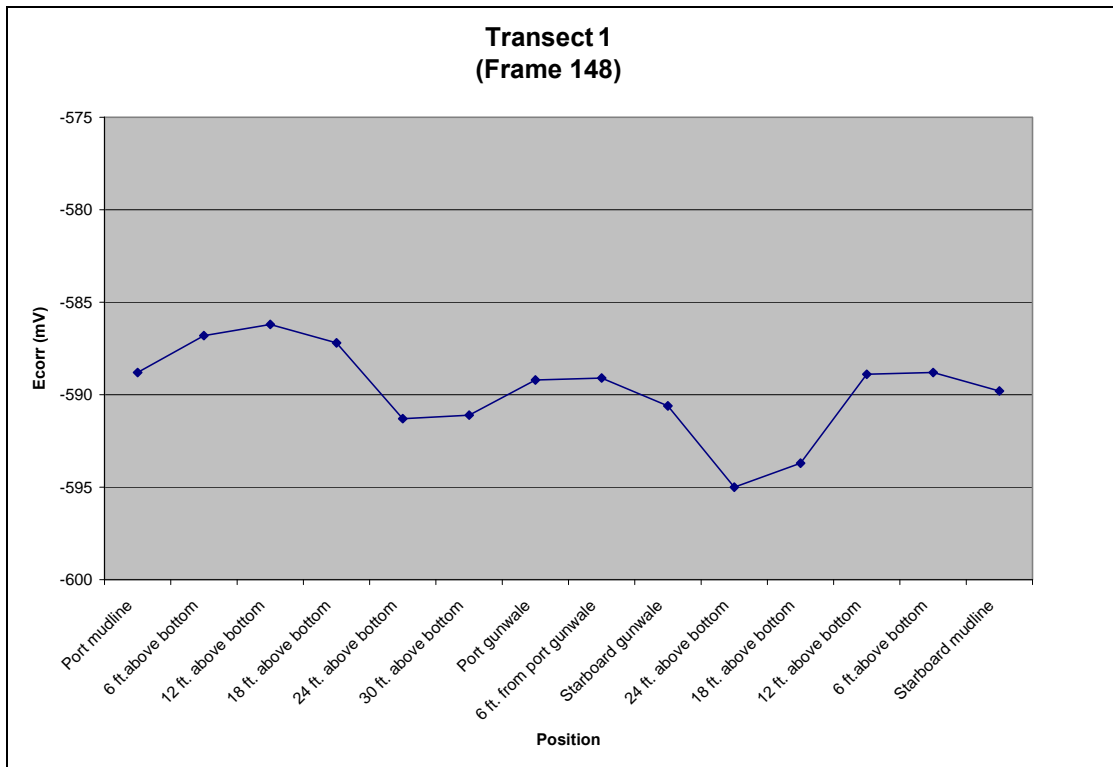
itself (Table 5.21)(Figure 5.32). Proximity to cuprous propellers may promote less negative readings at 12 ft. above the harbor bottom, port and starboard. The decrease near 24 ft. on both sides of the ship may reflect the initial drop off to the harbor bottom prior to the rise resulting from influence of the propellers. The drop in E_{corr} as the transect approaches the harbor bottom is consistent with E_{corr} data obtained from the ThermoOrion instrument inserted in holes drilled in concrete.

Figure 5.32. Graph of GMC data E_{corr} taken from Table 5.21, relative to hull position.

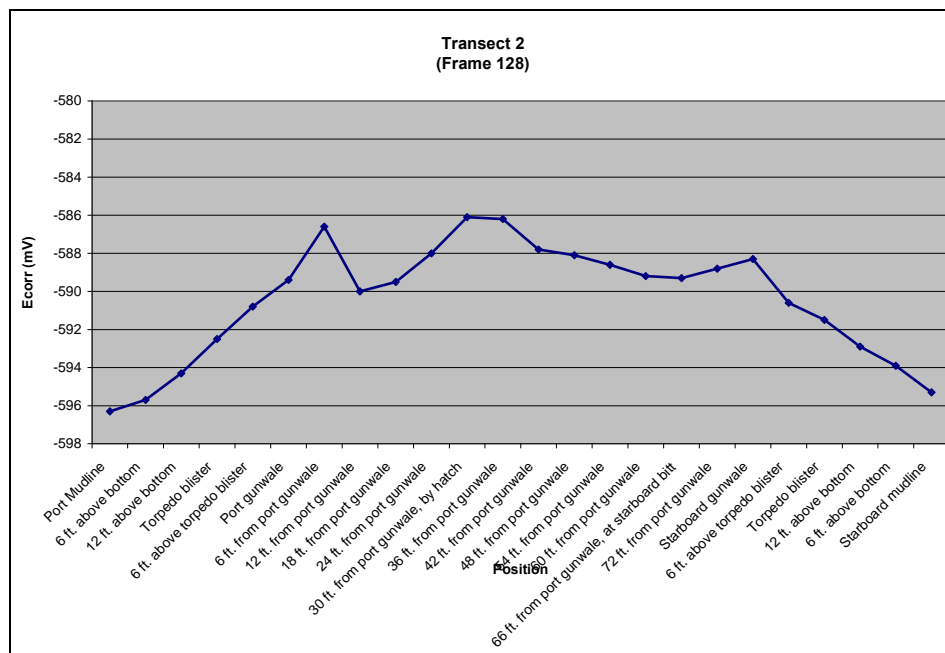
The next transect forward, transect 2, taken at approximately frame 128, shows a similar pattern in which from the gunwales to the harbor bottom E_{corr} decreases on both sides but holds fairly steady across the main deck (Table 5.22)(Figure 5.33). The decrease to the harbor bottom is again attributed to the reduction in oxygen availability.

Figure 5.33. Graph of GMC data E_{corr} taken from Table 5.22, relative to hull position.

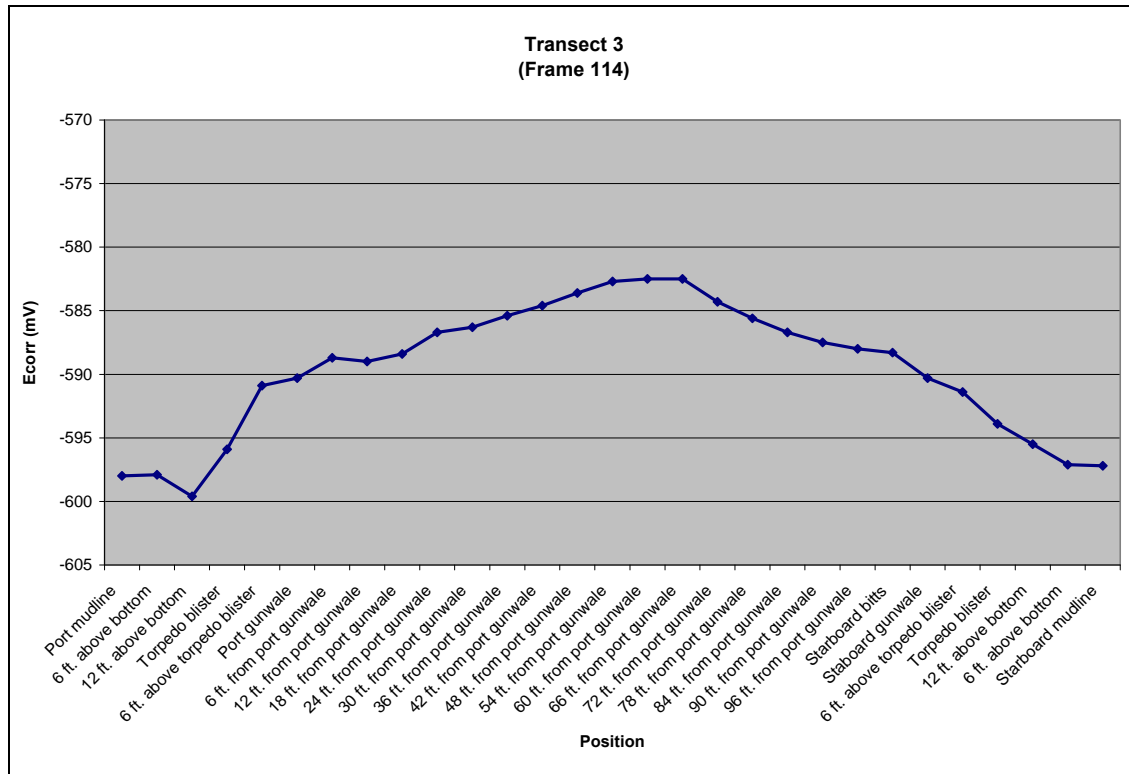
Transect 3, approximately frame 114, cuts across the main deck just forward of barrette no. 3, which extends about 6 ft. above the water surface and has accelerated water line corrosion vertically on its side. Because of this, E_{corr} amidships on this transect is higher as compared to transects 2, 5, 7, and 6 (Table 5.23)(Figure 5.34).

Figure 5.34. Graph of GMC data E_{corr} taken from Table 5.23, relative to hull position.

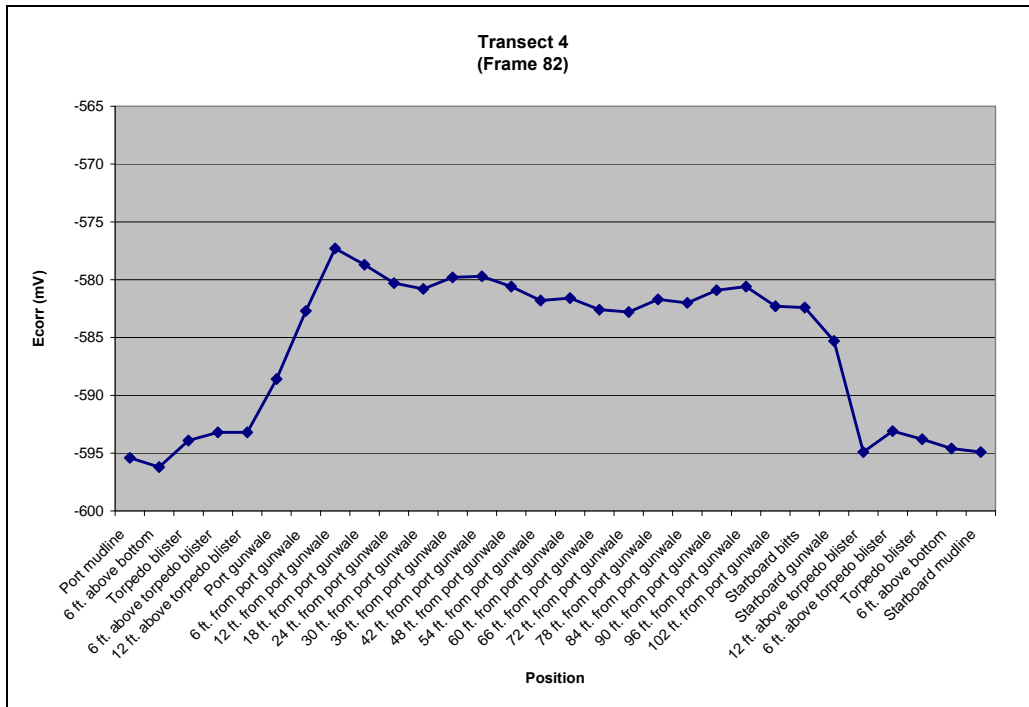
Transect 4 crosses the upper deck in the crew galley area in shallow water forward of the Memorial, at approximately frame 82. E_{corr} is -583 mV or higher over nearly the entire deck area—recent structural corrosion is consistent with higher E_{corr} in this area (Table 5.24)(Figure 5.35).

Figure 5.35. Graph of GMC data E_{corr} taken from Table 5.24, relative to hull position.

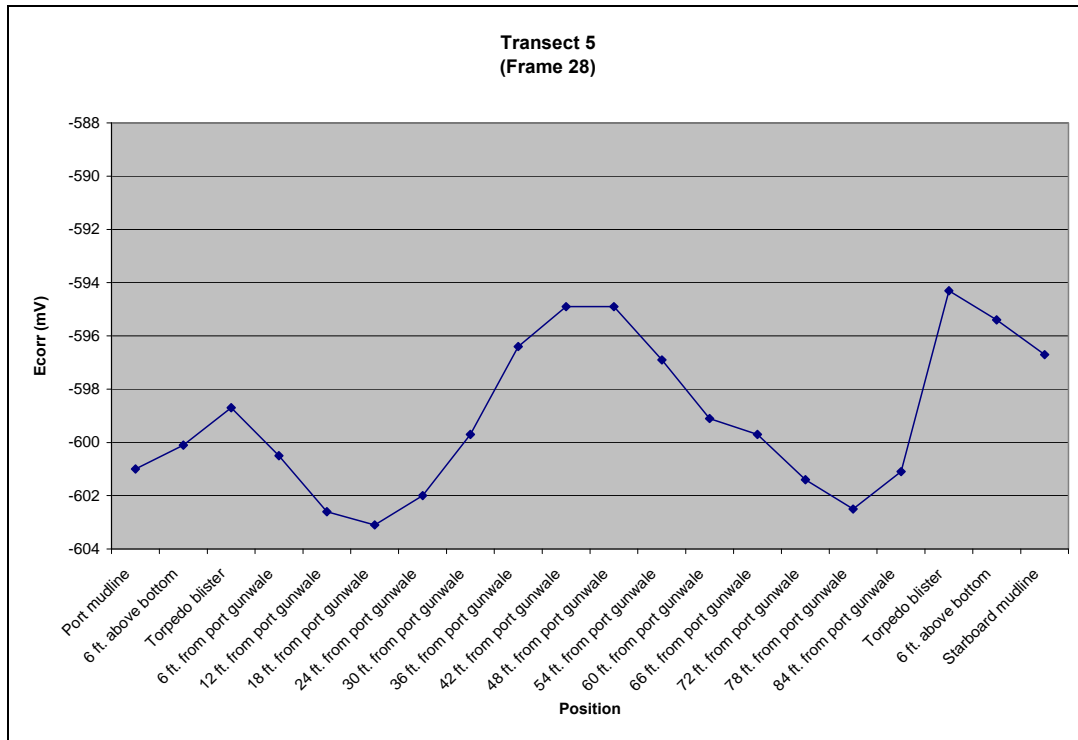
Moving forward along the hull, transect 5, at approximately frame 28, has the lowest overall E_{corr} values, which may be due to the fact that the deck is buried by several feet of sediment along the entire transect (Table 5.25)(Figure 5.36). The close proximity and exposure of the gun barrels of turret no. 1 above the harbor bottom may reflect a rise in E_{corr} near the centerline of the hull. A drop in E_{corr} from the torpedo blisters on either side to the harbor bottom is typical. Because the deck is collapsed in this area, the top of the torpedo blister and the gunwale are at about the same elevation.

Figure 5.36. Graph of GMC data E_{corr} taken from Table 5.25, relative to hull position.

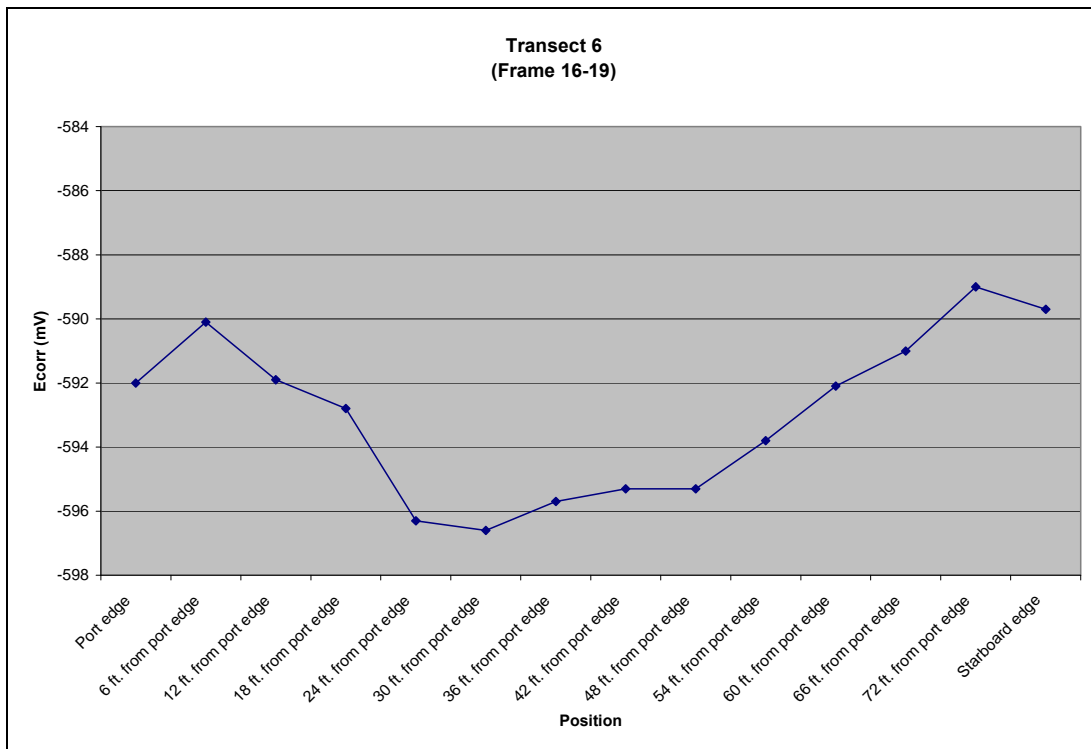
As is the case for transect 5, transect 6 is in an area of maximum damage from the 1941 explosion that sank *Arizona*, at approximate frames 16–19. Blown out deck plates at what used to be the gunwales are exposed to increased sea water exchange and maximum oxygen

availability. Because the plates flare out so much in this area, transects could not be taken to the harbor bottom. The lowest E_{corr} appear near the centerline where silt has accumulated (Table 5.26)(Figure 5.37).

Figure 5.37. Graph of GMC data E_{corr} taken from Table 5.26, relative to hull position.

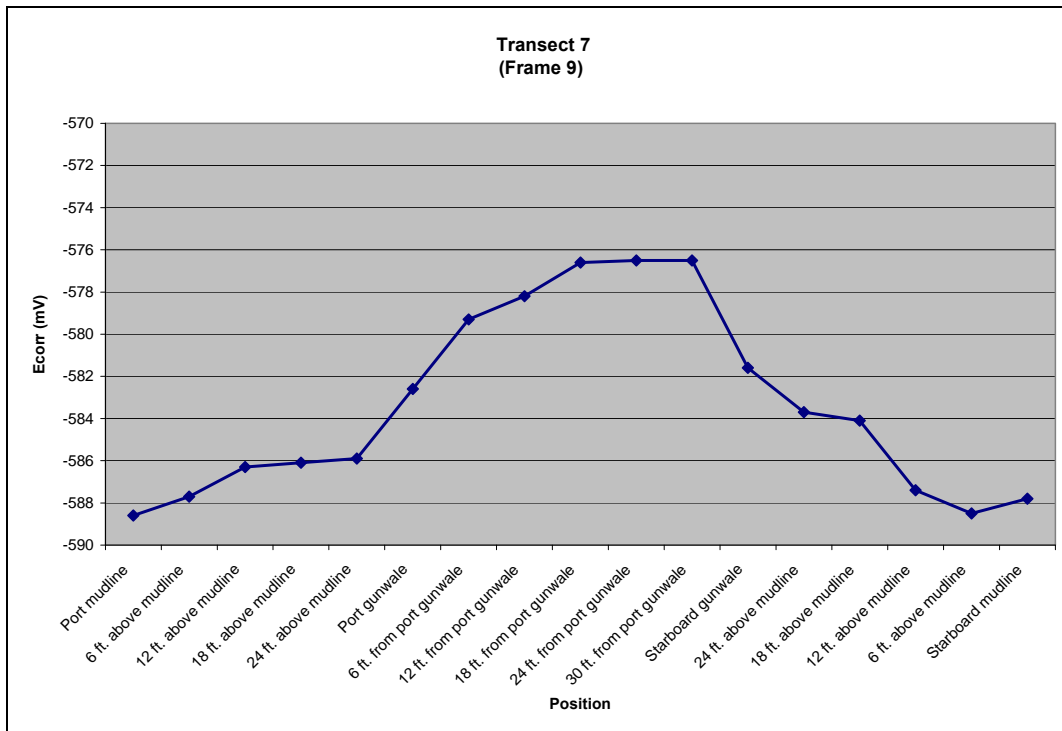
The final transect, transect 7, is near the bow, approximately frame 9, forward of the area of maximum damage, where the intact upper deck is in shallow water. As expected, E_{corr} values are relatively high along the exposed upper deck, near -575 mV, and drop to near -590 mV at the harbor bottom (Table 5.27)(Figure 5.38). E_{corr} transects with the GMC probe confirm the overall pattern produced by the sequential drilling and data collection through the concretion, that is that E_{corr} decreases with increased water depth. E_{corr} profiles generally tend to drop to lower potentials from stern (Frame 148) to bow (Frame 9) with maximum E_{corr} near -330 mV (SHE) or -575 mV (Ag/AgCl, GMC) to a minimum approaching -360 mV (SHE) or -605 mV (Ag/AgCl, GMC)(Figure 5.31).

Figure 5.38. Graph of GMC data E_{corr} taken from Table 5.27, relative to hull position.

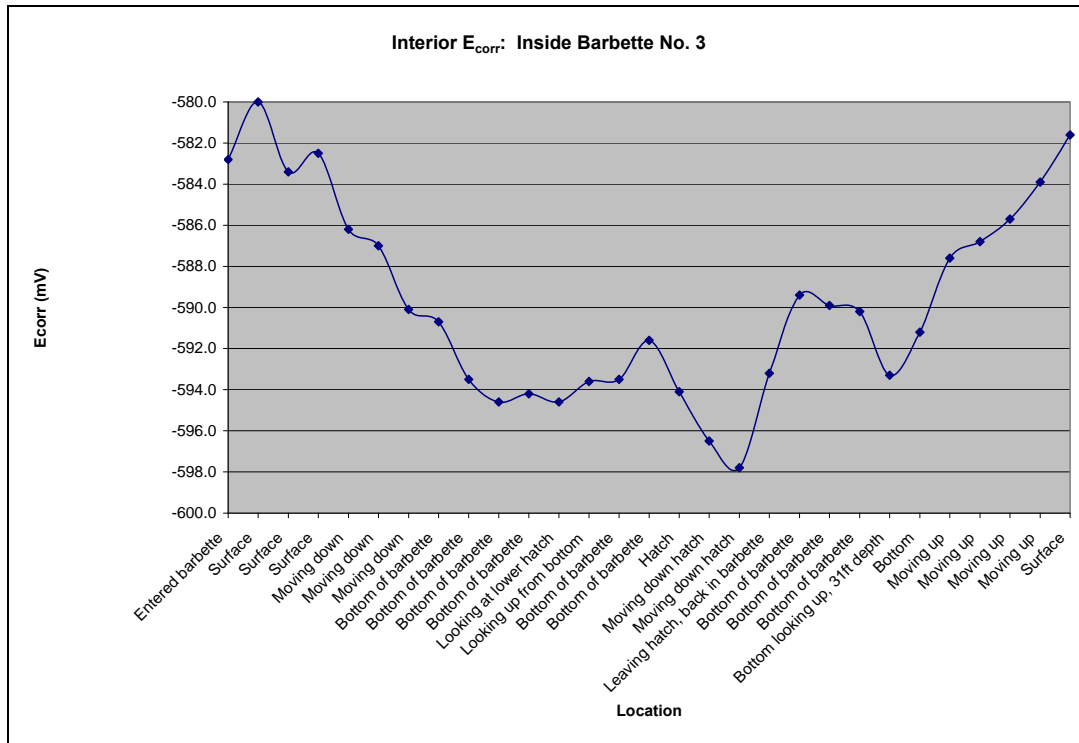
The trend showing increasing (more positive) E_{corr} in interior compartments was not observed inside barbette no. 3 (Figure 5.50). A descent from the surface to 31 ft. below the surface to the bottom of the barbette (roughly equivalent to the harbor bottom outside the ship) showed a decrease in E_{corr} , similar to the trend for E_{corr} on the external hull. The E_{corr} values inside the barbette are consistent with readings on the external hull in that E_{corr} values decrease with depth. Both observations are consistent with a reduced tendency to corrode. In both cases, the water column is directly open to the atmosphere and gases such as carbon dioxide and methane would dissociate from water and outgas to the atmosphere. In interior compartments, with egress only at open port holes, outgassing is limited.

Figure 5.50. Graph of interior E_{corr} relative to location inside Barbette No. 3

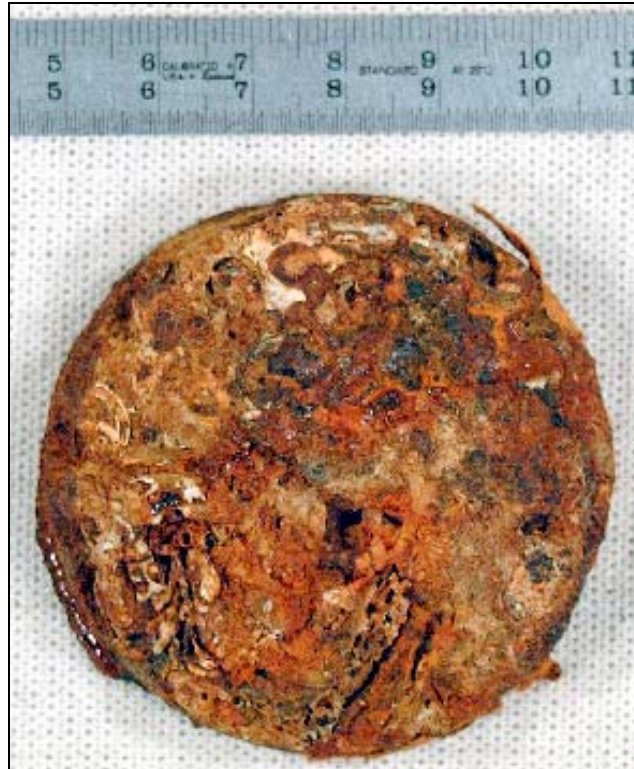
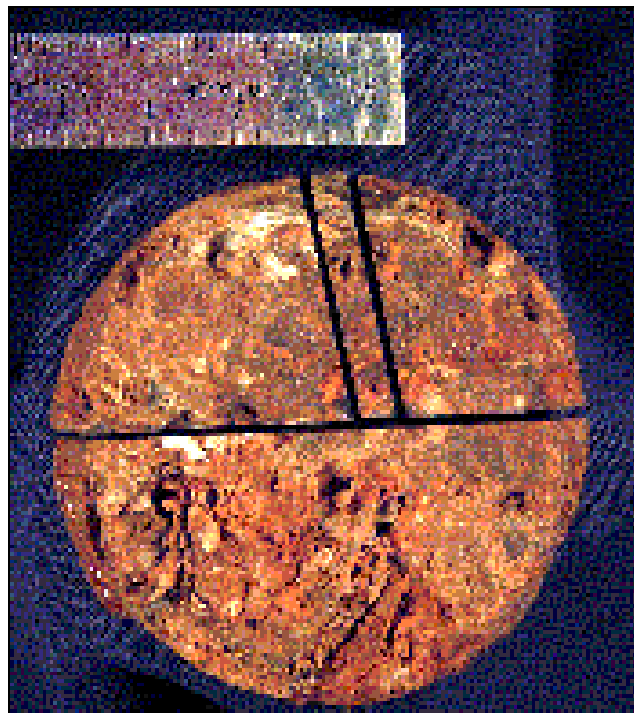
A 2.2 in. (5.5 cm) diameter concretion sample (USAR-01-045) was used for XRD and ESEM. The concretion was collected by using an air-powered hole-saw and sectioned on a diamond saw using water containing a 3% TRIMSOL solution to produce the XRD and ESEM sample, which was from the upper half of the disc (Figures 5.51 and 5.52).

Figure 5.51. Top view of concrete sample.

Figure 5.52. Concrete sample after sectioning.

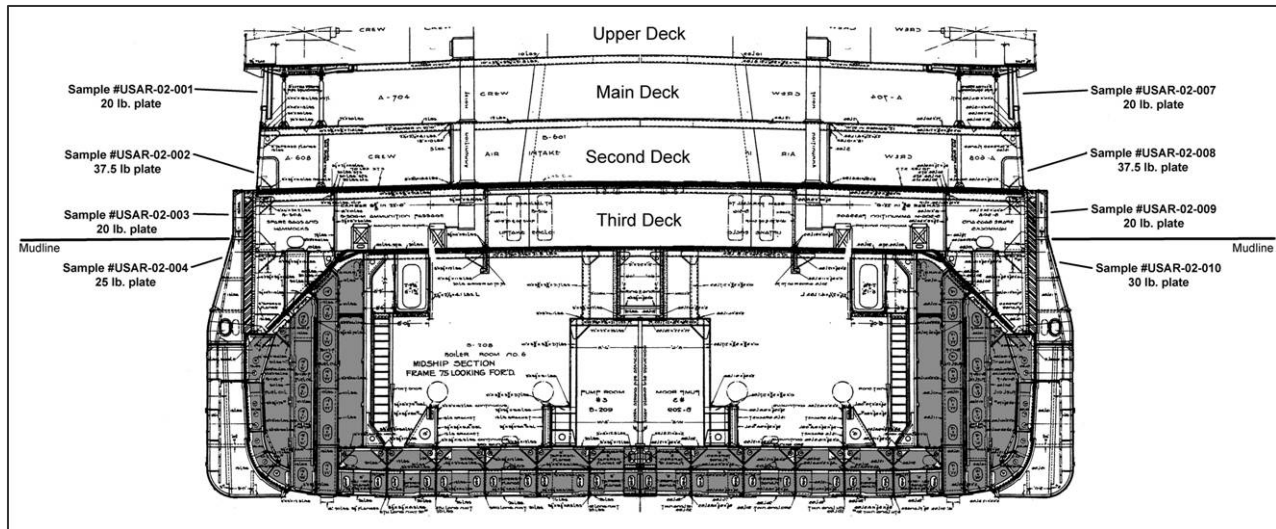
Figure 5.61. Location of samples removed from Arizona’s hull at frame 75.

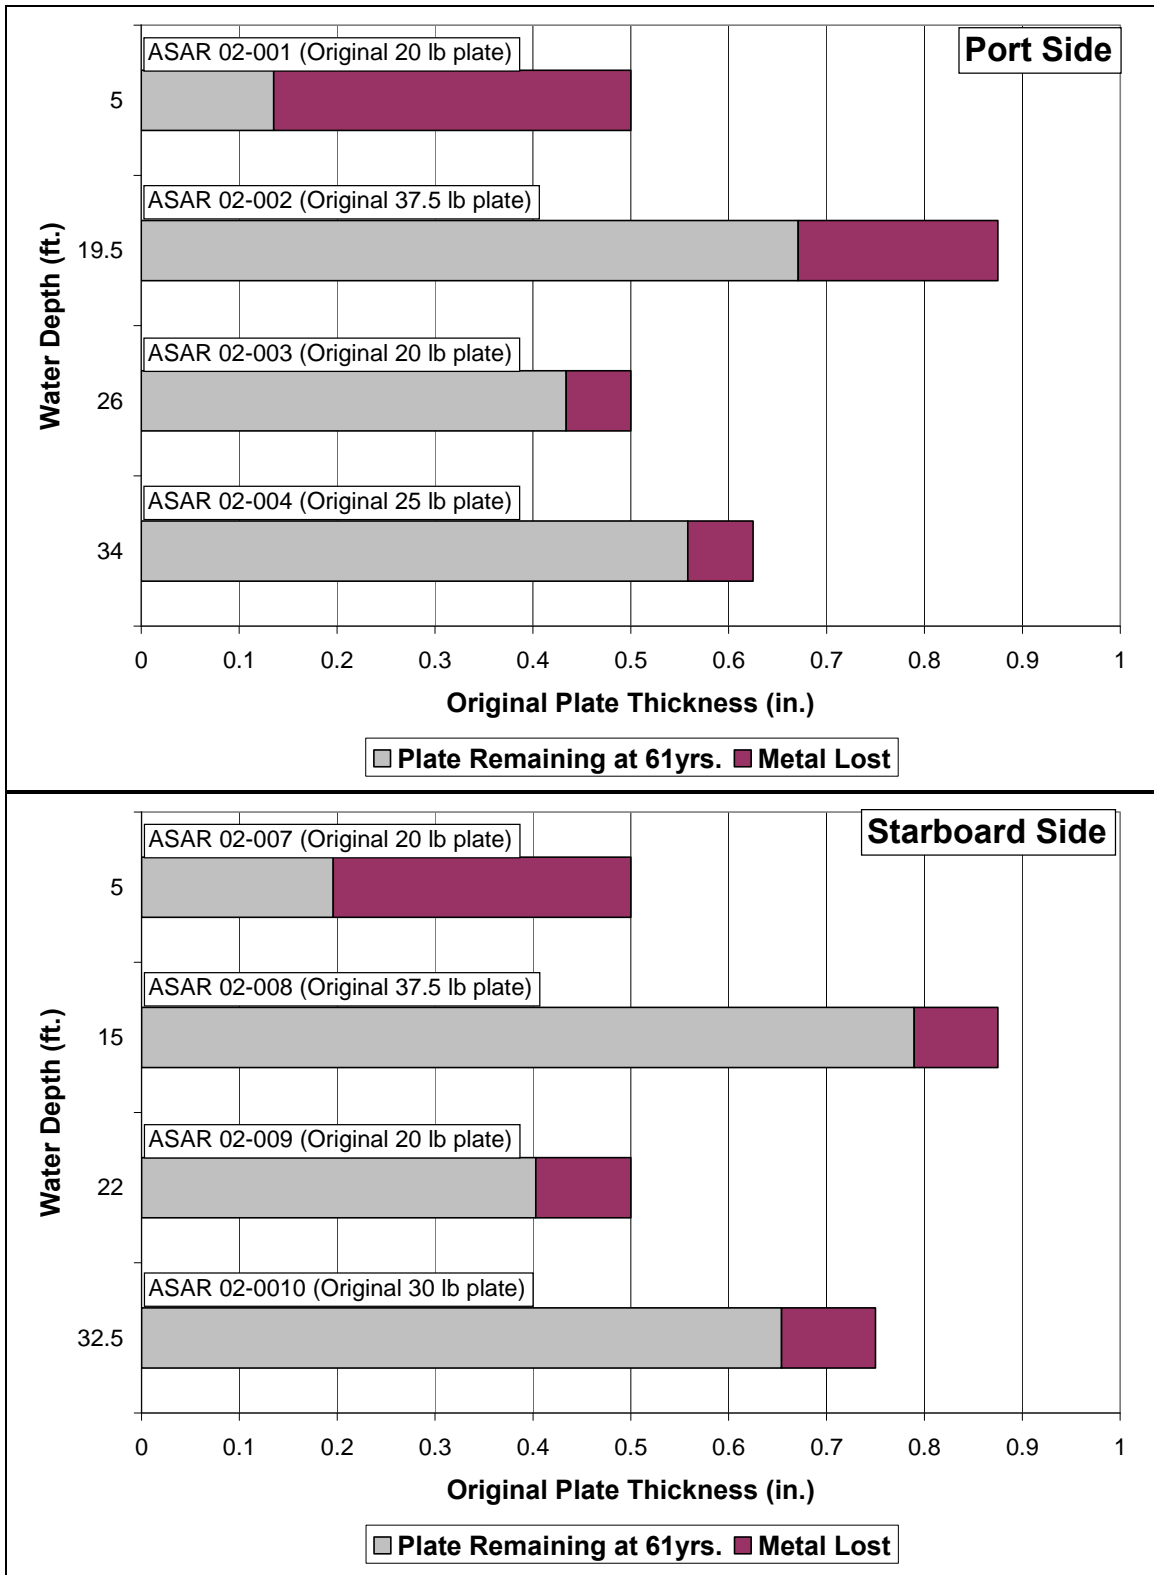
Results from equation [18] for each coupon are given in Figure 5.70 as a function of water depth, and the results from equation [20] are given in Table 5.34 and Figure 5.71. Because coupons were collected in 2002, $t = 61$ yr for these calculations. Note that for the two shallowest samples in Table 5.34 (USAR-02-001 and USAR-02-007, both in 5 ft. [1.52 m] water depth), i_{corr} was halved from the absolute value obtained from the direct measurement technique. Values were halved because, at those two locations, both the inside and outside of the hull are open to free-circulating seawater causing corrosion and concretion formation on both the interior and exterior sides of the hull at the same rate, effectively doubling the corrosion rate. On all other samples, there was little observable interior corrosion or concretion formation, and internal dissolved oxygen levels measured after coupon removal were at or near zero, indicating the majority of corrosion was taking place on the exterior side only.

It is significant to note that metal loss is greatest on the port side between the surface and about 20 ft. This is consistent with greater flow velocities on that side of the hull. Below about 20 ft., metal loss is nearly the same. An additional factor is the turbulence created by Navy launches and other port-side vessel traffic. The effect of water depth on corrosion rate is clearly evident in Figure 5.71 and Table 5.34. The two uppermost coupons, taken at the upper-deck level at approximately 5 ft. (1.52 m) water depth, incur the highest hull steel loss to corrosion (i.e. highest corrosion rate) of close to 3.0 mpy for the port side coupon (USAR-02-001) and 2.5 mpy for the starboard side coupon (USAR-02-007). To put this into perspective, 6 mpy (actual corrosion rate from both sides) corresponds to an average loss of 360 mils ($0.009 \mu\text{m}$) or 0.360 in. (9 mm) in 61 years, or the loss of nearly 75% of thickness on a $\frac{1}{2}$ in. (12.7 mm) steel plate. Two reasons for the relatively high corrosion rate near the surface is maximum availability of oxygen and corrosion attack from both sides of the hull plate. Neither of these locations, however, is structural in nature nor supports any critical vessel elements.

Figure 5.70. Metal loss as a function of original plate thickness and water depth

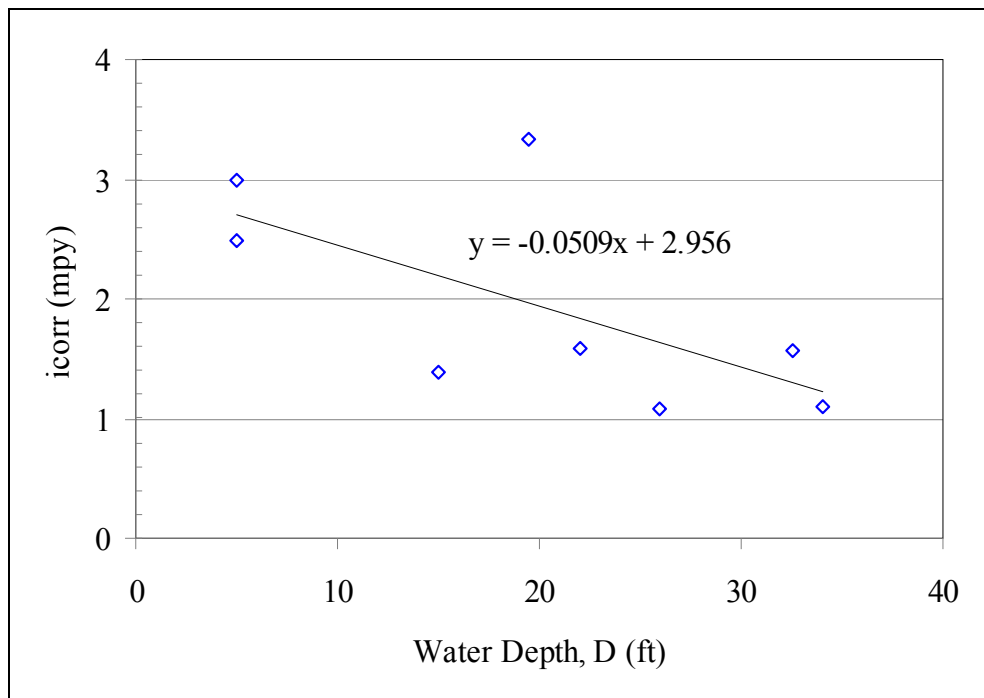
Figure 5.71. Corrosion rate (i_{corr}) of hull samples as a function of water depth.

Hull corrosion rate at the second-deck level varies from 3.3 mpy on the port side at a depth of 19.5 ft. (5.9 m) (USAR 02-002) to 1.4 mpy on the starboard side at a depth of 15 ft. (4.5 m) (USAR 02-008) (Table 5.34)(Figure 5.71). Examination of each of these coupons reveals a very thin layer of interior concretion, indicating limited marine activity on the interior side just above the torpedo blister. Average oxygen concentration of the interior spaces adjacent to the interior side of each sample was about 4.25 mg/L or 65% of the maximum at the surface. This was determined by inserting an oxygen probe into the interior space water immediately after removing the sample. Corrosion on interior surfaces of the hull likely contributes to the total metal loss in spaces where there is some exchange with fresh seawater, concretion is minimal, and oxygen is available to support corrosion in accord with equation [3]. However, such seawater exchange seems to be limited in this area.

Corrosion rate gradient (change in corrosion rate relative to water depth) is 0.05 mpy/ft. or 0.17mpy/m (Figure 5.71). MacLeod (2002:703) reports that the corrosion rate gradient of pre-steel-era iron shipwrecks, determined from annualized depth of corrosion as measured by penetration of graphitization into cast iron, is 0.36 mpy/m. The difference can be explained in terms of microstructural and chemical differences between cast iron and low carbon steel, as well as differences in environmental variables such as temperature, oxygen concentration, salinity, tidal conditions and marine organism activity.
