CHAPTER 5

Steel-Hull Corrosion Analysis of USS *Arizona*

Donald L. Johnson, Brent M. Wilson, John D. Makinson, Robert De Angelis, William N. Weins, and James D. Carr

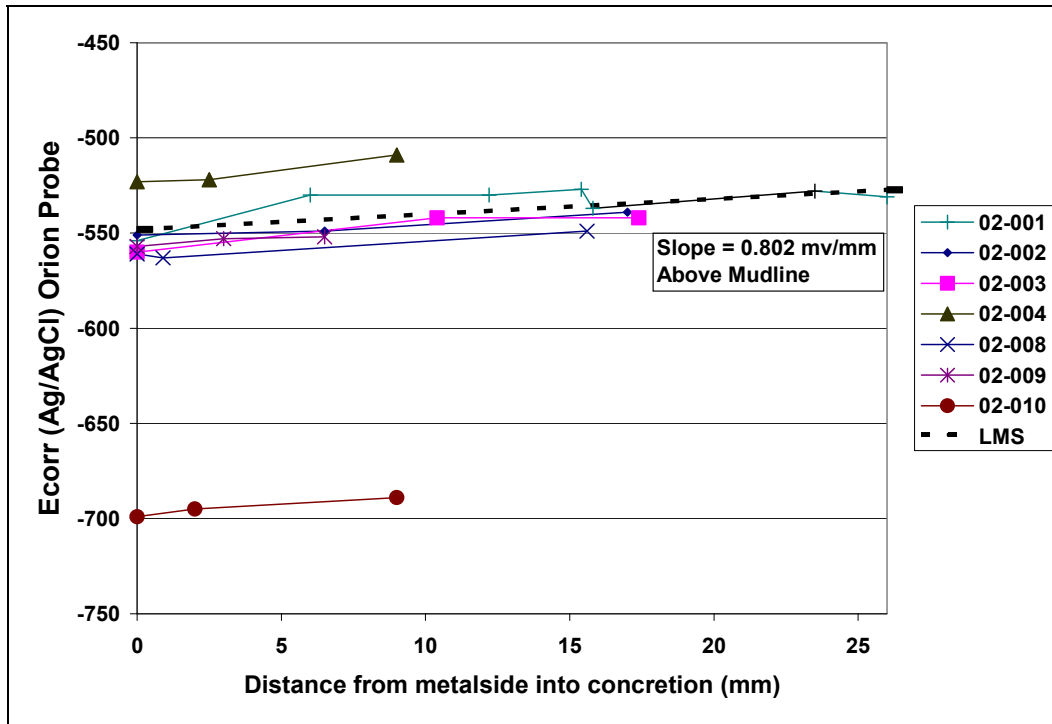
The E_{corr} gradient across the concretion for each of the hull coupon sites varies depending on the coupon site, but is typically about 1 mV/mm (Figure 5.72). pH also decreases through the thickness of the concretion (Figure 5.73)(Makinson, et al. 2002), the cause related to hydrolysis given by equation [7]. Bacterial activity may also be a cause of reduced pH, but the extent that each contributes is complex and variable from one site to another (Brenda Little, personal communication, 2003). As mentioned earlier, SRB accelerates the formation of hydrogen gas and hence has been shown to accelerate corrosion at low pH. Applying equation [14] to a typical set of data corresponding to coupon #USAR-02-008:

Figure 5.72. Corrosion potential as a function of distance from hull surface into concrete, August 2002.

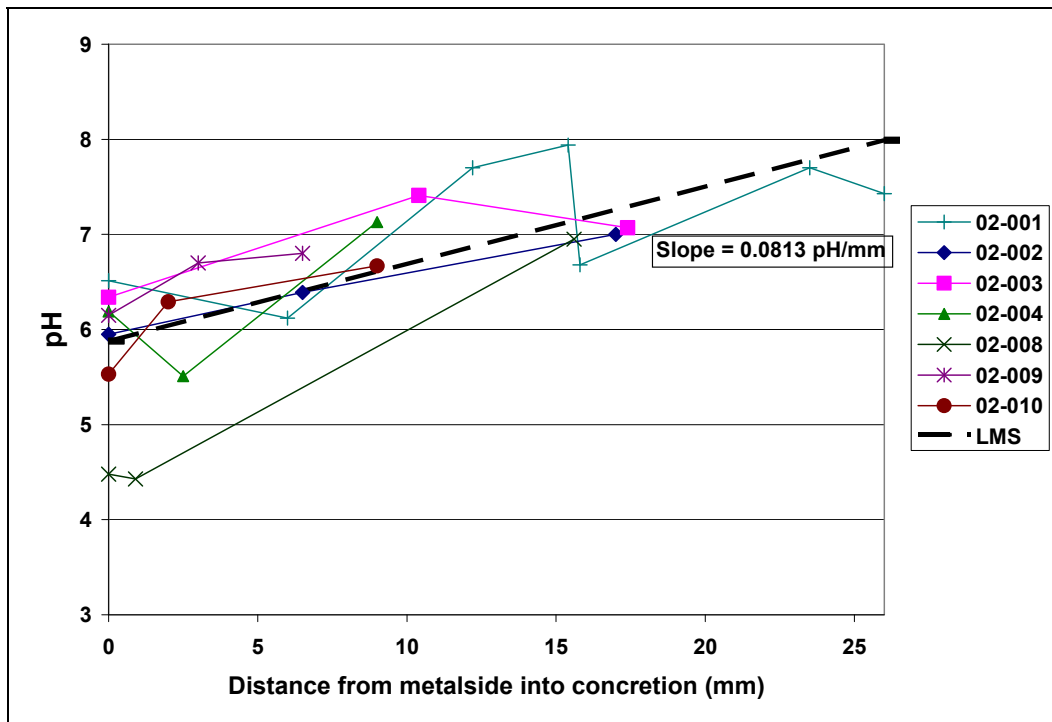
Figure 5.73. pH as a function of distance from hull surface into concrete, August 2002.

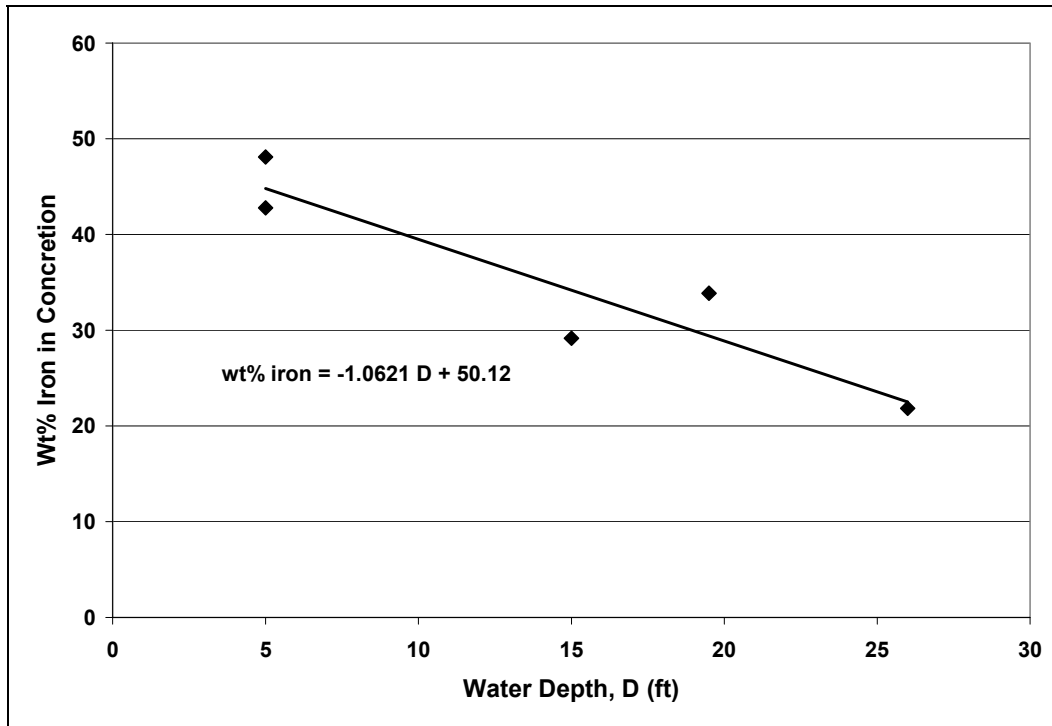
Because determining hull corrosion rate through direct measurement as described above is destructive and impractical, and because determining steel hull thickness with ultrasonic technology has proved unreliable, alternative indirect indicators of steel hull corrosion rate have been sought. The most promising indirect method for determine *Arizona*'s steel hull corrosion rate is correlation between hull iron loss and concretion iron gain, as measured through concretion analysis. External hull concretion analysis and its relationship to corrosion on USS *Arizona* began in the late 1980s. Henderson (1989) scraped samples of concretion from the hull, dried and weighed them, and separated the magnetic corrosion products with a bar magnet. In 1998, Johnson converted the data generated by Henderson (1989) to corrosion rate in mpy to illustrate that analysis of the concretion may have merit as a way to determine corrosion rate (Johnson, et al. 2003). Based on these observations, x-ray diffraction (XRD) and environmental scanning electron microscopy (ESEM) studies on USS *Arizona* concretion were initiated in 1999 at UNL to better understand in what form the iron exists in the concretion and how the metal hull and the concretion interact. Subsequently, x-ray studies were continued at Eglin Air Force Base, Florida and the University of Florida. Using XRD data, De Angelis (2002) identified the iron minerals siderite (FeCO_3), with lower residuals of aragonite (CaCO_3) and magnetite (Fe_3O_4), as the primary constituents in the concretion (Johnson, et al. 2003:91-92; Johnson, et al. 2006a, 2006b)(see above). Measuring distribution of iron in the concretion cross-section using ESEM and x-ray fluorescence (XRF), Johnson used graphical integration to determine the mean (total) iron content, the result, 40% to 50% by weight, was close to the same iron content obtained from chemical analysis of a sample representing the total thickness of the concretion (Johnson, et al. 2003:96-97). Data from *Arizona* concretion analysis revealed that the specific weight of the concretion per unit area (density x thickness) and total iron in concretion in weight percent (%Fe) decreases with water depth (Figure 5.75). The equation expressing the relationship between weight %Fe and water depth is given by:

Figure 5.75. Weight % iron vs. water depth.

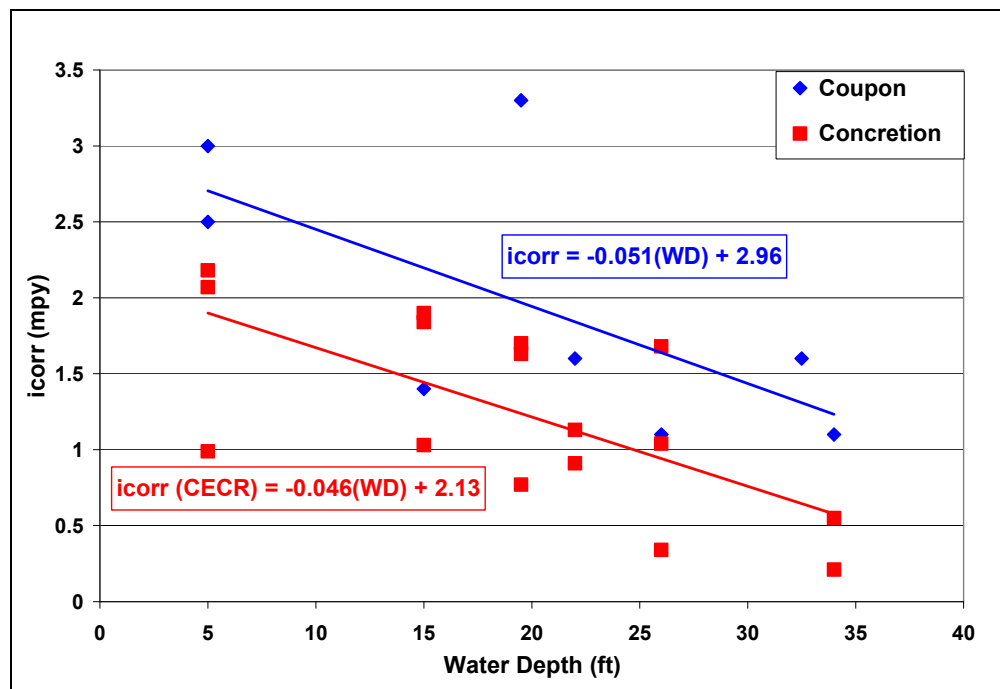
Physical and chemical properties for 16 concretion samples and corresponding corrosion rates calculated from equations [26] and [27] are tabulated in Table 5.38. Corrosion rates from direct measurement of hull coupons and concretion analysis are compared in Figure 5.76. The actual corrosion rate obtained from metal coupons is higher than that predicted by concretion analysis using equation [26], as indicated by the separation between the two trend lines. The reasons for the difference are: (1) higher initial (pre-concretion) corrosion rates that produced

Figure 5.76. Comparison of the corrosion rate on Arizona compiled from both coupon data and concretion iron content measurements as a function of water depth.

soluble iron that was not incorporated into concretion; (2) formation of an oxide layer between the steel surface and the concretion, which is not captured during concretion removal and therefore the iron within it is not included in the analysis; and (3) possible corrosion on the interior side of the hull plates. Analysis of the ratios of the two trend lines in Figure 5.76 reveals that corrosion rates obtained from the coupons using the direct measurement technique is higher than corrosion rates predicted by the concretion constituent analysis by a factor of 1.6. With this ratio factored in, a general equation for estimating corrosion rate directly from physical and chemical concretion properties is given in equation [28], where the constants in equations [26] and [27] are multiplied by 1.6 for English and SI units respectively to yield an expression for the actual corrosion rate, defined as the Concretion Equivalent Corrosion Rate (CECR):

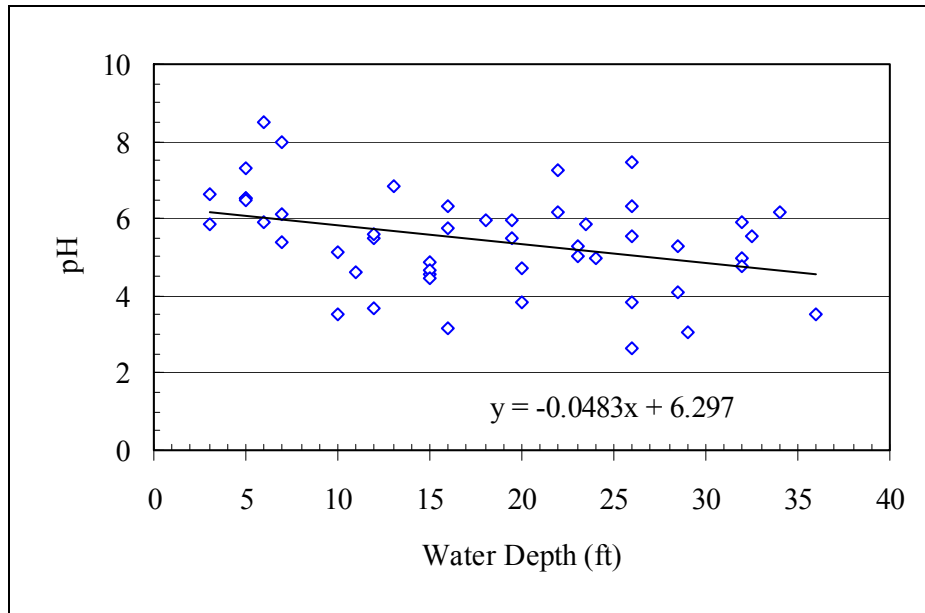
metal concretion interface with minimum pH at the sites where the concretion thickness is greatest (Figure 5.79). As oxygen consumption continues, the net oxygen level remains low on the metal surface and hydrolysis continues to maintain acidic conditions at the metal surface.

Figure 5.79. pH at metal/concretion interface as a function of water depth.

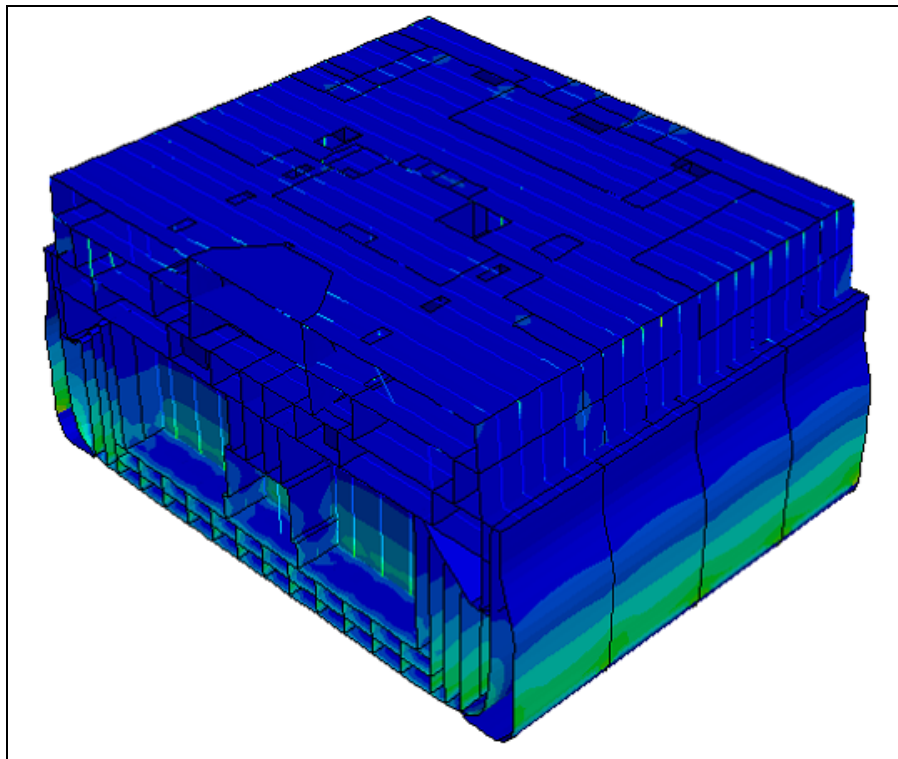
Figure 6.23 shows the computed stresses in the model when dimensions of the ship are taken directly from the design blueprints, and thus as the ship was built. The stresses everywhere are very low, which is to be expected as this is a warship and it was considerably overbuilt to be able to withstand battle damage. The stresses are higher in the vertical walls in the lower levels, as expected, since these walls are supporting much of the weight of the ship above.

Figure 6.23. Self-weight stresses in as-built condition (NIST Graphic).

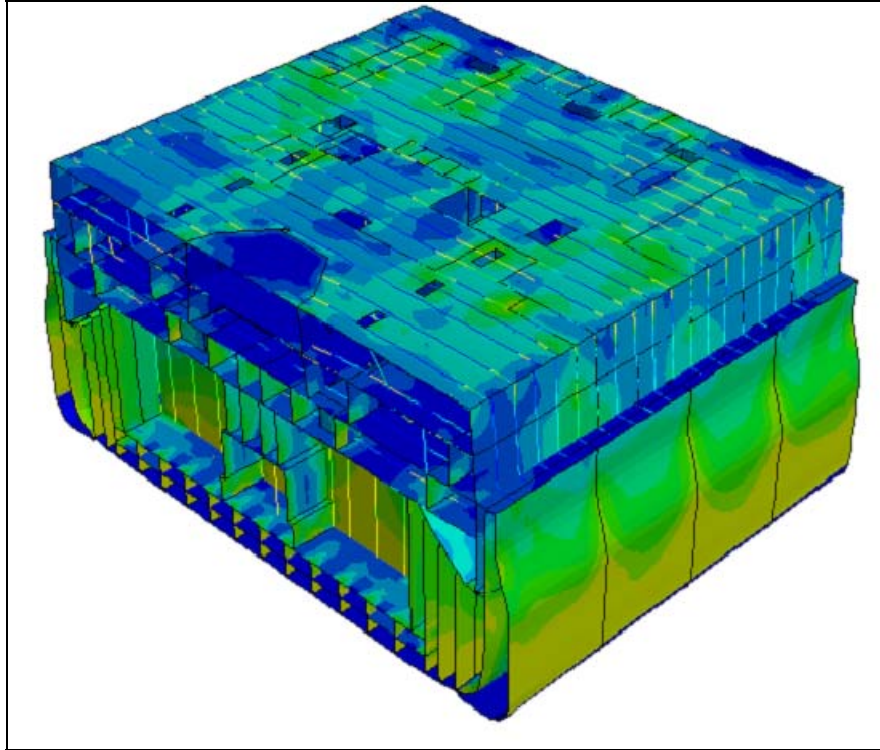
Overall the stress distribution is very similar to the as-built condition, with the overall stress levels somewhat higher. It is noteworthy that the deck beams in the upper deck have jumped significantly in stress, and the second, first and main decks remain almost unstressed (Figure 6.24).

Figure 6.24. Self-weight stresses after 10% thickness loss due to corrosion, approximate date = 1980 (NIST Graphic).

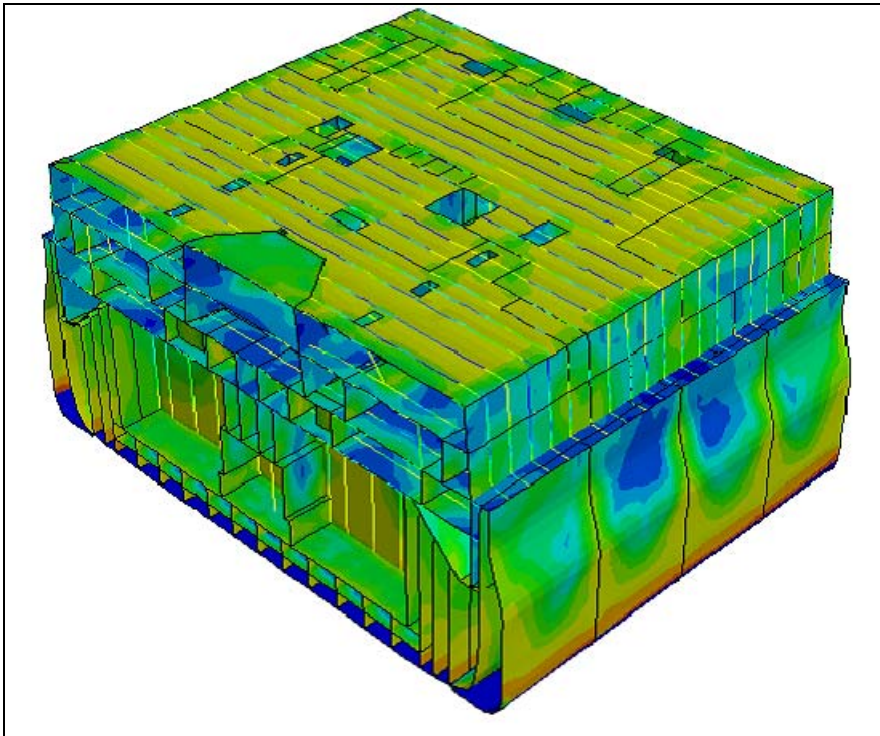
The upper deck is now showing sagging of the beams and deck plates as they continue to thin. Stresses at the turn of the bilge of the torpedo blisters are approaching the tensile strength of the steel. Stresses in the vertical members continue to increase (Figure 6.25).

Figure 6.25. Self-weight stresses after 20% thickness loss due to corrosion, approximate date = 2020 (NIST Graphic).

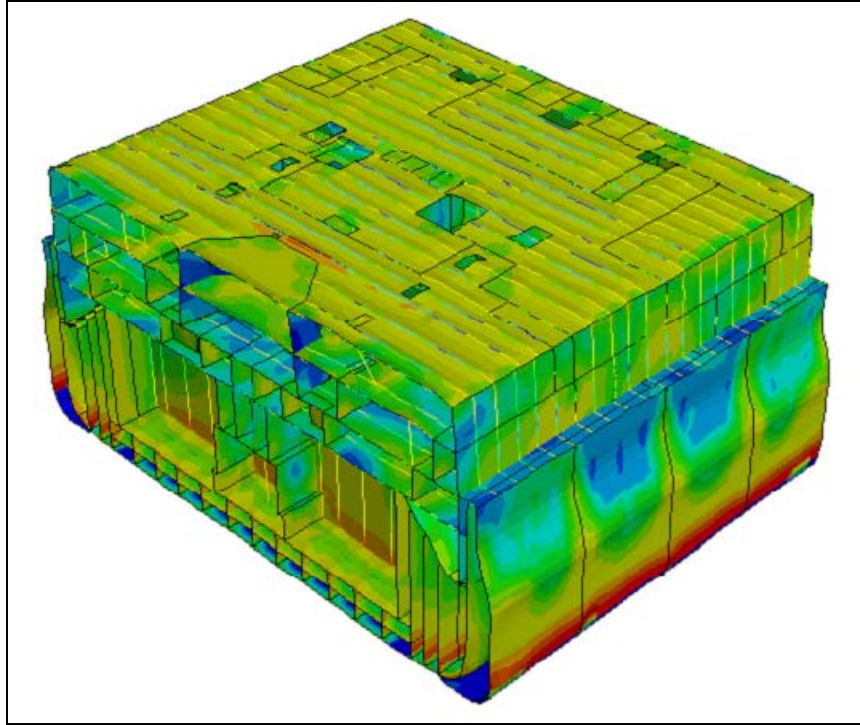
The turn of the bilge area of the torpedo blister, as well as the connections of the lower bulkheads to the hold platform are very close to critical. There is additional sagging in the upper deck, as well as increased stresses in the bulkheads of the lower deck (Figure 6.26).

Figure 6.26. Self-weight stresses after 30% thickness loss due to corrosion, approximate date = 2050 (NIST Graphic).

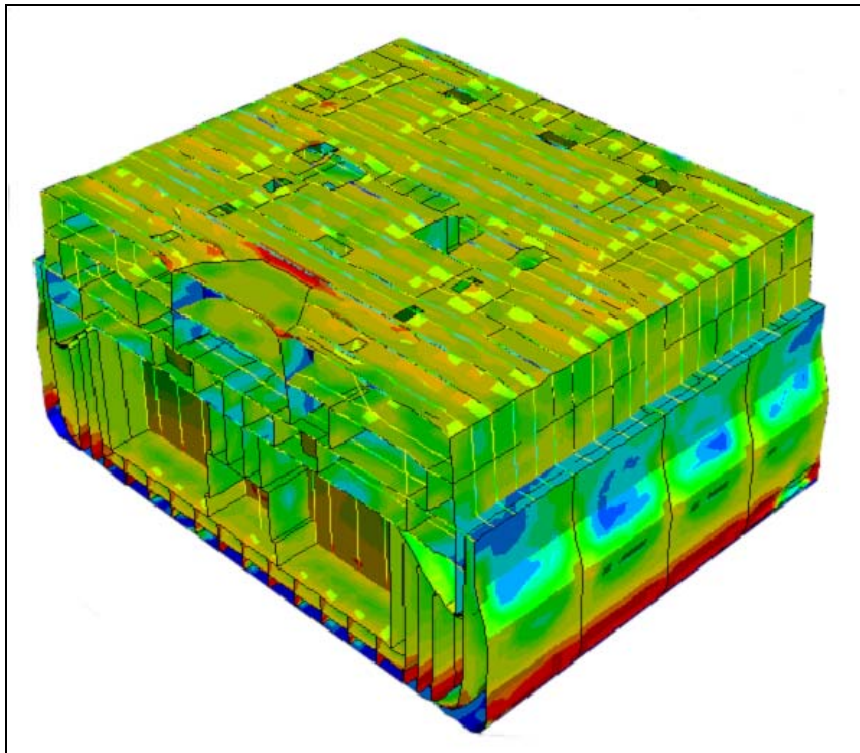
Localized collapse events have begun to appear, including the torpedo blisters, double bottom vertical wall segments, upper deck beams and the region around the stack armor, undoubtedly collapsing under the weight of this very thick steel (Figure 6.27).

Figure 6.27. Self-weight stresses after 50% thickness loss due to corrosion, approximate date = 2120 (NIST Graphic).

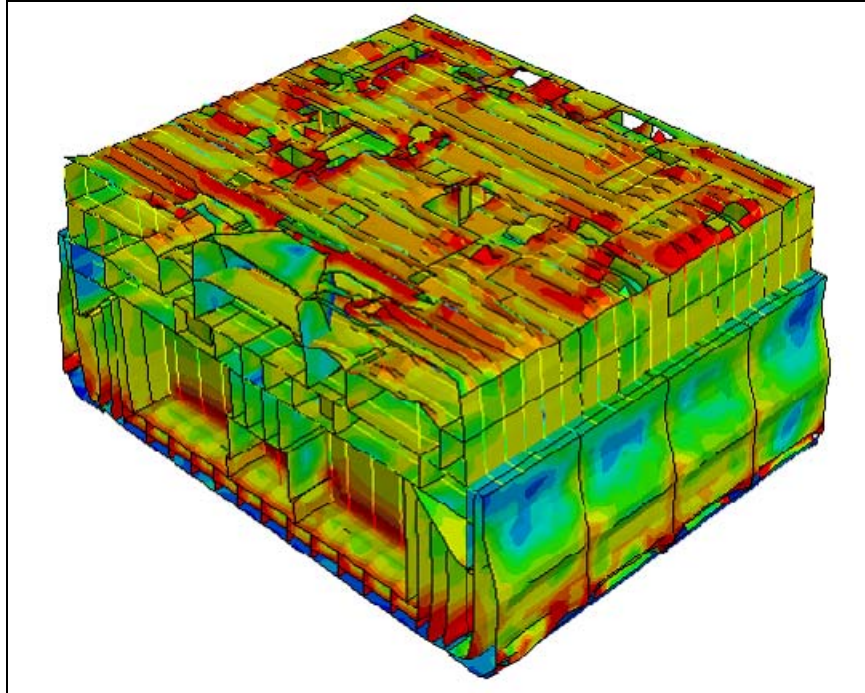
There is general collapse of the deck plating on the upper and main decks, collapse of the outer hull plating and torpedo blisters, very high stresses in the bulkheads at the hold platform in the engine spaces. Buckling of the hull shell plating has begun (Figure 6.28).

Figure 6.28. Self-weight stresses after 60% thickness loss due to corrosion, approximate date = 2150 (NIST Graphic).

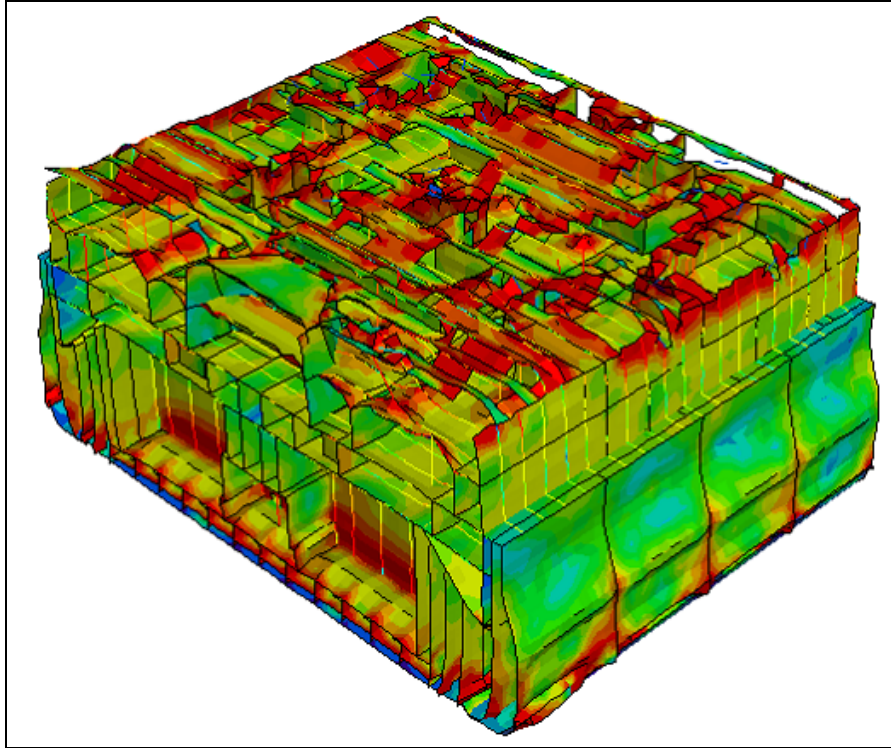
The upper deck is now unrecognizable, and much of the deck plating and deck beams will have fallen onto and accelerated the collapse of the main deck and those further below. The hull shell and torpedo blister continue to collapse, as does now the double bottom (Figure 6.29).

Figure 6.29. Self-weight stresses after 70% thickness loss due to corrosion, approximate date = 2180 (NIST Graphic).

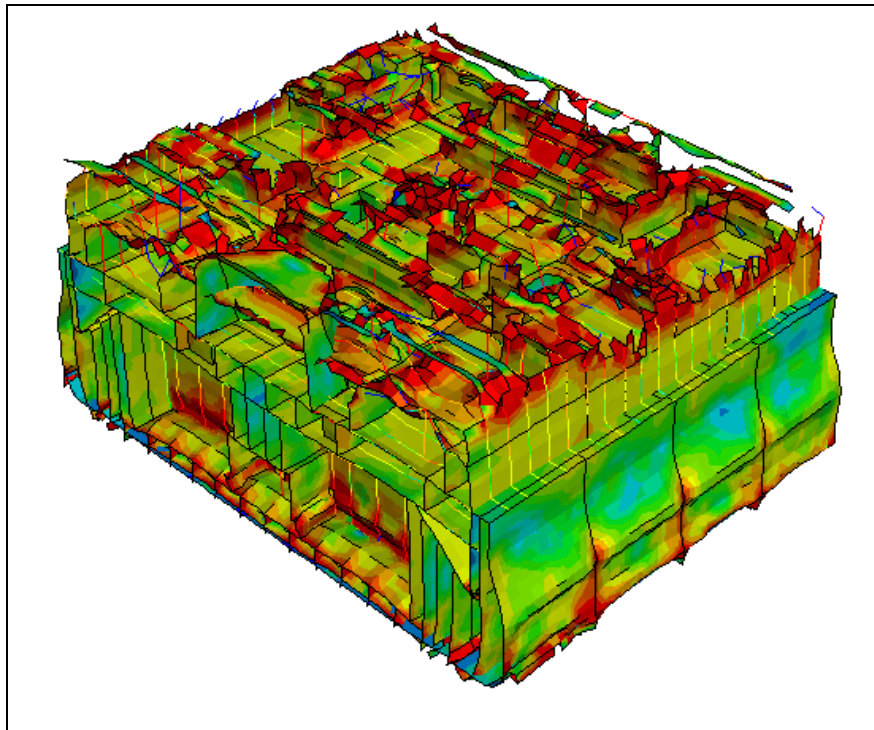
The decks of the superstructure (upper, main, and second) can be expected to further collapse and pancake onto the third deck. The double bottom has now completely collapsed. Note however that the core cylinder of the wreck, consisting of the volume bounded by the third deck, the inner bottom and the side oil tanks is still relatively intact (Figure 6.30–6.32).

Figure 6.30. Self-weight stresses after 80% thickness loss due to corrosion, approximate date = 2210 (NIST Graphic).

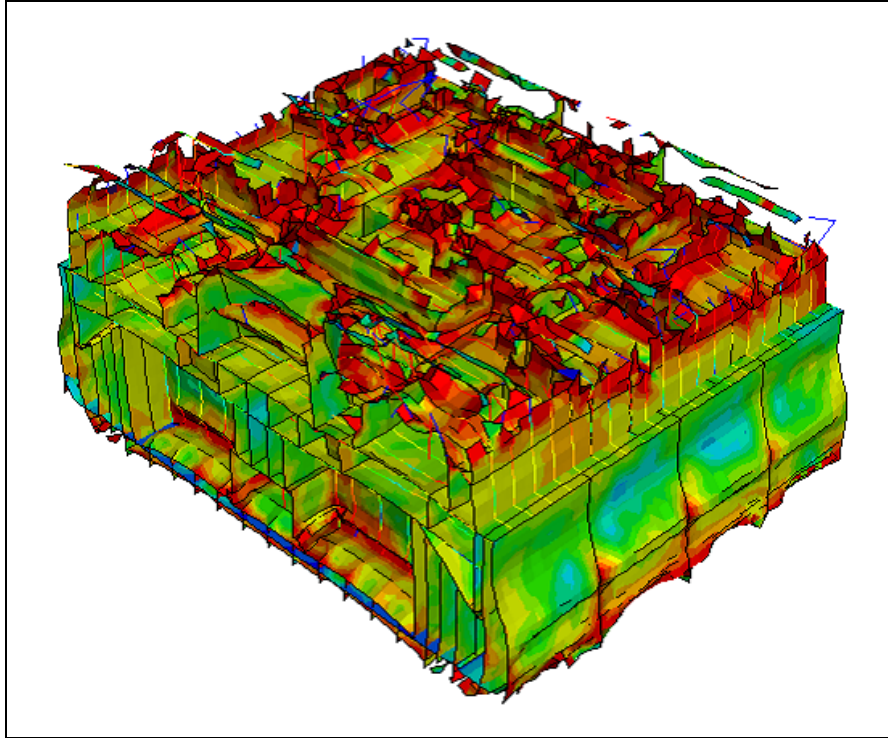
Figure 6.31. Self-weight stresses after 90% thickness loss due to corrosion, approximate date = 2240 (NIST Graphic).

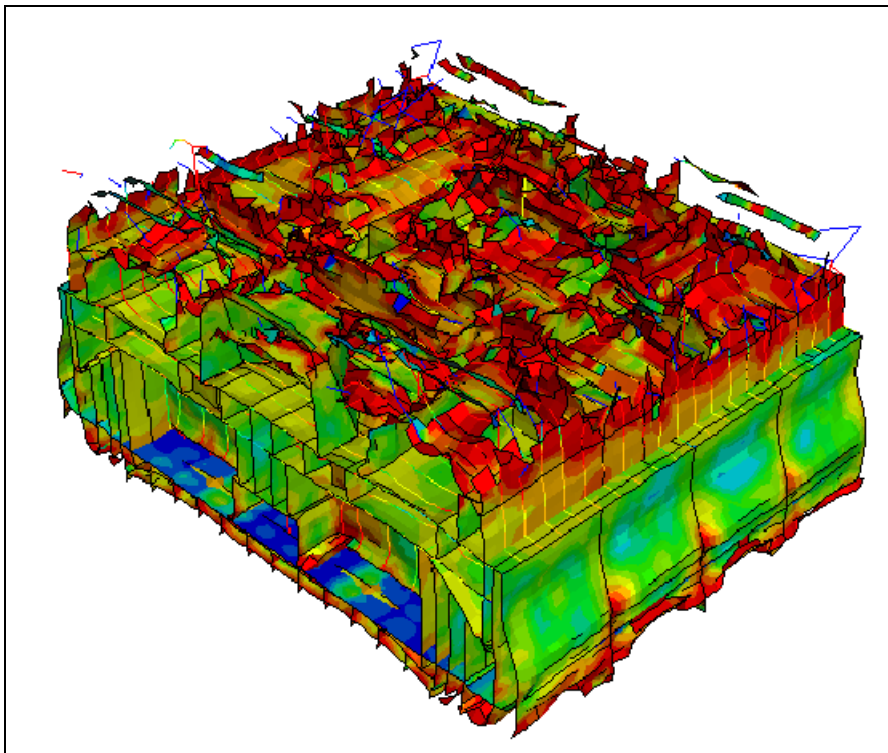
Figure 6.32. Self-weight stresses after 95% thickness loss due to corrosion, approximate date = 2250 (NIST Graphic).

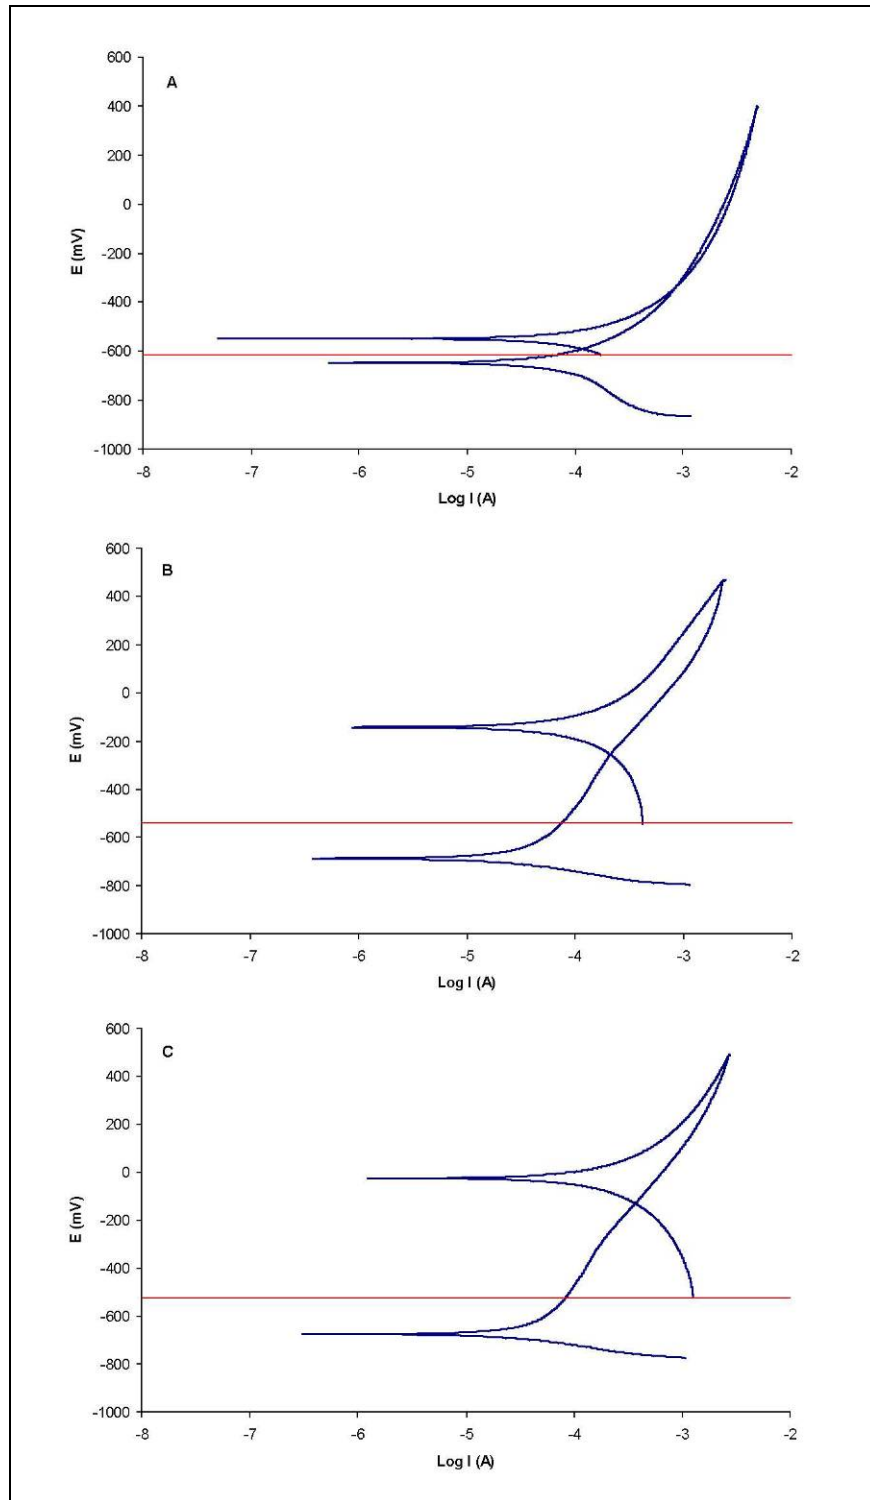
Initial CP scans of the A36 stainless steel coupons were similar (Figures 7.4A and 7.5A). After 1 week incubation inoculated and uninoculated cells are still similar (Figures 7.4B and 7.5B). Hysteresis of the curves is negative, there is no distinct primary passivation potential (E_{pp}), and there appears to be a transpassive region and a breakdown potential (E_b). In addition, the OCP is located within the passive region and is lower than the repassivation potential (E_{rp}). After 3 weeks, differences between cyclic polarization (CP) scans for the inoculated and uninoculated cells are apparent. The uninoculated cell did not change substantially from week 1 (Figure 7.4C). However, in the inoculated cell the E_{rp} decreased ~ 200 mV and while the hysteresis was still negative, it was shifted in the positive direction. A passive film is damaged when the potential is raised into the transpassive region. Negative hysteresis indicates that the film repairs itself and pits do not initiate, while positive hysteresis indicates that the film is not repaired and may indicate pit formation. Additionally, when the OCP is less than E_{rp} it is believed that pits will not grow, while in the opposite case it is believed that pits will continue to grow. Movement of the hysteresis in the positive direction and the decrease in the E_{rp} in the inoculated cell may indicate a trend toward pitting corrosion caused by the biofilm.

Figure 7.4. Cyclic polarization scans of uninoculated cells after 0 (A), 1 (B), and 3 (C) weeks. The open circuit potential is indicated by the horizontal line.

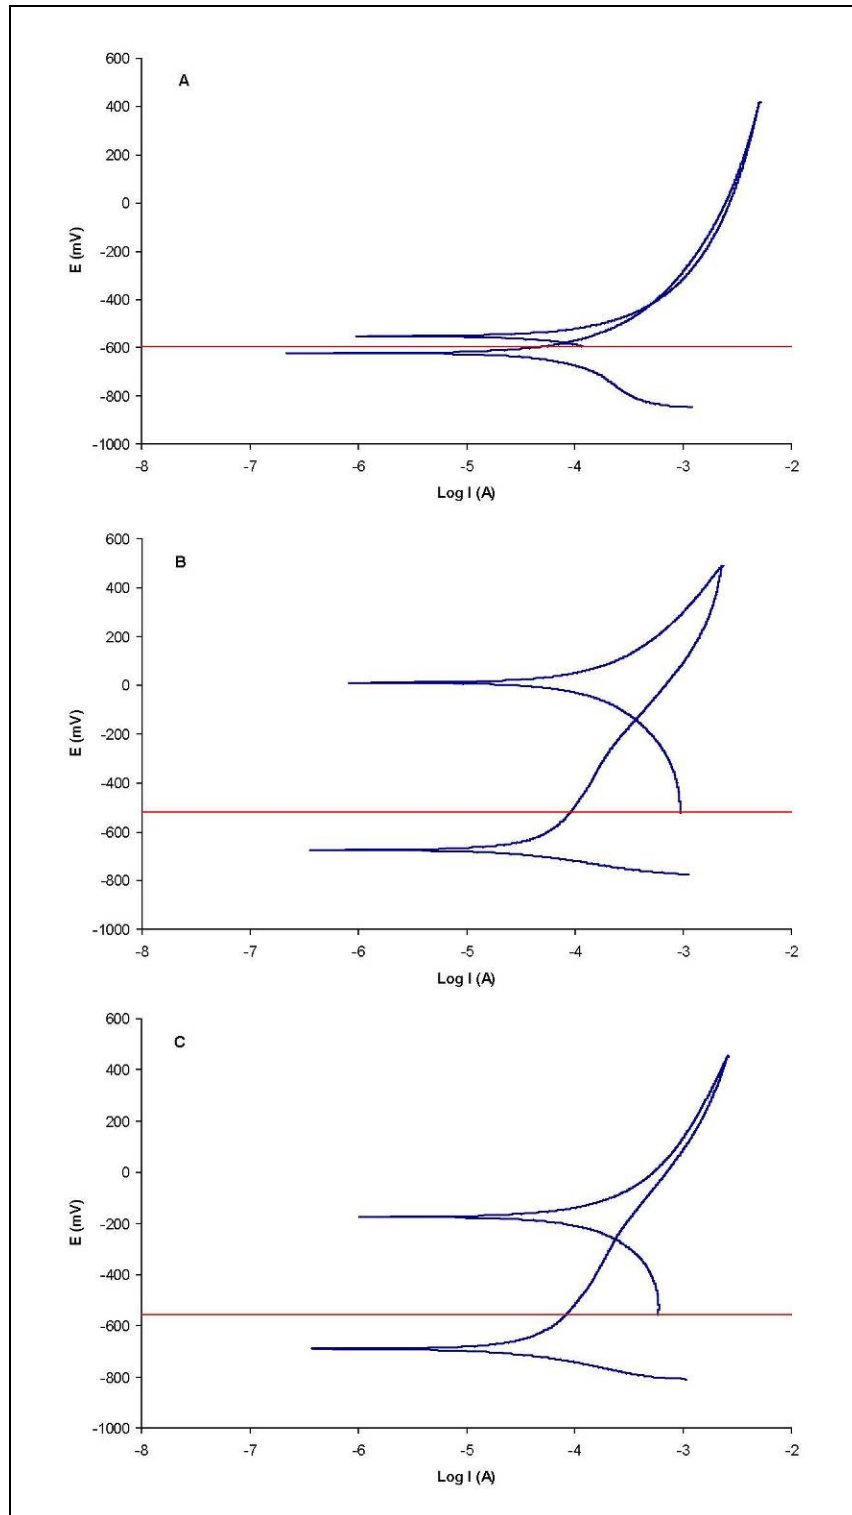
Figure 7.5. Cyclic polarization scans of inoculated cells after 0 (A), 1 (B), and 3 (C) weeks. The open circuit potential is indicated by the horizontal line.

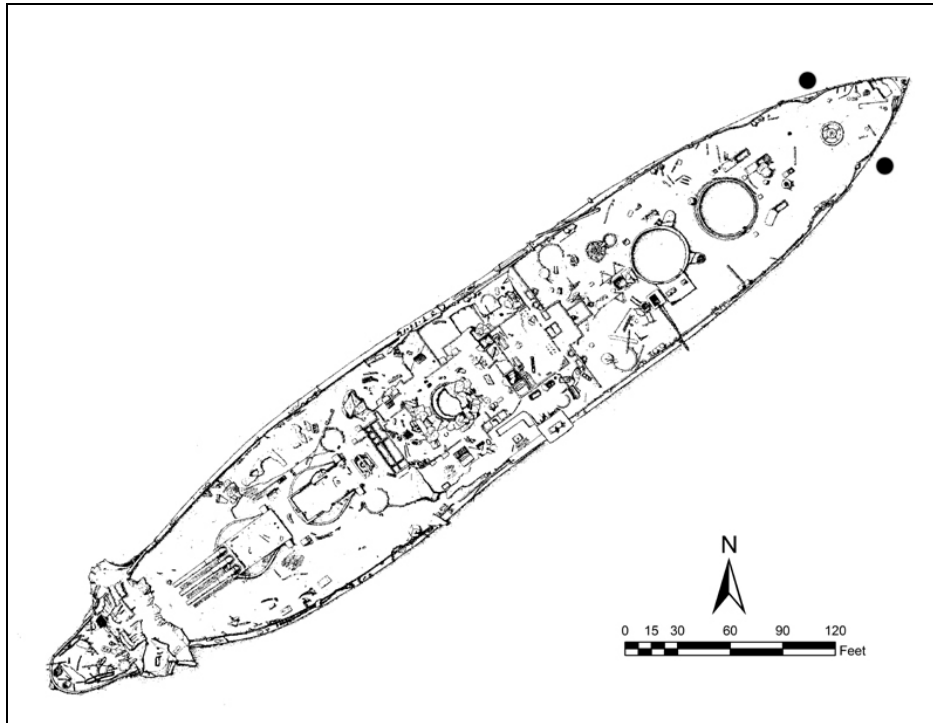
Concretion samples were collected from two locations on the exterior hull of USS *Arizona* in November 2004. Samples were collected with a pneumatic drill fitted with a 7.6 cm diameter hole saw. Sample 14 was collected on the ship's port side near the stern at a depth of 5.9 m below the water surface. Sample 15 was collected on the ship's starboard side near the stern at a depth of 4.7 m below the water surface. Samples were shipped on ice overnight to Harvard University (Figure 7.6).

Figure 7.6. Points at the stern indicate sample locations on the exterior hull of USS *Arizona*. Sample 14 was collected on the port side of the ship and sample 15 on the starboard side (Drawing by NPS-SRC).
