**REPORT OF INVESTIGATION**

**Underground Metal Mine  
(Gold)**

**Fatal Falling Material Accident  
August 12, 2010**

**Meikle Mine  
Barrick Goldstrike Mines Inc.  
Carlin, Eureka County, Nevada  
Mine I.D. No. 26-02246**

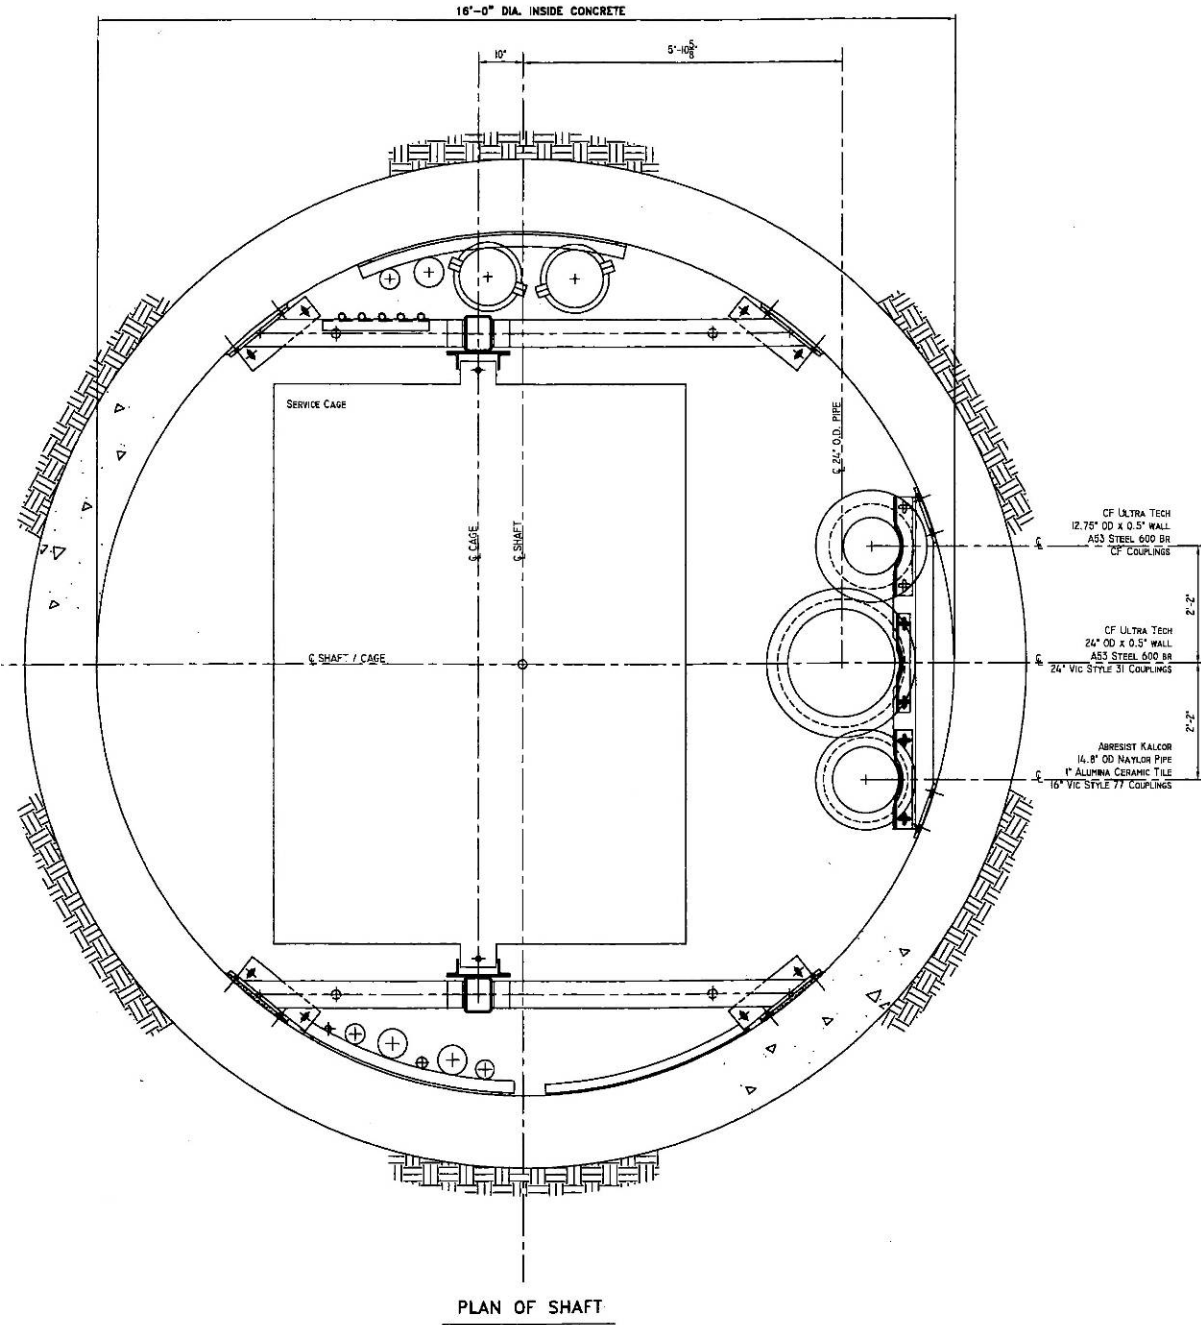
The ventilation shaft is reinforced concrete lined, has an inside diameter of 16 feet, and extends to a depth of 1330 feet (figure 1). The shaft housed the service and supply cage and served as an exhaust ventilation shaft. Placed in the shaft were utility conduits, electrical cable brackets, and the aggregate delivery system, which consisted of two 12-inch-diameter vertical pipes and one 24-inch-diameter vertical pipe. One 12-inch pipe was located on the north side of the 24-inch pipe and the other was located on the south side.

Figure 1 – Dynatec drawing showing plan view of Meikle ventilation and supply shaft. The three aggregate delivery pipes and support bracket are shown on the right side of the figure.

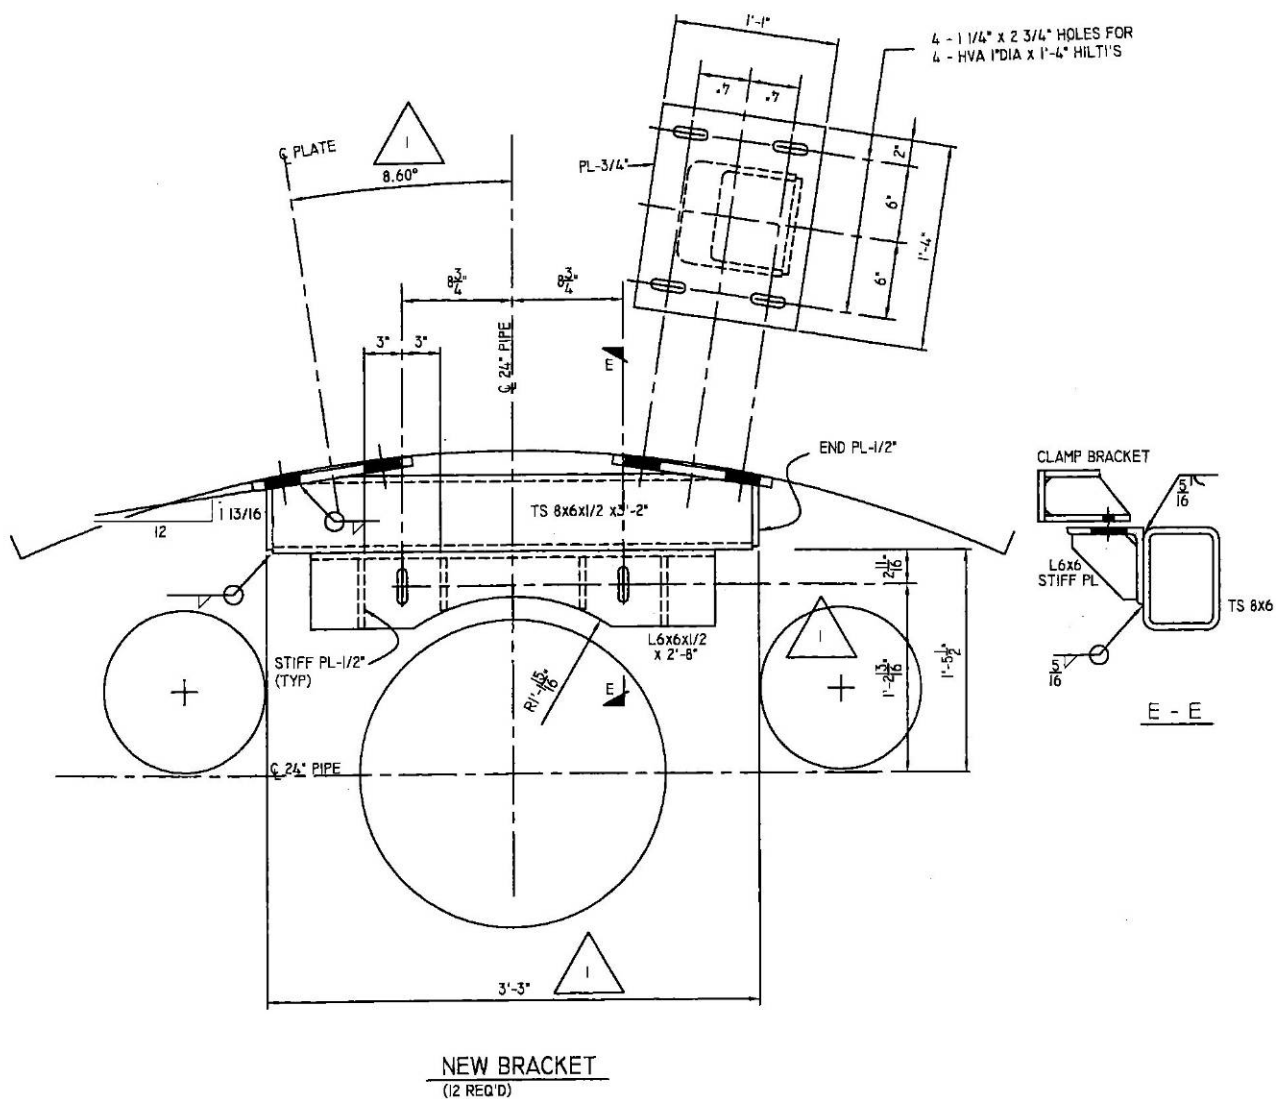
Figure 2 – Dynatec drawing showing new bracket support for 24-inch-diameter aggregate delivery pipe. Section E-E (right) shows cross-section of stiffened angle welded to tube bracket. Clamp bracket also shown aligned to bolt down with stiffened angle.

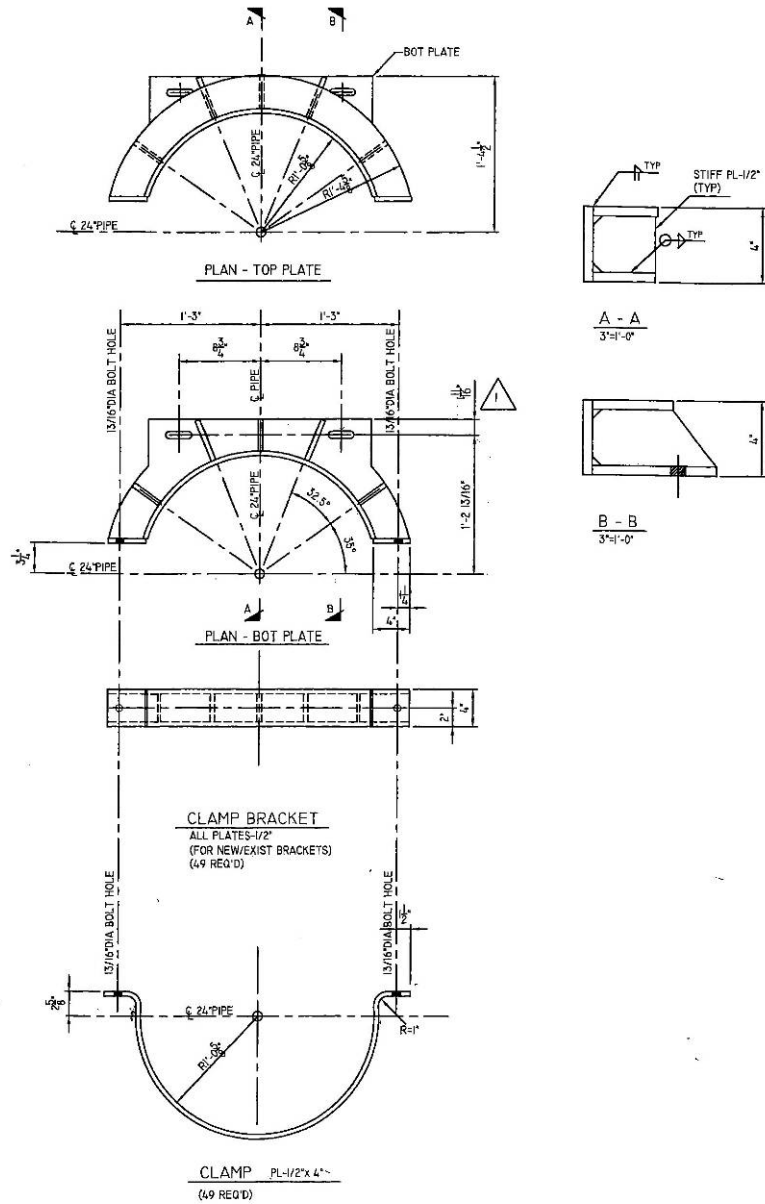
Figure 3 – Dynatec drawing showing typical clamp bracket and clamp assembly. Clamp bracket has slotted holes to accommodate alignment. Clamp is attached to clamp bracket with a single 3/4-inch, A325 bolt on each side.

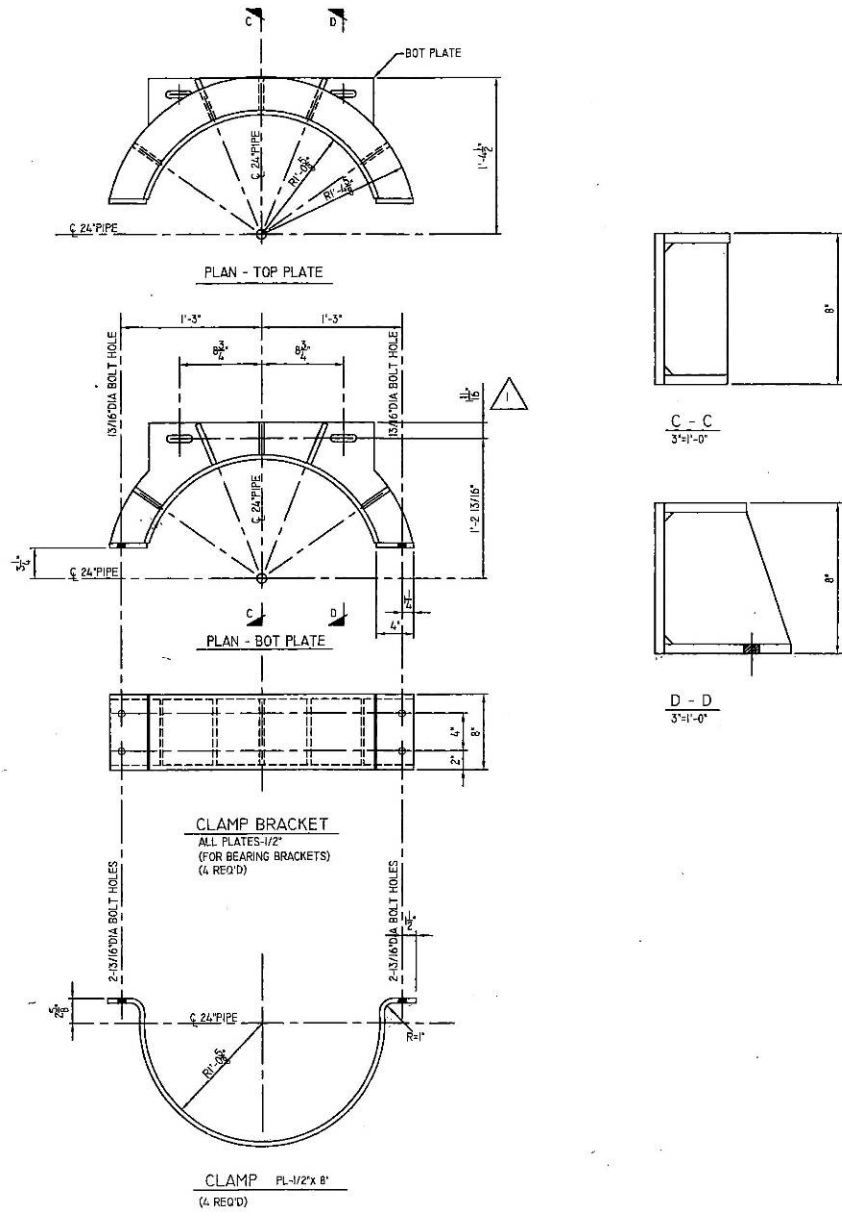
Figure 4 - Dynatec drawing showing bearing clamp bracket and clamp assembly. Clamp bracket has slotted holes to accommodate alignment. Clamp is attached to clamp bracket with two 3/4 inch, A325 bolts on each side.

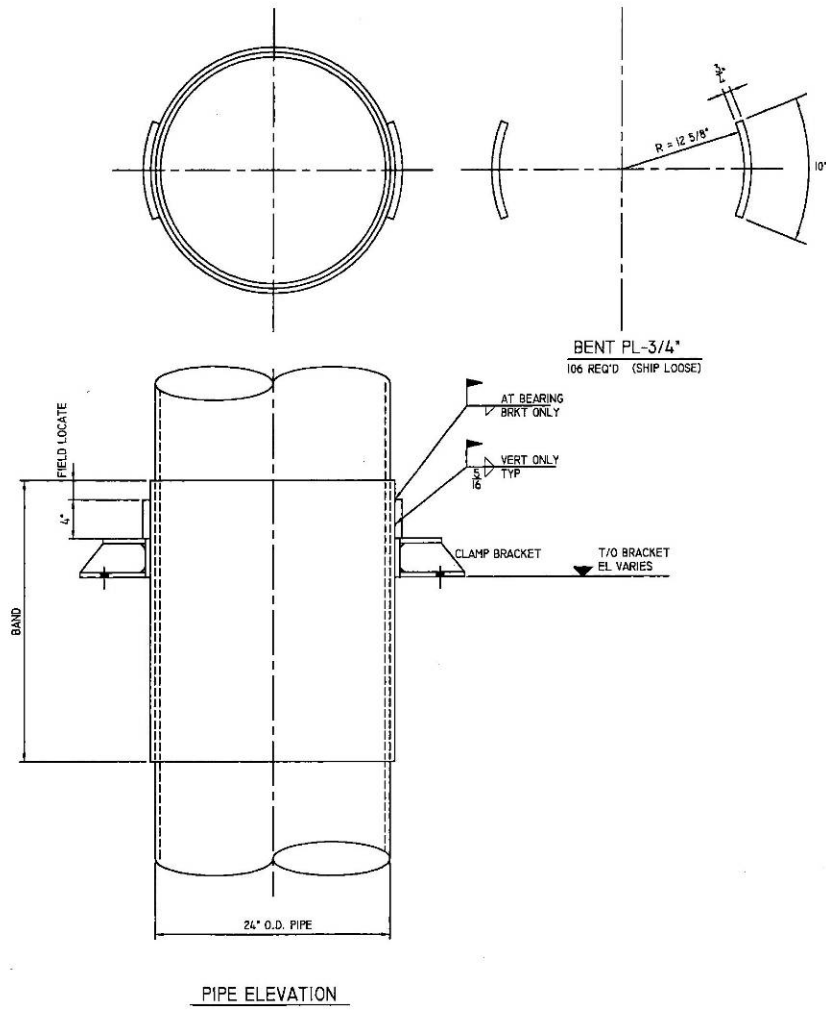
Figure 5 - Dynatec drawing showing two, 3/4-inch-thick bearing plates to be field welded to the pipe sleeve at each clamp bracket location.

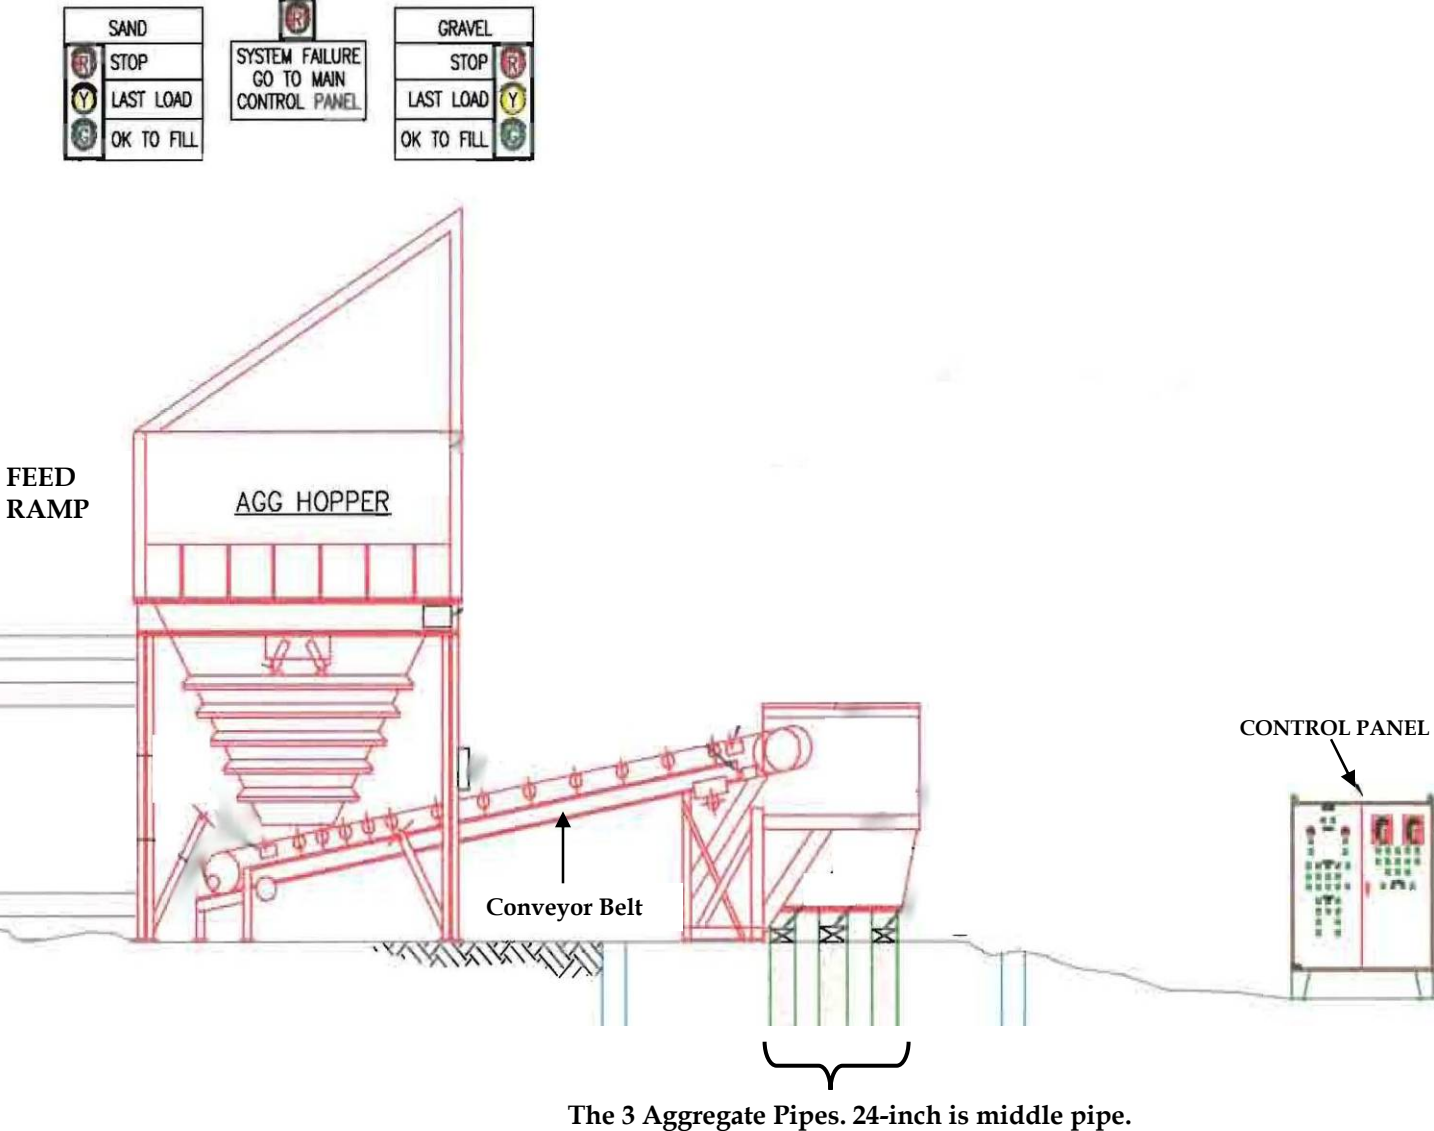
The feed bin at the surface was full. The 28-inch belt conveyor at the surface leading to the transfer box was full and overflowing (figure 6 and photo 16). The transfer box at the surface had three outlets. The center one for the 24-inch diameter pipe was open, while the two openings for the two 12-inch diameter pipes were closed. After the 24-inch pipe had fallen away, most of the material drained out of the transfer box except the materials above the two blocked off side pipes. Locks were found on the control panel at the surface for the two 12-inch diameter pipes. The lock-out date was June 22, 2010. The rock box (dead bed) at the

Figure 6 - Drawing showing the surface aggregate delivery system.

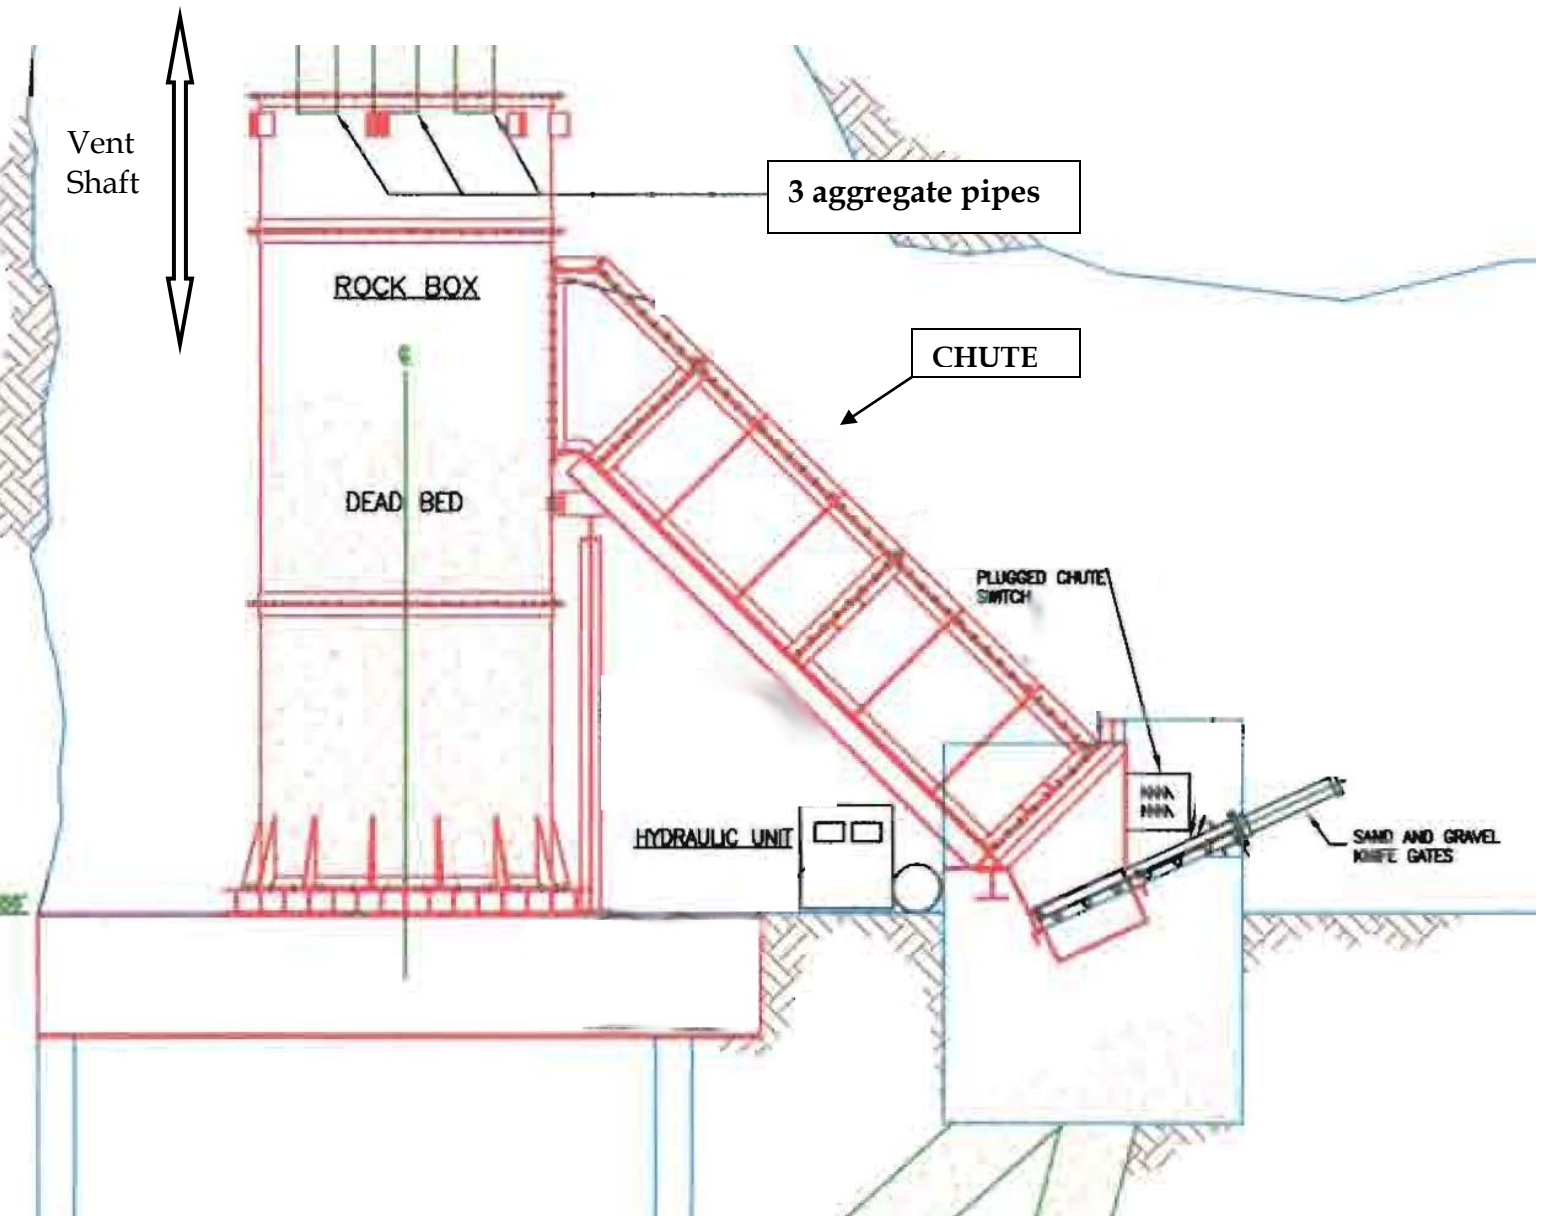
who replaced Roberts as the batch plant operator shortly after the aggregate pipe clogged. Taylor informed Noble it had been a slow day with only two trucks hauling about 20 batches out. Noble went underground to the 860 rock box and noticed the rock box and chute were full of aggregate (figure 7). He returned to the surface and met with Richard Nunn, leadman, and Thornley. Noble told them the aggregate pipe was full. Nunn assigned Noble to another task underground and instructed Thornley to begin working to unplug the system.

Figure 7 - Drawing showing the underground aggregate delivery system.

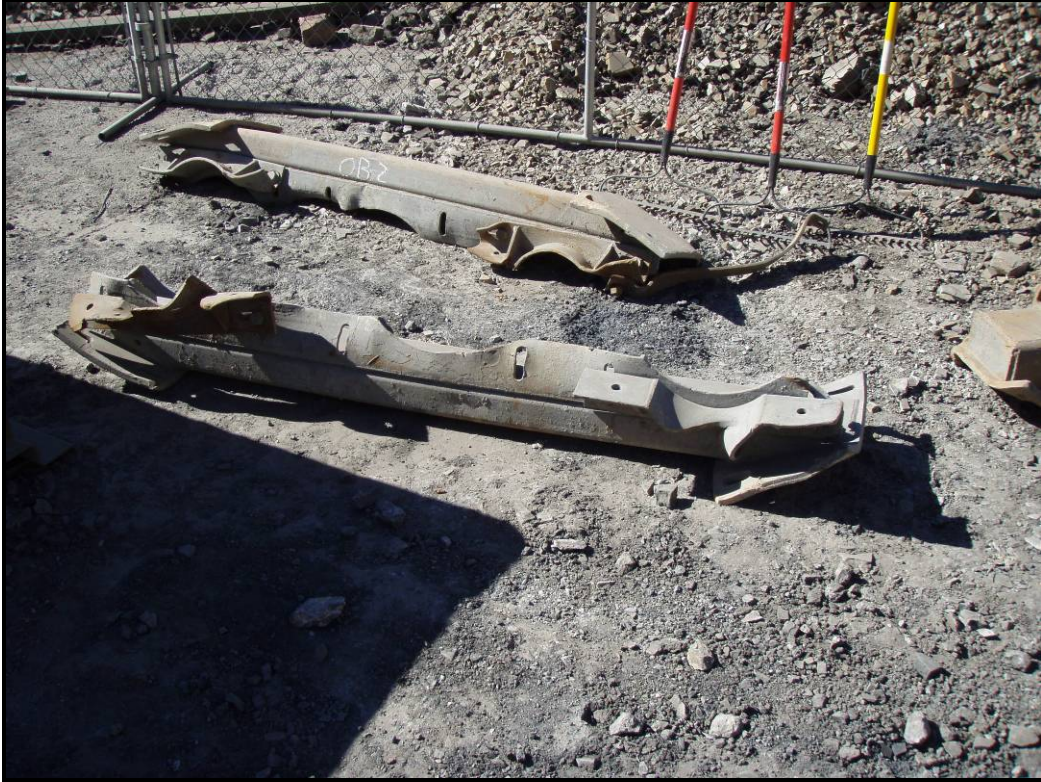
Two original brackets and one new bracket found in the debris were pulled from the shaft, but three original brackets no longer attached to the shaft wall were unaccounted for. One of the brackets unaccounted for was observed in the down-hole video still wedged in the shaft at the 860 level. The original brackets were readily distinguishable since they were equipped to hold all three aggregate pipes. The new brackets only held the center pipe. The two original brackets recovered were labeled by investigators as OB1 and OB2 (photo 29). They were 4-inch by 8-inch rectangular tubes measuring 75.75 inches long. The new bracket was labeled as NB1.

Photo 29 – Two original brackets (OB1 and OB2) at evidence yard.

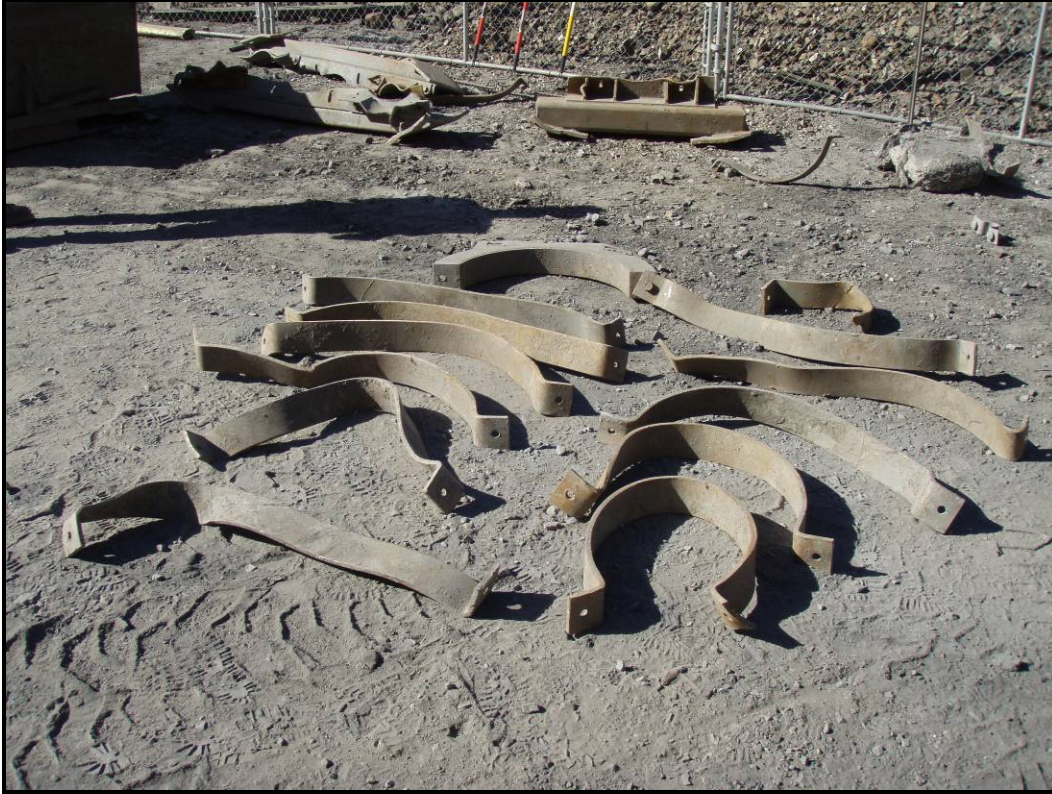
Thirteen single clamps (straps) and 2 bearing clamps were found in the debris, of which one bearing strap was still attached to the clamp bracket (photos 31 and 32). The straps were  $\frac{1}{2}$ -inch thick. One of the single straps was torn. The downhole video showed that 20 straps should have been in the debris. Fifteen were accounted for and five are missing.

Photo 31 – Single clamps at evidence yard, one of which still attached to a clamp bracket.

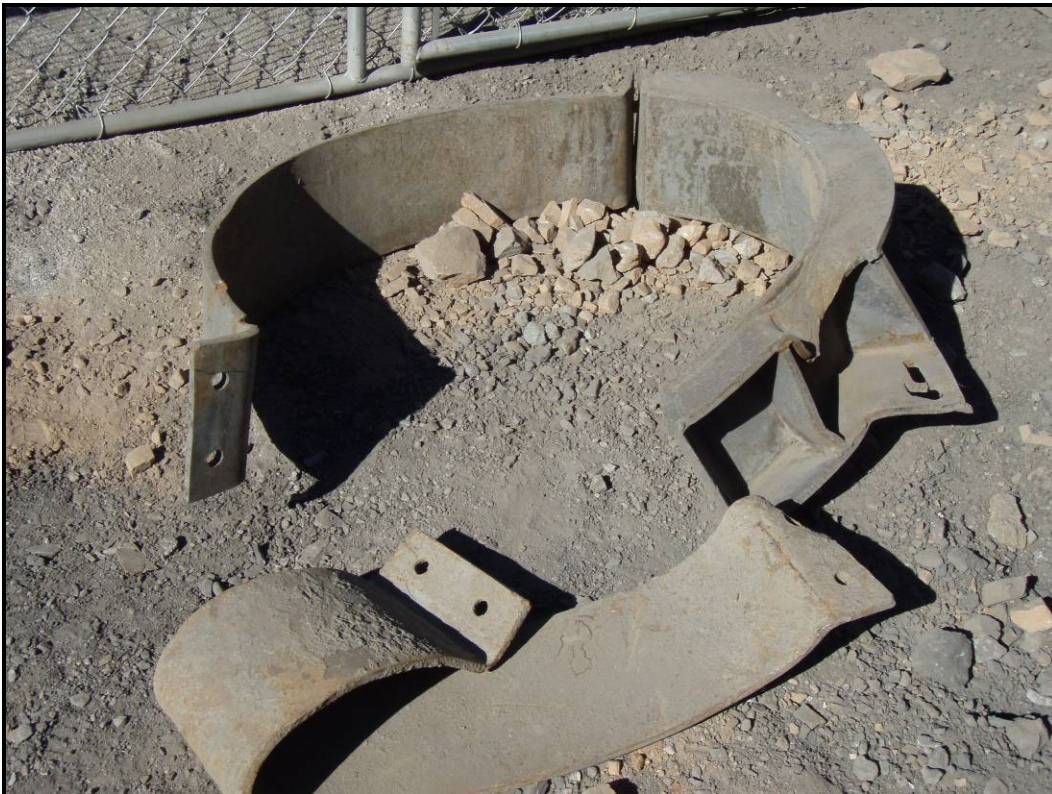
Photo 32 – Two bearing clamps at evidence yard, one of which still attached to clamp bracket.

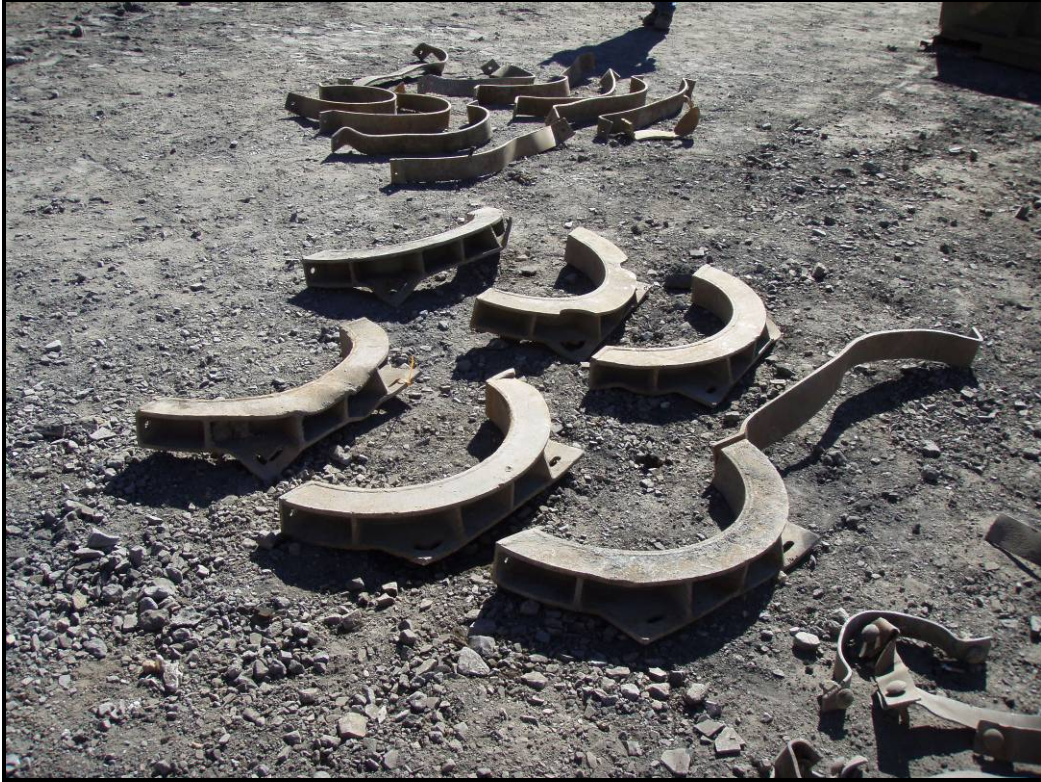
Six clamp brackets were found for the single clamps and one clamp bracket was found for a double bolt bearing clamp (photos 33 and 34). Both bolts in the end of the bearing strap still attached to the clamp bracket were A325. Of the clamp brackets found, four of them had oversized, burned out slots to accommodate poor fit-up in the shaft. The worst example of oversized holes was on the recovered piece labeled CB-2. The holes were so oversized that a bolt head would fit through the hole. A large washer would have been necessary for these holes to prevent pull-through. The slots were used to bolt (i.e., tie down) the clamp brackets to the brackets.

Photo 33 – Recovered clamp brackets at evidence yard.

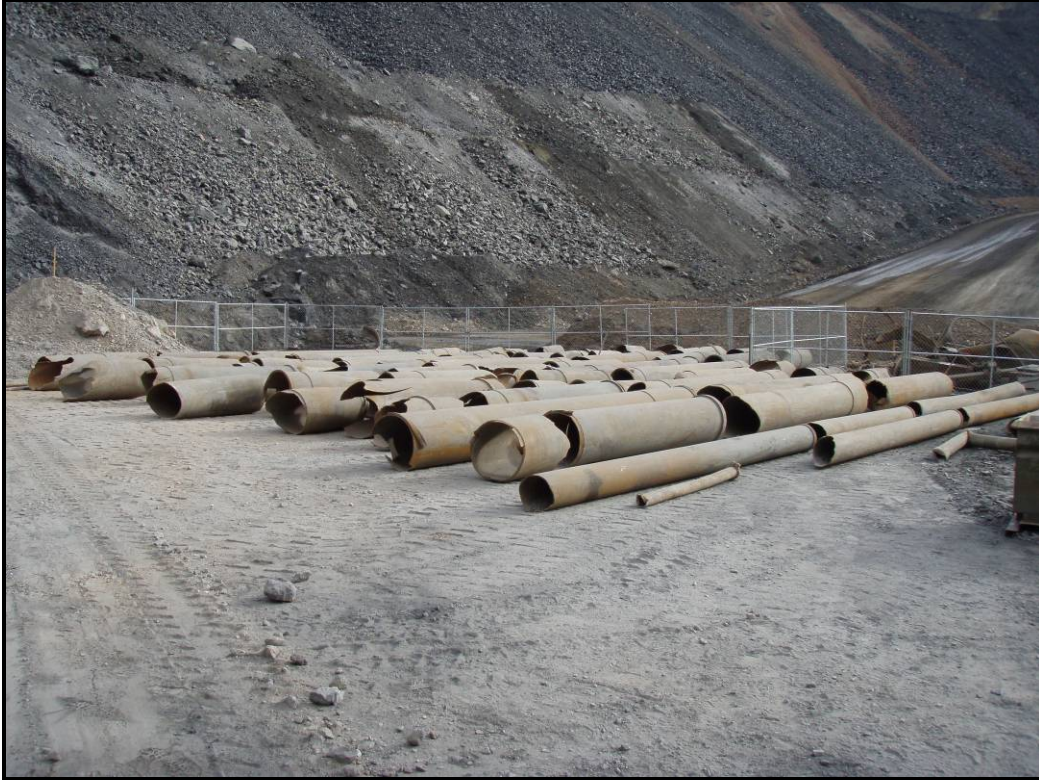
As a rough approximation, the cumulative length of the 72 pieces of the semi-intact 24-inch diameter pipe sections in the evidence yard was calculated to be 616 feet (photo 35). The total pipe length should have been 838 feet. Except for the three pieces, approximately 20 feet long, and still hung up at the 860 level, investigators could not account for 162 feet of pipe. The inherent brittleness of pipe and the tremendous energy involved with the impact of the pipes on the shaft sets, top of the conveyance, and debris at the shaft bottom caused the pipe to shatter into small shards. The multitudes of small shards in the evidence yard were the remnants of the missing 162-foot-length of pipe (photo 36).

Photo 35 – Recovered 24-inch-diameter partial pipe spools at evidence yard.

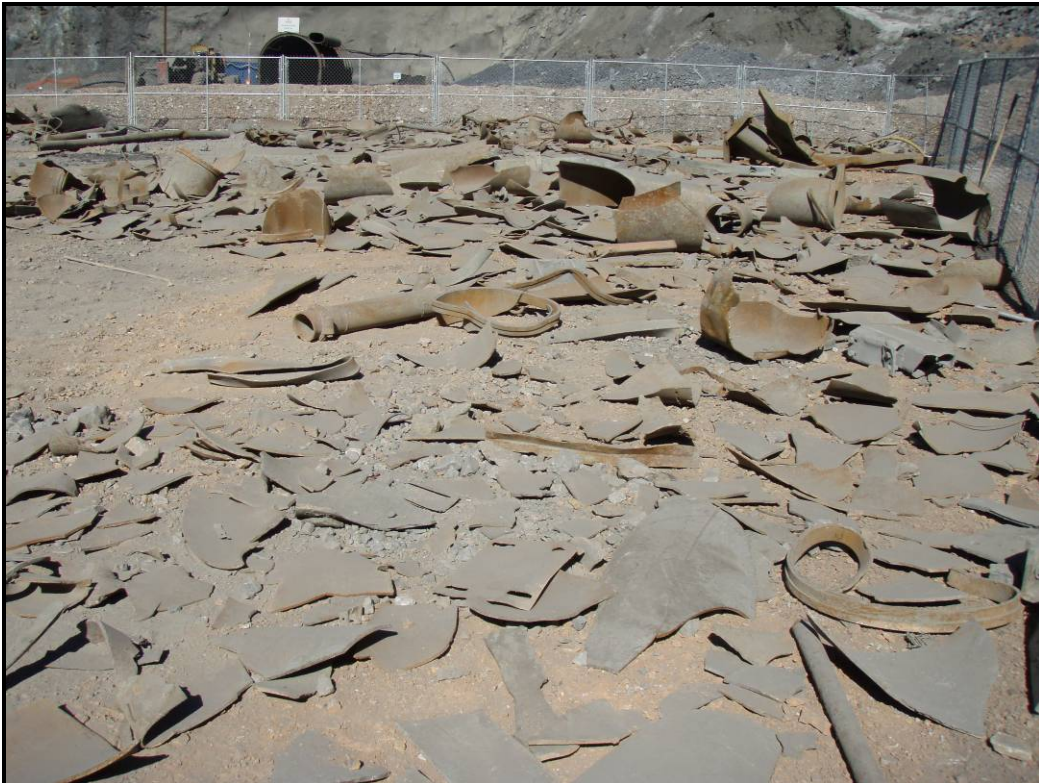
Photo 36 – Pipe shards from 24-inch-diameter aggregate pipe at evidence yard
