Motorcoach Roadway Departure
and Overturn on Interstate 95
Near Doswell, Virginia
May 31, 2011

NTSB/HAR-12/02
PB2012-916202

Highway Accident Report

Abstract: On Tuesday, May 31, 2011, approximately 4:55 a.m. eastern daylight time, a 2000 Setra 59-passenger motorcoach operated by Sky Express, Inc., occupied by a driver and 58 passengers, was traveling north on Interstate 95 in the right lane of the three northbound lanes near Doswell, Virginia. The motorcoach drifted from the highway to the right, struck a cable barrier, rotated counterclockwise around its vertical axis, overturned to the right, and rolled onto its roof. As a result of the accident, 4 of the 58 passengers were killed, 14 received serious injuries, and 35 received minor injuries. The driver sustained minor injuries and refused medical treatment.

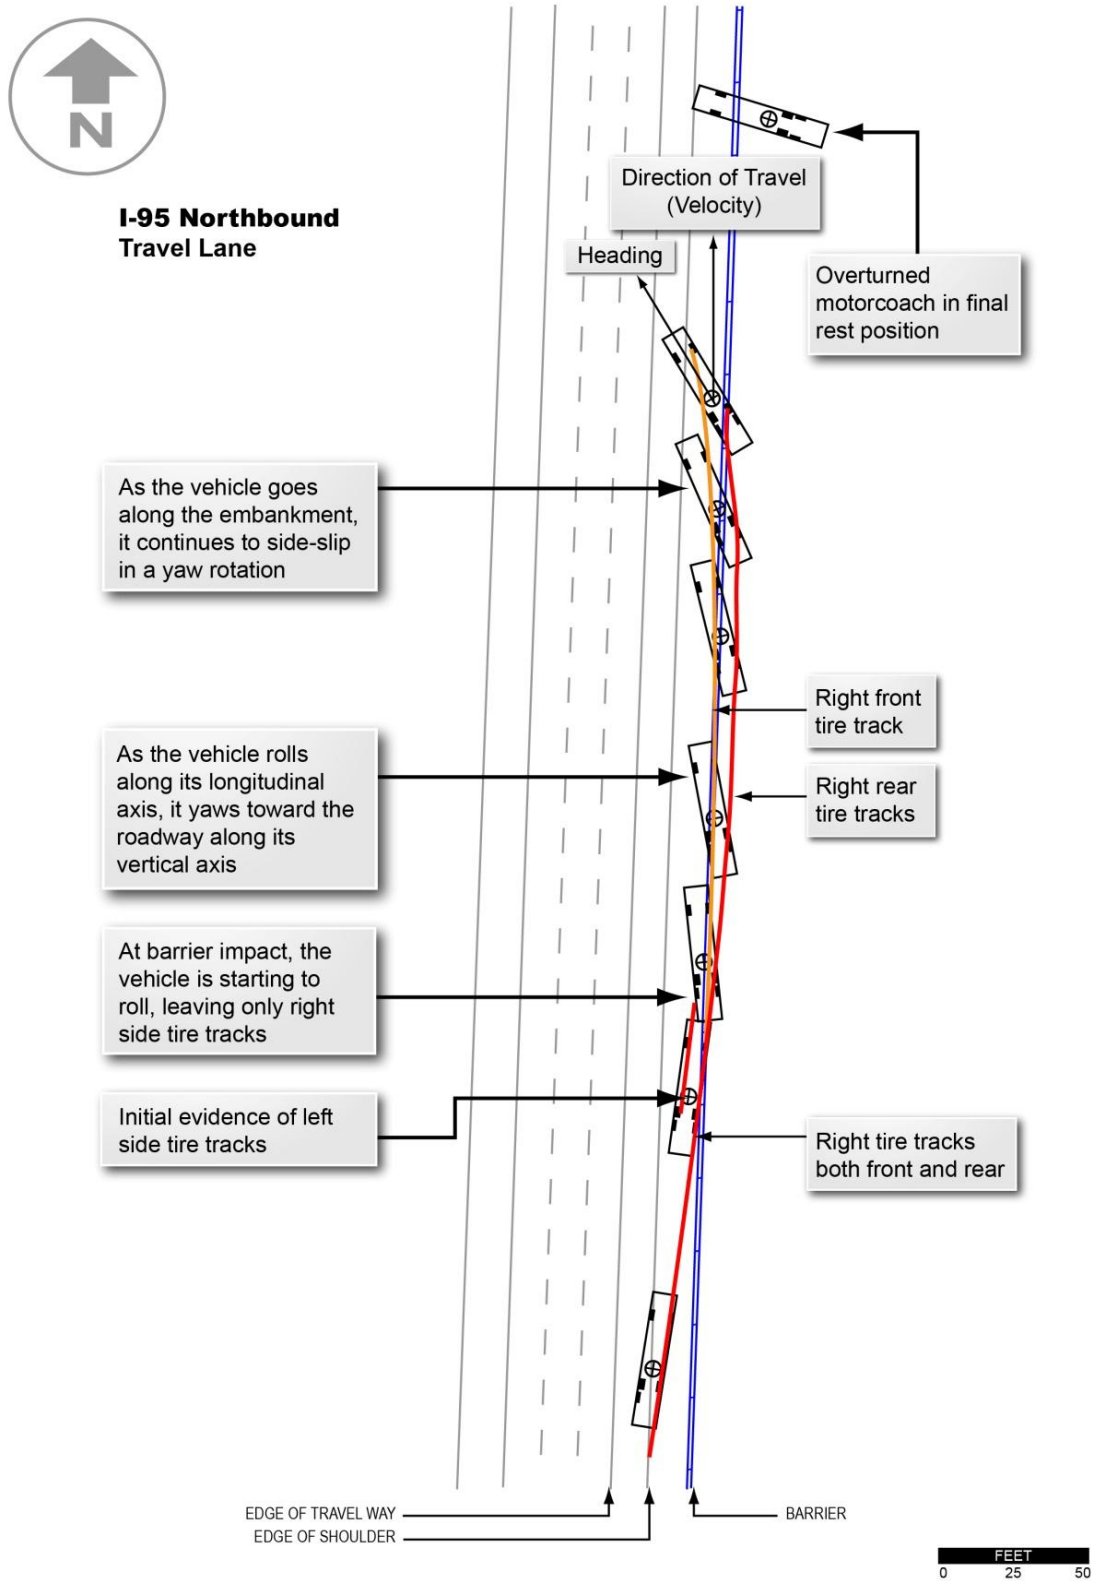
The motorcoach's impact with the low-tension cable barrier system caused a 6-foot cable deflection and displaced 21 cable posts. The maximum cable deflection occurred 273 feet from the location at which the motorcoach drifted from the road. Based on the ground scar evidence, investigators believe that, after striking the barrier, the motorcoach traveled several feet along the barrier while rotating counterclockwise (so its front was turning back toward the road) before overturning onto its passenger side, sliding, overturning onto its roof, and coming to final rest on its roof about 460 feet from where it left the roadway. (See figures 1, 2, and 3.)

Figure 2. Accident scene diagram.

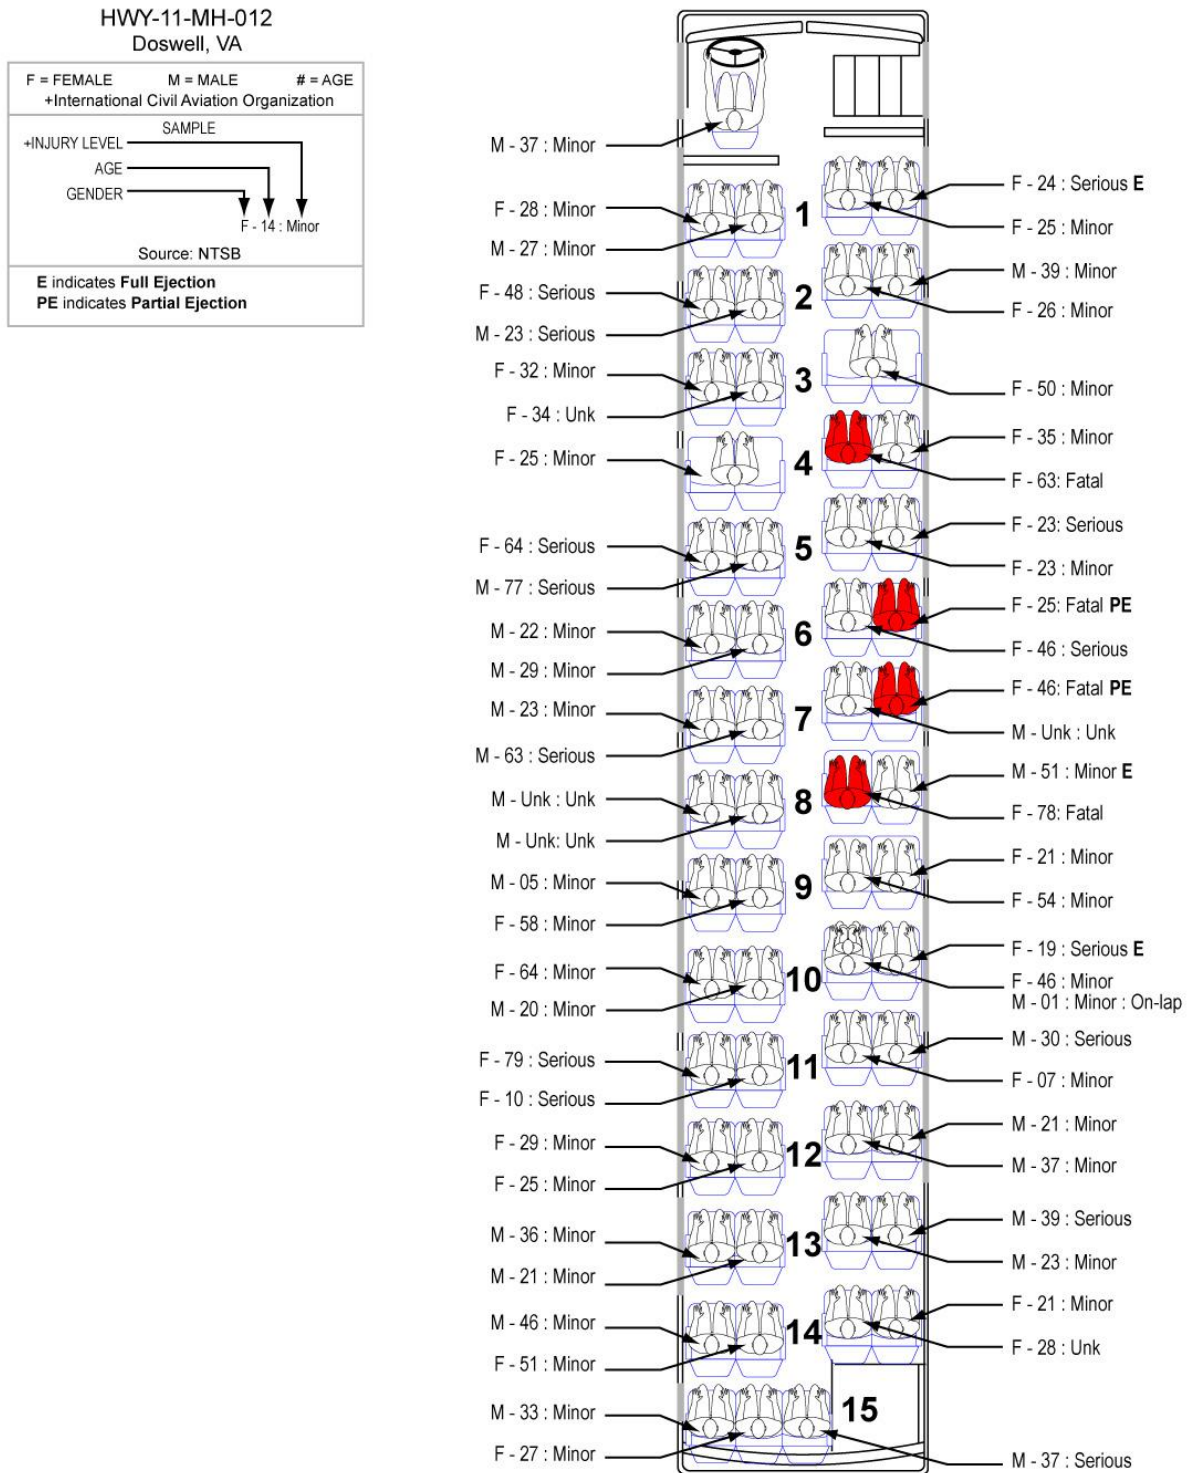
Figure 4 shows the seating locations of the motorcoach occupants, their level of injury, and their ejection status. Images of passengers who received fatal injuries are shaded, and those of passengers partially or fully ejected are indicated by callouts ending with “PE” or “E.”

Figure 4. Motorcoach occupant diagram, showing seating location, injury, and ejection information.

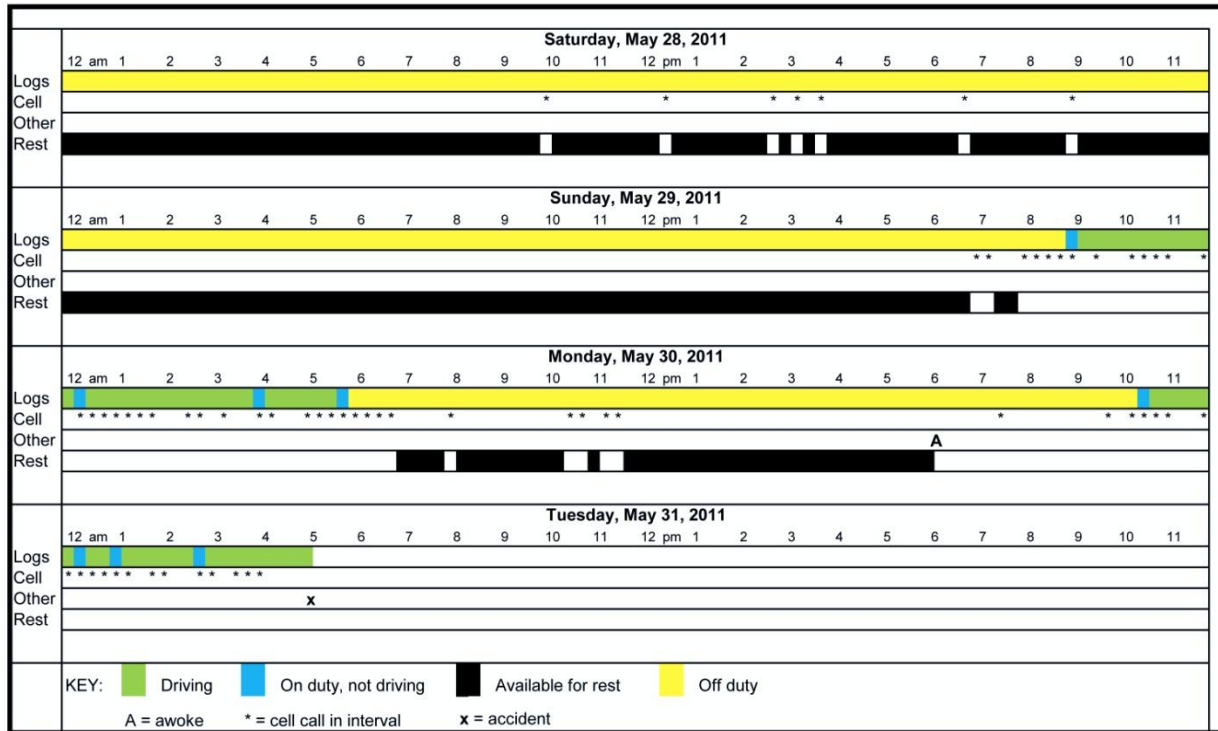
The driver’s cell phone records showed that, from 10:15 p.m. on May 30 until the time of the accident, he made or received 21 calls. Eighteen calls occurred that night during the timeframe when the logbook recorded his duty status as “driving,” with the last call occurring at 3:46 a.m., about 1 hour 11 minutes before the accident. (See figure 10 for more information on the driver’s work/sleep/wake history. The figure indicates calls made or received in any 15-minute interval.)

Figure 10. Motorcoach driver’s work/sleep/wake history. (Note: Investigators were unable to interview the driver or his wife. Activities preceding the accident were generated using the driver’s logbook, his statements to FMCSA investigators and the VSP, and his cellular provider’s records.)
