# HIGHWAY ACCIDENT REPORT

PROPANE TRACTOR-SEMITRAILER  
OVERTURN AND FIRE

U.S. Route 501,  
LYNCHBURG, VIRGINIA  
March 9, 1972

**Report Number: NTSB-HAR-73-3**

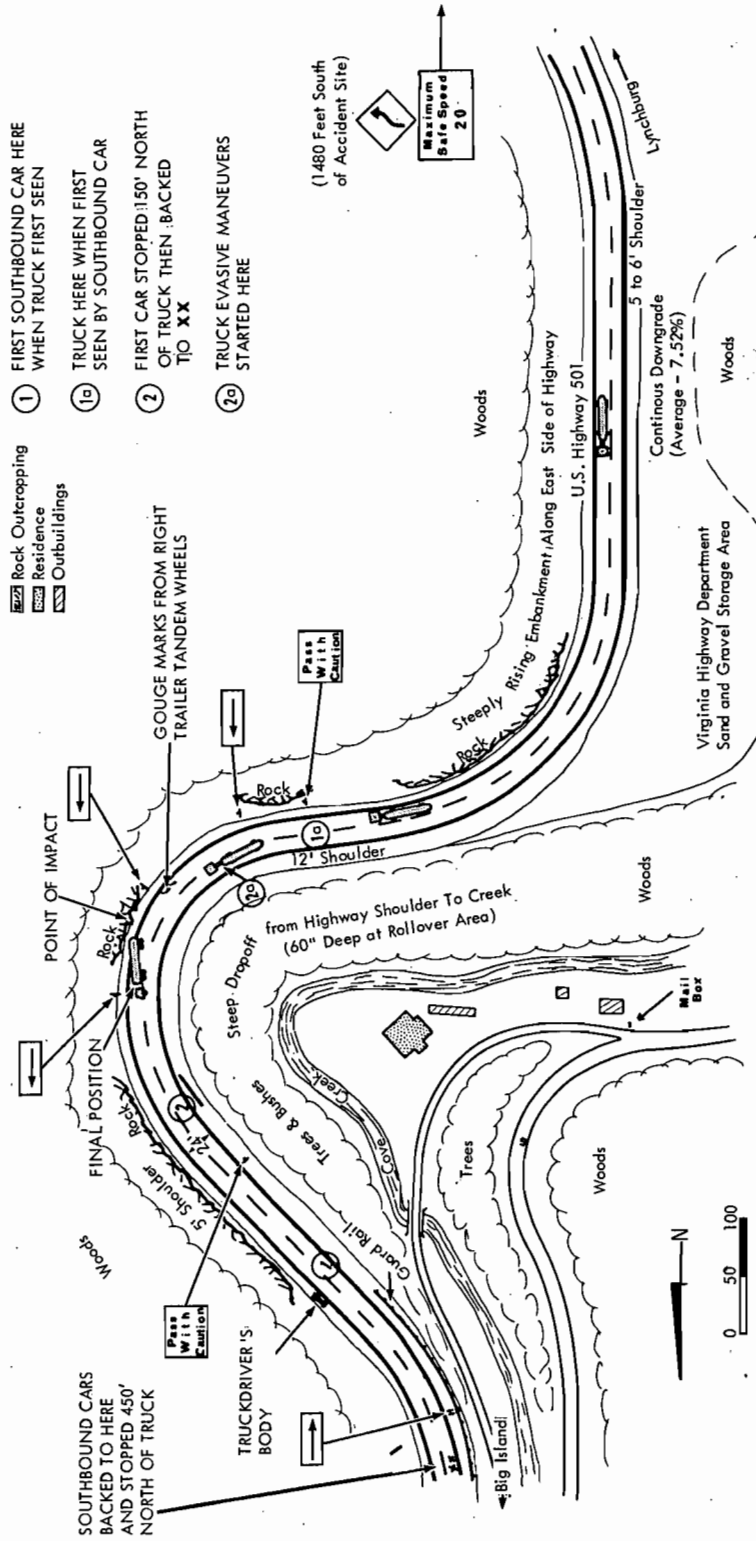
Figure 1. Accident site.

about 184 feet. Seeing a southbound automobile approaching beyond the curve, the truckdriver steered back to the right in order to return to his own side of the road and then to the left in order to avoid hitting the embankment. As he steered left, the left-rear trailer tandem tires lifed off the road and the truck rolled onto its right side. (See Figures 1 and 2.)

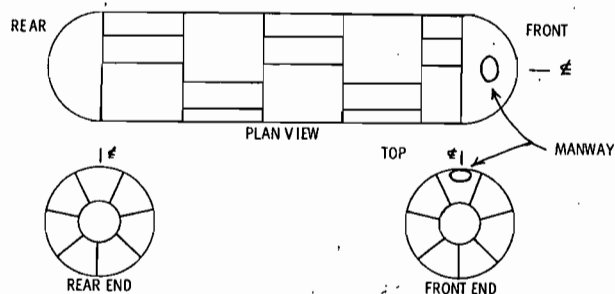
The single-compartment pressure vessel had a cylindrical body with hemispherical heads and was equipped with three equally spaced transverse baffles. The 0.387-inch-thick shell material was fabricated in sections and welded together. The 0.250-inch-thick hemispherical head material was fabricated in "orange peel" fashion of formed plates welded together. The trailer was equipped with a single 15.25-inch-diameter manway opening mounted in the upper top quadrant of the front hemispherical head. (See Figure 5.) The manway opening was reinforced with a 20-inch-diameter, 1.5-inch-thick steel ring welded into the head material. This ring was drilled and tapped to receive twenty-four 0.625-inch-diameter studs to secure the 20-inch-diameter, 1.125-inch-thick manway cover and seal.

**Figure 5. Schematic diagram of MC 331 pressure vessel, serial number 57178, showing relative location of tank sheets and manway.**
