HIGHWAY ACCIDENT REPORT

HOPPY'S OIL SERVICE, INC.,
TRUCK OVERTURN AND FIRE,
STATE ROUTE 128,
BRAintree, MASSACHUSETTS

OCTOBER 18, 1973

NATIONAL TRANSPORTATION SAFETY BOARD
Washington, D.C. 20591
REPORT NUMBER: NTSB-HAR-74-4

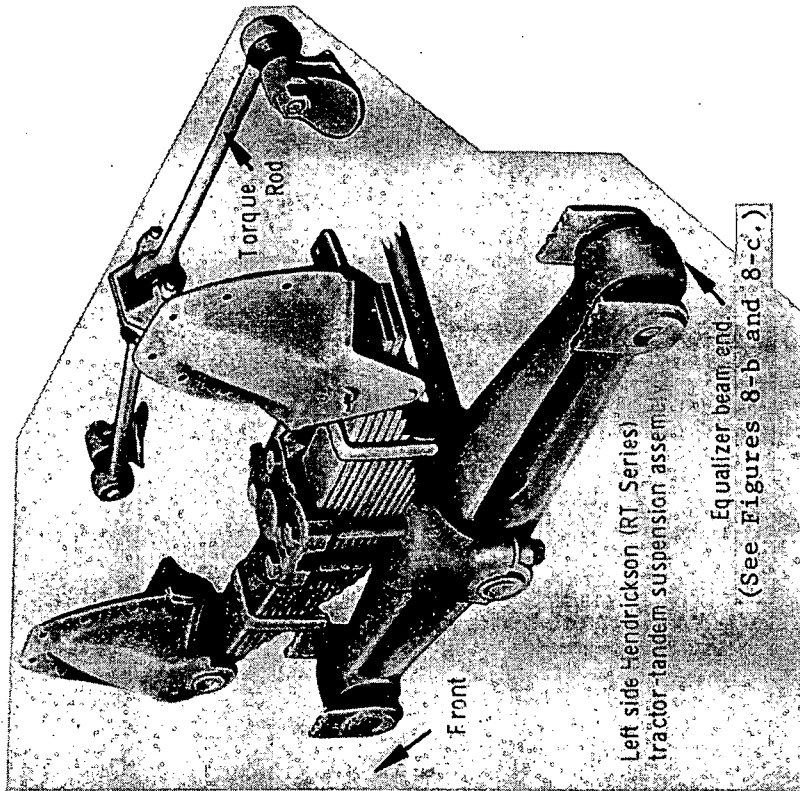
c. "A" - Cutting torch induced cavities.
(Insert from Figure 8-b.)

Figure 6. Failure due to use of cutting torch to remove bushings and sleeves from equalizer beam.

a local machine shop. He stated that the equalizer beams had been removed from the tractor tandem suspension and taken to German with the worn bushings still in the beams and that he did not remove the bushings.

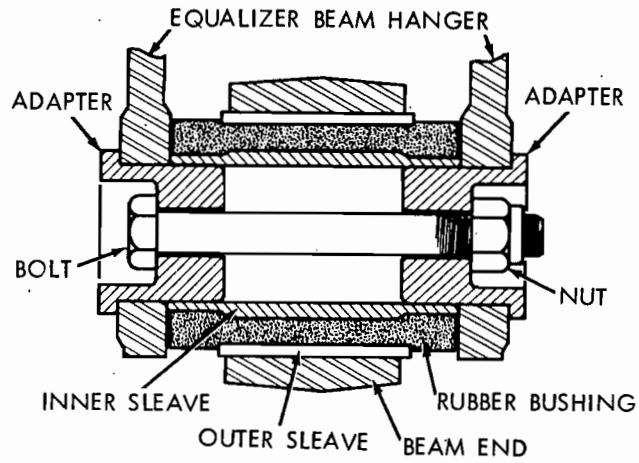
a. SECTIONAL VIEW OF BOLT TYPE EQUALIZER BEAM END MOUNTING.

Figure 8. Equalizer beam end assembly components.
