**Motorcoach Run-Off-The-Road Accident
Tallulah, Louisiana
October 13, 2003**

Highway Accident Report

NTSB/HAR-05/01

**NTSB/HAR-05/01
PB2005-916201
Notation 7711
Adopted April 19, 2005**

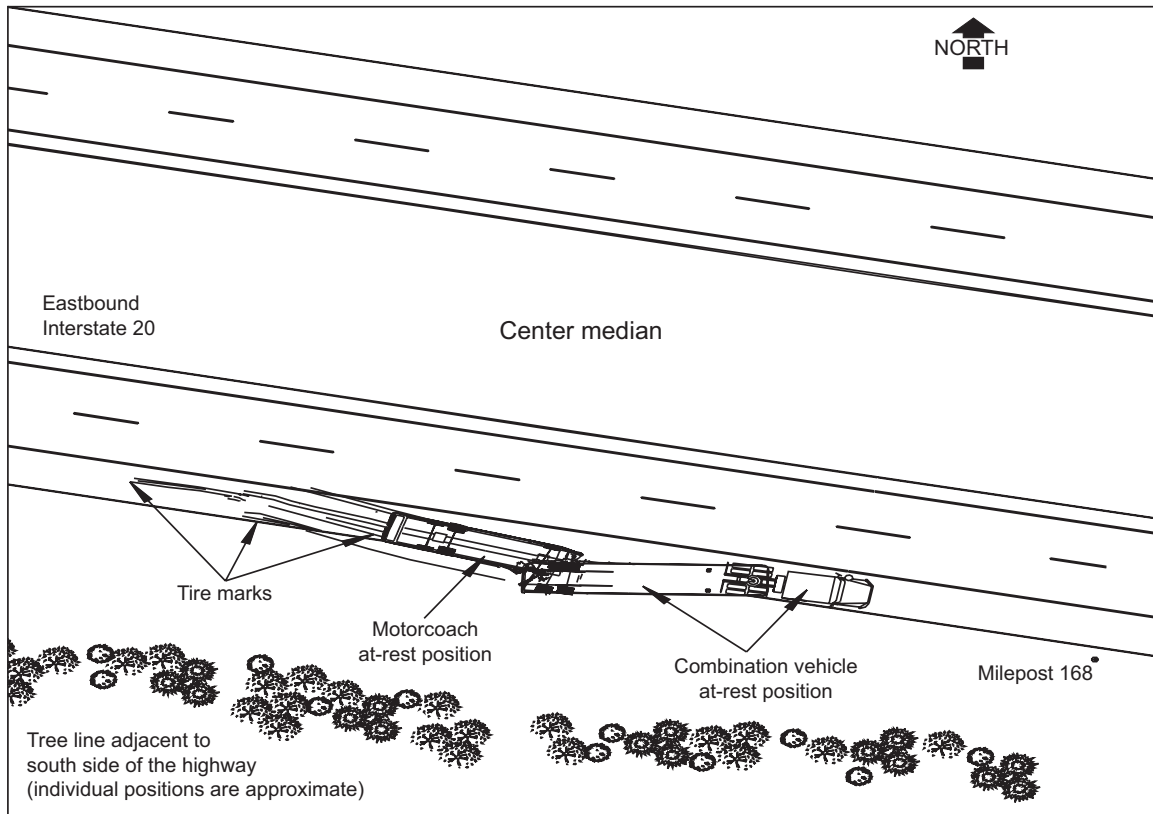
Figure 4. Accident site

The motorcoach traveled about 103 feet on the shoulder and then collided with the back of the semitrailer at milepost 167.9 while traveling at a speed between 60 and 65 mph.⁷ Postaccident inspection of the accident scene revealed no evidence of braking or steering by the motorcoach driver. When the collision occurred, the motorcoach’s right front tire was about 5 feet to the right of the white edgeline on the shoulder, and the right drive and tag axle tires were also on the shoulder. All the left-side tires were still within the right traffic lane. At impact, the front of the motorcoach was aligned so that the center of the vehicle made contact with the left rear corner of the combination vehicle’s semitrailer. As both vehicles moved forward, the motorcoach rotated clockwise slightly, and the semitrailer rotated counter-clockwise slightly; the vehicles remained together. They traveled approximately 62 feet and came to rest, still oriented to the east, adjacent to the right side of the interstate on the outside shoulder. (See figures 4 and 5.) The semitrailer’s tractor was on the shoulder, but the rear of the semitrailer had been pushed slightly into the grassy right-of-way to the right of the shoulder pavement.

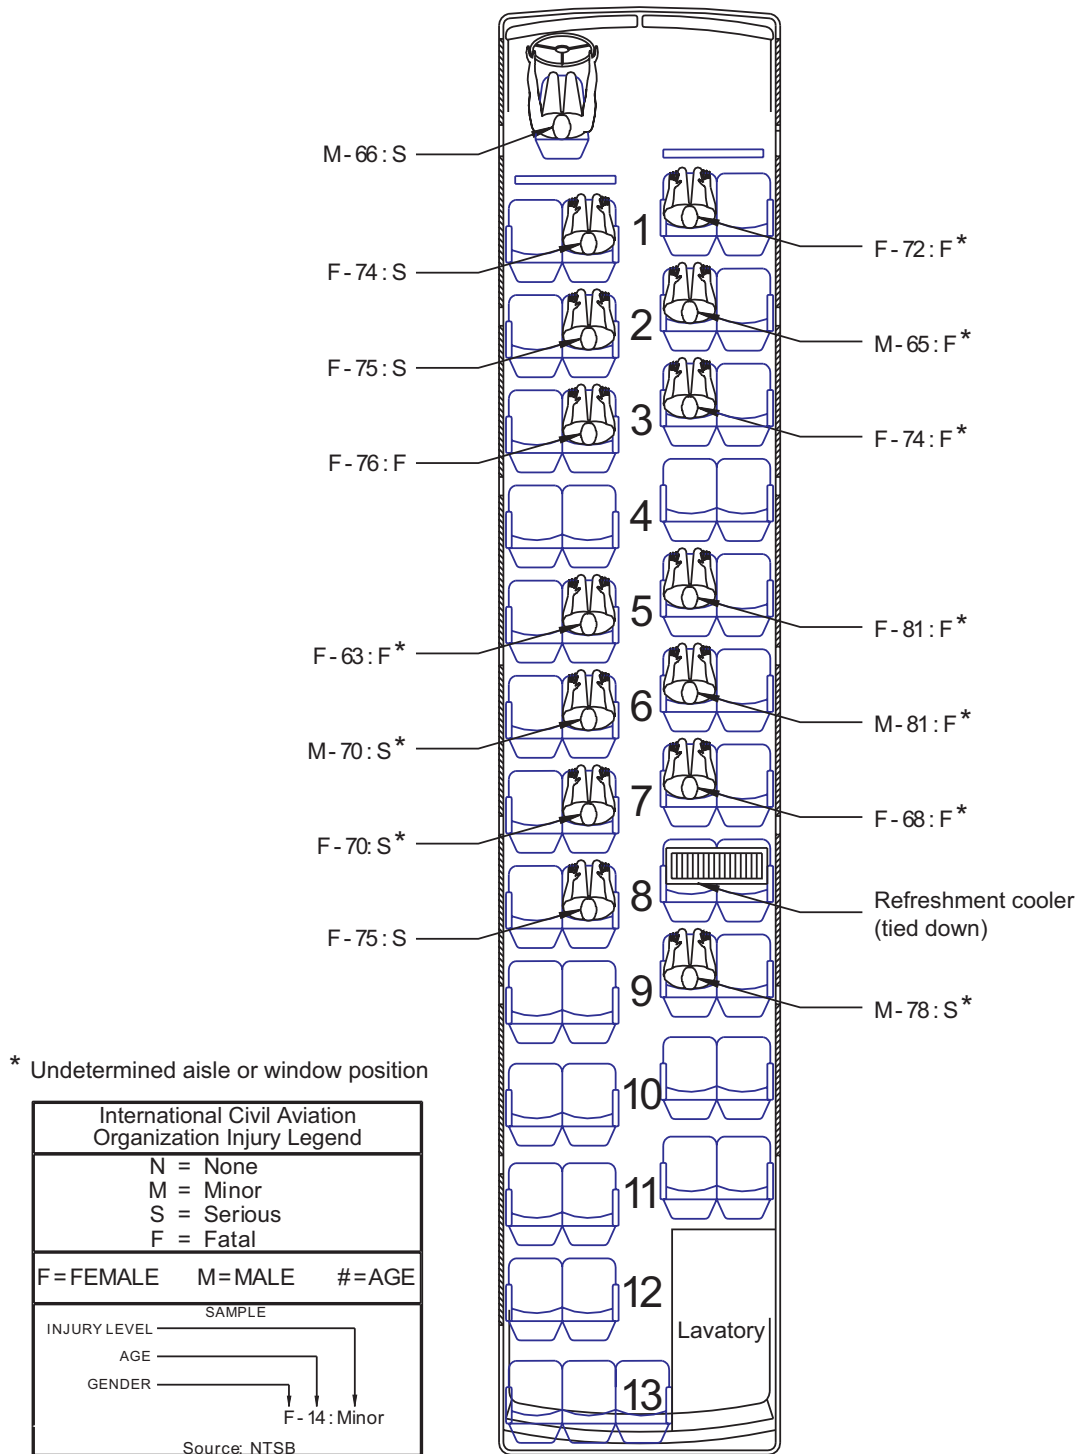
Figure 6. Accident motorcoach passenger seating chart.

The eight passengers who sustained fatal injuries were reportedly found trapped between seats by emergency responders; they received serious injuries to the head, upper torso, internal organs, and extremities. These passengers were seated in rows 1, 2, 3, 5, 6, and 7 on the passenger side and rows 3 and 5 on the driver side. (See figure 6.) The six seriously injured passengers sustained blunt trauma to the head, upper torso, and extremities. Emergency responders reportedly found all six trapped between seats or in the aisle of the accident motorcoach forward of their precrash seating positions. The driver was the only restrained⁸ occupant of the motorcoach, and he sustained serious injury to the left shoulder and lower right leg.
