Arizona-Southern California Outages on September 8, 2011

Causes and Recommendations

Prepared by the Staffs of the
Federal Energy Regulatory Commission
and the
North American Electric Reliability Corporation

April 2012

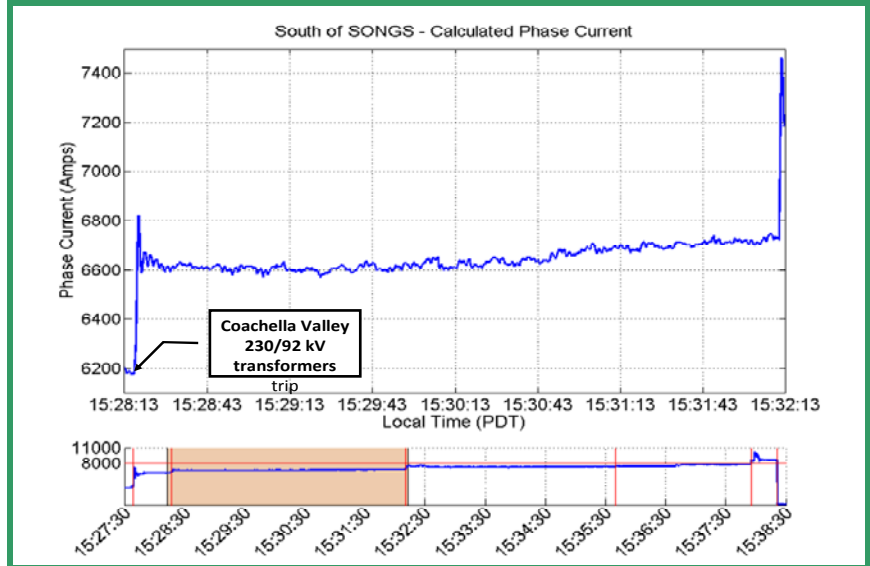
South of SONGS – Calculated Phase Current

15:28:17 – Two Coachella Valley 230/92 kV transformers and the Coachella Valley Ramon 230 kV “KS” line tripped. (030)

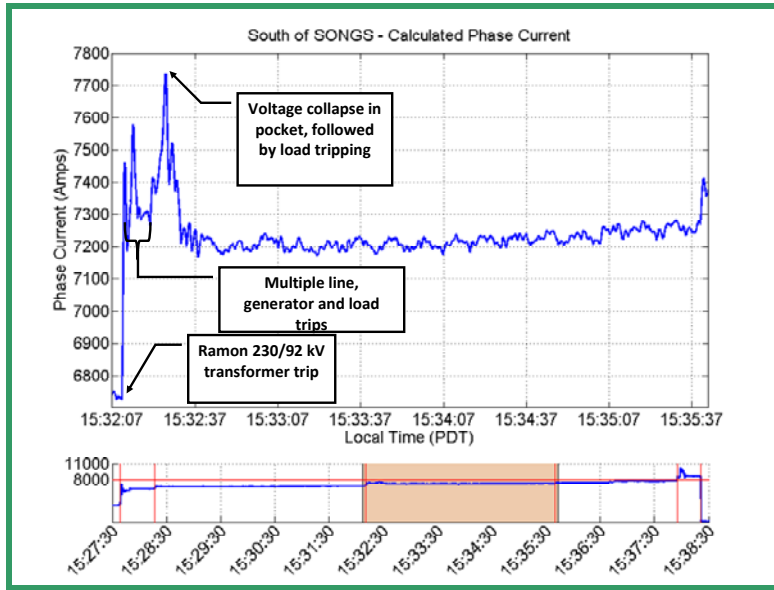
South of SONGS – Calculated Phase Current

Time: 15:32:10 – The Ramon 230/92 kV transformer tripped and IID shed 444 MW of load. (110)

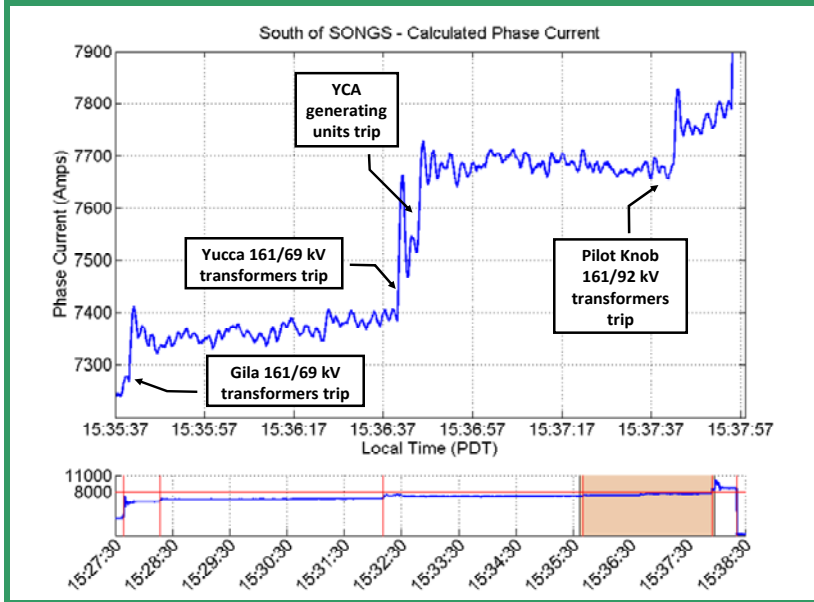
South of SONGS – Calculated Phase Current

Time: 15:35:31 – Yuma Cogen (YCA) tripped. (180)

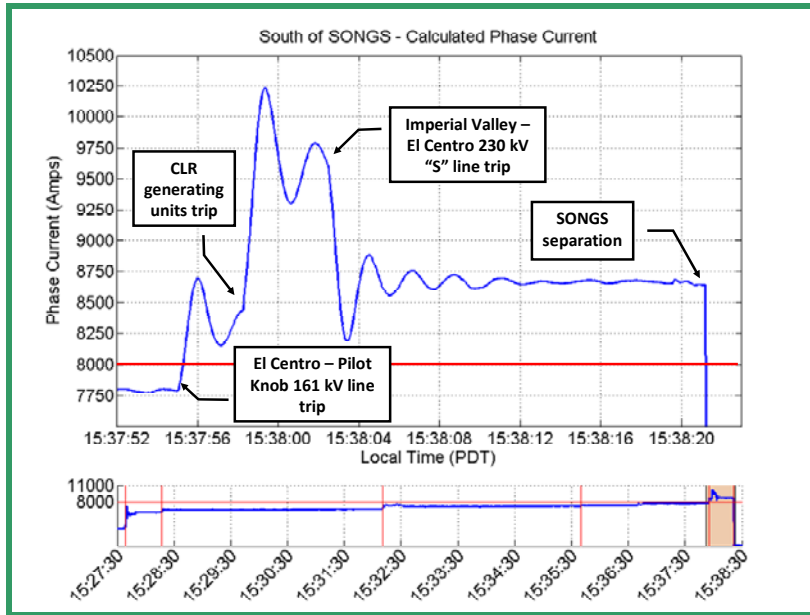
South of SONGS – Calculated Phase Current

Time: 15:37:55 – The El Centro-Pilot Knob 161 kV line tripped. (230)

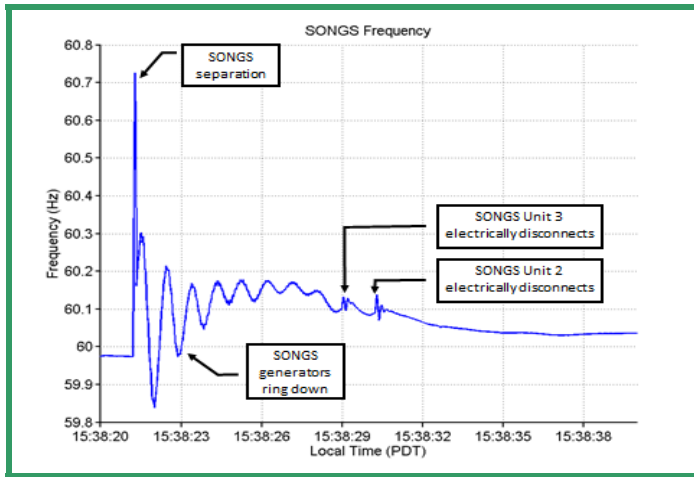
Figure 12 : Frequency Excursion in WECC Interconnection Immediately after the SONGS

shut down, at 15:38:30.209, SONGS Unit 2 electrically disconnected from the system. Loss of the 2,300 MW of SONGS' generation effectively reduced the loss of load for the main body of the Western Interconnection from a 3,400 MW loss to a net 1,100 MW load loss. This made the recovery from the resulting overfrequency event much easier. The SONGS generators did not lose offsite power because the SONGS switchyard was still connected to the SCE system.

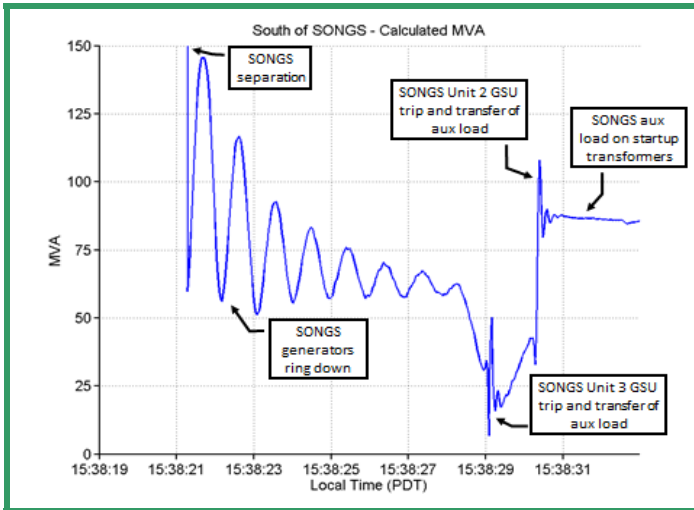
Figure 13: SONGS Generation Trips and Auxiliary Loads Transfer to 230 kV Bus

Although the SONGS generators remained connected to the SCE side of the switchyard at SONGS, at about 15:38:27.5, or approximately six seconds after the SONGS separation scheme initiated, the SONGS turbines both experienced a brief acceleration in speed and tripped due to turbine control logic. At the same time, local system frequency at SONGS was observed to spike from 59.974 Hz to 61.203 Hz. After the initial impulse caused by the system separation, the frequency in the main body of the Western Interconnection peaked near 60.170 Hz. This can be seen on Figures 12 and 13, on the next page. The turbine trip initiated a reactor shutdown, and the units began coasting down. A little more than a second later, at 15:38:28.963, SONGS Unit 3 electrically disconnected from the system, and less than three seconds after the reactors
