**Fire On Board U.S. Small Passenger Vessel  
*Express Shuttle II*  
Pithlachascotee River Near Port Richey, Florida  
October 17, 2004**

**Marine Accident Report**

**NTSB/MAR-06/02**

The National Transportation Safety Board determines that the probable cause of the fire on board the *Express Shuttle II* was a fractured, improperly installed fuel injection line on the inboard side of the starboard engine that allowed diesel fuel to spray onto the engine and ignite. Contributing to the cause of the fire was the failure of Paradise of Port Richey to have a preventive maintenance program, which could have identified the company's ongoing problem with the vessel's fuel lines before a failed line led to the fire. Contributing to the extent of the damage were the vessel's faulty fire detection system and the crew's failure to employ proper marine firefighting techniques.

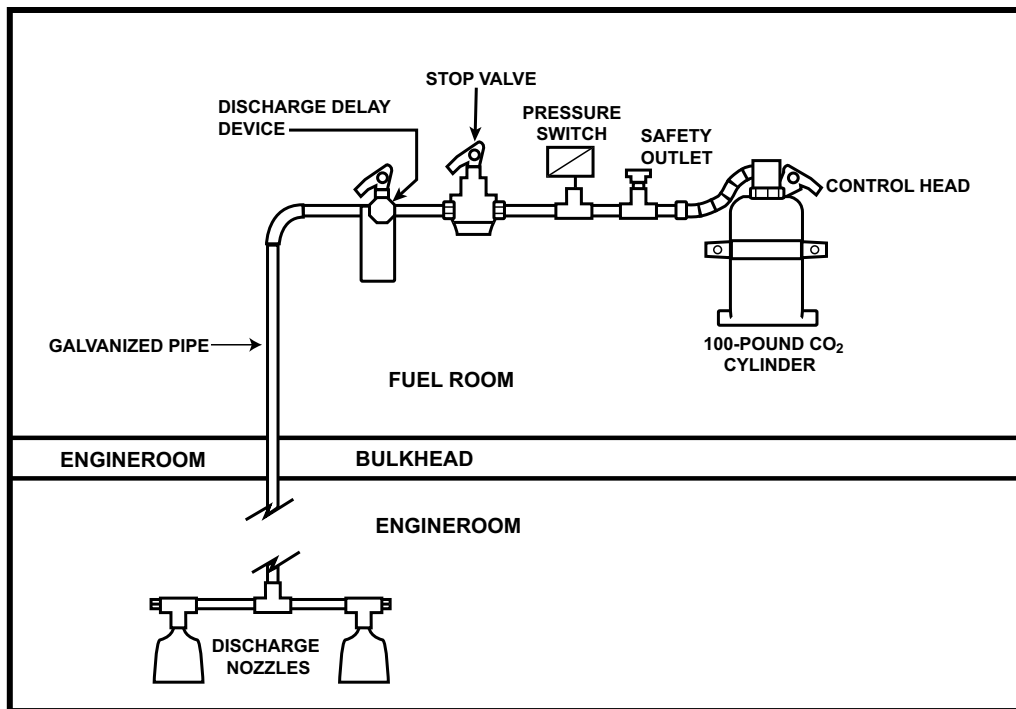
The fire suppression system (figure 6) in the engineroom of the *Express Shuttle II* was a custom-engineered, manually operated CO<sub>2</sub> system installed when the vessel was built. According to original drawings in the files of the Coast Guard Marine Safety Office (MSO) in Tampa, the MSO in Portland, Maine, approved the design of the *Express Shuttle II*'s fire suppression system. All components of the fire suppression system were below the main deck and could be accessed only through one of the hatches. A 100-pound cylinder of CO<sub>2</sub> gas was located in the fuel room, forward of the fuel tanks. The system was equipped with a safety outlet that would release gas if excess pressure built up inside the cylinder at any time. Galvanized piping ran about 10 feet from the gas cylinder through the engineroom bulkhead to two nozzles in the engineroom. One nozzle was directed toward each engine.

**Figure 6.** Components of *Express Shuttle II*'s fixed fire suppression system. CO<sub>2</sub> gas could be discharged by releasing the control-head lever on the cylinder. The pressure of the gas would activate a pressure switch that would close the air vents in the engineroom and shut down the engines. The gas would then travel through a stop valve and on to a discharge-delay device, which would postpone the release of gas to the engineroom for 30 seconds. Gas could be discharged immediately by releasing the lever on the discharge-delay device.

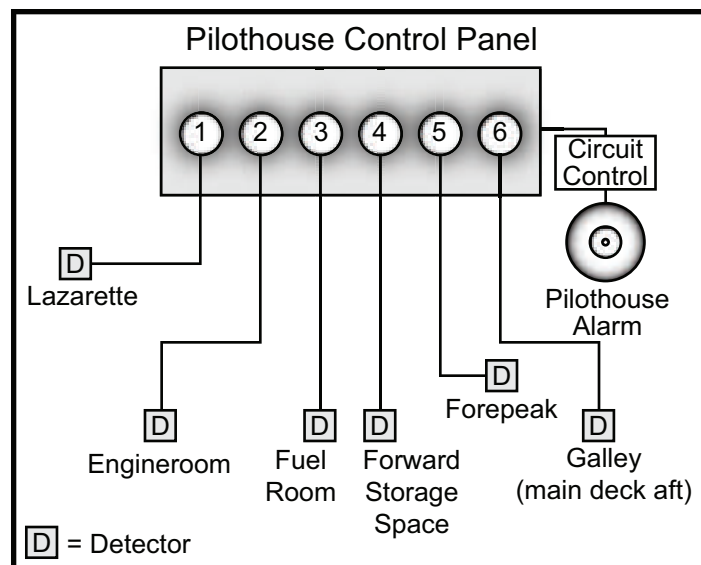
None of the system components—control panel, detectors, wires—was found after the fire, which precluded investigators from reconstructing the system that had been installed in the vessel. Instead, investigators developed a probable system configuration from control panel and wiring diagrams on file at MSO Tampa. Investigators also relied on interviews with the technician who repaired the system 2 weeks before the fire, and with the port captain who had been present at annual Coast Guard inspections of the *Express Shuttle II*.

According to the diagrams, the control panel for the fire detection system was located in the pilothouse, to the right of the wheel. The panel was connected to a 12-volt battery power supply. The connection was protected from overloading by a 10-amp fuse fitted onto the 12-volt power supply wire directly below the alarm panel. The control panel contained an indicator light for each of the six fire detection zones on the vessel: (1) lazarette (aftmost hull compartment), (2) engine room, (3) fuel room, (4) forward storage space, (5) forepeak, and (6) galley (figure 7). The galley was a space at the rear of the passenger cabin on the main deck where soft drinks were served.

**Figure 7.** Schematic of *Express Shuttle II*'s fire detection system.

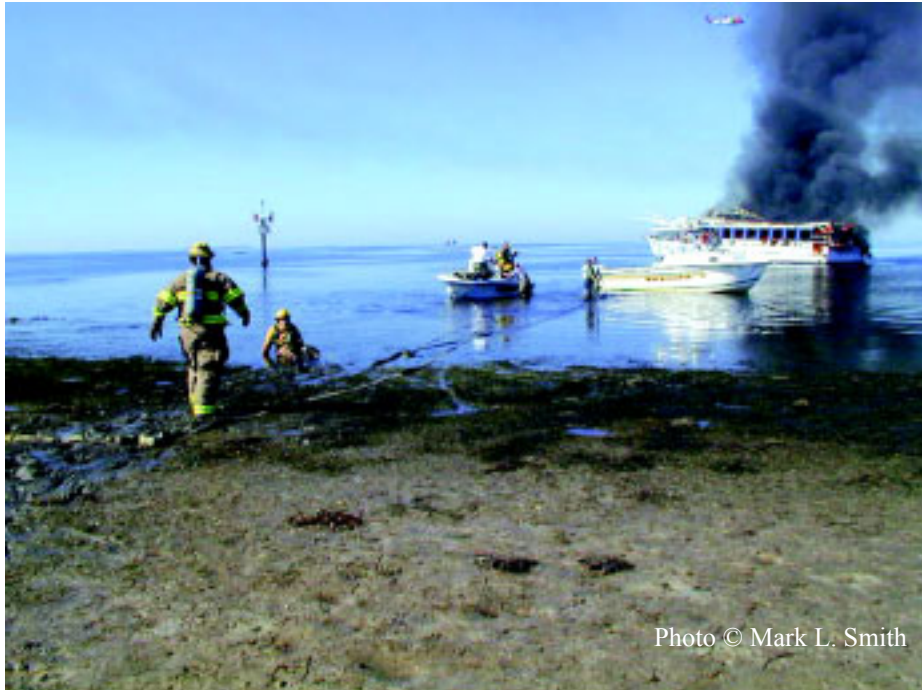
**Figure 15.** Firefighters laid hoses from shore to a Pasco County sheriff's office boat, then walked through mud to a police boat that took them to the sheriff's boat. The sheriff's boat shuttled them and their equipment close enough to the *Express Shuttle II* for them to direct water onto the fire. Later, they fought the fire with foam pumped from the tanks of fire engines on shore.
