**Multiple Vehicle Collision on Interstate 95
Fairfield, Connecticut
January 17, 2003**

Highway Accident Report

NTSB/HAR-05/03

Abstract: On Interstate 95 (I-95) near Fairfield, Connecticut, two consecutive accidents occurred within 11 minutes in the early morning hours of January 17, 2003. At the time of the accidents, light snow was falling, the roads were wet and icy, and snow covered the roadway shoulders. About 4:50 a.m., a 1996 Freightliner tractor flatbed semitrailer was involved in a nonfatal multivehicle accident. The truck was traveling in a work zone on I-95 north, near milepost 26.6, at a driver-estimated speed of 50 mph, when it slid out of control. The vehicle entered the median, overturned and overrode the portable concrete barrier, and collided with a southbound 1997 Dodge Avenger sedan. A southbound 2001 Freightliner tractor/refrigerated trailer combination unit struck the Dodge sedan and then struck the 1996 Freightliner tractor. The three vehicles came to rest blocking the southbound lanes of the highway. During the accident sequence, the flatbed semitrailer separated from the 1996 Freightliner tractor. The semitrailer came to rest perpendicular to the roadway,

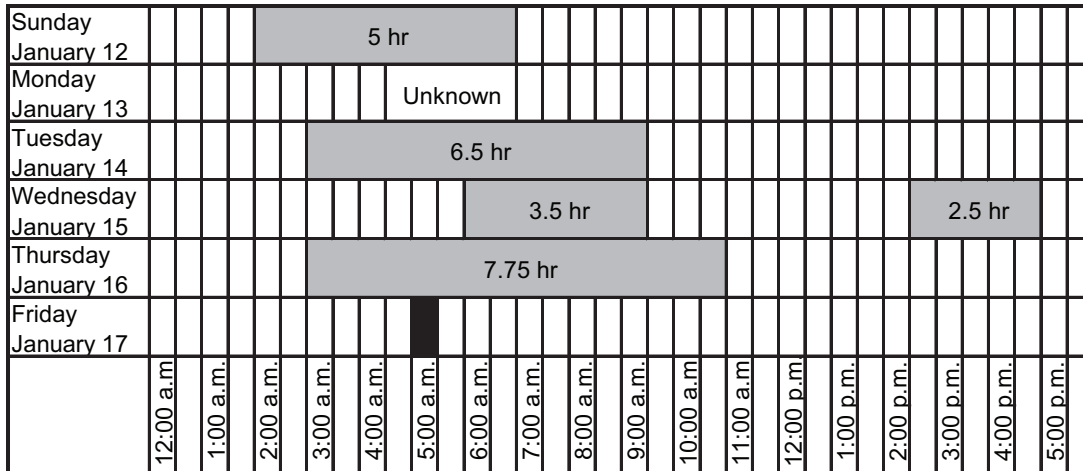
Figure 6. Chevrolet driver sleep pattern prior to accident.

Safety Board investigators reconstructed the activities of the Chevrolet driver during rush week and prior to the accident using information gathered during interviews with the driver's dormitory roommate; the chapter president of Delta Kappa Epsilon; and the driver's friend, also a Yale student. (See table 5.) The driver's sleep/wake pattern was also derived from this information. (See figure 6.)
