EPA/OSHA JOINT CHEMICAL ACCIDENT INVESTIGATION REPORT

Shell Chemical Company Deer Park, Texas

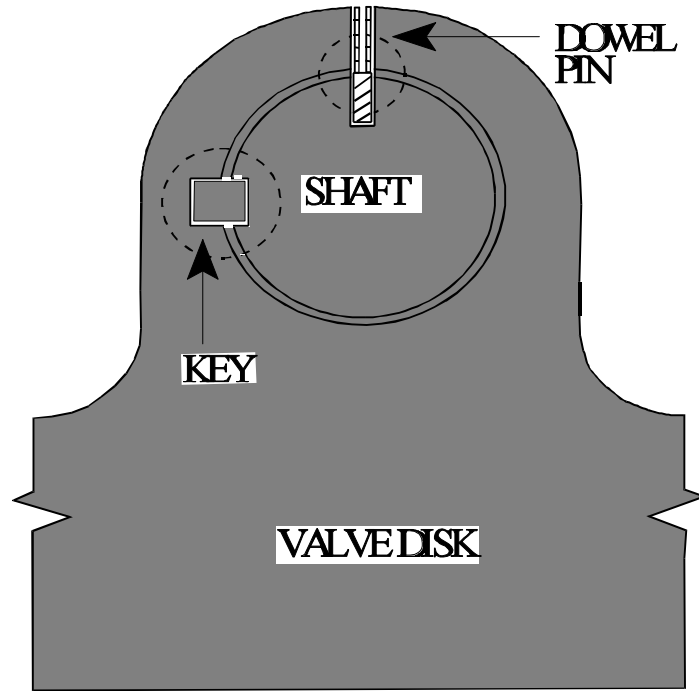
Figure 3: Expanded View of Check Valve Disk/Shaft/Key/Dowel Pin Arrangement

Analysis of sample number 5, the 36-inch diameter Clow Model GMZ check valve (and its internal components), revealed that it had suffered little or no heat damage. Analysis also indicated the following (see Figures 2 and 3 on pages 25-26 for an illustration of the valve):

torque from the drive shaft to the disk fell out of its keyway, disconnecting the drive shaft from the disk. System pressure was high enough to eject the unrestrained drive shaft from the valve, carrying with it the external counterweight assembly, weighing over 200 lbs., a distance of 43 feet away.

The absence of the drive shaft left a hole in the valve body the diameter of the shaft (3.75 inches) directly to atmosphere, and initiated a high-pressure light hydrocarbon leak. The leak continued for approximately 2 to 3 minutes, forming a large cloud of flammable light hydrocarbon vapor. The vapor cloud ignited, resulting in an explosion felt and heard over 10 miles away. The explosion and ensuing fire caused extensive damage to the facility, completely or partially destroying many major components, piping systems, instruments, and electrical systems, and requiring the complete shut-down of the affected unit for cleanup and repair. Minor damage occurred to nearby residences and automobiles (mostly broken glass and minor structural damage due to the blast wave). Nearby highways were closed for several hours. Damage cost to the facility alone is estimated at approximately 90 million dollars. Fortunately, no fatalities and only minor injuries to workers resulted from the accident.

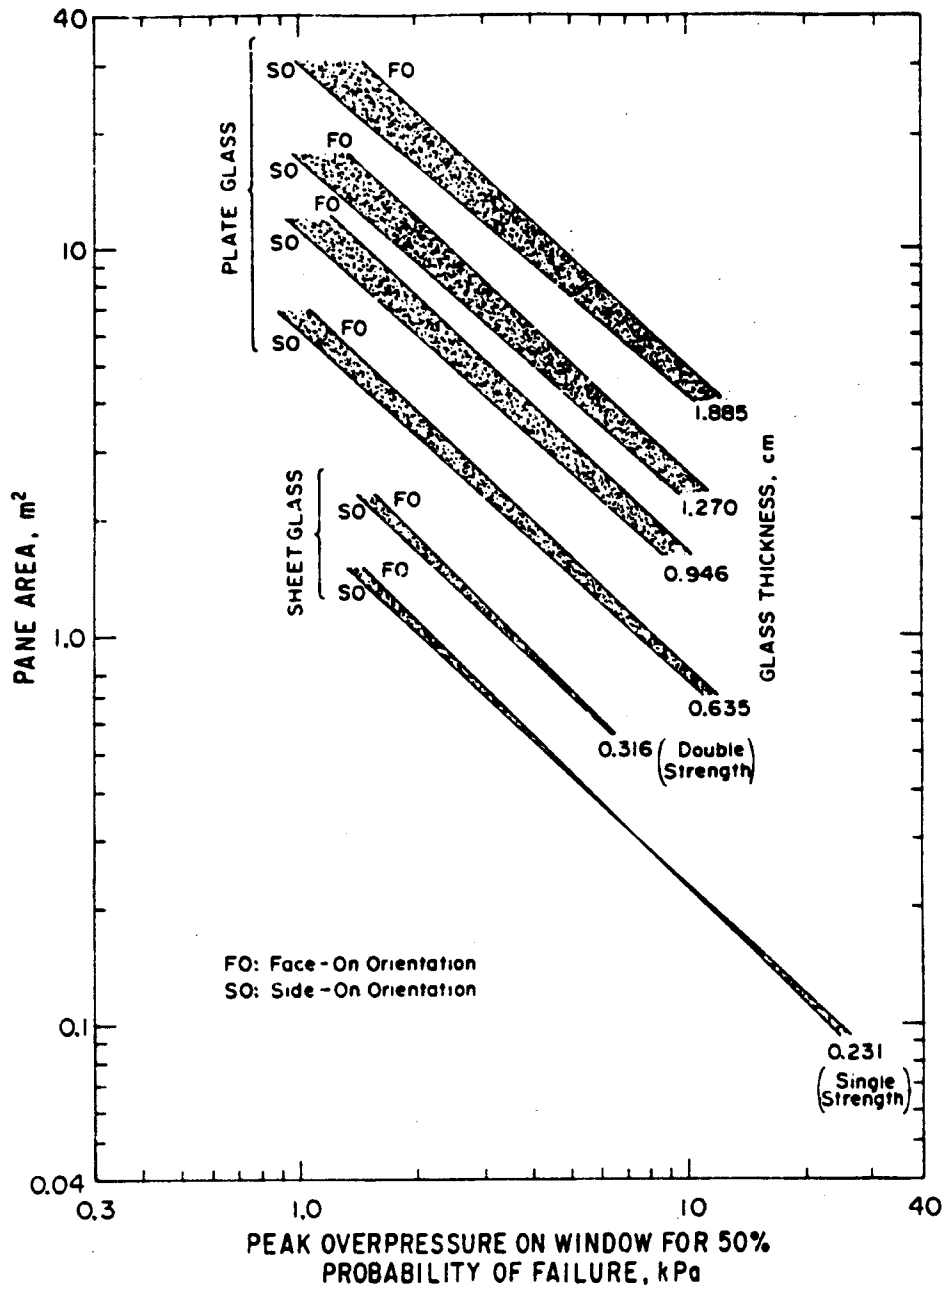
Figure D-1
Peak Blast-Wave Overpressure on a Window for 50-Percent Probability of Failure

- The release of about 15,000 pounds of gas is consistent with the blast effects observed at Shell.
- About 3,000 pounds of gas was involved in the explosion (for a yield factor of 0.2), which was equivalent to about 31,000 pounds of TNT.
- A vapor cloud containing about 15,000 pounds, rapidly released into a highly congested area with a volume of about 20,000 cubic meters, could generate overpressures sufficient to produce the effects observed at Shell.

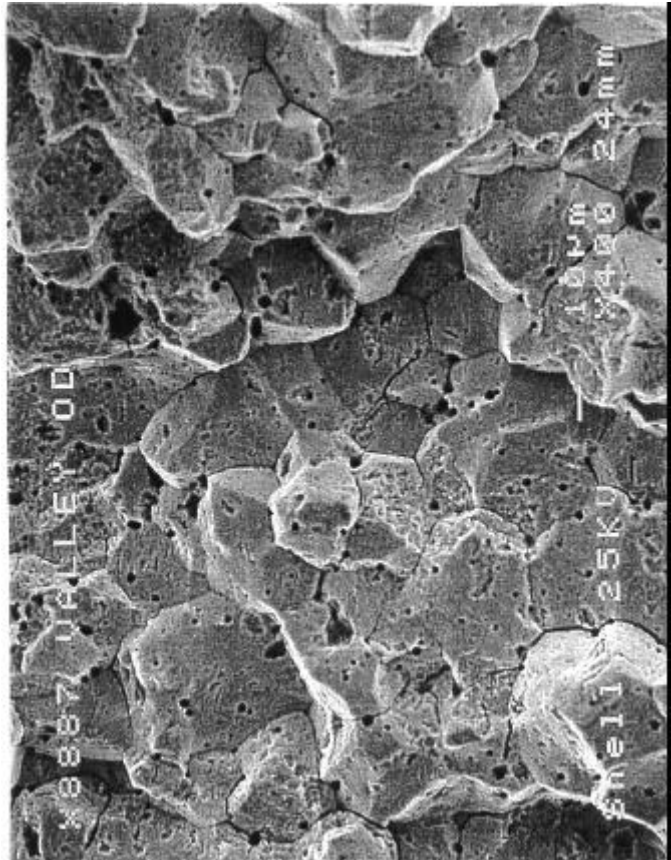
Figure E-20: 400X magnification SEM fractograph of the dowel pin shows details of the intergranular “rock candy” fracture surface at the outside diameter of the dowel pin, a characteristic of hydrogen embrittlement failure mode.
