Appendix A. River corridor severity scores for impaired sites in the Yellow River Basin, Alabama and Florida

Appendix C. Clear Creek Watershed Focal Area. Sites with orange headings are unpaved road sites. Specific definitions and calculations described for calculating the Sediment Risk Index (SRI) are detailed in Witmer (2009).

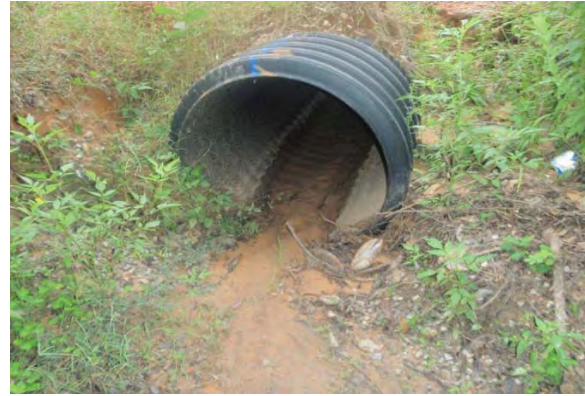
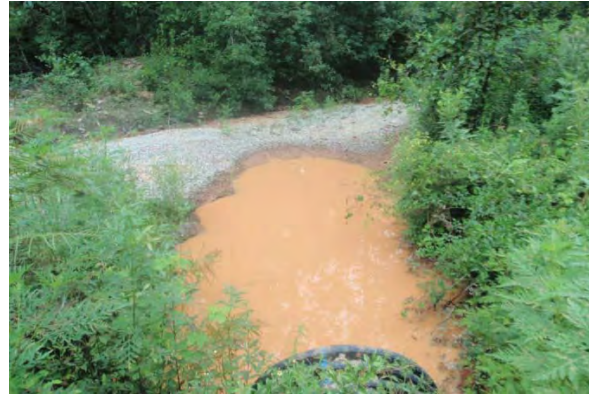
Unnamed tributary	co-0812-r-002	Sedimentation Risk Index <b>28</b>
-------------------	---------------	---------------------------------------

Risk Factor	Ranking	Score
<i>US Channel Morph</i>	DA	3
<i>DS Channel Morph</i>	PONDED	1
<i>DS Bank Alteration</i>	HIGH	1
<i>Upstream Skew Angle</i>	5-30°	3
<i>Crossing fill condition</i>	Poor/Bare soil	1
<i>Inlet/Outlet Condition</i>	Sed Islands/Scouring	3
<i>Road Approach Material</i>	All Sand/Clay	3
<i>Potential Eroded Volume Mean</i>	>40 y <sup>3</sup>	1
<i>Approach Slope Mean</i>	<2%	5
<i>Soil K Factor</i>	<0.20	5
<i>Upstream Rt Outlet</i>	Bare soil	0
<i>Upstream Lt Outlet</i>	Bare soil	0
<i>Upstream Rt Ditch</i>	Bare soil	0
<i>Upstream Lt Ditch</i>	Bare soil	0
<i>Downstream Rt Outlet</i>	Bare soil	0
<i>Downstream Lt Outlet</i>	Other	0
<i>Downstream Rt Ditch</i>	Bare soil	0
<i>Downstream Lt Ditch</i>	Bare soil	0
<i>Outlet Total</i>	Unimproved Outlet System	1
<i>Ditches Total</i>	Unimproved Drainage System	1
<b>SRI Total</b>	<b>High Risk</b>	<b>28</b>

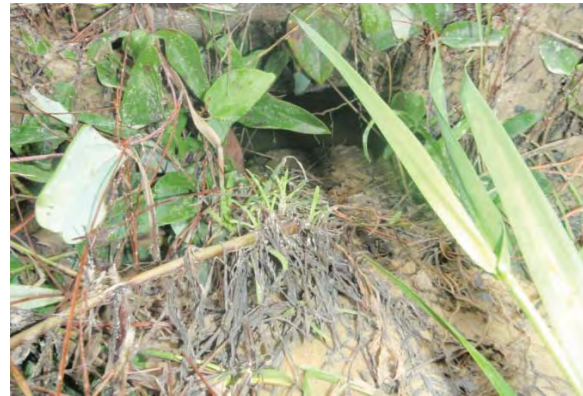
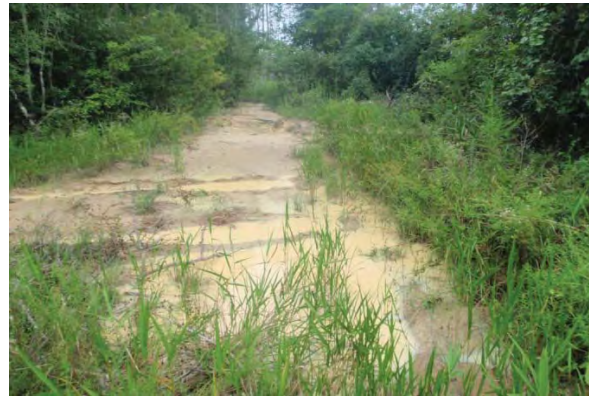
Unnamed tributary	co-0820-r-003	Sedimentation Risk Index <b>28</b>
-------------------	---------------	---------------------------------------

Risk Factor	Ranking	Score
<i>US Channel Morph</i>	DA	3
<i>DS Channel Morph</i>	WETLAND	5
<i>DS Bank Alteration</i>	HIGH	1
<i>Upstream Skew Angle</i>	5-30°	3
<i>Crossing fill condition</i>	Poor/Bare soil	1
<i>Inlet/Outlet Condition</i>	Blocked	1
<i>Road Approach Material</i>	All Sand/Clay	3
<i>Potential Eroded Volume Mean</i>	>40 y <sup>3</sup>	1
<i>Approach Slope Mean</i>	<2%	5
<i>Soil K Factor</i>	0.21-0.40	3
<i>Upstream Rt Outlet</i>	Bare soil	0
<i>Upstream Lt Outlet</i>	Bare soil	0
<i>Upstream Rt Ditch</i>	Bare soil	0
<i>Upstream Lt Ditch</i>	Bare soil	0
<i>Downstream Rt Outlet</i>	Bare soil	0
<i>Downstream Lt Outlet</i>	Bare soil	0
<i>Downstream Rt Ditch</i>	Bare soil	0
<i>Downstream Lt Ditch</i>	Bare soil	0
<i>Outlet Total</i>	Unimproved Outlet System	1
<i>Ditches Total</i>	Unimproved Drainage System	1
<b>SRI Total</b>	<b>High Risk</b>	<b>28</b>

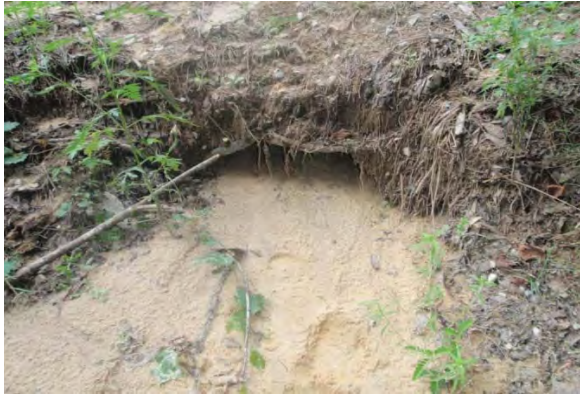
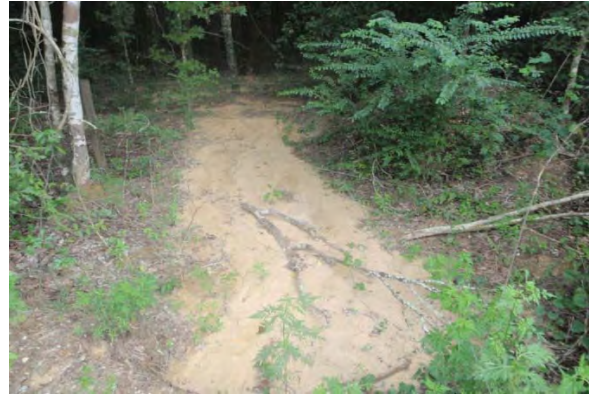
Unnamed tributary	co-0812-r-009	Sedimentation Risk Index <b>30</b>
-------------------	---------------	---------------------------------------

Risk Factor	Ranking	Score
<i>US Channel Morph</i>	PONDED	1
<i>DS Channel Morph</i>	DA	3
<i>DS Bank Alteration</i>	HIGH	1
<i>Upstream Skew Angle</i>	>30°	1
<i>Crossing fill condition</i>	Poor/Bare soil	1
<i>Inlet/Outlet Condition</i>	Sed Islands/Scouring	3
<i>Road Approach Material</i>	All Aggregate	5
<i>Potential Eroded Volume Mean</i>	<21 y <sup>3</sup>	5
<i>Approach Slope Mean</i>	2.1-4%	3
<i>Soil K Factor</i>	<0.20	5
<i>Upstream Rt Outlet</i>	Bare soil	0
<i>Upstream Lt Outlet</i>	Bare soil	0
<i>Upstream Rt Ditch</i>	Bare soil	0
<i>Upstream Lt Ditch</i>	Bare soil	0
<i>Downstream Rt Outlet</i>	Bare soil	0
<i>Downstream Lt Outlet</i>	Bare soil	0
<i>Downstream Rt Ditch</i>	Bare soil	0
<i>Downstream Lt Ditch</i>	Bare soil	0
<i>Outlet Total</i>	Unimproved Outlet System	1
<i>Ditches Total</i>	Unimproved Drainage System	1
<b>SRI Total</b>	<b>High Risk</b>	<b>30</b>

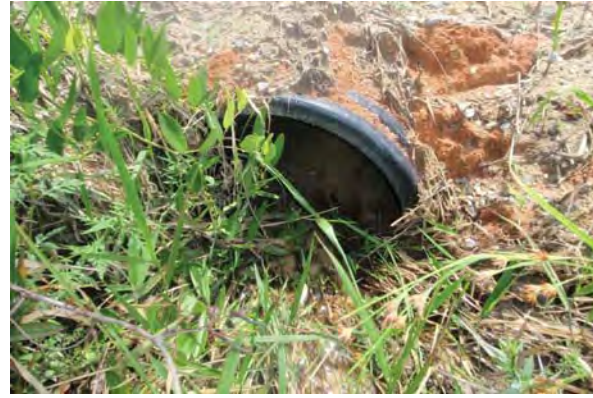
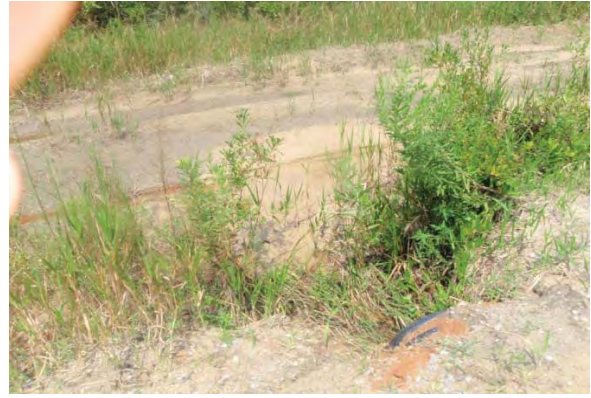
Unnamed tributary	co-0831-r-005	Sedimentation Risk Index <b>30</b>
-------------------	---------------	---------------------------------------

Risk Factor	Ranking	Score
<i>US Channel Morph</i>	DA	3
<i>DS Channel Morph</i>	DA	3
<i>DS Bank Alteration</i>	HIGH	1
<i>Upstream Skew Angle</i>	>30°	1
<i>Crossing fill condition</i>	Poor/Bare soil	1
<i>Inlet/Outlet Condition</i>	Sed Islands/Scouring	3
<i>Road Approach Material</i>	All Sand/Clay	3
<i>Potential Eroded Volume Mean</i>	>40 y <sup>3</sup>	1
<i>Approach Slope Mean</i>	<2%	5
<i>Soil K Factor</i>	<0.20	5
<i>Upstream Rt Outlet</i>	Bare soil	0
<i>Upstream Lt Outlet</i>	Bare soil	0
<i>Upstream Rt Ditch</i>	Bare soil	0
<i>Upstream Lt Ditch</i>	Bare soil	0
<i>Downstream Rt Outlet</i>	Bare soil	0
<i>Downstream Lt Outlet</i>	Vegetated	1
<i>Downstream Rt Ditch</i>	Bare soil	0
<i>Downstream Lt Ditch</i>	Bare soil	0
<i>Outlet Total</i>	Partially Improved Outlet System	3
<i>Ditches Total</i>	Unimproved Drainage System	1
<b>SRI Total</b>	<b>High Risk</b>	<b>30</b>

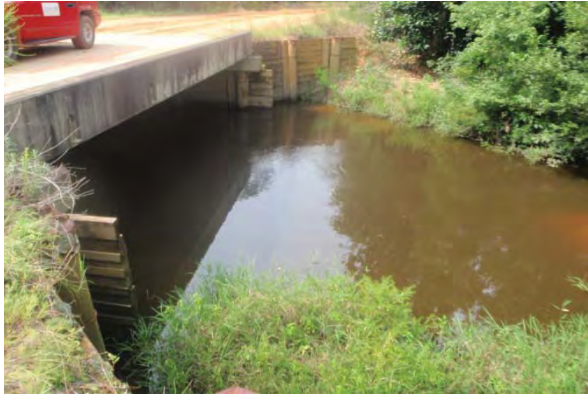
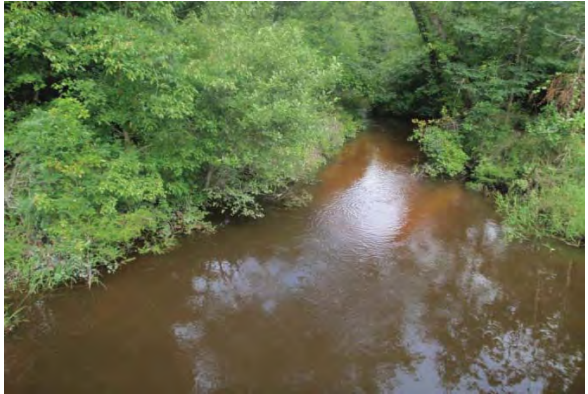
<h1>Clear Creek</h1>	<h2>co-0812-r-011</h2>	<i>Sedimentation Risk Index</i> <b>32</b>
----------------------	------------------------	--

Risk Factor	Ranking	Score
<i>US Channel Morph</i>	DA	3
<i>DS Channel Morph</i>	DA	3
<i>DS Bank Alteration</i>	MINOR/PARTIAL	3
<i>Upstream Skew Angle</i>	>30°	1
<i>Crossing fill condition</i>	Poor/Bare soil	1
<i>Inlet/Outlet Condition</i>	Sed Islands/Scouring	3
<i>Road Approach Material</i>	All Sand/Clay	3
<i>Potential Eroded Volume Mean</i>	21-40 y <sup>3</sup>	3
<i>Approach Slope Mean</i>	2.1-4%	3
<i>Soil K Factor</i>	<0.20	5
<i>Upstream Rt Outlet</i>	Vegetated	1
<i>Upstream Lt Outlet</i>	Vegetated	1
<i>Upstream Rt Ditch</i>	Bare soil	0
<i>Upstream Lt Ditch</i>	Bare soil	0
<i>Downstream Rt Outlet</i>	Vegetated	1
<i>Downstream Lt Outlet</i>	Bare soil	0
<i>Downstream Rt Ditch</i>	Bare soil	0
<i>Downstream Lt Ditch</i>	Bare soil	0
<i>Outlet Total</i>	Partially Improved Outlet System	3
<i>Ditches Total</i>	Unimproved Drainage System	1
<b><i>SRI Total</i></b>	<b>High Risk</b>	<b>32</b>

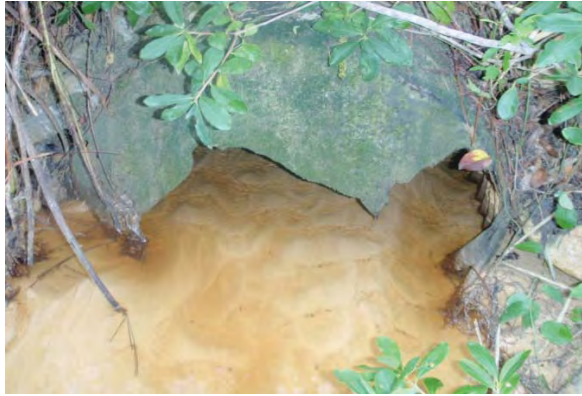
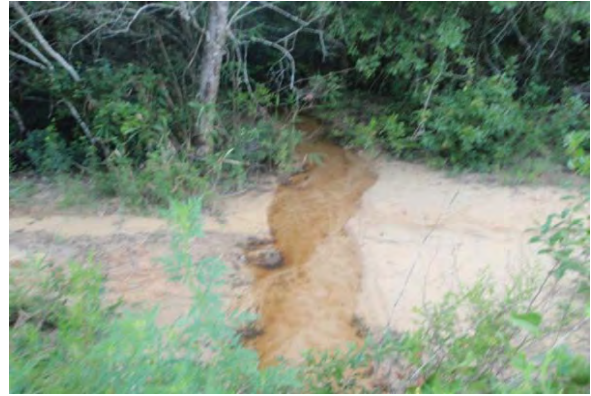
Unnamed tributary	co-0820-r-002	Sedimentation Risk Index <b>32</b>
-------------------	---------------	---------------------------------------

Risk Factor	Ranking	Score
<i>US Channel Morph</i>	E	5
<i>DS Channel Morph</i>	E	5
<i>DS Bank Alteration</i>	HIGH	1
<i>Upstream Skew Angle</i>	5-30°	3
<i>Crossing fill condition</i>	Poor/Bare soil	1
<i>Inlet/Outlet Condition</i>	Sed Islands/Scouring	3
<i>Road Approach Material</i>	All Sand/Clay	3
<i>Potential Eroded Volume Mean</i>	>40 y <sup>3</sup>	1
<i>Approach Slope Mean</i>	2.1-4%	3
<i>Soil K Factor</i>	<0.20	5
<i>Upstream Rt Outlet</i>	Bare soil	0
<i>Upstream Lt Outlet</i>	Bare soil	0
<i>Upstream Rt Ditch</i>	Bare soil	0
<i>Upstream Lt Ditch</i>	Bare soil	0
<i>Downstream Rt Outlet</i>	Bare soil	0
<i>Downstream Lt Outlet</i>	Bare soil	0
<i>Downstream Rt Ditch</i>	Bare soil	0
<i>Downstream Lt Ditch</i>	Bare soil	0
<i>Outlet Total</i>	Unimproved Outlet System	1
<i>Ditches Total</i>	Unimproved Drainage System	1
<b>SRI Total</b>	<b>High Risk</b>	<b>32</b>

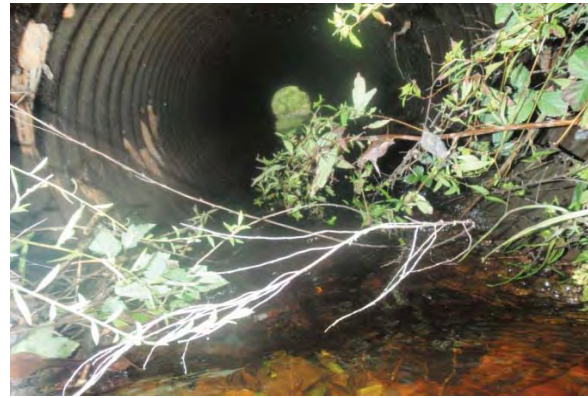
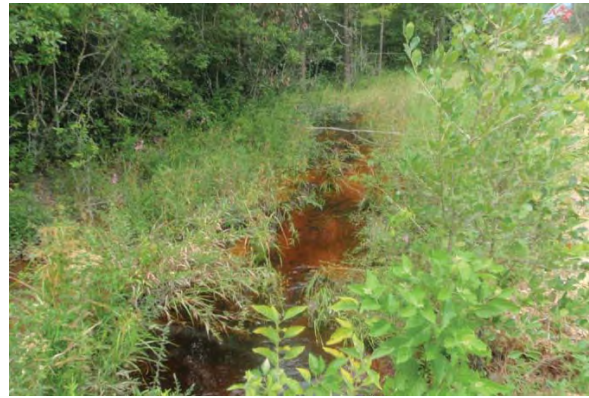
Unnamed tributary	co-0820-r-010	Sedimentation Risk Index <b>32</b>
-------------------	---------------	---------------------------------------

Risk Factor	Ranking	Score
<i>US Channel Morph</i>	WETLAND	5
<i>DS Channel Morph</i>	C	5
<i>DS Bank Alteration</i>	HIGH	1
<i>Upstream Skew Angle</i>	>30°	1
<i>Crossing fill condition</i>	Poor/Bare soil	1
<i>Inlet/Outlet Condition</i>	Sed Islands/Scouring	3
<i>Road Approach Material</i>	All Sand/Clay	3
<i>Potential Eroded Volume Mean</i>	>40 y <sup>3</sup>	1
<i>Approach Slope Mean</i>	<2%	5
<i>Soil K Factor</i>	<0.20	5
<i>Upstream Rt Outlet</i>	Bare soil	0
<i>Upstream Lt Outlet</i>	Bare soil	0
<i>Upstream Rt Ditch</i>	Bare soil	0
<i>Upstream Lt Ditch</i>	Bare soil	0
<i>Downstream Rt Outlet</i>	Bare soil	0
<i>Downstream Lt Outlet</i>	Bare soil	0
<i>Downstream Rt Ditch</i>	Bare soil	0
<i>Downstream Lt Ditch</i>	Bare soil	0
<i>Outlet Total</i>	Unimproved Outlet System	1
<i>Ditches Total</i>	Unimproved Drainage System	1
<b>SRI Total</b>	<b>High Risk</b>	<b>32</b>

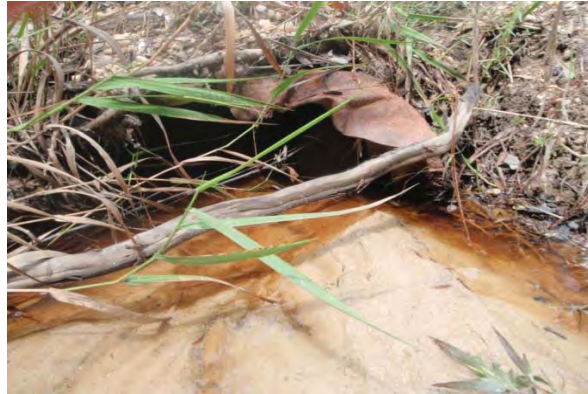
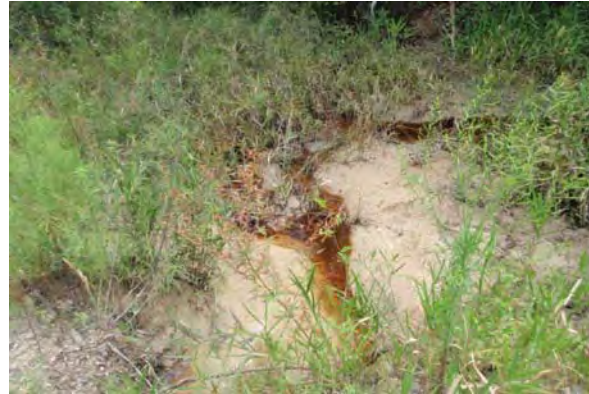
Unnamed tributary	co-0830-r-001	Sedimentation Risk Index <b>32</b>
-------------------	---------------	---------------------------------------

Risk Factor	Ranking	Score
<i>US Channel Morph</i>	DA	3
<i>DS Channel Morph</i>	E	5
<i>DS Bank Alteration</i>	HIGH	1
<i>Upstream Skew Angle</i>	5-30°	3
<i>Crossing fill condition</i>	Poor/Bare soil	1
<i>Inlet/Outlet Condition</i>	Sed Islands/Scouring	3
<i>Road Approach Material</i>	All Sand/Clay	3
<i>Potential Eroded Volume Mean</i>	>40 y <sup>3</sup>	1
<i>Approach Slope Mean</i>	<2%	5
<i>Soil K Factor</i>	<0.20	5
<i>Upstream Rt Outlet</i>	Bare soil	0
<i>Upstream Lt Outlet</i>	Bare soil	0
<i>Upstream Rt Ditch</i>	Bare soil	0
<i>Upstream Lt Ditch</i>	Bare soil	0
<i>Downstream Rt Outlet</i>	Bare soil	0
<i>Downstream Lt Outlet</i>	Bare soil	0
<i>Downstream Rt Ditch</i>	Bare soil	0
<i>Downstream Lt Ditch</i>	Bare soil	0
<i>Outlet Total</i>	Unimproved Outlet System	1
<i>Ditches Total</i>	Unimproved Drainage System	1
<b>SRI Total</b>	<b>High Risk</b>	<b>32</b>

Notes: Culvert almost buried.

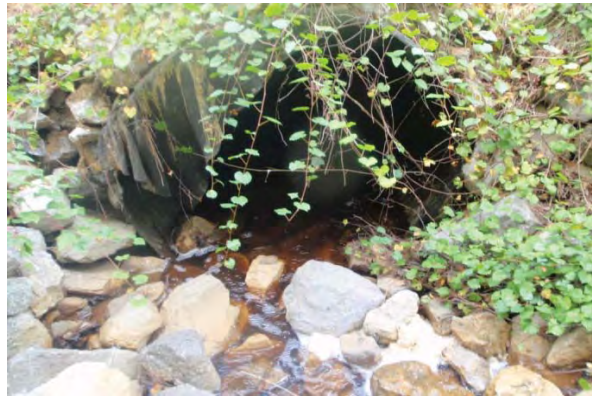
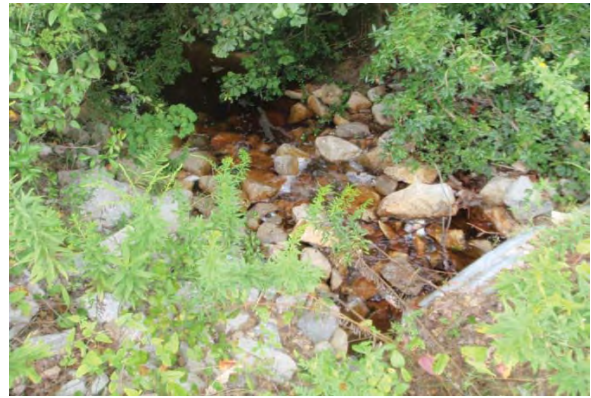
<h1>Unnamed tributary</h1>	<h2>co-0831-r-004</h2>	<i>Sedimentation Risk Index</i> <b>32</b>
----------------------------	------------------------	--

Risk Factor	Ranking	Score
<i>US Channel Morph</i>	B	5
<i>DS Channel Morph</i>	D	1
<i>DS Bank Alteration</i>	HIGH	1
<i>Upstream Skew Angle</i>	>30°	1
<i>Crossing fill condition</i>	Poor/Bare soil	1
<i>Inlet/Outlet Condition</i>	Sed Islands/Scouring	3
<i>Road Approach Material</i>	All Sand/Clay	3
<i>Potential Eroded Volume Mean</i>	21-40 y <sup>3</sup>	3
<i>Approach Slope Mean</i>	<2%	5
<i>Soil K Factor</i>	<0.20	5
<i>Upstream Rt Outlet</i>	Rip Rap	1
<i>Upstream Lt Outlet</i>	Rip Rap	1
<i>Upstream Rt Ditch</i>	Bare soil	0
<i>Upstream Lt Ditch</i>	Bare soil	0
<i>Downstream Rt Outlet</i>	Vegetated	1
<i>Downstream Lt Outlet</i>	Bare soil	0
<i>Downstream Rt Ditch</i>	Bare soil	0
<i>Downstream Lt Ditch</i>	Bare soil	0
<i>Outlet Total</i>	Partially Improved Outlet System	3
<i>Ditches Total</i>	Unimproved Drainage System	1
<b>SRI Total</b>	<b>High Risk</b>	<b>32</b>
<b>Additional Site Features</b>		
<i>Crossing Type and Quantity:</i>	Culvert, 1

Notes: Rip rap blocking stream bed.

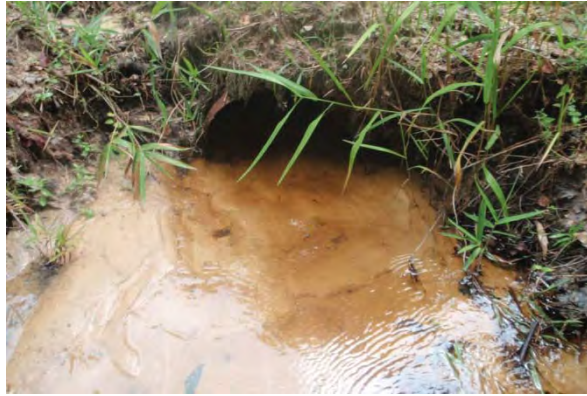
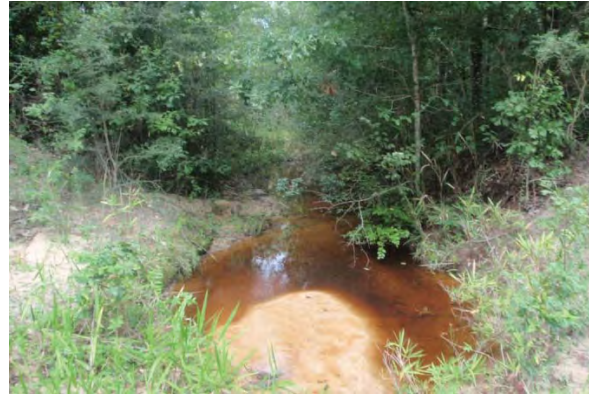
Unnamed tributary	co-0820-r-005	Sedimentation Risk Index <b>34</b>
-------------------	---------------	---------------------------------------

Risk Factor	Ranking	Score
<i>US Channel Morph</i>	DA	3
<i>DS Channel Morph</i>	DA	3
<i>DS Bank Alteration</i>	HIGH	1
<i>Upstream Skew Angle</i>	5-30°	3
<i>Crossing fill condition</i>	Poor/Bare soil	1
<i>Inlet/Outlet Condition</i>	Sed Islands/Scouring	3
<i>Road Approach Material</i>	All Sand/Clay	3
<i>Potential Eroded Volume Mean</i>	<21 y <sup>3</sup>	5
<i>Approach Slope Mean</i>	<2%	5
<i>Soil K Factor</i>	0.21-0.40	3
<i>Upstream Rt Outlet</i>	Vegetated	1
<i>Upstream Lt Outlet</i>	Vegetated	1
<i>Upstream Rt Ditch</i>	Bare soil	0
<i>Upstream Lt Ditch</i>	Bare soil	0
<i>Downstream Rt Outlet</i>	Bare soil	0
<i>Downstream Lt Outlet</i>	Bare soil	0
<i>Downstream Rt Ditch</i>	Bare soil	0
<i>Downstream Lt Ditch</i>	Bare soil	0
<i>Outlet Total</i>	Partially Improved Outlet System	3
<i>Ditches Total</i>	Unimproved Drainage System	1
<b>SRI Total</b>	<b>High Risk</b>	<b>34</b>

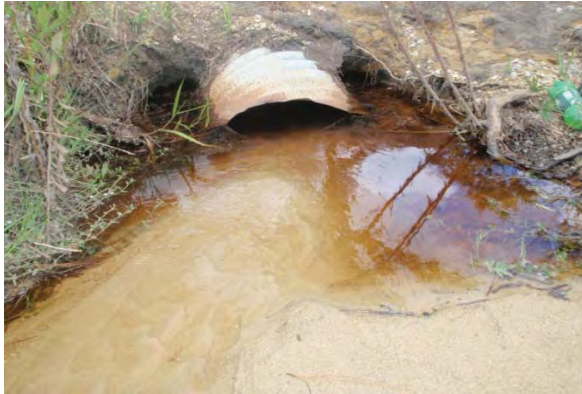
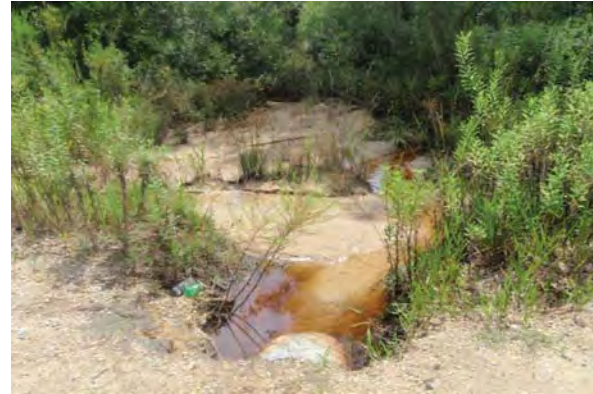
Unnamed tributary	co-0831-r-003	Sedimentation Risk Index <b>36</b>
-------------------	---------------	---------------------------------------

Risk Factor	Ranking	Score
<i>US Channel Morph</i>	DA	3
<i>DS Channel Morph</i>	DA	3
<i>DS Bank Alteration</i>	MINOR/PARTIAL	3
<i>Upstream Skew Angle</i>	5-30°	3
<i>Crossing fill condition</i>	Poor/Bare soil	1
<i>Inlet/Outlet Condition</i>	Sed Islands/Scouring	3
<i>Road Approach Material</i>	All Sand/Clay	3
<i>Potential Eroded Volume Mean</i>	<21 y <sup>3</sup>	5
<i>Approach Slope Mean</i>	<2%	5
<i>Soil K Factor</i>	<0.20	5
<i>Upstream Rt Outlet</i>	Bare soil	0
<i>Upstream Lt Outlet</i>	Bare soil	0
<i>Upstream Rt Ditch</i>	Bare soil	0
<i>Upstream Lt Ditch</i>	Bare soil	0
<i>Downstream Rt Outlet</i>	Bare soil	0
<i>Downstream Lt Outlet</i>	Bare soil	0
<i>Downstream Rt Ditch</i>	Bare soil	0
<i>Downstream Lt Ditch</i>	Bare soil	0
<i>Outlet Total</i>	Unimproved Outlet System	1
<i>Ditches Total</i>	Unimproved Drainage System	1
<b>SRI Total</b>	<b>High Risk</b>	<b>36</b>

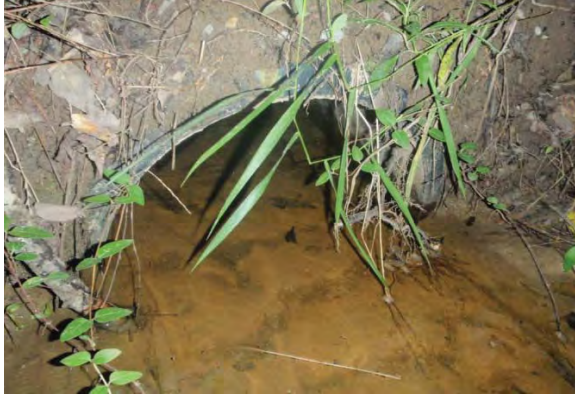
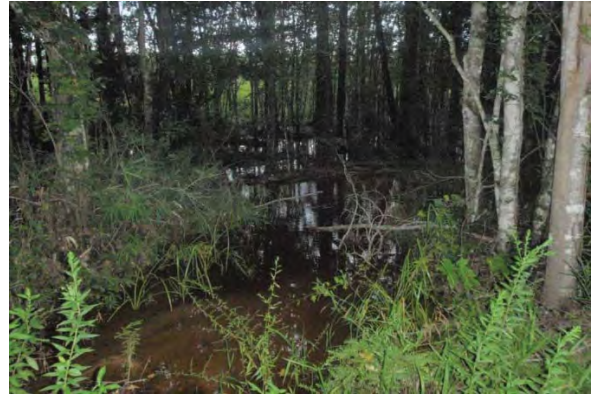
Unnamed tributary	co-0812-r-013b	Sedimentation Risk Index <b>38</b>
-------------------	----------------	---------------------------------------

Risk Factor	Ranking	Score
<i>US Channel Morph</i>	WETLAND	5
<i>DS Channel Morph</i>	WETLAND	5
<i>DS Bank Alteration</i>	NATURAL	5
<i>Upstream Skew Angle</i>	5-30°	3
<i>Crossing fill condition</i>	Poor/Bare soil	1
<i>Inlet/Outlet Condition</i>	Sed Islands/Scouring	3
<i>Road Approach Material</i>	All Sand/Clay	3
<i>Potential Eroded Volume Mean</i>	>40 y <sup>3</sup>	1
<i>Approach Slope Mean</i>	<2%	5
<i>Soil K Factor</i>	<0.20	5
<i>Upstream Rt Outlet</i>	Bare soil	0
<i>Upstream Lt Outlet</i>	Bare soil	0
<i>Upstream Rt Ditch</i>	Bare soil	0
<i>Upstream Lt Ditch</i>	Bare soil	0
<i>Downstream Rt Outlet</i>	Bare soil	0
<i>Downstream Lt Outlet</i>	Bare soil	0
<i>Downstream Rt Ditch</i>	Bare soil	0
<i>Downstream Lt Ditch</i>	Bare soil	0
<i>Outlet Total</i>	Unimproved Outlet System	1
<i>Ditches Total</i>	Unimproved Drainage System	1
<b>SRI Total</b>	<b>Medium Risk</b>	<b>38</b>

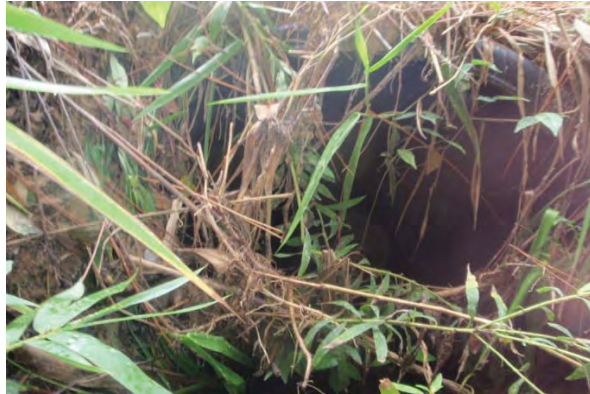
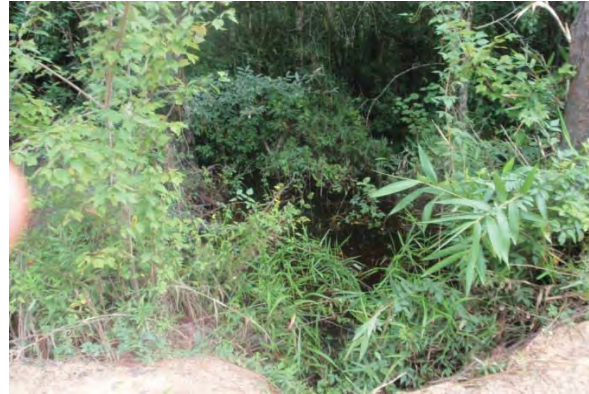
Unnamed tributary	co-0820-r-006	Sedimentation Risk Index <b>38</b>
-------------------	---------------	---------------------------------------

Risk Factor	Ranking	Score
<i>US Channel Morph</i>	WETLAND	5
<i>DS Channel Morph</i>	DA	3
<i>DS Bank Alteration</i>	HIGH	1
<i>Upstream Skew Angle</i>	5-30°	3
<i>Crossing fill condition</i>	Poor/Bare soil	1
<i>Inlet/Outlet Condition</i>	Sed Islands/Scouring	3
<i>Road Approach Material</i>	All Sand/Clay	3
<i>Potential Eroded Volume Mean</i>	<21 y <sup>3</sup>	5
<i>Approach Slope Mean</i>	<2%	5
<i>Soil K Factor</i>	<0.20	5
<i>Upstream Rt Outlet</i>	Vegetated	1
<i>Upstream Lt Outlet</i>	Bare soil	0
<i>Upstream Rt Ditch</i>	Bare soil	0
<i>Upstream Lt Ditch</i>	Bare soil	0
<i>Downstream Rt Outlet</i>	Vegetated	1
<i>Downstream Lt Outlet</i>	Vegetated	1
<i>Downstream Rt Ditch</i>	Bare soil	0
<i>Downstream Lt Ditch</i>	Bare soil	0
<i>Outlet Total</i>	Partially Improved Outlet System	3
<i>Ditches Total</i>	Unimproved Drainage System	1
<b>SRI Total</b>	<b>Medium Risk</b>	<b>38</b>

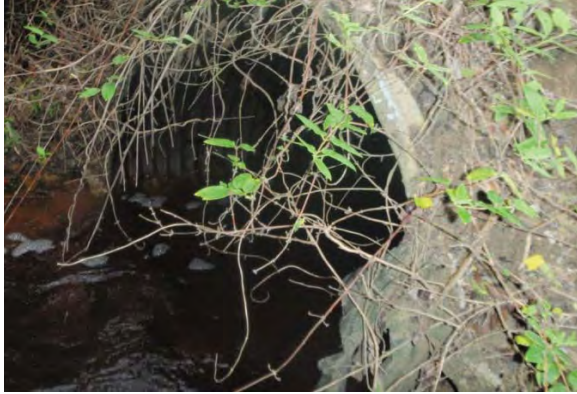
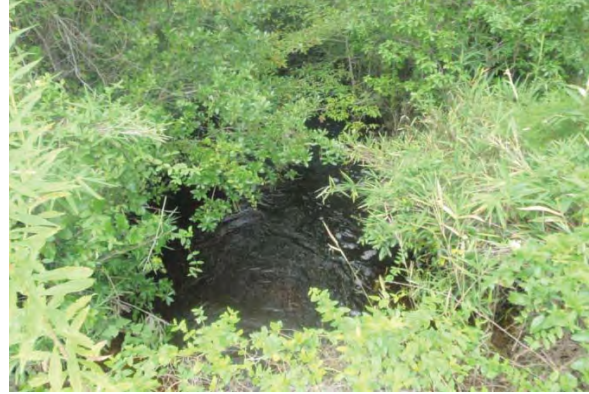
Unnamed tributary	co-0820-r-007	Sedimentation Risk Index <b>38</b>
-------------------	---------------	---------------------------------------

Risk Factor	Ranking	Score
<i>US Channel Morph</i>	DA	3
<i>DS Channel Morph</i>	C	5
<i>DS Bank Alteration</i>	MINOR/PARTIAL	3
<i>Upstream Skew Angle</i>	5-30°	3
<i>Crossing fill condition</i>	Poor/Bare soil	1
<i>Inlet/Outlet Condition</i>	No Impairment	5
<i>Road Approach Material</i>	All Sand/Clay	3
<i>Potential Eroded Volume Mean</i>	>40 y <sup>3</sup>	1
<i>Approach Slope Mean</i>	<2%	5
<i>Soil K Factor</i>	<0.20	5
<i>Upstream Rt Outlet</i>	Vegetated	1
<i>Upstream Lt Outlet</i>	Vegetated	1
<i>Upstream Rt Ditch</i>	Bare soil	0
<i>Upstream Lt Ditch</i>	Bare soil	0
<i>Downstream Rt Outlet</i>	Bare soil	0
<i>Downstream Lt Outlet</i>	Vegetated	1
<i>Downstream Rt Ditch</i>	Bare soil	0
<i>Downstream Lt Ditch</i>	Bare soil	0
<i>Outlet Total</i>	Partially Improved Outlet System	3
<i>Ditches Total</i>	Unimproved Drainage System	1
<b>SRI Total</b>	<b>Medium Risk</b>	<b>38</b>

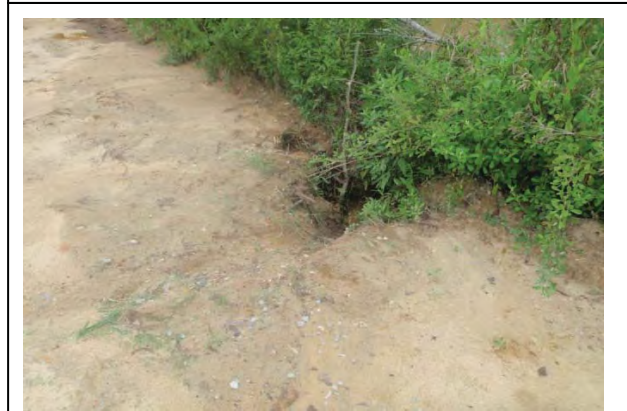
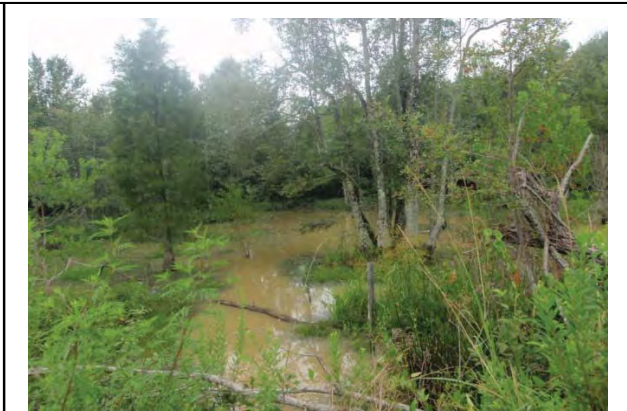
Unnamed tributary	co-0812-r-001	Sedimentation Risk Index <b>40</b>
-------------------	---------------	---------------------------------------

Risk Factor	Ranking	Score
<i>US Channel Morph</i>	PONDED	1
<i>DS Channel Morph</i>	WETLAND	5
<i>DS Bank Alteration</i>	HIGH	1
<i>Upstream Skew Angle</i>	<5°	5
<i>Crossing fill condition</i>	Good/Vegetated	5
<i>Inlet/Outlet Condition</i>	No Impairment	5
<i>Road Approach Material</i>	All Sand/Clay	3
<i>Potential Eroded Volume Mean</i>	>40 y <sup>3</sup>	1
<i>Approach Slope Mean</i>	<2%	5
<i>Soil K Factor</i>	<0.20	5
<i>Upstream Rt Outlet</i>	Vegetated	1
<i>Upstream Lt Outlet</i>	Vegetated	1
<i>Upstream Rt Ditch</i>	Bare soil	0
<i>Upstream Lt Ditch</i>	Bare soil	0
<i>Downstream Rt Outlet</i>	Bare soil	0
<i>Downstream Lt Outlet</i>	Bare soil	0
<i>Downstream Rt Ditch</i>	Bare soil	0
<i>Downstream Lt Ditch</i>	Bare soil	0
<i>Outlet Total</i>	Partially Improved Outlet System	3
<i>Ditches Total</i>	Unimproved Drainage System	1
<b>SRI Total</b>	<b>Medium Risk</b>	<b>40</b>

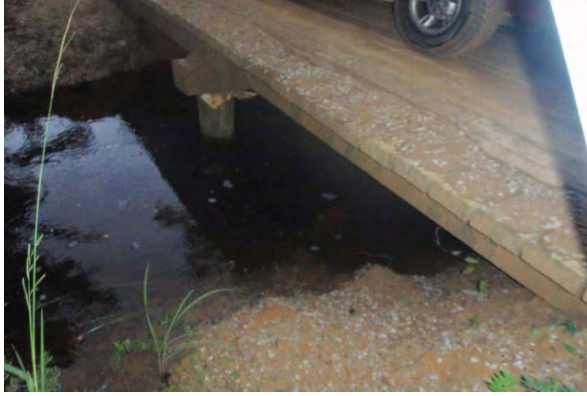
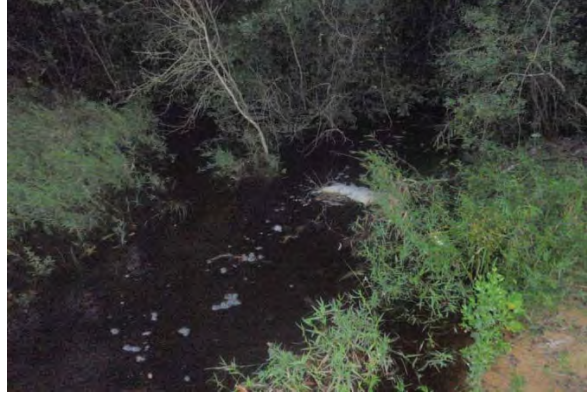
<h1>Beaver Creek</h1>	<h2>co-0812-r-013a</h2>	<i>Sedimentation Risk Index</i> <b>40</b>
-----------------------	-------------------------	--

Risk Factor	Ranking	Score
<i>US Channel Morph</i>	DA	3
<i>DS Channel Morph</i>	DA	3
<i>DS Bank Alteration</i>	NATURAL	5
<i>Upstream Skew Angle</i>	<5°	5
<i>Crossing fill condition</i>	Poor/Bare soil	1
<i>Inlet/Outlet Condition</i>	No Impairment	5
<i>Road Approach Material</i>	All Sand/Clay	3
<i>Potential Eroded Volume Mean</i>	>40 y <sup>3</sup>	1
<i>Approach Slope Mean</i>	<2%	5
<i>Soil K Factor</i>	<0.20	5
<i>Upstream Rt Outlet</i>	Vegetated	1
<i>Upstream Lt Outlet</i>	Bare soil	0
<i>Upstream Rt Ditch</i>	Bare soil	0
<i>Upstream Lt Ditch</i>	Bare soil	0
<i>Downstream Rt Outlet</i>	Bare soil	0
<i>Downstream Lt Outlet</i>	Bare soil	0
<i>Downstream Rt Ditch</i>	Bare soil	0
<i>Downstream Lt Ditch</i>	Bare soil	0
<i>Outlet Total</i>	Partially Improved Outlet System	3
<i>Ditches Total</i>	Unimproved Drainage System	1
<b><i>SRI Total</i></b>	<b>Medium Risk</b>	<b>40</b>

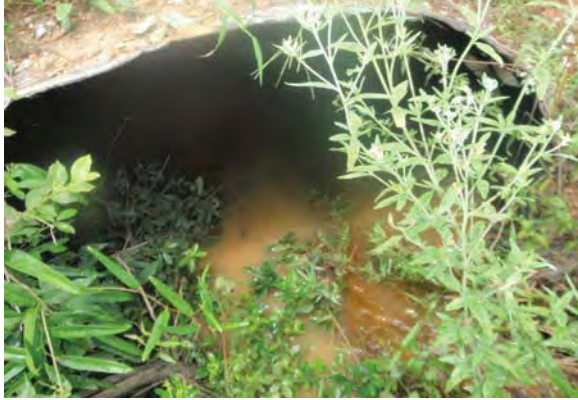
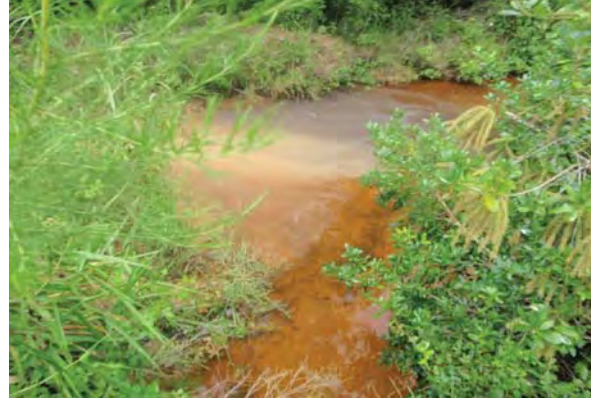
<b>Dry Creek</b>	<b>co-0820-r-004</b>	<i>Sedimentation Risk Index</i> <b>40</b>
------------------	----------------------	--

Risk Factor	Ranking	Score
<i>US Channel Morph</i>	WETLAND	5
<i>DS Channel Morph</i>	E	5
<i>DS Bank Alteration</i>	HIGH	1
<i>Upstream Skew Angle</i>	<5°	5
<i>Crossing fill condition</i>	Poor/Bare soil	1
<i>Inlet/Outlet Condition</i>	Sed Islands/Scouring	3
<i>Road Approach Material</i>	All Sand/Clay	3
<i>Potential Eroded Volume Mean</i>	21-40 y <sup>3</sup>	3
<i>Approach Slope Mean</i>	<2%	5
<i>Soil K Factor</i>	<0.20	5
<i>Upstream Rt Outlet</i>	Vegetated	1
<i>Upstream Lt Outlet</i>	Vegetated	1
<i>Upstream Rt Ditch</i>	Bare soil	0
<i>Upstream Lt Ditch</i>	Bare soil	0
<i>Downstream Rt Outlet</i>	Vegetated	1
<i>Downstream Lt Outlet</i>	Bare soil	0
<i>Downstream Rt Ditch</i>	Bare soil	0
<i>Downstream Lt Ditch</i>	Bare soil	0
<i>Outlet Total</i>	Partially Improved Outlet System	3
<i>Ditches Total</i>	Unimproved Drainage System	1
<b>SRI Total</b>	<b>Medium Risk</b>	<b>40</b>

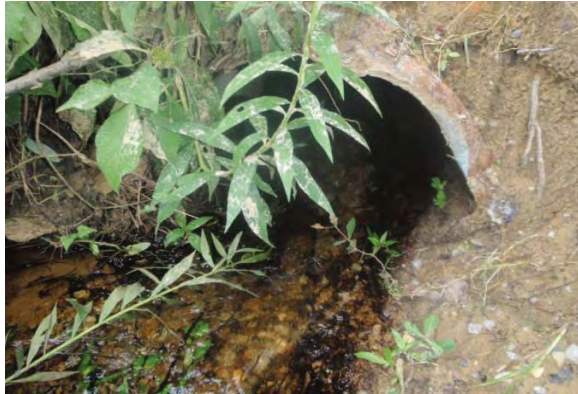
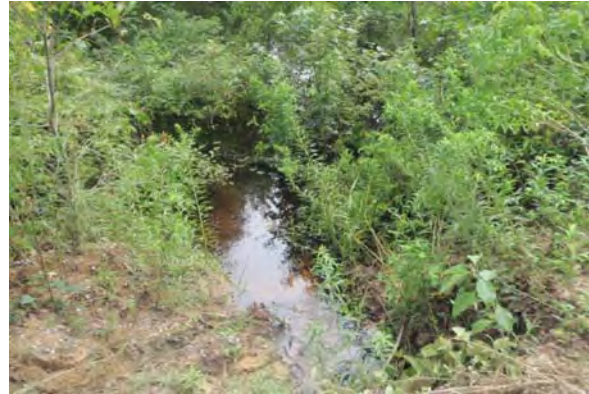
Unnamed tributary	co-0820-r-008	Sedimentation Risk Index <b>40</b>
-------------------	---------------	---------------------------------------

Risk Factor	Ranking	Score
<i>US Channel Morph</i>	WETLAND	5
<i>DS Channel Morph</i>	DA	3
<i>DS Bank Alteration</i>	HIGH	1
<i>Upstream Skew Angle</i>	<5°	5
<i>Crossing fill condition</i>	Poor/Bare soil	1
<i>Inlet/Outlet Condition</i>	Sed Islands/Scouring	3
<i>Road Approach Material</i>	All Sand/Clay	3
<i>Potential Eroded Volume Mean</i>	<21 y <sup>3</sup>	5
<i>Approach Slope Mean</i>	<2%	5
<i>Soil K Factor</i>	<0.20	5
<i>Upstream Rt Outlet</i>	Bare soil	0
<i>Upstream Lt Outlet</i>	Bare soil	0
<i>Upstream Rt Ditch</i>	Bare soil	0
<i>Upstream Lt Ditch</i>	Bare soil	0
<i>Downstream Rt Outlet</i>	Vegetated	1
<i>Downstream Lt Outlet</i>	Vegetated	1
<i>Downstream Rt Ditch</i>	Bare soil	0
<i>Downstream Lt Ditch</i>	Bare soil	0
<i>Outlet Total</i>	Partially Improved Outlet System	3
<i>Ditches Total</i>	Unimproved Drainage System	1
<b>SRI Total</b>	<b>Medium Risk</b>	<b>40</b>

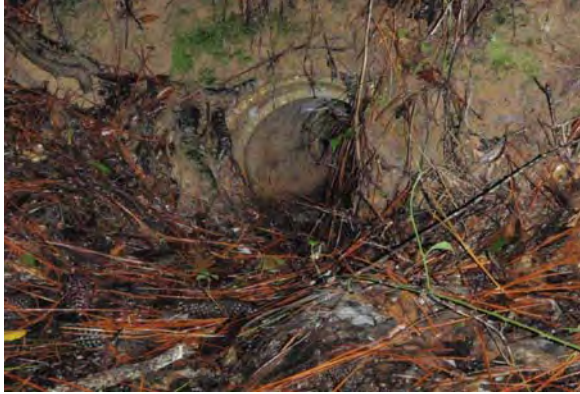
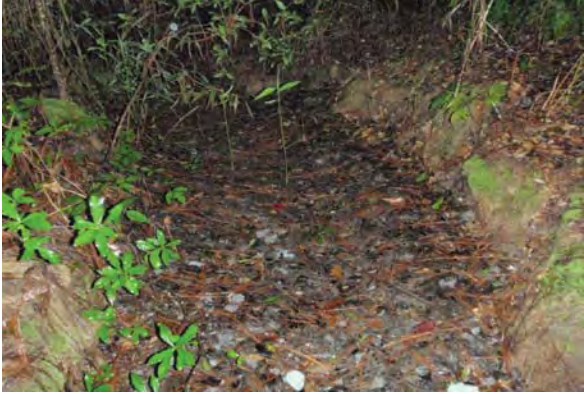
<h1>Unnamed tributary</h1>	<h2>co-0731-r-010</h2>	<i>Sedimentation Risk Index</i> <b>42</b>
----------------------------	------------------------	--

Risk Factor	Ranking	Score
<i>US Channel Morph</i>	DA	3
<i>DS Channel Morph</i>	E	5
<i>DS Bank Alteration</i>	MINOR/PARTIAL	3
<i>Upstream Skew Angle</i>	5-30°	3
<i>Crossing fill condition</i>	Good/Vegetated	5
<i>Inlet/Outlet Condition</i>	Sed Islands/Scouring	3
<i>Road Approach Material</i>	All Sand/Clay	3
<i>Potential Eroded Volume Mean</i>	>40 y <sup>3</sup>	1
<i>Approach Slope Mean</i>	2.1-4%	3
<i>Soil K Factor</i>	<0.20	5
<i>Upstream Rt Outlet</i>	Vegetated	1
<i>Upstream Lt Outlet</i>	Vegetated	1
<i>Upstream Rt Ditch</i>	Bare soil	0
<i>Upstream Lt Ditch</i>	Bare soil	0
<i>Downstream Rt Outlet</i>	Vegetated	1
<i>Downstream Lt Outlet</i>	Vegetated	1
<i>Downstream Rt Ditch</i>	Vegetated	1
<i>Downstream Lt Ditch</i>	Vegetated	1
<i>Outlet Total</i>	Improved Outlet System	5
<i>Ditches Total</i>	Partially Improved Drainage System	3
<b><i>SRI Total</i></b>	<b>Medium Risk</b>	<b>42</b>

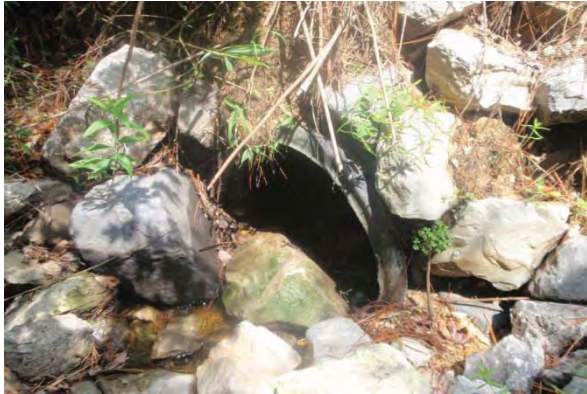
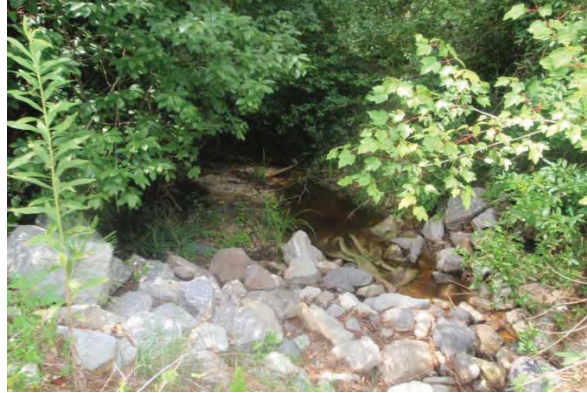
Unnamed tributary	co-0812-r-005	Sedimentation Risk Index <b>42</b>
-------------------	---------------	---------------------------------------

Risk Factor	Ranking	Score
<i>US Channel Morph</i>	C	5
<i>DS Channel Morph</i>	C	5
<i>DS Bank Alteration</i>	HIGH	1
<i>Upstream Skew Angle</i>	5-30°	3
<i>Crossing fill condition</i>	Fair/Rip Rap	3
<i>Inlet/Outlet Condition</i>	No Impairment	5
<i>Road Approach Material</i>	All Sand/Clay	3
<i>Potential Eroded Volume Mean</i>	>40 y <sup>3</sup>	1
<i>Approach Slope Mean</i>	<2%	5
<i>Soil K Factor</i>	<0.20	5
<i>Upstream Rt Outlet</i>	Vegetated	1
<i>Upstream Lt Outlet</i>	Vegetated	1
<i>Upstream Rt Ditch</i>	Bare soil	0
<i>Upstream Lt Ditch</i>	Bare soil	0
<i>Downstream Rt Outlet</i>	Vegetated	1
<i>Downstream Lt Outlet</i>	Vegetated	1
<i>Downstream Rt Ditch</i>	Bare soil	0
<i>Downstream Lt Ditch</i>	Bare soil	0
<i>Outlet Total</i>	Improved Outlet System	5
<i>Ditches Total</i>	Unimproved Drainage System	1
<b>SRI Total</b>	<b>Medium Risk</b>	<b>42</b>

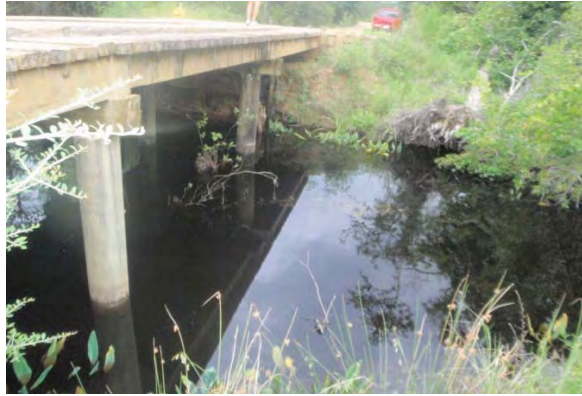
Crossing Structure: DS

Risk Factor	Ranking	Score
<i>US Channel Morph</i>	WETLAND	5
<i>DS Channel Morph</i>	DA	3
<i>DS Bank Alteration</i>	NATURAL	5
<i>Upstream Skew Angle</i>	5-30°	3
<i>Crossing fill condition</i>	Good/Vegetated	5
<i>Inlet/Outlet Condition</i>	No Impairment	5
<i>Road Approach Material</i>	All Sand/Clay	3
<i>Potential Eroded Volume Mean</i>	>40 y <sup>3</sup>	1
<i>Approach Slope Mean</i>	2.1-4%	3
<i>Soil K Factor</i>	<0.20	5
<i>Upstream Rt Outlet</i>	Vegetated	1
<i>Upstream Lt Outlet</i>	Vegetated	1
<i>Upstream Rt Ditch</i>	Bare soil	0
<i>Upstream Lt Ditch</i>	Bare soil	0
<i>Downstream Rt Outlet</i>	Vegetated	1
<i>Downstream Lt Outlet</i>	Bare soil	0
<i>Downstream Rt Ditch</i>	Bare soil	0
<i>Downstream Lt Ditch</i>	Bare soil	0
<i>Outlet Total</i>	Partially Improved Outlet System	3
<i>Ditches Total</i>	Unimproved Drainage System	1
<b>SRI Total</b>	<b>Medium Risk</b>	<b>42</b>

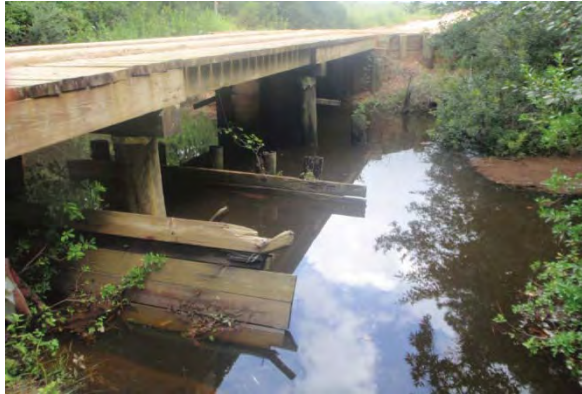
Crossing Structure: US

Risk Factor	Ranking	Score
<i>US Channel Morph</i>	DA	3
<i>DS Channel Morph</i>	DA	3
<i>DS Bank Alteration</i>	MINOR/PARTIAL	3
<i>Upstream Skew Angle</i>	<5°	5
<i>Crossing fill condition</i>	Good/Vegetated	5
<i>Inlet/Outlet Condition</i>	No Impairment	5
<i>Road Approach Material</i>	All Sand/Clay	3
<i>Potential Eroded Volume Mean</i>	>40 y <sup>3</sup>	1
<i>Approach Slope Mean</i>	<2%	5
<i>Soil K Factor</i>	<0.20	5
<i>Upstream Rt Outlet</i>	Bare soil	0
<i>Upstream Lt Outlet</i>	Bare soil	0
<i>Upstream Rt Ditch</i>	Bare soil	0
<i>Upstream Lt Ditch</i>	Bare soil	0
<i>Downstream Rt Outlet</i>	Bare soil	0
<i>Downstream Lt Outlet</i>	Bare soil	0
<i>Downstream Rt Ditch</i>	Vegetated	1
<i>Downstream Lt Ditch</i>	Bare soil	0
<i>Outlet Total</i>	Unimproved Outlet System	1
<i>Ditches Total</i>	Partially Improved Drainage System	3
<b>SRI Total</b>	<b>Medium Risk</b>	<b>42</b>

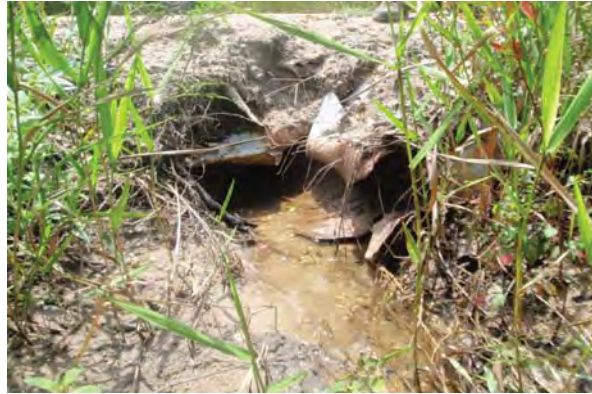
Crossing Structure: US

Risk Factor	Ranking	Score
<i>US Channel Morph</i>	E	5
<i>DS Channel Morph</i>	E	5
<i>DS Bank Alteration</i>	MINOR/PARTIAL	3
<i>Upstream Skew Angle</i>	5-30°	3
<i>Crossing fill condition</i>	Poor/Bare soil	1
<i>Inlet/Outlet Condition</i>	Sed Islands/Scouring	3
<i>Road Approach Material</i>	All Sand/Clay	3
<i>Potential Eroded Volume Mean</i>	<21 y <sup>3</sup>	5
<i>Approach Slope Mean</i>	<2%	5
<i>Soil K Factor</i>	<0.20	5
<i>Upstream Rt Outlet</i>	Vegetated	1
<i>Upstream Lt Outlet</i>	Vegetated	1
<i>Upstream Rt Ditch</i>	Bare soil	0
<i>Upstream Lt Ditch</i>	Bare soil	0
<i>Downstream Rt Outlet</i>	Vegetated	1
<i>Downstream Lt Outlet</i>	Vegetated	1
<i>Downstream Rt Ditch</i>	Bare soil	0
<i>Downstream Lt Ditch</i>	Bare soil	0
<i>Outlet Total</i>	Improved Outlet System	5
<i>Ditches Total</i>	Unimproved Drainage System	1
<b>SRI Total</b>	<b>Medium Risk</b>	<b>44</b>

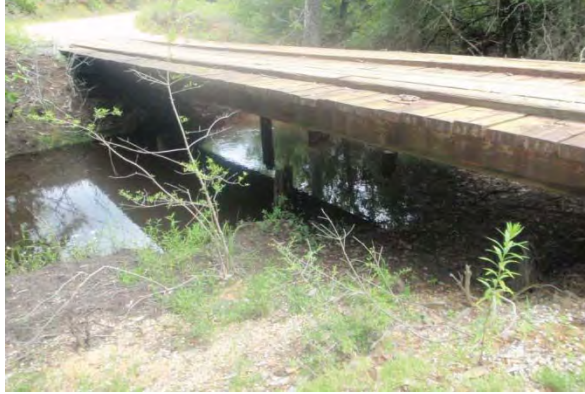
Crossing Structure: DS

Risk Factor	Ranking	Score
<i>US Channel Morph</i>	B	5
<i>DS Channel Morph</i>	B	5
<i>DS Bank Alteration</i>	NATURAL	5
<i>Upstream Skew Angle</i>	<5°	5
<i>Crossing fill condition</i>	Poor/Bare soil	1
<i>Inlet/Outlet Condition</i>	No Impairment	5
<i>Road Approach Material</i>	All Sand/Clay	3
<i>Potential Eroded Volume Mean</i>	21-40 y <sup>3</sup>	3
<i>Approach Slope Mean</i>	<2%	5
<i>Soil K Factor</i>	<0.20	5
<i>Upstream Rt Outlet</i>	Vegetated	1
<i>Upstream Lt Outlet</i>	Bare soil	0
<i>Upstream Rt Ditch</i>	Bare soil	0
<i>Upstream Lt Ditch</i>	Bare soil	0
<i>Downstream Rt Outlet</i>	Bare soil	0
<i>Downstream Lt Outlet</i>	Bare soil	0
<i>Downstream Rt Ditch</i>	Bare soil	0
<i>Downstream Lt Ditch</i>	Bare soil	0
<i>Outlet Total</i>	Partially Improved Outlet System	3
<i>Ditches Total</i>	Unimproved Drainage System	1
<b>SRI Total</b>	<b>Low Risk</b>	<b>46</b>

Notes: Semi-private road. Dead end, does not appear to receive a lot of traffic.

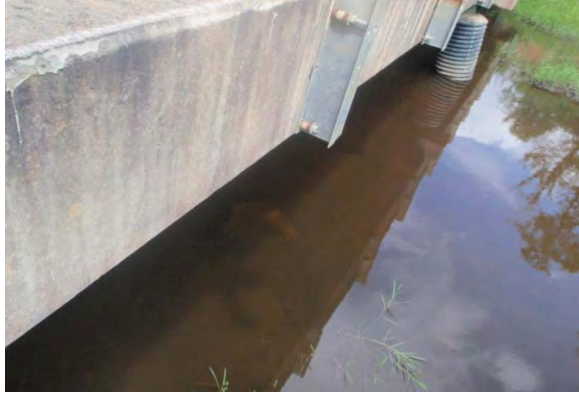
Crossing Structure: DS

Risk Factor	Ranking	Score
<i>US Channel Morph</i>	C	5
<i>DS Channel Morph</i>	C	5
<i>DS Bank Alteration</i>	MINOR/PARTIAL	3
<i>Upstream Skew Angle</i>	5-30°	3
<i>Crossing fill condition</i>	Fair/Rip Rap	3
<i>Inlet/Outlet Condition</i>	No Impairment	5
<i>Road Approach Material</i>	All Aggregate	5
<i>Potential Eroded Volume Mean</i>	<21 y <sup>3</sup>	5
<i>Approach Slope Mean</i>	2.1-4%	3
<i>Soil K Factor</i>	<0.20	5
<i>Upstream Rt Outlet</i>	Vegetated	1
<i>Upstream Lt Outlet</i>	Vegetated	1
<i>Upstream Rt Ditch</i>	Bare soil	0
<i>Upstream Lt Ditch</i>	Bare soil	0
<i>Downstream Rt Outlet</i>	Bare soil	0
<i>Downstream Lt Outlet</i>	Vegetated	1
<i>Downstream Rt Ditch</i>	Bare soil	0
<i>Downstream Lt Ditch</i>	Bare soil	0
<i>Outlet Total</i>	Partially Improved Outlet System	3
<i>Ditches Total</i>	Unimproved Drainage System	1
<b>SRI Total</b>	<b>Low Risk</b>	<b>46</b>

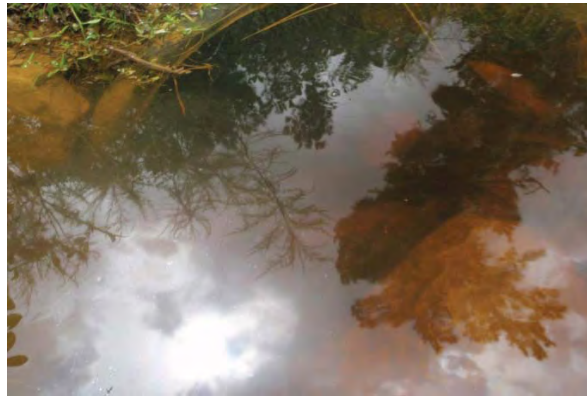
Crossing Structure: DS

Risk Factor	Ranking	Score
<i>US Channel Morph</i>	B	5
<i>DS Channel Morph</i>	C	5
<i>DS Bank Alteration</i>	HIGH	1
<i>Upstream Skew Angle</i>	<5°	5
<i>Crossing fill condition</i>	Poor/Bare soil	1
<i>Inlet/Outlet Condition</i>	Sed Islands/Scouring	3
<i>Road Approach Material</i>	All Sand/Clay	3
<i>Potential Eroded Volume Mean</i>	<21 y <sup>3</sup>	5
<i>Approach Slope Mean</i>	<2%	5
<i>Soil K Factor</i>	<0.20	5
<i>Upstream Rt Outlet</i>	Vegetated	1
<i>Upstream Lt Outlet</i>	Vegetated	1
<i>Upstream Rt Ditch</i>	Vegetated	1
<i>Upstream Lt Ditch</i>	Vegetated	1
<i>Downstream Rt Outlet</i>	Bare soil	0
<i>Downstream Lt Outlet</i>	Bare soil	0
<i>Downstream Rt Ditch</i>	Vegetated	1
<i>Downstream Lt Ditch</i>	Vegetated	1
<i>Outlet Total</i>	Partially Improved Outlet System	3
<i>Ditches Total</i>	Improved Drainage System	5
<b>SRI Total</b>	<b>Low Risk</b>	<b>46</b>

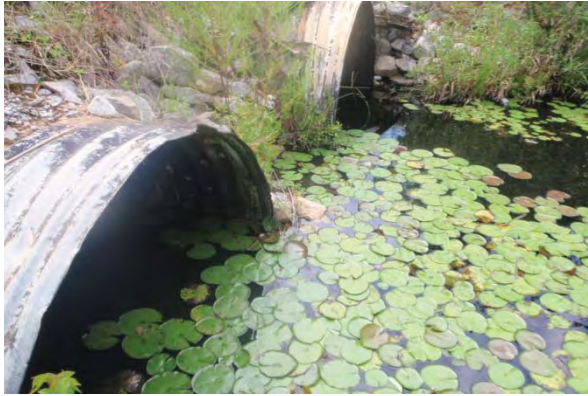
Crossing Structure: DS

Risk Factor	Ranking	Score
<i>US Channel Morph</i>	BEAVER DAM	3
<i>DS Channel Morph</i>	PONDED	1
<i>DS Bank Alteration</i>	MINOR/PARTIAL	3
<i>Upstream Skew Angle</i>	<5°	5
<i>Crossing fill condition</i>	Good/Vegetated	5
<i>Inlet/Outlet Condition</i>	No Impairment	5
<i>Road Approach Material</i>	All Sand/Clay	3
<i>Potential Eroded Volume Mean</i>	<21 y <sup>3</sup>	5
<i>Approach Slope Mean</i>	<2%	5
<i>Soil K Factor</i>	<0.20	5
<i>Upstream Rt Outlet</i>	Vegetated	1
<i>Upstream Lt Outlet</i>	Vegetated	1
<i>Upstream Rt Ditch</i>	Vegetated	1
<i>Upstream Lt Ditch</i>	Vegetated	1
<i>Downstream Rt Outlet</i>	Vegetated	1
<i>Downstream Lt Outlet</i>	Vegetated	1
<i>Downstream Rt Ditch</i>	Vegetated	1
<i>Downstream Lt Ditch</i>	Bare soil	0
<i>Outlet Total</i>	Improved Outlet System	5
<i>Ditches Total</i>	Partially Improved Drainage System	3
<b>SRI Total</b>	<b>Low Risk</b>	<b>48</b>

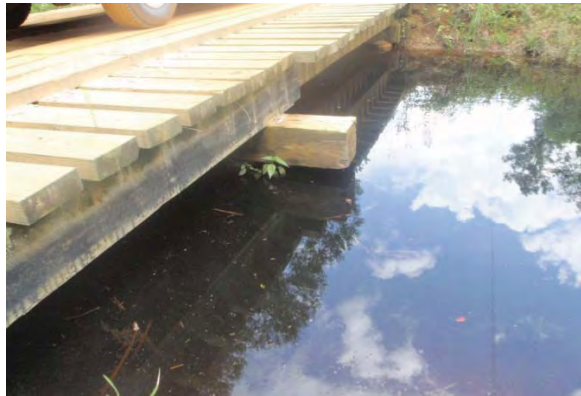
Crossing Structure: DS

Risk Factor	Ranking	Score
<i>US Channel Morph</i>	DA	3
<i>DS Channel Morph</i>	DA	3
<i>DS Bank Alteration</i>	HIGH	1
<i>Upstream Skew Angle</i>	<5°	5
<i>Crossing fill condition</i>	Good/Vegetated	5
<i>Inlet/Outlet Condition</i>	No Impairment	5
<i>Road Approach Material</i>	All Sand/Clay	3
<i>Potential Eroded Volume Mean</i>	<21 y <sup>3</sup>	5
<i>Approach Slope Mean</i>	<2%	5
<i>Soil K Factor</i>	<0.20	5
<i>Upstream Rt Outlet</i>	Vegetated	1
<i>Upstream Lt Outlet</i>	Vegetated	1
<i>Upstream Rt Ditch</i>	Vegetated	1
<i>Upstream Lt Ditch</i>	Bare soil	0
<i>Downstream Rt Outlet</i>	Vegetated	1
<i>Downstream Lt Outlet</i>	Vegetated	1
<i>Downstream Rt Ditch</i>	Bare soil	0
<i>Downstream Lt Ditch</i>	Vegetated	1
<i>Outlet Total</i>	Improved Outlet System	5
<i>Ditches Total</i>	Partially Improved Drainage System	3
<b>SRI Total</b>	<b>Low Risk</b>	<b>48</b>

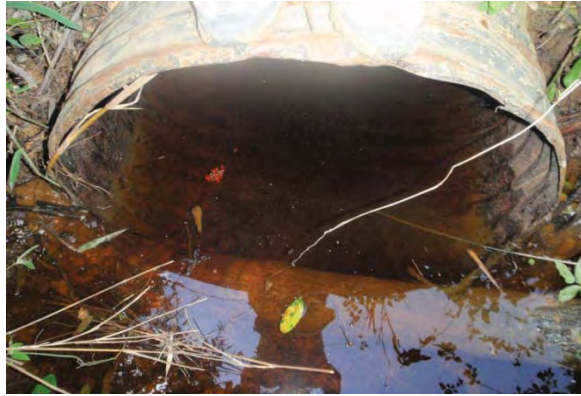
Crossing Structure: US

Risk Factor	Ranking	Score
<i>US Channel Morph</i>	A	5
<i>DS Channel Morph</i>	C	5
<i>DS Bank Alteration</i>	MINOR/PARTIAL	3
<i>Upstream Skew Angle</i>	5-30°	3
<i>Crossing fill condition</i>	Good/Vegetated	5
<i>Inlet/Outlet Condition</i>	Sed Islands/Scouring	3
<i>Road Approach Material</i>	All Sand/Clay	3
<i>Potential Eroded Volume Mean</i>	<21 y <sup>3</sup>	5
<i>Approach Slope Mean</i>	<2%	5
<i>Soil K Factor</i>	<0.20	5
<i>Upstream Rt Outlet</i>	Vegetated	1
<i>Upstream Lt Outlet</i>	Vegetated	1
<i>Upstream Rt Ditch</i>	Bare soil	0
<i>Upstream Lt Ditch</i>	Vegetated	1
<i>Downstream Rt Outlet</i>	Vegetated	1
<i>Downstream Lt Outlet</i>	Vegetated	1
<i>Downstream Rt Ditch</i>	Bare soil	0
<i>Downstream Lt Ditch</i>	Vegetated	1
<i>Outlet Total</i>	Improved Outlet System	5
<i>Ditches Total</i>	Partially Improved Drainage System	3
<b>SRI Total</b>	<b>Low Risk</b>	<b>50</b>

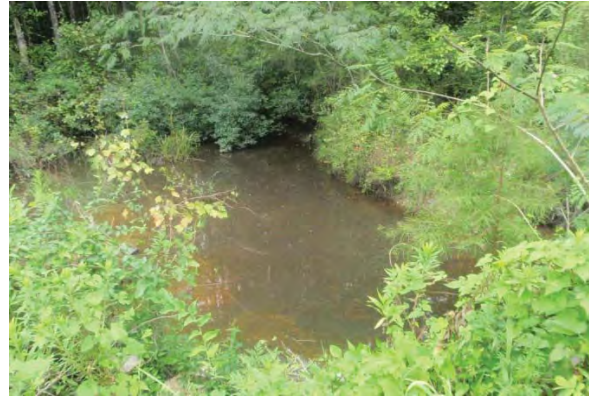
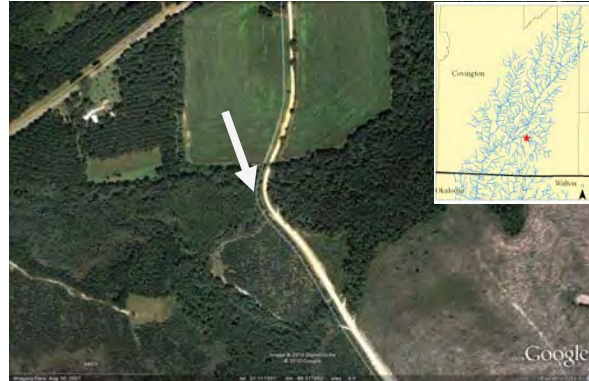
Crossing Structure: DS

Risk Factor	Ranking	Score
<i>US Channel Morph</i>	E	5
<i>DS Channel Morph</i>	E	5
<i>DS Bank Alteration</i>	MINOR/PARTIAL	3
<i>Upstream Skew Angle</i>	<5°	5
<i>Crossing fill condition</i>	Good/Vegetated	5
<i>Inlet/Outlet Condition</i>	No Impairment	5
<i>Road Approach Material</i>	All Sand/Clay	3
<i>Potential Eroded Volume Mean</i>	<21 y <sup>3</sup>	5
<i>Approach Slope Mean</i>	<2%	5
<i>Soil K Factor</i>	<0.20	5
<i>Upstream Rt Outlet</i>	Vegetated	1
<i>Upstream Lt Outlet</i>	Vegetated	1
<i>Upstream Rt Ditch</i>	Vegetated	1
<i>Upstream Lt Ditch</i>	Bare soil	0
<i>Downstream Rt Outlet</i>	Vegetated	1
<i>Downstream Lt Outlet</i>	Vegetated	1
<i>Downstream Rt Ditch</i>	Bare soil	0
<i>Downstream Lt Ditch</i>	Bare soil	0
<i>Outlet Total</i>	Improved Outlet System	5
<i>Ditches Total</i>	Partially Improved Drainage System	3
<b>SRI Total</b>	<b>Low Risk</b>	<b>54</b>

Notes: Highly vegetated.

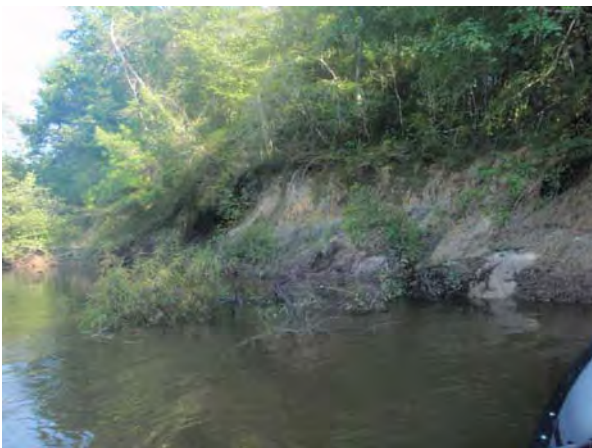
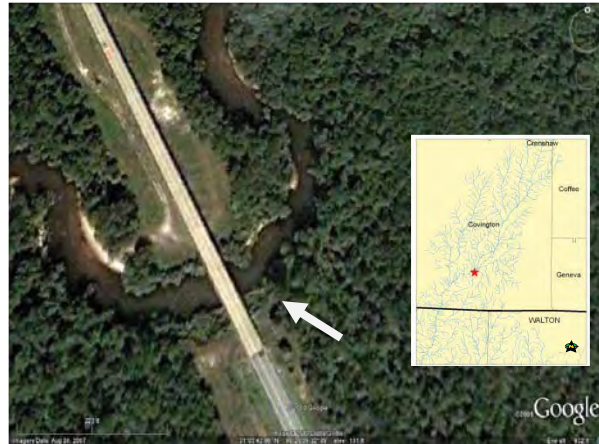
<b>Yellow River</b>	<b>co-0807-008</b>	<b>Severity Score</b> <b>5.25</b>
---------------------	--------------------	--------------------------------------

Risk Factor	Ranking	Score	Feature	Within Range	Descriptive Field
<i>Channel Stability</i>	Fair	1	303(d)	Yes	METALS (MERCURY)
<i>Channel Alteration</i>	None	0	Wetland Species	No	N/A
<i>Bank Erosion</i>	Active	1	Rare and Imperiled	No	N/A
<i>BEHI</i>	Moderate	0.5	Sturgeon Spawning	No	N/A
<i>Local NPSP</i>	Obvious Sources	1	Candidate Mussels	Yes	FUZZY PIGTOE, SOUTHERN SANDSHELL
<i>Shoring Structures</i>	Present	1.5	Sturgeon C.H.	No	N/A
<i>Pipe Discharge</i>	Not Present	0	Notes: Shoring structure under Hwy 55 bridge composed of concrete and rip rap.		
<i>Water Odors</i>	Not Present	0			
<i>Fish Passage Barrier</i>	Not Present	0			
<i>RB: Riparian Buffer</i>	100+ ft	0			
<i>LB: Riparian Buffer</i>	100+ ft	0			
<i>RB: Floodplain Access</i>	Full	0			
<i>LB: Floodplain Access</i>	Partial	0.25			
<b>River Threat Index:</b>		<b>5.25</b>			
<b>Additional Site Features</b>					
<i>Stream Channel Woody Material:</i>	Infrequent

Restoration Recommendations: TBD

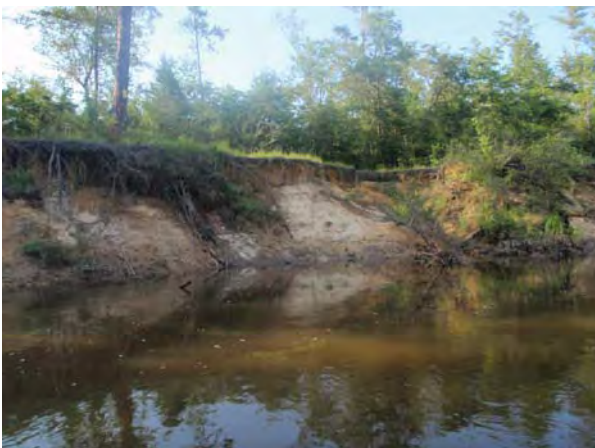
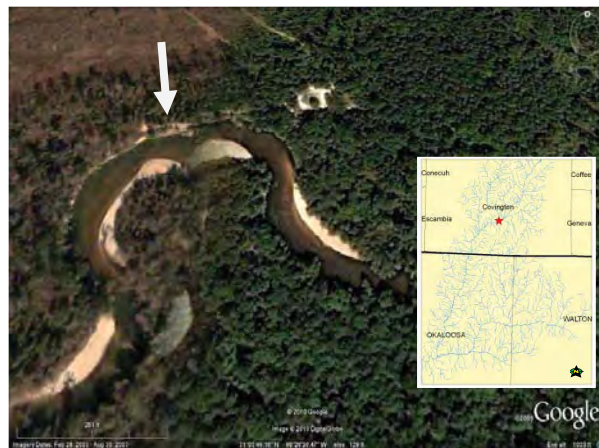
<b>Yellow River</b>	<b>co-0807-009</b>	<b>Severity Score</b> <b>5</b>
---------------------	--------------------	-----------------------------------

Risk Factor	Ranking	Score	Feature	Within Range	Descriptive Field
<i>Channel Stability</i>	Fair	1	303(d)	Yes	METALS (MERCURY)
<i>Channel Alteration</i>	None	0	Wetland Species	No	N/A
<i>Bank Erosion</i>	Mass-wasting	1.5	Rare and Imperiled	No	N/A
<i>BEHI</i>	High	1	Land Use/Cover	No	N/A
<i>Local NPSP</i>	No Evidence	0	Candidate Mussels	Yes	FUZZY PIGTOE, SOUTHERN SANDSHELL
<i>Shoring Structures</i>	Not Present	0	Sturgeon C.H.	Yes	N/A
<i>Pipe Discharge</i>	Not Present	0	<b>Additional Site Features</b>		
<i>Water Odors</i>	Not Present	0	<i>Stream Channel Woody Material:</i> Infrequent		
<i>Fish Passage Barrier</i>	Not Present	0	<i>Impoundments:</i> None		
<i>RB: Riparian Buffer</i>	0-29 ft	0.75	<i>Substrate Composition:</i> Medium Sand		
<i>LB: Riparian Buffer</i>	100+ ft	0	<i>Bank Material:</i> Sand		
<i>RB: Floodplain Access</i>	None	0.75			
<i>LB: Floodplain Access</i>	Full	0			
<b>River Threat Index:</b>		<b>5</b>

Notes: Past silviculture area. Large reach.
