Appendix A. River corridor severity scores for impaired sites in the Yellow River Basin, Alabama and Florida

Appendix C. Clear Creek Watershed Focal Area. Sites with orange headings are unpaved road sites. Specific definitions and calculations described for calculating the Sediment Risk Index (SRI) are detailed in Witmer (2009).

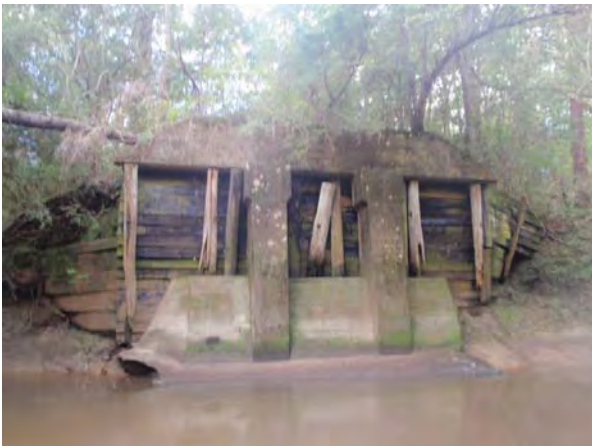
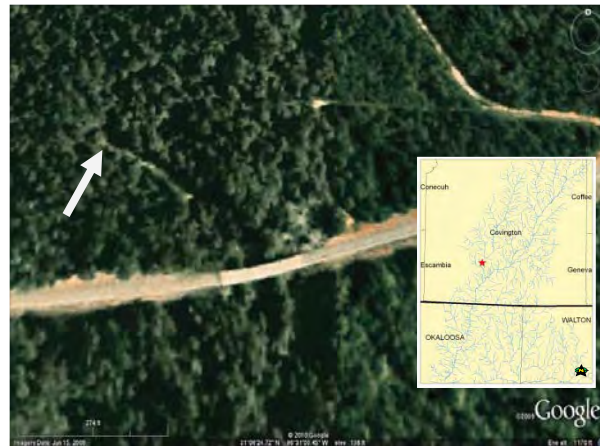
Risk Factor	Ranking	Score	Feature	Within Range	Descriptive Field
<i>Channel Stability</i>	Good	0.5	303(d)	No	N/A
<i>Channel Alteration</i>	Historic, Mostly Recovered	0.5	Wetland Species	No	N/A
<i>Bank Erosion</i>	Not Eroding	0	Rare and Imperiled	No	N/A
<i>BEHI</i>	High	1	Land Use/Cover	Yes	N/A/ EAST GULF COASTAL PLAIN SOUTHERN MESIC SLOPE FOREST, UPLAND LONGLEAF PINE WOODLAND - OPEN UNDERSTORY MODI
<i>Local NPSP</i>	No Evidence	0	Candidate Mussels	Yes	CHOCTAW BEAN
<i>Shoring Structures</i>	Present	1.5	Sturgeon C.H.	No	N/A
<i>Pipe Discharge</i>	Not Present	0	<b>Additional Site Features</b>		
<i>Water Odors</i>	Not Present	0	<i>Stream Channel Woody Material:</i> Infrequent		
<i>Fish Passage Barrier</i>	Not Present	0	<i>Impoundments:</i> None		
<i>RB: Riparian Buffer</i>	0-29 ft	0.75	<i>Substrate Composition:</i> Medium Sand		
<i>LB: Riparian Buffer</i>	100+ ft	0	<i>Bank Material:</i> Sand and Manmade Materials

<i>RB: Floodplain Access</i>	Partial	0.25			
<i>LB: Floodplain Access</i>	Full	0			
<b>River Threat Index:</b>		<b>4.5</b>

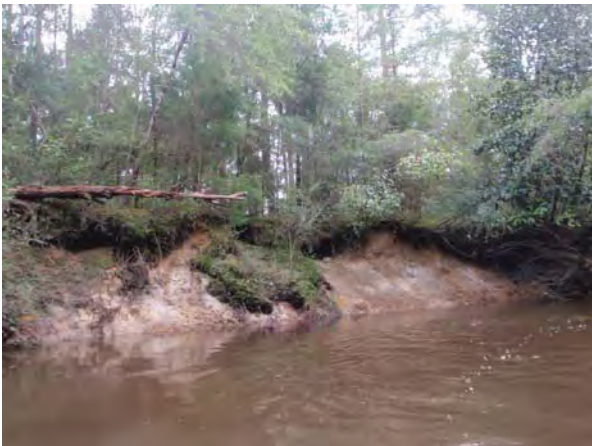
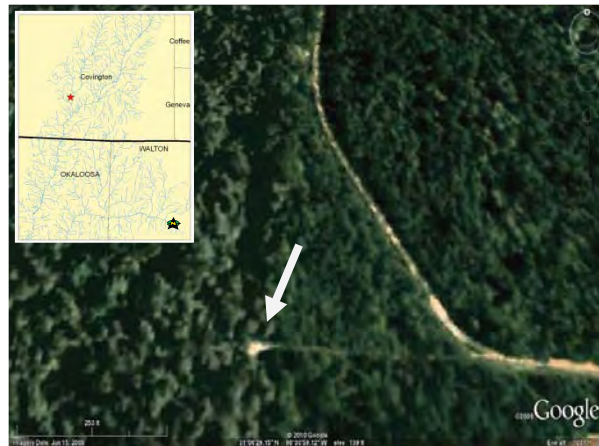
<b>Five Runs Creek</b>	<b>co-0924-002</b>	<b>Severity Score</b> <b>4.5</b>
------------------------	--------------------	-------------------------------------

Risk Factor	Ranking	Score	Feature	Within Range	Descriptive Field
<i>Channel Stability</i>	Fair	1	303(d)	No	N/A
<i>Channel Alteration</i>	None	0	Wetland Species	No	N/A
<i>Bank Erosion</i>	Mass Wasting	1.5	Rare and Imperiled	No	N/A
<i>BEHI</i>	High	1	Land Use/Cover	Yes	N/A/ EAST GULF COASTAL PLAIN INTERIOR UPLAND LONGLEAF PINE WOODLAND - LOBLOLLY MODIFIER
<i>Local NPSP</i>	Moderate Potential	1	Candidate Mussels	Yes	CHOCTAW BEAN
<i>Shoring Structures</i>	Not Present	0	Sturgeon C.H.	No	N/A
<i>Pipe Discharge</i>	Not Present	0	<b>Additional Site Features</b>		
<i>Water Odors</i>	Not Present	0	<i>Stream Channel Woody Material:</i> Moderate		
<i>Fish Passage Barrier</i>	Not Present	0	<i>Impoundments:</i> None		
<i>RB: Riparian Buffer</i>	100+ ft	0	<i>Substrate Composition:</i> Medium Sand		
<i>LB: Riparian Buffer</i>	100+ ft	0	<i>Bank Material:</i> Sand		
<i>RB: Floodplain Access</i>	Full	0			
<i>LB: Floodplain Access</i>	Full	0

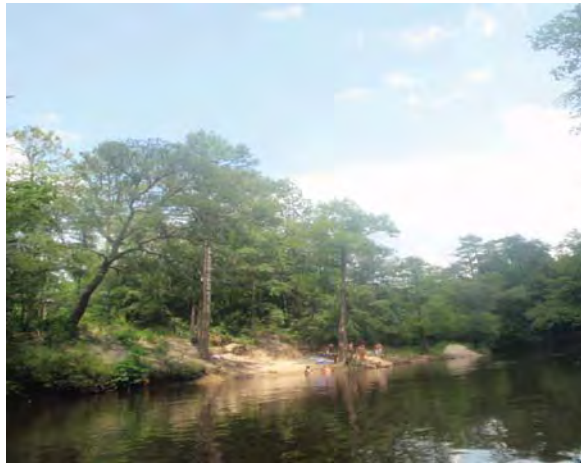
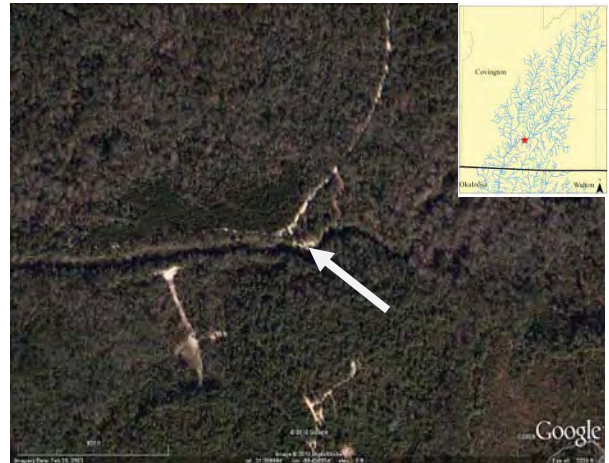
<b>Yellow River</b>	<b>co-0610-001</b>	<i>River Threat Index</i> <b>4.25</b>
---------------------	--------------------	--

Risk Factor	Ranking	Score	Feature	Within Range	Descriptive Field
<i>Channel Stability</i>	Good	0.5	303(d)	No	N/A
<i>Channel Alteration</i>	None	0	Wetland Species	No	N/A
<i>Bank Erosion</i>	Active Erosion	1	Rare and Imperiled	No	N/A
<i>BEHI</i>	Moderate	0.5	Land Use/Cover	No	N/A
<i>Local NPSP</i>	Obvious Sources	1.5	Candidate Mussels	No	N/A
<i>Shoring Structures</i>	Not Present	0	Sturgeon C.H.	Yes	N/A
<i>Pipe Discharge</i>	Not Present	0	<b>Additional Site Features</b>		
<i>Water Odors</i>	Not Present	0	<i>Stream Channel Woody Material:</i> Infrequent		
<i>Fish Passage Barrier</i>	Not Present	0	<i>Impoundments:</i> None		
<i>RB: Riparian Buffer</i>	0-29 ft	0.75	<i>Substrate Composition:</i> Sand		
<i>LB: Riparian Buffer</i>	100+ ft	0	<i>Bank Material:</i> Sand, limestone, some clay		
<i>RB: Floodplain Access</i>	Full	0			
<i>LB: Floodplain Access</i>	Full	0			
<b>River Threat Index:</b>		<b>4.25</b>

Notes: Recreational site and known Gulf Sturgeon spawning location. High sediment load coming from unimproved unpaved Drip Rock Road. Fake (?) surveillance closed circuit cameras installed on surrounding trees. Trash barrels present on shore.

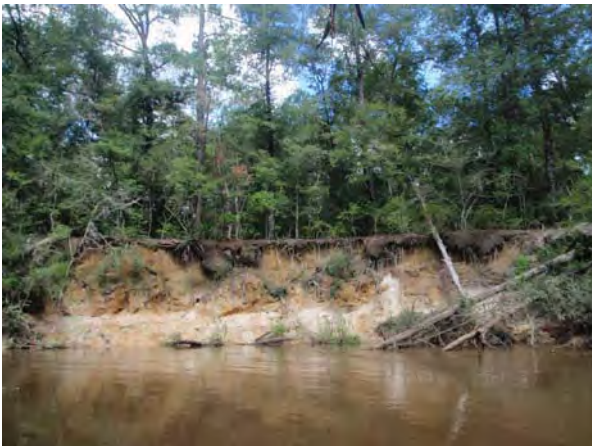
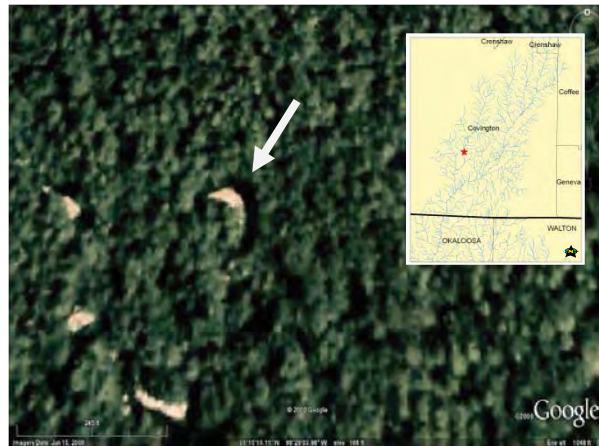
<b>Five Runs Creek</b>	<b>co-0923-003</b>	<i>Severity Score</i> <b>3.75</b>
------------------------	--------------------	--------------------------------------

Risk Factor	Ranking	Score	Feature	Within Range	Descriptive Field
<i>Channel Stability</i>	Poor	1.5	303(d)	No	N/A
<i>Channel Alteration</i>	None	0	Wetland Species	No	N/A
<i>Bank Erosion</i>	Active	1	Rare and Imperiled	No	N/A
<i>BEHI</i>	High	1	Land Use/Cover	No	N/A
<i>Local NPSP</i>	No Evidence	0	Candidate Mussels	No	N/A
<i>Shoring Structures</i>	Not Present	0	Sturgeon C.H.	No	N/A
<i>Pipe Discharge</i>	Not Present	0	<b>Additional Site Features</b>		
<i>Water Odors</i>	Not Present	0	<i>Stream Channel Woody Material:</i> Moderate		
<i>Fish Passage Barrier</i>	Not Present	0	<i>Impoundments:</i> None		
<i>RB: Riparian Buffer</i>	100+ ft	0	<i>Substrate Composition:</i> Medium Sand		
<i>LB: Riparian Buffer</i>	100+ ft	0	<i>Bank Material:</i> Clay and Sand		
<i>RB: Floodplain Access</i>	Full	0			
<i>LB: Floodplain Access</i>	Partial	0.25			
<b>River Threat Index:</b>		<b>3.75</b>

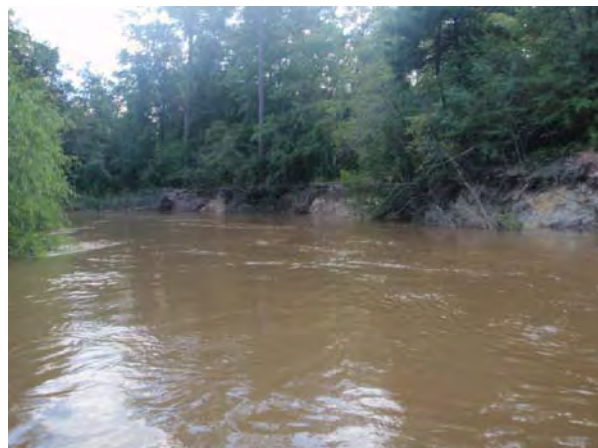
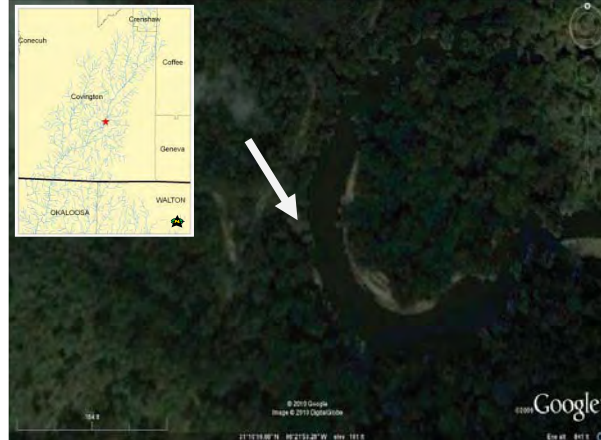
<b>Yellow River</b>	<b>co-0813-003</b>	<b>Severity Score</b> <b>3.25</b>
---------------------	--------------------	--------------------------------------

Risk Factor	Ranking	Score	Feature	Within Range	Descriptive Field
<i>Channel Stability</i>	Fair	1	303(d)	No	N/A
<i>Channel Alteration</i>	None	0	Wetland Species	No	N/A
<i>Bank Erosion</i>	Active	1	Rare and Imperiled	No	N/A
<i>BEHI</i>	Moderate	0.5	Land Use/Cover	Yes	N/A/ UPLAND LONGLEAF PINE WOODLAND - OPEN UNDERSTORY MODI
<i>Local NPSP</i>	No Evidence	0	Candidate Mussels	No	N/A
<i>Shoring Structures</i>	Not Present	0	Sturgeon C.H.	No	N/A
<i>Pipe Discharge</i>	Not Present	0	<b>Additional Site Features</b>		
<i>Water Odors</i>	Not Present	0	<i>Stream Channel Woody Material:</i> Infrequent		
<i>Fish Passage Barrier</i>	Not Present	0	<i>Impoundments:</i> None		
<i>RB: Riparian Buffer</i>	0-29 ft	0.75	<i>Substrate Composition:</i> Medium Sand		
<i>LB: Riparian Buffer</i>	100+ ft	0	<i>Bank Material:</i> Sandy Loam		
<i>RB: Floodplain Access</i>	Full	0			
<i>LB: Floodplain Access</i>	Full	0			
<b>River Threat Index:</b>		<b>3.25</b>

Notes: Large reach of active erosion.

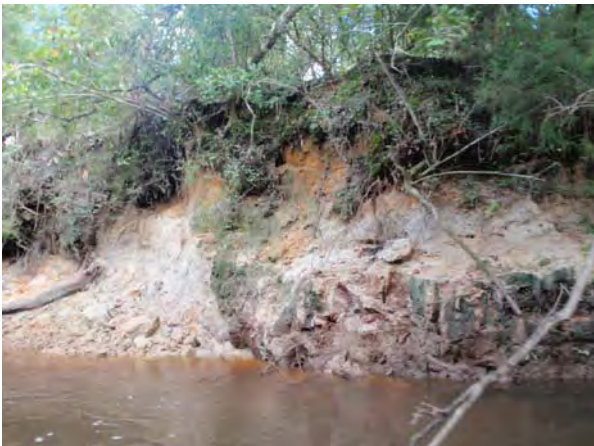
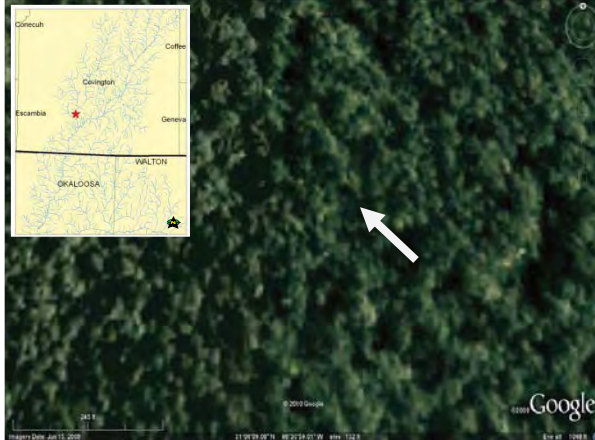
<b>Five Runs Creek</b>	<b>co-0924-004</b>	<i>Severity Score</i> <b>2.75</b>
------------------------	--------------------	--------------------------------------

Risk Factor	Ranking	Score	Feature	Within Range	Descriptive Field
<i>Channel Stability</i>	Fair	1	303(d)	No	N/A
<i>Channel Alteration</i>	None	0	Wetland Species	No	N/A
<i>Bank Erosion</i>	Active	1	Rare and Imperiled	No	N/A
<i>BEHI</i>	Low-Very Low	0.5	Land Use/Cover	No	N/A
<i>Local NPSP</i>	No Evidence	0	Candidate Mussels	Yes	CHOCTAW BEAN
<i>Shoring Structures</i>	Not Present	0	Sturgeon C.H.	No	N/A
<i>Pipe Discharge</i>	Not Present	0	<b>Additional Site Features</b>		
<i>Water Odors</i>	Not Present	0	<i>Stream Channel Woody Material:</i> Moderate		
<i>Fish Passage Barrier</i>	Not Present	0	<i>Impoundments:</i> None		
<i>RB: Riparian Buffer</i>	100+ ft	0	<i>Substrate Composition:</i> Medium Sand		
<i>LB: Riparian Buffer</i>	100+ ft	0	<i>Bank Material:</i> Sand and Clay		
<i>RB: Floodplain Access</i>	Partial	0.25			
<i>LB: Floodplain Access</i>	Full	0			
<b>River Threat Index:</b>		<b>2.75</b>

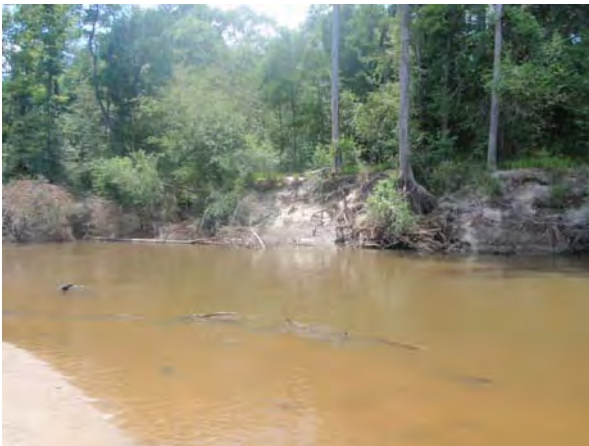
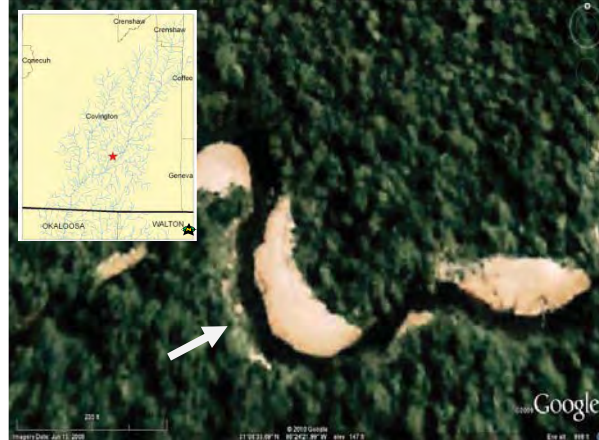
<b>Yellow River</b>	<b>co-0807-003</b>	<b>Severity Score</b> <b>2.5</b>
---------------------	--------------------	-------------------------------------

Risk Factor	Ranking	Score	Feature	Within Range	Descriptive Field
<i>Channel Stability</i>	Good	0.5	303(d)	No	N/A
<i>Channel Alteration</i>	None	0	Wetland Species	No	N/A
<i>Bank Erosion</i>	Active	1	Rare and Imperiled	No	N/A
<i>BEHI</i>	Moderate	0.5	Land Use/Cover	Yes	N/A / EAST GULF COASTAL PLAIN SMALL STREAM AND RIVER FLOODPLAIN FOREST
<i>Local NPSP</i>	No Evidence	0	Candidate Mussels	No	N/A
<i>Shoring Structures</i>	Not Present	0	Sturgeon C.H.	No	N/A
<i>Pipe Discharge</i>	Not Present	0	<b>Additional Site Features</b>		
<i>Water Odors</i>	Not Present	0	<i>Stream Channel Woody Material:</i> Moderate		
<i>Fish Passage Barrier</i>	Not Present	0	<i>Impoundments:</i> None		
<i>RB: Riparian Buffer</i>	100+ ft	0	<i>Substrate Composition:</i> Medium Sand		
<i>LB: Riparian Buffer</i>	50-99 ft	0.25	<i>Bank Material:</i> Sand		
<i>RB: Floodplain Access</i>	Full	0			
<i>LB: Floodplain Access</i>	Partial	0.25			
<b>River Threat Index:</b>		<b>2.5</b>

Notes: Numerous deposits and some bank erosion present.

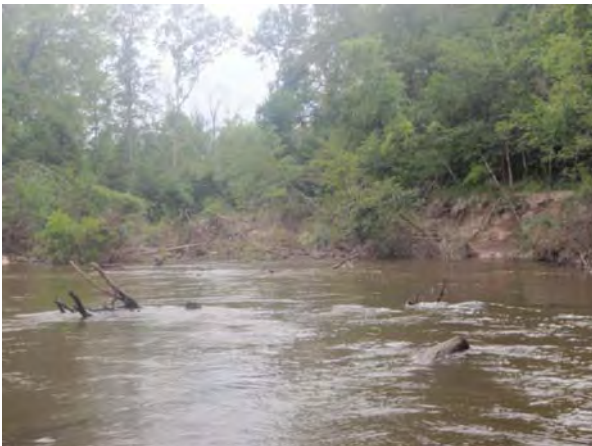
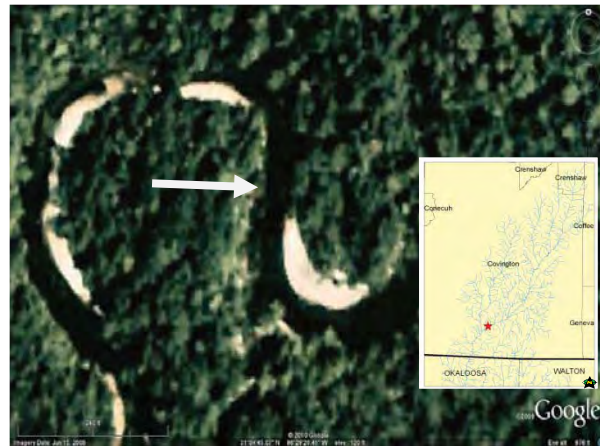
<h1>Yellow River</h1>	<h2>co-0805-004</h2>	<b>Severity Score</b> <h1>2.25</h1>
-----------------------	----------------------	--

Risk Factor	Ranking	Score	Feature	Within Range	Descriptive Field
<i>Channel Stability</i>	Good	0.5	303(d)	Yes	METALS- MERCURY
<i>Channel Alteration</i>	None	0	Wetland Species	No	N/A
<i>Bank Erosion</i>	Active	1	Rare and Imperiled	No	N/A
<i>BEHI</i>	Moderate	0.5	Land Use/ Cover	Yes	N/A / UPLAND LONGLEAF PINE WOODLAND - OPEN UNDERSTORY MODI
<i>Local NPSP</i>	No Evidence	0	Candidate Mussels	No	N/A
<i>Shoring Structures</i>	Not Present	0	Sturgeon C.H.	Yes	N/A
<i>Pipe Discharge</i>	Not Present	0	<b>Additional Site Features</b>		
<i>Water Odors</i>	Not Present	0	<i>Stream Channel Woody Material:</i> Moderate		
<i>Fish Passage Barrier</i>	Not Present	0	<i>Impoundments:</i> None		
<i>RB: Riparian Buffer</i>	100+ ft	0	<i>Substrate Composition:</i> Medium Sand		
<i>LB: Riparian Buffer</i>	100+ ft	0	<i>Bank Material:</i> Sand		
<i>RB: Floodplain Access</i>	Partial	0.25			
<i>LB: Floodplain Access</i>	Full	0			
<b>River Threat Index:</b>		<b>2.25</b>

Notes: Numerous amounts of large woody debris and deep pools.

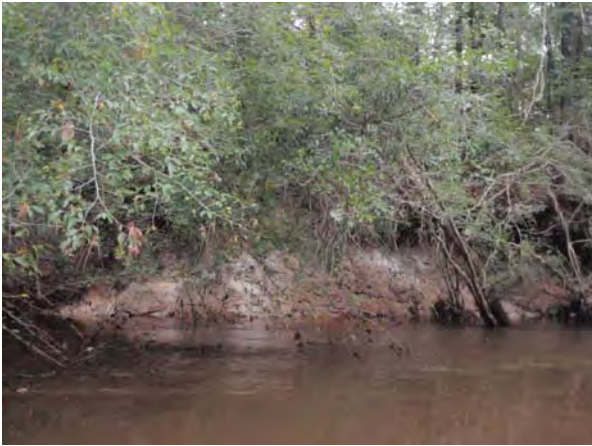
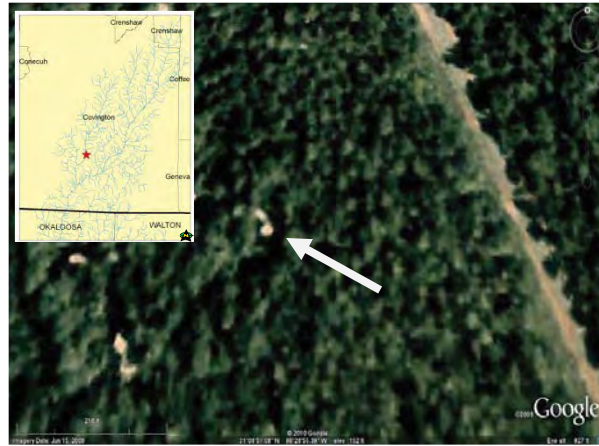
<b>Five Runs Creek</b>	<b>co-0924-001</b>	<i>Severity Score</i> <b>2.25</b>
------------------------	--------------------	--------------------------------------

Risk Factor	Ranking	Score	Feature	Within Range	Descriptive Field
<i>Channel Stability</i>	Good	0.5	303(d)	No	N/A
<i>Channel Alteration</i>	None	0	Wetland Species	No	N/A
<i>Bank Erosion</i>	Active	1	Rare and Imperiled	No	N/A
<i>BEHI</i>	Moderate	0.5	Land Use/Cover	No	N/A
<i>Local NPSP</i>	No Evidence	0	Candidate Mussels	No	N/A
<i>Shoring Structures</i>	Not Present	0	Sturgeon C.H.	No	N/A
<i>Pipe Discharge</i>	Not Present	0	<b>Additional Site Features</b>		
<i>Water Odors</i>	Not Present	0	<i>Stream Channel Woody Material:</i> Numerous		
<i>Fish Passage Barrier</i>	Not Present	0	<i>Impoundments:</i> None		
<i>RB: Riparian Buffer</i>	100+ ft	0	<i>Substrate Composition:</i> Medium Sand		
<i>LB: Riparian Buffer</i>	100+ ft	0	<i>Bank Material:</i> Sand and Roots		
<i>RB: Floodplain Access</i>	Partial	0.25			
<i>LB: Floodplain Access</i>	Full	0			
<b>River Threat Index:</b>		<b>2.25</b>

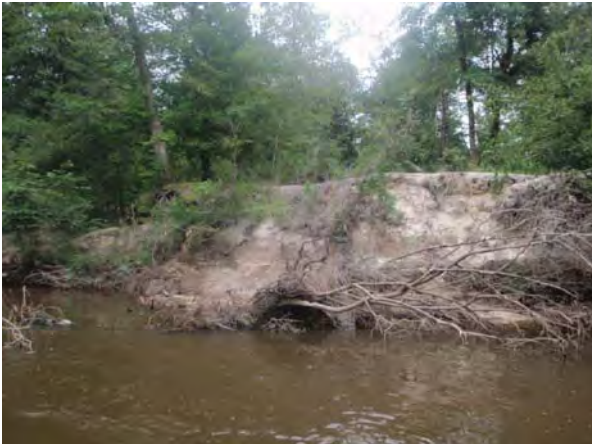
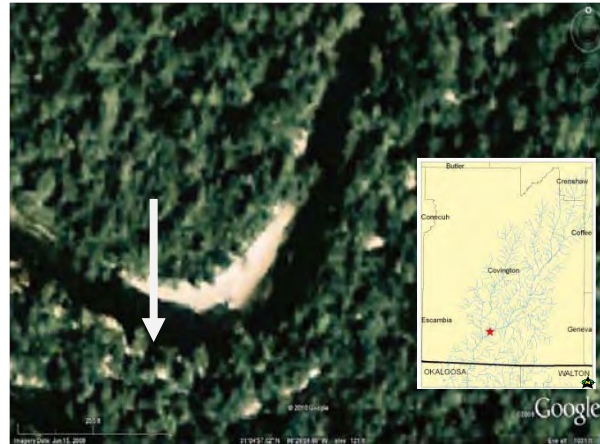
<b>Yellow River</b>	<b>co-0805-002</b>	<b>Severity Score</b> <b>1.75</b>
---------------------	--------------------	--------------------------------------

Risk Factor	Ranking	Score	Feature	Within Range	Descriptive Field
<i>Channel Stability</i>	Good	0.5	303(d)	Yes	METALS- MERCURY
<i>Channel Alteration</i>	None	0	Wetland Species	No	N/A
<i>Bank Erosion</i>	Historic	0.5	Rare and Imperiled	No	N/A
<i>BEHI</i>	Moderate	0.5	Land Use/ Cover	Yes	N/A / OPEN WATER (FRESH)
<i>Local NPSP</i>	No Evidence	0	Candidate Mussels	No	N/A
<i>Shoring Structures</i>	Not Present	0	Sturgeon C.H.	Yes	N/A
<i>Pipe Discharge</i>	Not Present	0	<b>Additional Site Features</b>		
<i>Water Odors</i>	Not Present	0	<i>Stream Channel Woody Material:</i> Moderate		
<i>Fish Passage Barrier</i>	Not Present	0	<i>Impoundments:</i> None		
<i>RB: Riparian Buffer</i>	100+ ft	0	<i>Substrate Composition:</i> Medium Sand		
<i>LB: Riparian Buffer</i>	50-99 ft	0.25	<i>Bank Material:</i> Sand		
<i>RB: Floodplain Access</i>	Full	0			
<i>LB: Floodplain Access</i>	Full	0			
<b>River Threat Index:</b>		<b>1.75</b>

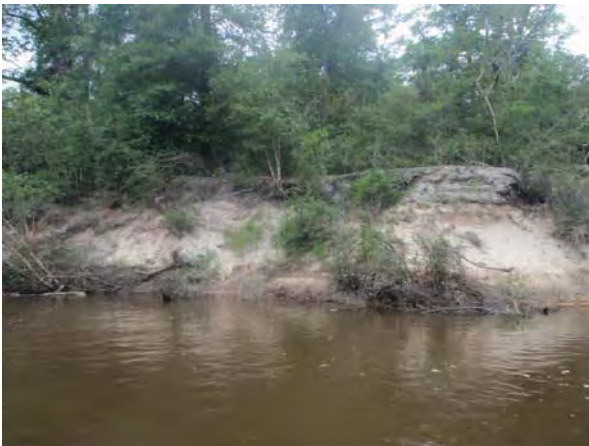
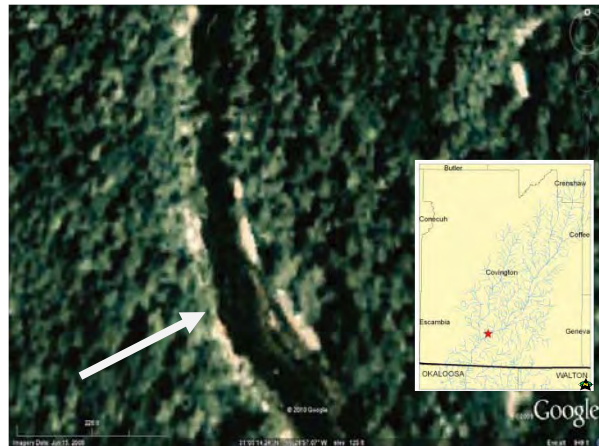
<b>Yellow River</b>	<b>co-0805-001</b>	<b>Severity Score</b> <b>1.75</b>
---------------------	--------------------	--------------------------------------

Risk Factor	Ranking	Score	Feature	Within Range	Descriptive Field
<i>Channel Stability</i>	Good	0.5	303(d)	Yes	METALS- MERCURY
<i>Channel Alteration</i>	None	0	Wetland Species	No	N/A
<i>Bank Erosion</i>	Historic	0.5	Rare and Imperiled	No	N/A
<i>BEHI</i>	Moderate	0.5	Land Use/ Cover	No	N/A
<i>Local NPSP</i>	No Evidence	0	Candidate Mussels	No	N/A
<i>Shoring Structures</i>	Not Present	0	Sturgeon C.H.	Yes	N/A
<i>Pipe Discharge</i>	Not Present	0	<b>Additional Site Features</b>		
<i>Water Odors</i>	Not Present	0	<i>Stream Channel Woody Material:</i> Numerous		
<i>Fish Passage Barrier</i>	Not Present	0	<i>Impoundments:</i> None		
<i>RB: Riparian Buffer</i>	100+ ft	0	<i>Substrate Composition:</i> Medium Sand		
<i>LB: Riparian Buffer</i>	100+ ft	0	<i>Bank Material:</i> Sand		
<i>RB: Floodplain Access</i>	Partial	0.25			
<i>LB: Floodplain Access</i>	Full	0			
<b>River Threat Index:</b>		<b>1.75</b>

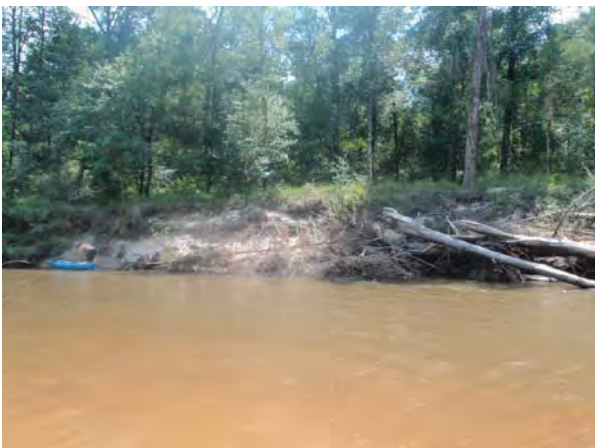
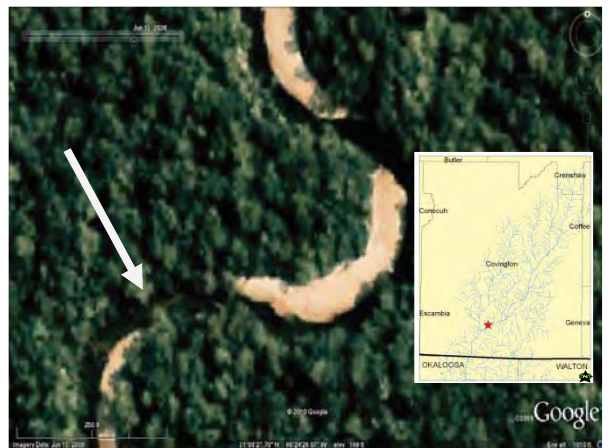
<h1>Yellow River</h1>	<h2>co-0807-005</h2>	<b>Severity Score</b> <h1>1.75</h1>
-----------------------	----------------------	--

Risk Factor	Ranking	Score	Feature	Within Range	Descriptive Field
<i>Channel Stability</i>	Good	0.5	303(d)	No	N/A
<i>Channel Alteration</i>	None	0	Wetland Species	No	N/A
<i>Bank Erosion</i>	Historic	0.5	Rare and Imperiled	No	N/A
<i>BEHI</i>	Moderate	0.5	Land Use/Cover	Yes	N/A / EAST GULF COASTAL PLAIN SMALL STREAM AND RIVER FLOODPLAIN FOREST
<i>Local NPSP</i>	No Evidence	0	Candidate Mussels	No	N/A
<i>Shoring Structures</i>	Not Present	0	Sturgeon C.H.	No	N/A
<i>Pipe Discharge</i>	Not Present	0	<b>Additional Site Features</b>		
<i>Water Odors</i>	Not Present	0	<i>Stream Channel Woody Material:</i> None		
<i>Fish Passage Barrier</i>	Not Present	0	<i>Impoundments:</i> None		
<i>RB: Riparian Buffer</i>	100+ ft	0	<i>Substrate Composition:</i> Medium Sand		
<i>LB: Riparian Buffer</i>	100+ ft	0	<i>Bank Material:</i> Sand		
<i>RB: Floodplain Access</i>	Full	0			
<i>LB: Floodplain Access</i>	Partial	0.25			
<b>River Threat Index:</b>		<b>1.75</b>

Notes: Some erosion and fresh deposits across the channel. Top of left bank is vegetated with grasses which have shallow roots making this site more prone to erosion.

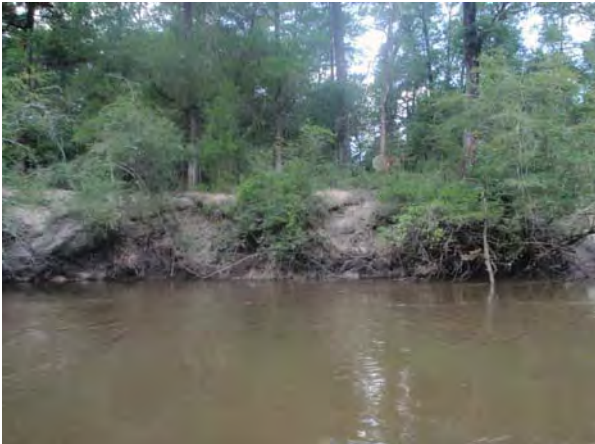
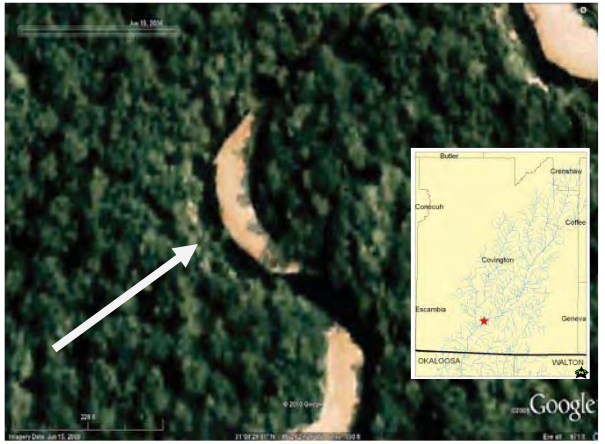
<b>Yellow River</b>	<b>co-0807-004</b>	<b>Severity Score</b> <b>1.75</b>
---------------------	--------------------	--------------------------------------

Risk Factor	Ranking	Score	Feature	Within Range	Descriptive Field
<i>Channel Stability</i>	Good	0.5	303(d)	No	N/A
<i>Channel Alteration</i>	None	0	Wetland Species	No	N/A
<i>Bank Erosion</i>	Historic	0.5	Rare and Imperiled	No	N/A
<i>BEHI</i>	Moderate	0.5	Land Use/Cover	Yes	N/A/ UPLAND LONGLEAF PINE WOODLAND - OPEN UNDERSTORY MODI
<i>Local NPSP</i>	No Evidence	0	Candidate Mussels	No	N/A
<i>Shoring Structures</i>	Not Present	0	Sturgeon C.H.	No	N/A
<i>Pipe Discharge</i>	Not Present	0	<b>Additional Site Features</b>		
<i>Water Odors</i>	Not Present	0	<i>Stream Channel Woody Material:</i> Moderate		
<i>Fish Passage Barrier</i>	Not Present	0	<i>Impoundments:</i> None		
<i>RB: Riparian Buffer</i>	100+ ft	0	<i>Substrate Composition:</i> Medium Sand		
<i>LB: Riparian Buffer</i>	100+ ft	0	<i>Bank Material:</i> Sand		
<i>RB: Floodplain Access</i>	Partial	0.25			
<i>LB: Floodplain Access</i>	Full	0			
<b>River Threat Index:</b>		<b>1.75</b>

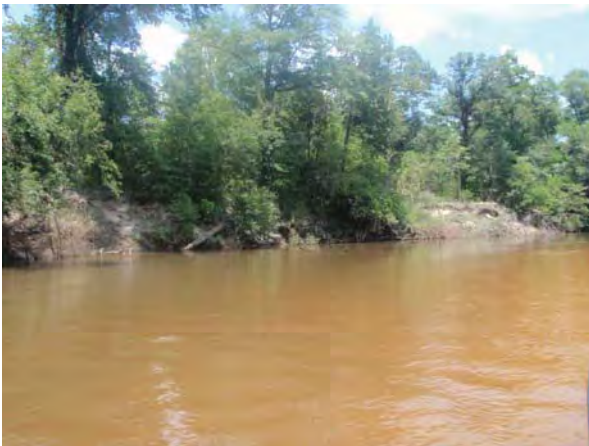
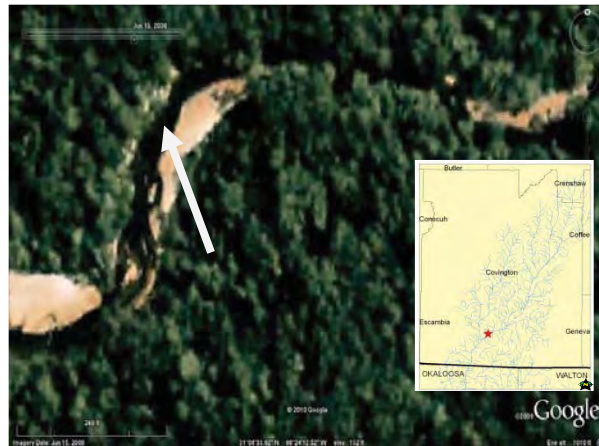
<b>Yellow River</b>	<b>co-0807-002</b>	<b>Severity Score</b> <b>1.75</b>
---------------------	--------------------	--------------------------------------

Risk Factor	Ranking	Score	Feature	Within Range	Descriptive Field
<i>Channel Stability</i>	Good	0.5	303(d)	No	N/A
<i>Channel Alteration</i>	None	0	Wetland Species	No	N/A
<i>Bank Erosion</i>	Historic	0.5	Rare and Imperiled	No	N/A
<i>BEHI</i>	Moderate	0.5	Land Use/Cover	Yes	N/A/ EAST GULF COASTAL PLAIN SMALL STREAM AND RIVER FLOODPLAIN FOREST
<i>Local NPSP</i>	No Evidence	0	Candidate Mussels	No	N/A
<i>Shoring Structures</i>	Not Present	0	Sturgeon C.H.	No	N/A
<i>Pipe Discharge</i>	Not Present	0	<b>Additional Site Features</b>		
<i>Water Odors</i>	Not Present	0	<i>Stream Channel Woody Material:</i> Moderate		
<i>Fish Passage Barrier</i>	Not Present	0	<i>Impoundments:</i> None		
<i>RB: Riparian Buffer</i>	100+ ft	0	<i>Substrate Composition:</i> Medium Sand		
<i>LB: Riparian Buffer</i>	100+ ft	0	<i>Bank Material:</i> Sand		
<i>RB: Floodplain Access</i>	Full	0			
<i>LB: Floodplain Access</i>	Partial	0.25			
<b>River Threat Index:</b>		<b>1.75</b>

Notes: Some erosion is apparent, but may be due to natural meander incision.

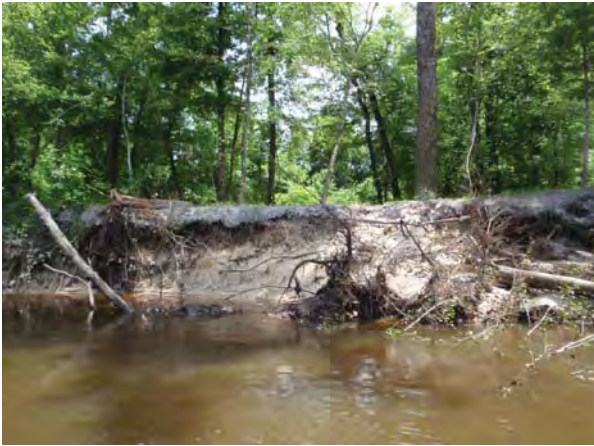
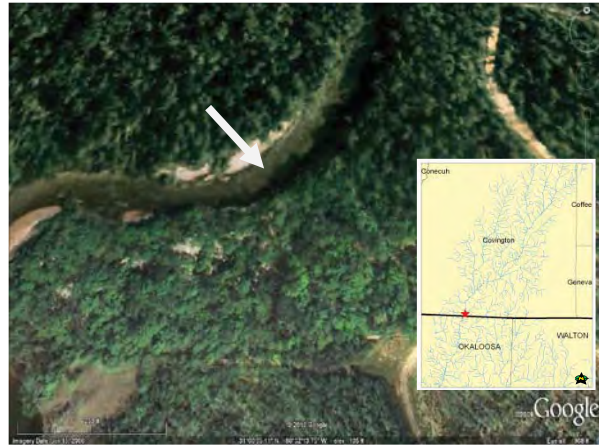
<h1>Yellow River</h1>	<h2>co-0609-010</h2>	<b>Severity Score</b> <h1>1.5</h1>
-----------------------	----------------------	---------------------------------------

Risk Factor	Ranking	Score	Feature	Within Range	Descriptive Field
<i>Channel Stability</i>	Good	0.5	303(d)	Yes	METALS- MERCURY
<i>Channel Alteration</i>	None	0	Wetland Species	No	N/A
<i>Bank Erosion</i>	Historic	0.5	Rare and Imperiled	No	N/A
<i>BEHI</i>	Low- Very Low	0	Land Use/ Cover	No	N/A
<i>Local NPSP</i>	Slight	0.5	Candidate Mussels	No	N/A
<i>Shoring Structures</i>	Not Present	0	Sturgeon C.H.	Yes	N/A
<i>Pipe Discharge</i>	Not Present	0	<b>Additional Site Features</b>		
<i>Water Odors</i>	Not Present	0	<i>Stream Channel Woody Material:</i> Infrequent		
<i>Fish Passage Barrier</i>	Not Present	0	<i>Impoundments:</i> None		
<i>RB: Riparian Buffer</i>	100+ ft	0	<i>Substrate Composition:</i> Medium Sand		
<i>LB: Riparian Buffer</i>	100+ ft	0	<i>Bank Material:</i> Sand		
<i>RB: Floodplain Access</i>	Full	0			
<i>LB: Floodplain Access</i>	Full	0			
<b>River Threat Index:</b>		<b>1.5</b>

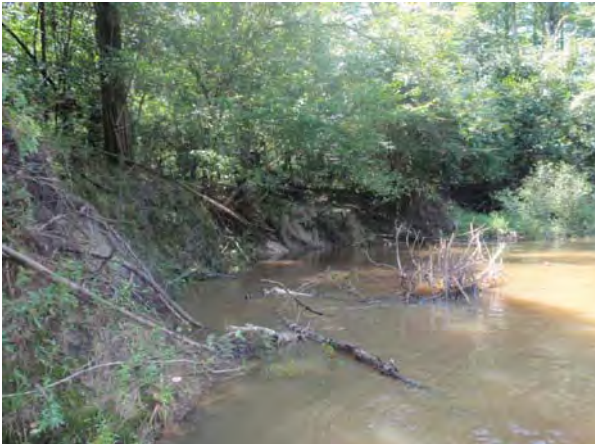
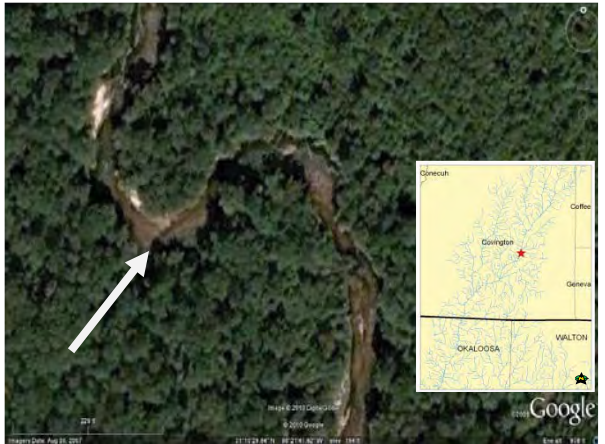
<b>Yellow River</b>	<b>co-0813-002</b>	<i>Severity Score</i> <b>1.5</b>
---------------------	--------------------	-------------------------------------

Risk Factor	Ranking	Score	Feature	Within Range	Descriptive Field
<i>Channel Stability</i>	Good	0.5	303(d)	No	N/A
<i>Channel Alteration</i>	None	0	Wetland Species	No	N/A
<i>Bank Erosion</i>	Historic	0.5	Rare and Imperiled	No	N/A
<i>BEHI</i>	Moderate	0.5	Land Use/Cover	Yes	N/A/ UPLAND LONGLEAF PINE WOODLAND - OPEN UNDERSTORY MODI
<i>Local NPSP</i>	No Evidence	0	Candidate Mussels	No	N/A
<i>Shoring Structures</i>	Not Present	0	Sturgeon C.H.	No	N/A
<i>Pipe Discharge</i>	Not Present	0	<b>Additional Site Features</b>		
<i>Water Odors</i>	Not Present	0	<i>Stream Channel Woody Material:</i> Moderate		
<i>Fish Passage Barrier</i>	Not Present	0	<i>Impoundments:</i> None		
<i>RB: Riparian Buffer</i>	100+ ft	0	<i>Substrate Composition:</i> Medium Sand		
<i>LB: Riparian Buffer</i>	100+ ft	0	<i>Bank Material:</i> Silty Loam		
<i>RB: Floodplain Access</i>	Full	0			
<i>LB: Floodplain Access</i>	Full	0			
<b>River Threat Index:</b>		<b>1.5</b>

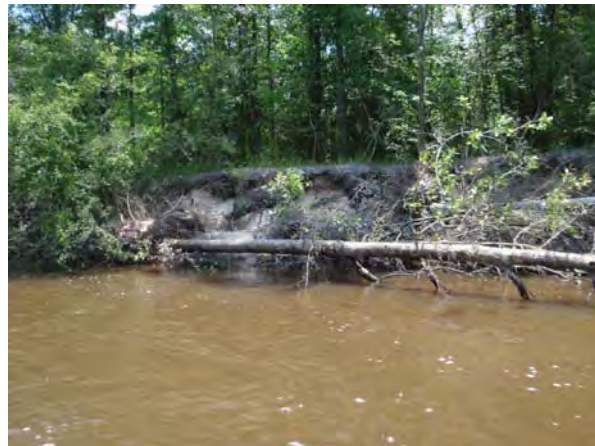
<b>Yellow River</b>	<b>co-0609-002</b>	<i>Severity Score</i> <b>1</b>
---------------------	--------------------	-----------------------------------

Notes: New growth on bank degradation

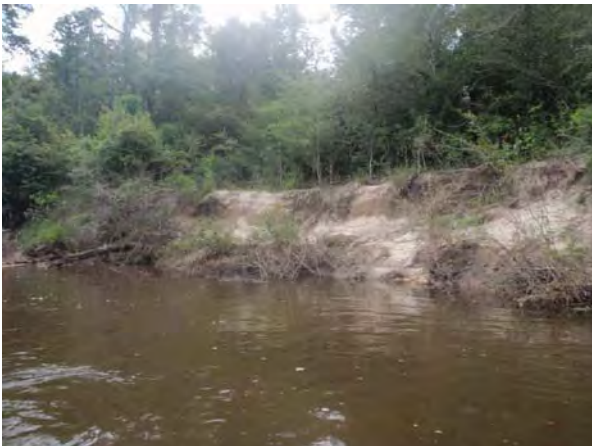
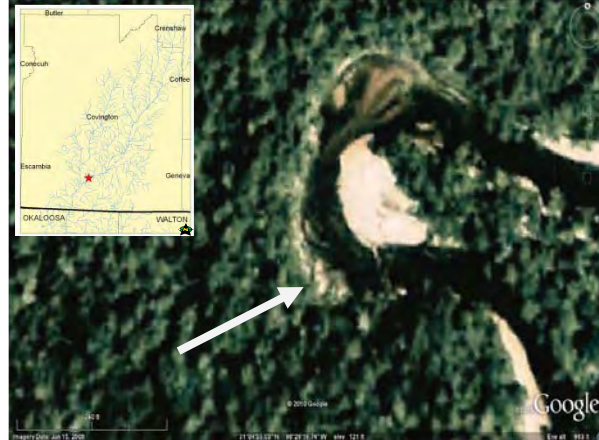
Yellow River	co-0805-003	Severity Score 1.75
--------------	-------------	------------------------

Risk Factor	Ranking	Score	Feature	Within Range	Descriptive Field
<i>Channel Stability</i>	Good	0.5	303(d)	Yes	METALS- MERCURY
<i>Channel Alteration</i>	None	0	Wetland Species	No	N/A
<i>Bank Erosion</i>	Historic	0.5	Rare and Imperiled	No	N/A
<i>BEHI</i>	Moderate	0.5	Land Use/ Cover	No	N/A
<i>Local NPSP</i>	No Evidence	0	Candidate Mussels	No	N/A
<i>Shoring Structures</i>	Not Present	0	Sturgeon C.H.	Yes	N/A
<i>Pipe Discharge</i>	Not Present	0	<b>Additional Site Features</b>		
<i>Water Odors</i>	Not Present	0	<i>Stream Channel Woody Material:</i> Moderate		
<i>Fish Passage Barrier</i>	Not Present	0	<i>Impoundments:</i> None		
<i>RB: Riparian Buffer</i>	100+ ft	0	<i>Substrate Composition:</i> Medium Sand		
<i>LB: Riparian Buffer</i>	50-99 ft	0.25	<i>Bank Material:</i> Sand		
<i>RB: Floodplain Access</i>	Full	0			
<i>LB: Floodplain Access</i>	Full	0			
<b>River Threat Index:</b>		<b>1.75</b>

Notes: Some bank erosion apparent may be natural meander incision. Large aggradational site across channel could indicate some channel instability.

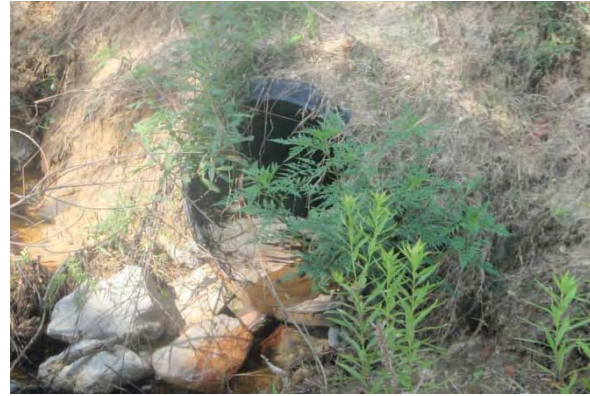
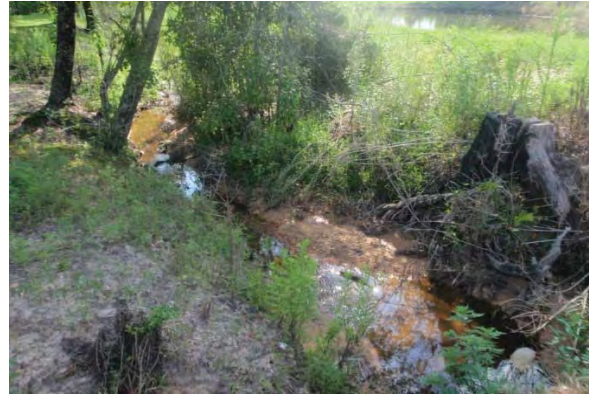
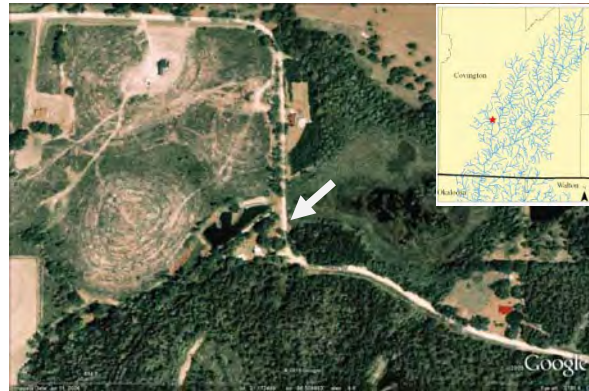
<b>Unnamed tributary</b>	<b>co-0810-r-017</b>	<b>Sedimentation Risk Index</b> <b>30</b>
--------------------------	----------------------	--

Risk Factor	Ranking	Score
<i>US Channel Morph</i>	BEAVER DAM	3
<i>DS Channel Morph</i>	PONDED	1
<i>DS Bank Alteration</i>	HIGH	1
<i>Upstream Skew Angle</i>	5-30°	3
<i>Crossing fill condition</i>	Poor/Bare soil	1
<i>Inlet/Outlet Condition</i>	Sed Islands/Scouring	3
<i>Road Approach Material</i>	All Sand/Clay	3
<i>Potential Eroded Volume Mean</i>	<21 y <sup>3</sup>	5
<i>Approach Slope Mean</i>	2.1-4%	3
<i>Soil K Factor</i>	0.21-0.40	3
<i>Upstream Rt Outlet</i>	Vegetated	1
<i>Upstream Lt Outlet</i>	Bare soil	0
<i>Upstream Rt Ditch</i>	Bare soil	0
<i>Upstream Lt Ditch</i>	Bare soil	0
<i>Downstream Rt Outlet</i>	Bare soil	0
<i>Downstream Lt Outlet</i>	Vegetated	1
<i>Downstream Rt Ditch</i>	Bare soil	0
<i>Downstream Lt Ditch</i>	Bare soil	0
<i>Outlet Total</i>	Partially Improved Outlet System	3
<i>Ditches Total</i>	Unimproved Drainage System	1
<b>SRI Total</b>	<b>High Risk</b>	<b>30</b>
<b>Additional Site Features</b>

Notes: DS channel parallels private pond.

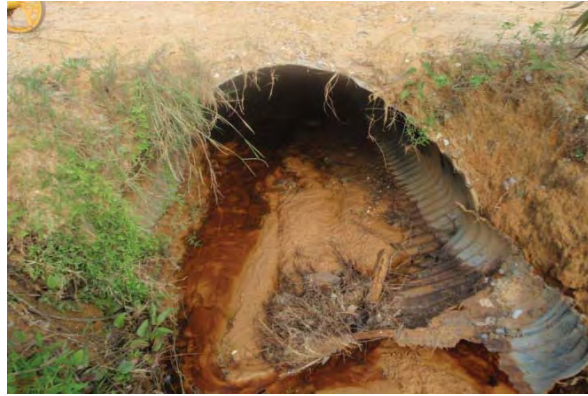
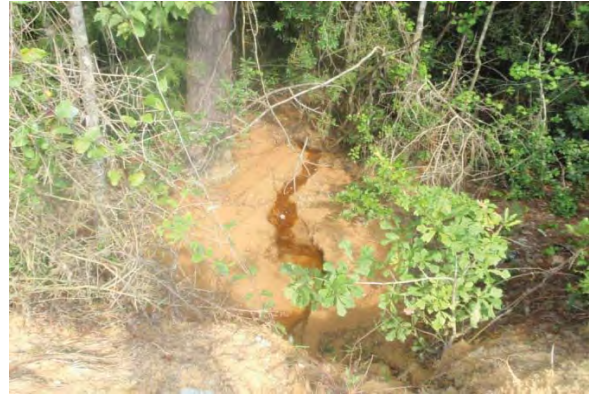
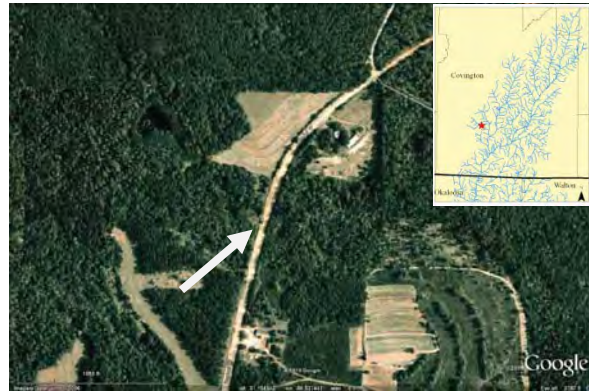
<h1 style="margin:0;">Boggy Creek</h1>	<h2 style="margin:0;">co-0810-r-019</h2>	<b>Sedimentation Risk Index</b> <h1 style="margin:0; color: white;">34</h1>
--	--	--

Risk Factor	Ranking	Score
<i>US Channel Morph</i>	PONDED	1
<i>DS Channel Morph</i>	E	5
<i>DS Bank Alteration</i>	HIGH	1
<i>Upstream Skew Angle</i>	5-30°	3
<i>Crossing fill condition</i>	Poor/Bare soil	1
<i>Inlet/Outlet Condition</i>	Sed Islands/Scouring	3
<i>Road Approach Material</i>	All Sand/Clay	3
<i>Potential Eroded Volume Mean</i>	<21 y <sup>3</sup>	5
<i>Approach Slope Mean</i>	2.1-4%	3
<i>Soil K Factor</i>	0.21-0.40	3
<i>Upstream Rt Outlet</i>	Bare soil	0
<i>Upstream Lt Outlet</i>	Bare soil	0
<i>Upstream Rt Ditch</i>	Vegetated	1
<i>Upstream Lt Ditch</i>	Vegetated	1
<i>Downstream Rt Outlet</i>	Vegetated	1
<i>Downstream Lt Outlet</i>	Vegetated	1
<i>Downstream Rt Ditch</i>	Bare soil	0
<i>Downstream Lt Ditch</i>	Bare soil	0
<b>Outlet Total</b>	Partially Improved Outlet System	3
<b>Ditches Total</b>	Partially Improved Drainage System	3
<b>SRI Total</b>	<b>High Risk</b>	<b>34</b>

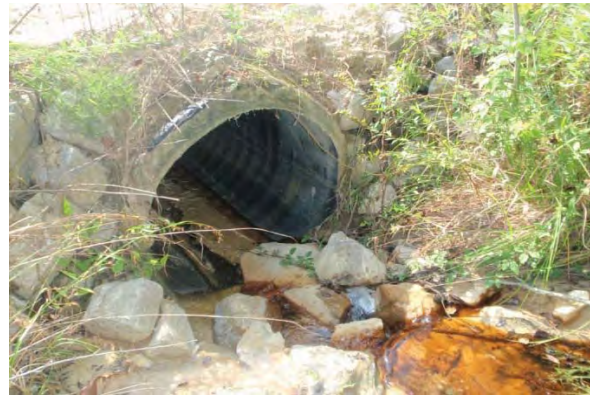
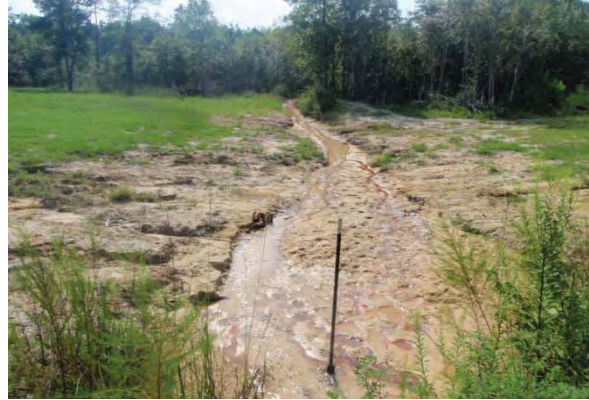
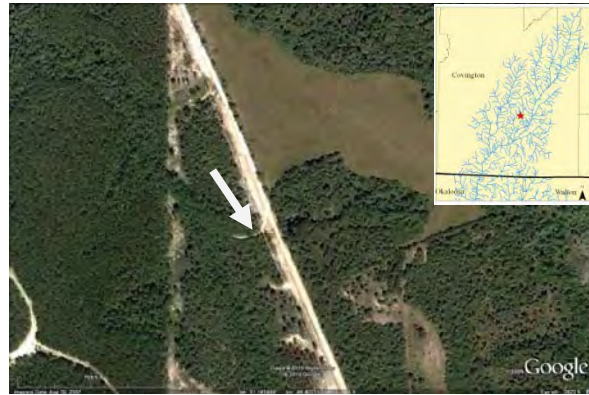
Unnamed tributary	co-0901-r-014	Sedimentation Risk Index <b>34</b>
-------------------	---------------	---------------------------------------

Risk Factor	Ranking	Score
<i>US Channel Morph</i>	C	5
<i>DS Channel Morph</i>	C	5
<i>DS Bank Alteration</i>	HIGH	1
<i>Upstream Skew Angle</i>	>30°	1
<i>Crossing fill condition</i>	Poor/Bare soil	1
<i>Inlet/Outlet Condition</i>	Sed Islands/Scouring	3
<i>Road Approach Material</i>	All Sand/Clay	3
<i>Potential Eroded Volume Mean</i>	<21 y <sup>3</sup>	5
<i>Approach Slope Mean</i>	2.1-4%	3
<i>Soil K Factor</i>	<0.20	5
<i>Upstream Rt Outlet</i>	Bare soil	0
<i>Upstream Lt Outlet</i>	Bare soil	0
<i>Upstream Rt Ditch</i>	Bare soil	0
<i>Upstream Lt Ditch</i>	Bare soil	0
<i>Downstream Rt Outlet</i>	Bare soil	0
<i>Downstream Lt Outlet</i>	Bare soil	0
<i>Downstream Rt Ditch</i>	Bare soil	0
<i>Downstream Lt Ditch</i>	Bare soil	0
<i>Outlet Total</i>	Unimproved Outlet System	1
<i>Ditches Total</i>	Unimproved Drainage System	1
<b>SRI Total</b>	<b>High Risk</b>	<b>34</b>

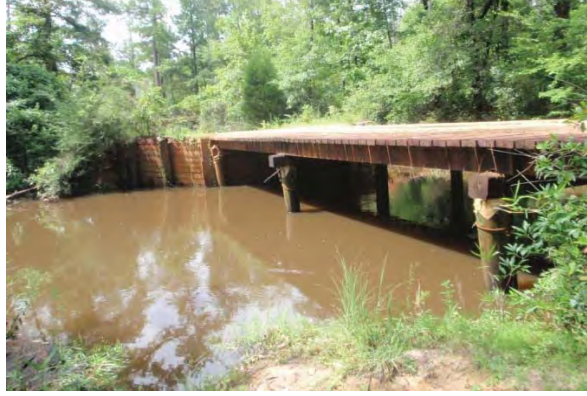
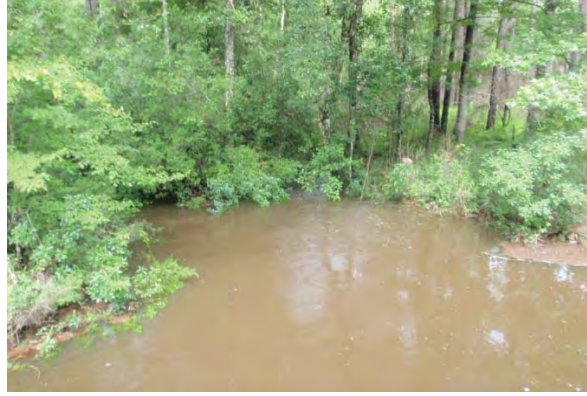
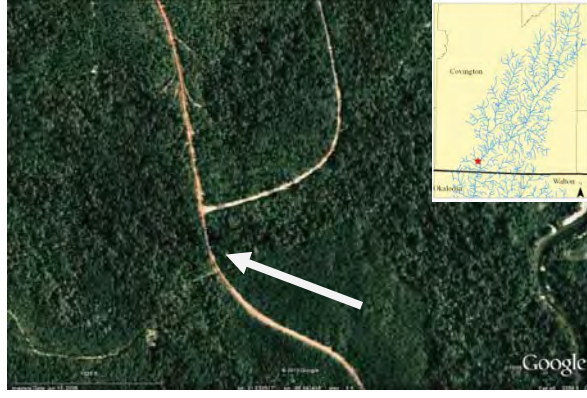
<h1>Rum Creek</h1>	<h2>co-0729-r-001</h2>	<i>Sedimentation Risk Index</i> <b>36</b>
--------------------	------------------------	--

Risk Factor	Ranking	Score
<i>US Channel Morph</i>	DA	3
<i>DS Channel Morph</i>	WETLAND	5
<i>DS Bank Alteration</i>	MINOR/PARTIAL	3
<i>Upstream Skew Angle</i>	5-30°	3
<i>Crossing fill condition</i>	Poor/Bare soil	1
<i>Inlet/Outlet Condition</i>	No Impairment	5
<i>Road Approach Material</i>	All Sand/Clay	3
<i>Potential Eroded Volume Mean</i>	>40 y <sup>3</sup>	1
<i>Approach Slope Mean</i>	2.1-4%	3
<i>Soil K Factor</i>	<0.20	5
<i>Upstream Rt Outlet</i>	Bare soil	0
<i>Upstream Lt Outlet</i>	Bare soil	0
<i>Upstream Rt Ditch</i>	Bare soil	0
<i>Upstream Lt Ditch</i>	Bare soil	0
<i>Downstream Rt Outlet</i>	Vegetated	1
<i>Downstream Lt Outlet</i>	Bare soil	0
<i>Downstream Rt Ditch</i>	Bare soil	0
<i>Downstream Lt Ditch</i>	Bare soil	0
<i>Outlet Total</i>	Partially Improved Outlet System	3
<i>Ditches Total</i>	Unimproved Drainage System	1
<b><i>SRI Total</i></b>	<b>High Risk</b>	<b>36</b>

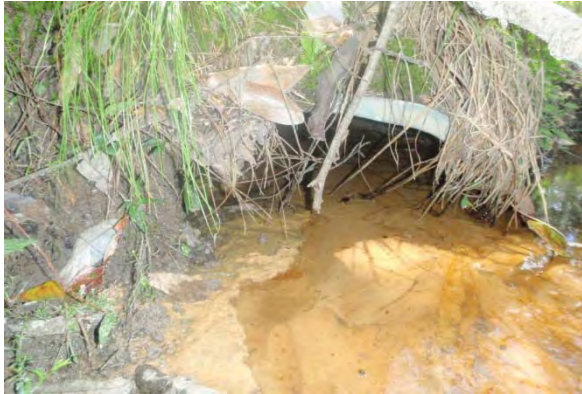
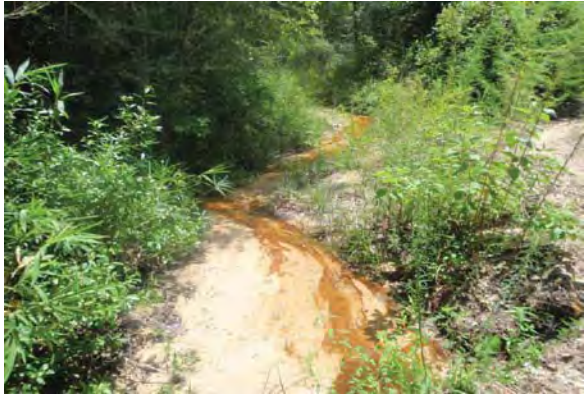
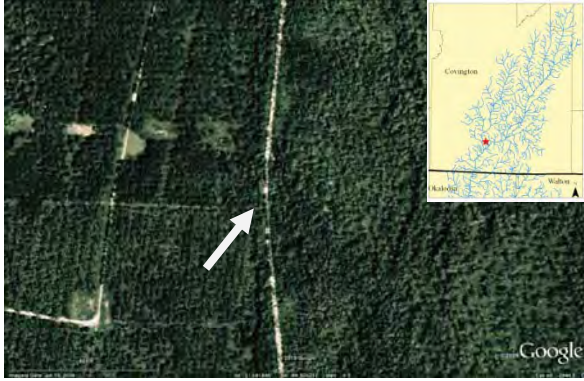
<h1>Unnamed tributary</h1>	<h2>co-0810-r-005</h2>	<i>Sedimentation Risk Index</i> <b>36</b>
----------------------------	------------------------	--

Risk Factor	Ranking	Score
<i>US Channel Morph</i>	DA	3
<i>DS Channel Morph</i>	DA	3
<i>DS Bank Alteration</i>	MINOR/PARTIAL	3
<i>Upstream Skew Angle</i>	>30°	1
<i>Crossing fill condition</i>	Poor/Bare soil	1
<i>Inlet/Outlet Condition</i>	Blocked	1
<i>Road Approach Material</i>	All Sand/Clay	3
<i>Potential Eroded Volume Mean</i>	<21 y <sup>3</sup>	5
<i>Approach Slope Mean</i>	<2%	5
<i>Soil K Factor</i>	<0.20	5
<i>Upstream Rt Outlet</i>	Vegetated	1
<i>Upstream Lt Outlet</i>	Vegetated	1
<i>Upstream Rt Ditch</i>	Vegetated	1
<i>Upstream Lt Ditch</i>	Bare soil	0
<i>Downstream Rt Outlet</i>	Bare soil	0
<i>Downstream Lt Outlet</i>	Bare soil	0
<i>Downstream Rt Ditch</i>	Bare soil	0
<i>Downstream Lt Ditch</i>	Bare soil	0
<b>Outlet Total</b>	Partially Improved Outlet System	<b>3</b>
<b>Ditches Total</b>	Partially Improved Drainage System	<b>3</b>
<b>SRI Total</b>	<b>High Risk</b>	<b>36</b>
<b>Additional Site Features</b>

Notes: Buried culvert.

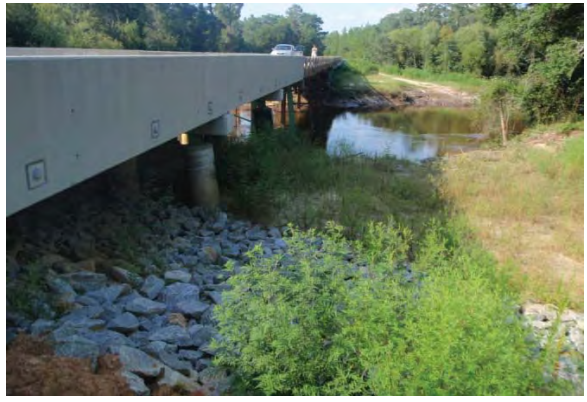
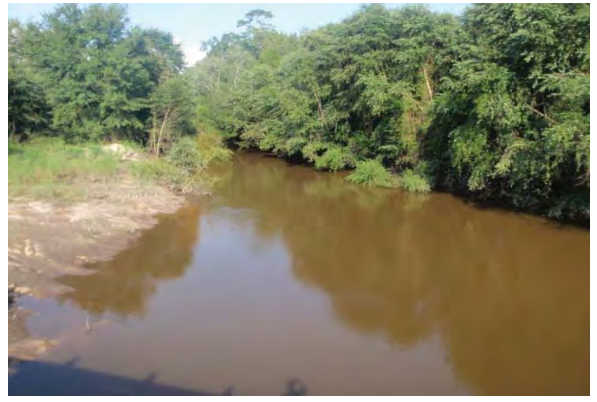
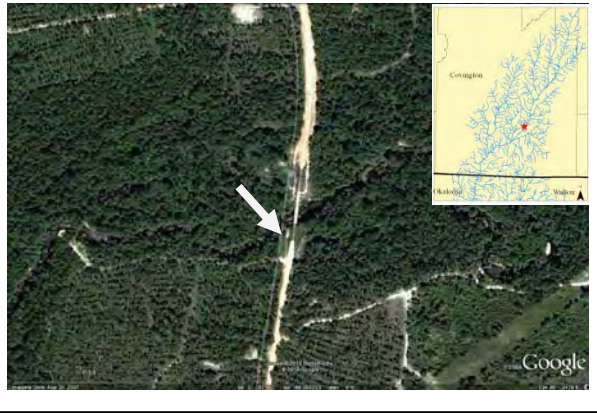
<h1>Yellow River</h1>	<h2>co-0901-r-018</h2>	<i>Sedimentation Risk Index</i> <b>36</b>
-----------------------	------------------------	--

Risk Factor	Ranking	Score
<i>US Channel Morph</i>	C	5
<i>DS Channel Morph</i>	C	5
<i>DS Bank Alteration</i>	HIGH	1
<i>Upstream Skew Angle</i>	<5°	5
<i>Crossing fill condition</i>	Poor/Bare soil	1
<i>Inlet/Outlet Condition</i>	Sed Islands/Scouring	3
<i>Road Approach Material</i>	All Sand/Clay	3
<i>Potential Eroded Volume Mean</i>	>40 y <sup>3</sup>	1
<i>Approach Slope Mean</i>	<2%	5
<i>Soil K Factor</i>	<0.20	5
<i>Upstream Rt Outlet</i>	Bare soil	0
<i>Upstream Lt Outlet</i>	Bare soil	0
<i>Upstream Rt Ditch</i>	Bare soil	0
<i>Upstream Lt Ditch</i>	Bare soil	0
<i>Downstream Rt Outlet</i>	Bare soil	0
<i>Downstream Lt Outlet</i>	Bare soil	0
<i>Downstream Rt Ditch</i>	Bare soil	0
<i>Downstream Lt Ditch</i>	Bare soil	0
<i>Outlet Total</i>	Unimproved Outlet System	1
<i>Ditches Total</i>	Unimproved Drainage System	1
<b><i>SRI Total</i></b>	<b>High Risk</b>	<b>36</b>
<b>Additional Site Features</b>		
<i>Crossing Type and Quantity:</i>	Bridge, 1

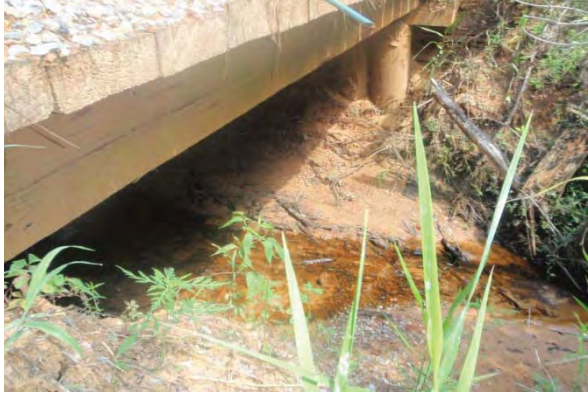
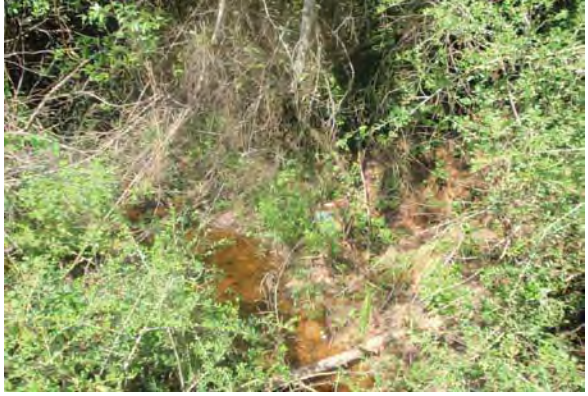
<b>Unnamed tributary</b>	<b>co-0810-r-001</b>	<i>Sedimentation Risk Index</i> <b>38</b>
--------------------------	----------------------	--

Risk Factor	Ranking	Score
<i>US Channel Morph</i>	WETLAND	5
<i>DS Channel Morph</i>	B	5
<i>DS Bank Alteration</i>	HIGH	1
<i>Upstream Skew Angle</i>	5-30°	3
<i>Crossing fill condition</i>	Fair/Rip Rap	3
<i>Inlet/Outlet Condition</i>	Sed Islands/Scouring	3
<i>Road Approach Material</i>	All Native Soil	1
<i>Potential Eroded Volume Mean</i>	>40 y <sup>3</sup>	1
<i>Approach Slope Mean</i>	<2%	5
<i>Soil K Factor</i>	<0.20	5
<i>Upstream Rt Outlet</i>	Vegetated	1
<i>Upstream Lt Outlet</i>	Vegetated	1
<i>Upstream Rt Ditch</i>	Bare soil	0
<i>Upstream Lt Ditch</i>	Bare soil	0
<i>Downstream Rt Outlet</i>	Vegetated	1
<i>Downstream Lt Outlet</i>	Vegetated	1
<i>Downstream Rt Ditch</i>	Bare soil	0
<i>Downstream Lt Ditch</i>	Bare soil	0
<i>Outlet Total</i>	Improved Outlet System	5
<i>Ditches Total</i>	Unimproved Drainage System	1
<b>SRI Total</b>	<b>Medium Risk</b>	<b>38</b>

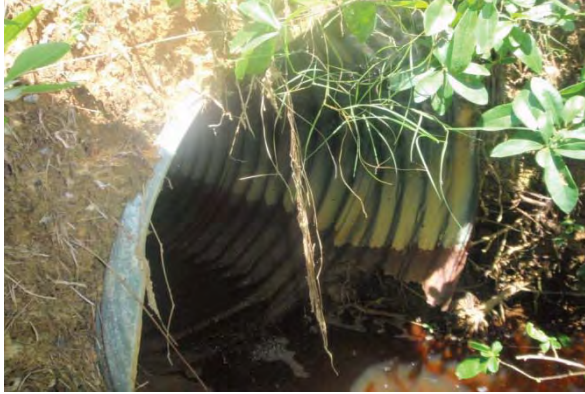
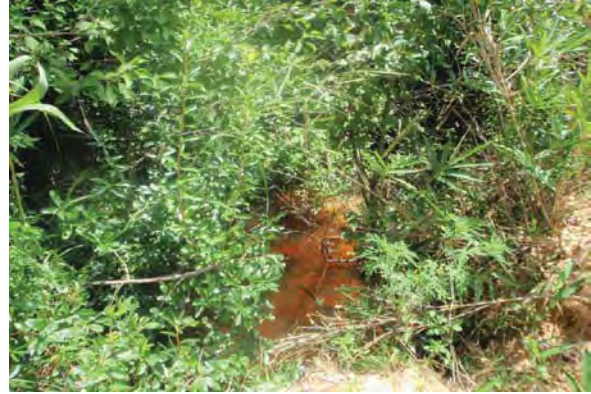
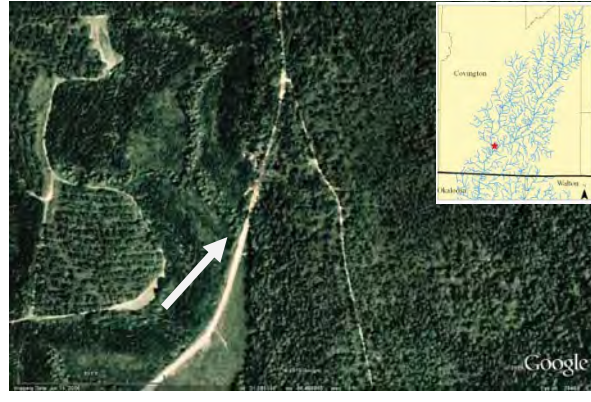
Unnamed tributary	co-0810-r-006	Sedimentation Risk Index <b>38</b>
-------------------	---------------	---------------------------------------

Risk Factor	Ranking	Score
US Channel Morph	DA	3
DS Channel Morph	C	5
DS Bank Alteration	HIGH	1
Upstream Skew Angle	5-30°	3
Crossing fill condition	Poor/Bare soil	1
Inlet/Outlet Condition	No Impairment	5
Road Approach Material	All Sand/Clay	3
Potential Eroded Volume Mean	<21 y <sup>3</sup>	5
Approach Slope Mean	2.1-4%	3
Soil K Factor	<0.20	5
Upstream Rt Outlet	Bare soil	0
Upstream Lt Outlet	Bare soil	0
Upstream Rt Ditch	Bare soil	0
Upstream Lt Ditch	Bare soil	0
Downstream Rt Outlet	Bare soil	0
Downstream Lt Outlet	Bare soil	0
Downstream Rt Ditch	Synthetic	1
Downstream Lt Ditch	Bare soil	0
<b>Outlet Total</b>	Unimproved Outlet System	1
<b>Ditches Total</b>	Partially Improved Drainage System	3
<b>SRI Total</b>	<b>Medium Risk</b>	<b>38</b>
<b>Additional Site Features</b>		
<u>Crossing Type and Quantity:</u>	Culvert, 1	
<u>Crossing Materials:</u>	Metal	
<u>Soil Types:</u>	BoB,BoC,FoA,FuB, MBA,RaA	
<u>Rt Approach Prism Fill:</u>	0.25in

Notes: Road actively eroding over culvert.
