Appendix A. River corridor severity scores for impaired sites in the Yellow River Basin, Alabama and Florida

Appendix C. Clear Creek Watershed Focal Area. Sites with orange headings are unpaved road sites. Specific definitions and calculations described for calculating the Sediment Risk Index (SRI) are detailed in Witmer (2009).

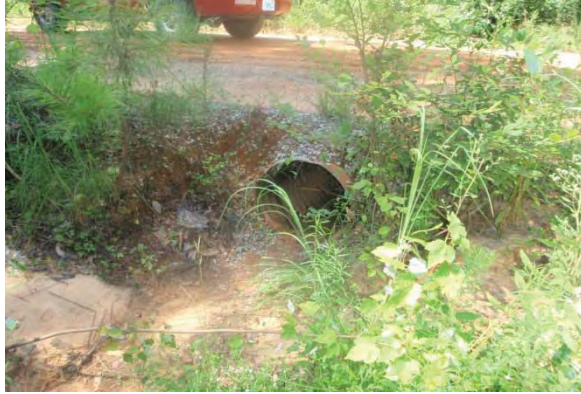
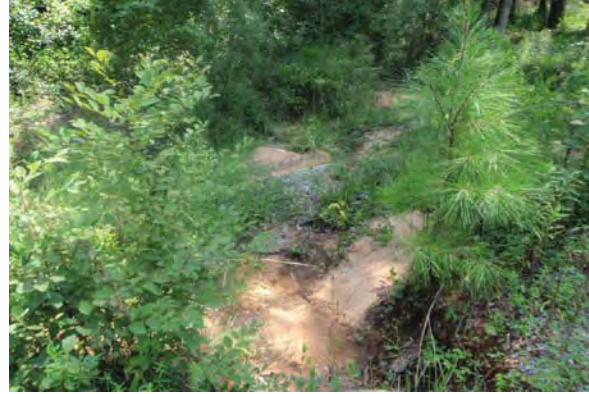
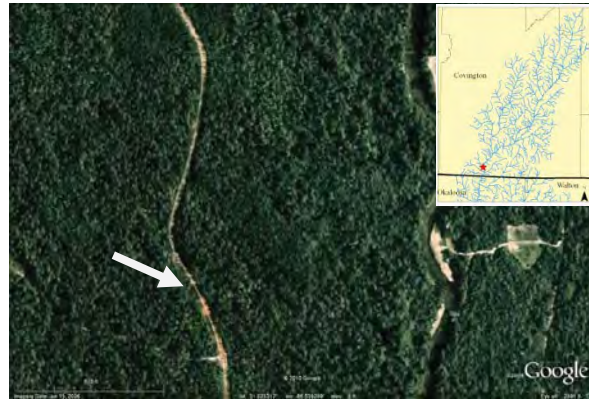
<b>Unnamed tributary</b>	<b>co-0810-r-002</b>	<i>Sedimentation Risk Index</i> <b>40</b>
--------------------------	----------------------	--

Risk Factor	Ranking	Score
<i>US Channel Morph</i>	E	5
<i>DS Channel Morph</i>	E	5
<i>DS Bank Alteration</i>	HIGH	1
<i>Upstream Skew Angle</i>	5-30°	3
<i>Crossing fill condition</i>	Poor/Bare soil	1
<i>Inlet/Outlet Condition</i>	Sed Islands/Scouring	3
<i>Road Approach Material</i>	All Native Soil	1
<i>Potential Eroded Volume Mean</i>	<21 y <sup>3</sup>	5
<i>Approach Slope Mean</i>	<2%	5
<i>Soil K Factor</i>	<0.20	5
<i>Upstream Rt Outlet</i>	Vegetated	1
<i>Upstream Lt Outlet</i>	Bare soil	0
<i>Upstream Rt Ditch</i>	Bare soil	0
<i>Upstream Lt Ditch</i>	Bare soil	0
<i>Downstream Rt Outlet</i>	Vegetated	1
<i>Downstream Lt Outlet</i>	Bare soil	0
<i>Downstream Rt Ditch</i>	Synthetic	1
<i>Downstream Lt Ditch</i>	Bare soil	0
<b>Outlet Total</b>	Partially Improved Outlet System	3
<b>Ditches Total</b>	Partially Improved Drainage System	3
<b>SRI Total</b>	<b>Medium Risk</b>	<b>40</b>

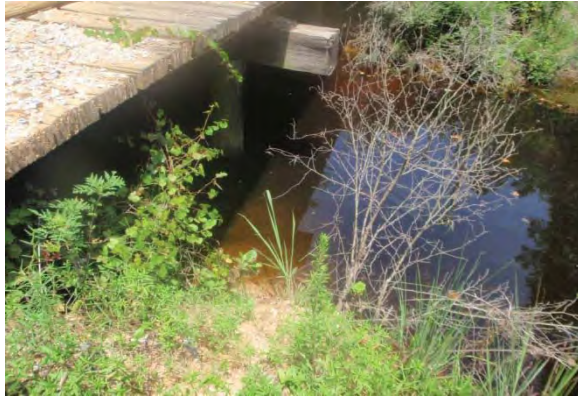
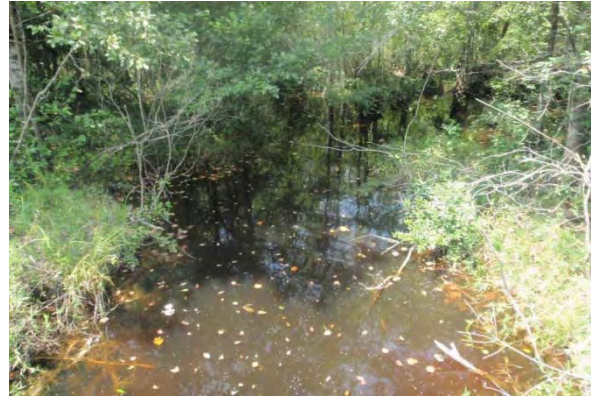
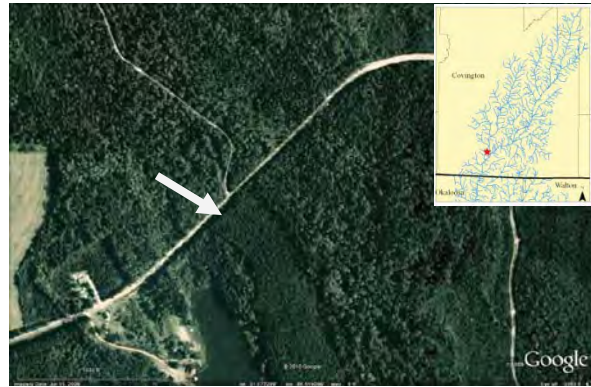
<h1>Unnamed tributary</h1>	<h2>co-0810-r-009</h2>	<i>Sedimentation Risk Index</i> <b>40</b>
----------------------------	------------------------	--

Risk Factor	Ranking	Score
<i>US Channel Morph</i>	DA	3
<i>DS Channel Morph</i>	DA	3
<i>DS Bank Alteration</i>	HIGH	1
<i>Upstream Skew Angle</i>	5-30°	3
<i>Crossing fill condition</i>	Fair/Rip Rap	3
<i>Inlet/Outlet Condition</i>	No Impairment	5
<i>Road Approach Material</i>	All Sand/Clay	3
<i>Potential Eroded Volume Mean</i>	<21 y <sup>3</sup>	5
<i>Approach Slope Mean</i>	2.1-4%	3
<i>Soil K Factor</i>	<0.20	5
<i>Upstream Rt Outlet</i>	Vegetated	1
<i>Upstream Lt Outlet</i>	Vegetated	1
<i>Upstream Rt Ditch</i>	Bare soil	0
<i>Upstream Lt Ditch</i>	Bare soil	0
<i>Downstream Rt Outlet</i>	Vegetated	1
<i>Downstream Lt Outlet</i>	Vegetated	1
<i>Downstream Rt Ditch</i>	Bare soil	0
<i>Downstream Lt Ditch</i>	Bare soil	0
<i>Outlet Total</i>	Improved Outlet System	5
<i>Ditches Total</i>	Unimproved Drainage System	1
<b><i>SRI Total</i></b>	<b>Medium Risk</b>	<b>40</b>

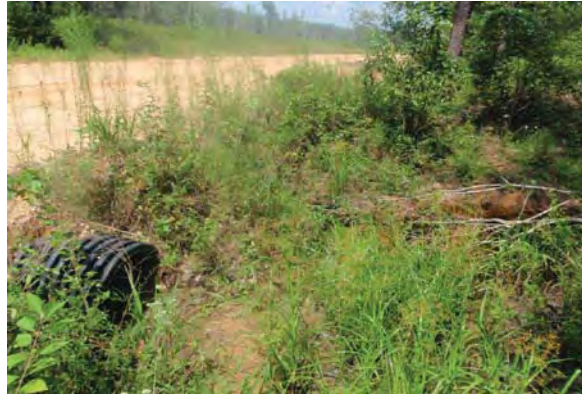
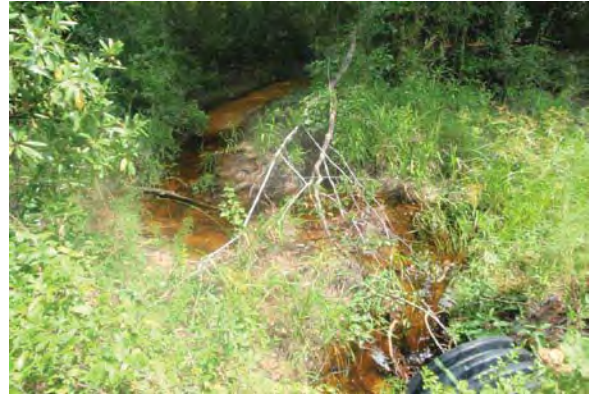
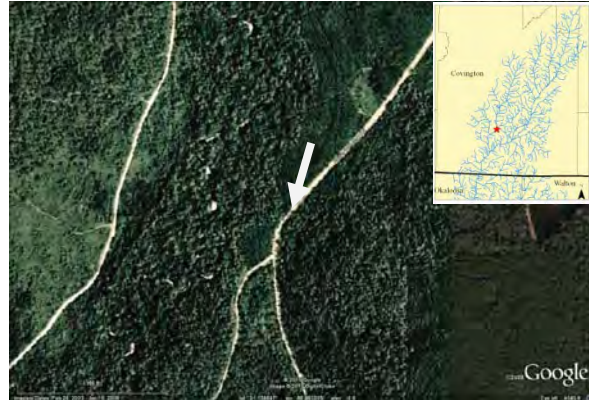
Unnamed tributary	co-0810-r-011	Sedimentation Risk Index <b>40</b>
-------------------	---------------	---------------------------------------

Risk Factor	Ranking	Score
<i>US Channel Morph</i>	DA	3
<i>DS Channel Morph</i>	DA	3
<i>DS Bank Alteration</i>	HIGH	1
<i>Upstream Skew Angle</i>	5-30°	3
<i>Crossing fill condition</i>	Poor/Bare soil	1
<i>Inlet/Outlet Condition</i>	Sed Islands/Scouring	3
<i>Road Approach Material</i>	All Sand/Clay	3
<i>Potential Eroded Volume Mean</i>	<21 y <sup>3</sup>	5
<i>Approach Slope Mean</i>	<2%	5
<i>Soil K Factor</i>	<0.20	5
<i>Upstream Rt Outlet</i>	Vegetated	1
<i>Upstream Lt Outlet</i>	Vegetated	1
<i>Upstream Rt Ditch</i>	Synthetic	1
<i>Upstream Lt Ditch</i>	Bare soil	0
<i>Downstream Rt Outlet</i>	Vegetated	1
<i>Downstream Lt Outlet</i>	Vegetated	1
<i>Downstream Rt Ditch</i>	Bare soil	0
<i>Downstream Lt Ditch</i>	Bare soil	0
<i>Outlet Total</i>	Improved Outlet System	5
<i>Ditches Total</i>	Partially Improved Drainage System	3
<b>SRI Total</b>	<b>Medium Risk</b>	<b>40</b>

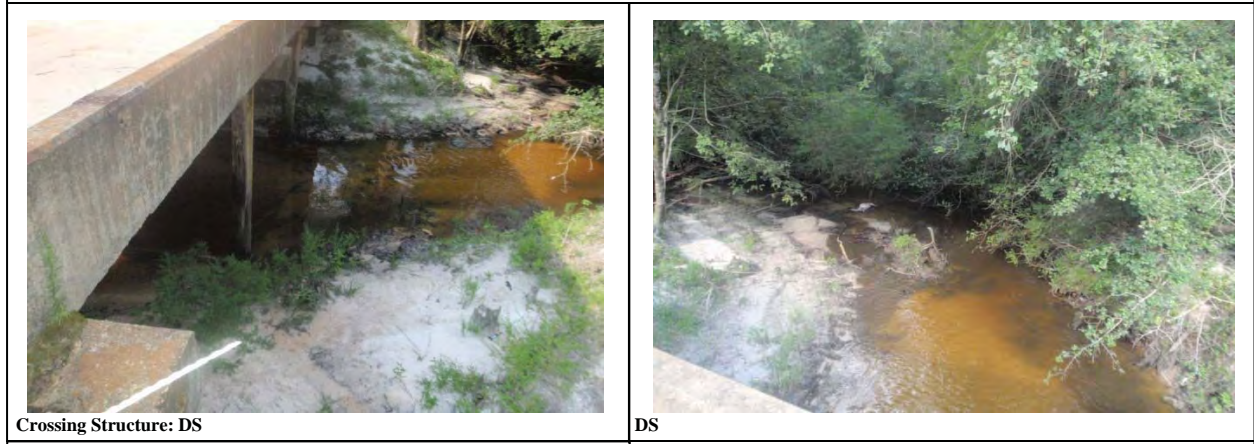
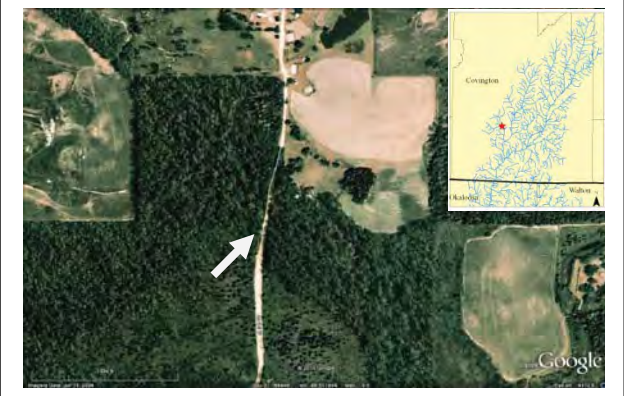
<h1>Hog Foot Creek</h1>	<h2>co-0810-r-018</h2>	<i>Sedimentation Risk Index</i> <b>40</b>
-------------------------	------------------------	--

Risk Factor	Ranking	Score
<i>US Channel Morph</i>	C	5
<i>DS Channel Morph</i>	DA	3
<i>DS Bank Alteration</i>	HIGH	1
<i>Upstream Skew Angle</i>	5-30°	3
<i>Crossing fill condition</i>	Poor/Bare soil	1
<i>Inlet/Outlet Condition</i>	Sed Islands/Scouring	3
<i>Road Approach Material</i>	All Sand/Clay	3
<i>Potential Eroded Volume Mean</i>	<21 y <sup>3</sup>	5
<i>Approach Slope Mean</i>	<2%	5
<i>Soil K Factor</i>	<0.20	5
<i>Upstream Rt Outlet</i>	Bare soil	0
<i>Upstream Lt Outlet</i>	Vegetated	1
<i>Upstream Rt Ditch</i>	Vegetated	1
<i>Upstream Lt Ditch</i>	Bare soil	0
<i>Downstream Rt Outlet</i>	Vegetated	1
<i>Downstream Lt Outlet</i>	Bare soil	0
<i>Downstream Rt Ditch</i>	Vegetated	1
<i>Downstream Lt Ditch</i>	Vegetated	1
<i>Outlet Total</i>	Partially Improved Outlet System	3
<i>Ditches Total</i>	Partially Improved Drainage System	3
<b><i>SRI Total</i></b>	<b>Medium Risk</b>	<b>40</b>
<b>Additional Site Features</b>

Notes: Culvert approx. 150 ft north of the bridge crossing. Dry and rip rap-filled.

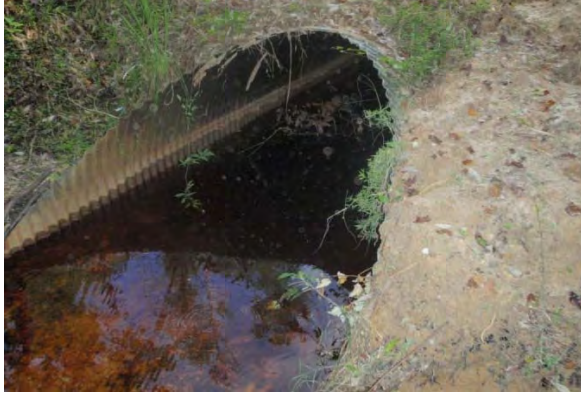
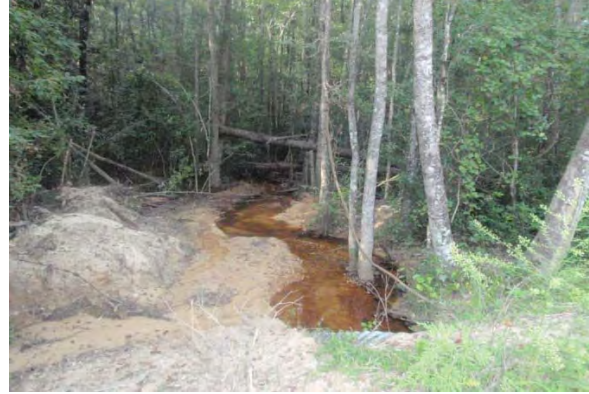
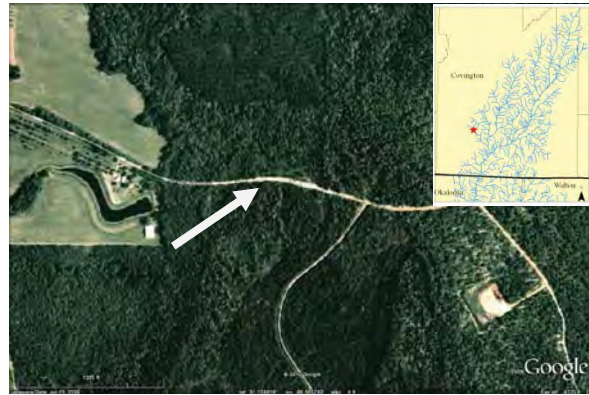
<b>Unnamed tributary</b>	<b>co-0810-r-021</b>	<i>Sedimentation Risk Index</i> <b>40</b>
--------------------------	----------------------	--

Risk Factor	Ranking	Score
<i>US Channel Morph</i>	WETLAND	5
<i>DS Channel Morph</i>	C	5
<i>DS Bank Alteration</i>	HIGH	1
<i>Upstream Skew Angle</i>	<5°	5
<i>Crossing fill condition</i>	Poor/Bare soil	1
<i>Inlet/Outlet Condition</i>	Sed Islands/Scouring	3
<i>Road Approach Material</i>	All Sand/Clay	3
<i>Potential Eroded Volume Mean</i>	<21 y <sup>3</sup>	5
<i>Approach Slope Mean</i>	2.1-4%	3
<i>Soil K Factor</i>	<0.20	5
<i>Upstream Rt Outlet</i>	Bare soil	0
<i>Upstream Lt Outlet</i>	Vegetated	1
<i>Upstream Rt Ditch</i>	Bare soil	0
<i>Upstream Lt Ditch</i>	Bare soil	0
<i>Downstream Rt Outlet</i>	Vegetated	1
<i>Downstream Lt Outlet</i>	Bare soil	0
<i>Downstream Rt Ditch</i>	Bare soil	0
<i>Downstream Lt Ditch</i>	Bare soil	0
<i>Outlet Total</i>	Partially Improved Outlet System	3
<i>Ditches Total</i>	Unimproved Drainage System	1
<b>SRI Total</b>	<b>Medium Risk</b>	<b>40</b>

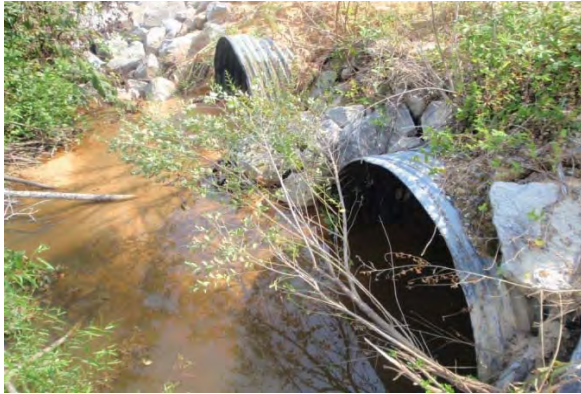
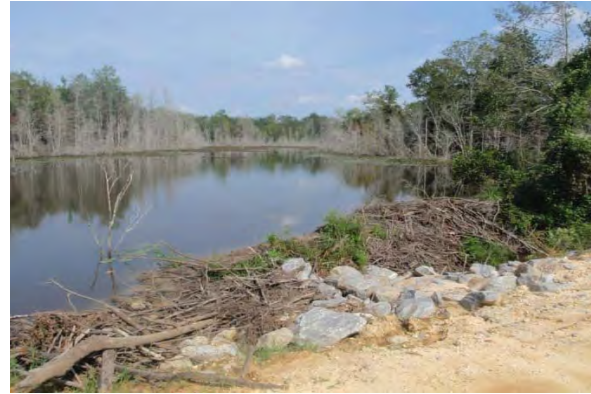
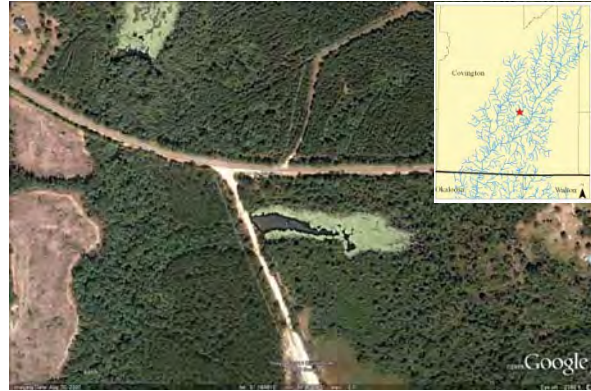
Unnamed tributary	co-0901-r-013	Sedimentation Risk Index <b>40</b>
-------------------	---------------	---------------------------------------

Risk Factor	Ranking	Score
<i>US Channel Morph</i>	BEAVER DAM	3
<i>DS Channel Morph</i>	E	5
<i>DS Bank Alteration</i>	NATURAL	5
<i>Upstream Skew Angle</i>	>30°	1
<i>Crossing fill condition</i>	Fair/Rip Rap	3
<i>Inlet/Outlet Condition</i>	Sed Islands/Scouring	3
<i>Road Approach Material</i>	All Native Soil	1
<i>Potential Eroded Volume Mean</i>	<21 y <sup>3</sup>	5
<i>Approach Slope Mean</i>	2.1-4%	3
<i>Soil K Factor</i>	<0.20	5
<i>Upstream Rt Outlet</i>	Bare soil	0
<i>Upstream Lt Outlet</i>	Rip Rap	1
<i>Upstream Rt Ditch</i>	Bare soil	0
<i>Upstream Lt Ditch</i>	Rip Rap	1
<i>Downstream Rt Outlet</i>	Vegetated	1
<i>Downstream Lt Outlet</i>	Vegetated	1
<i>Downstream Rt Ditch</i>	Vegetated	1
<i>Downstream Lt Ditch</i>	Vegetated	1
<i>Outlet Total</i>	Partially Improved Outlet System	3
<i>Ditches Total</i>	Partially Improved Drainage System	3
<b>SRI Total</b>	<b>Medium Risk</b>	<b>40</b>

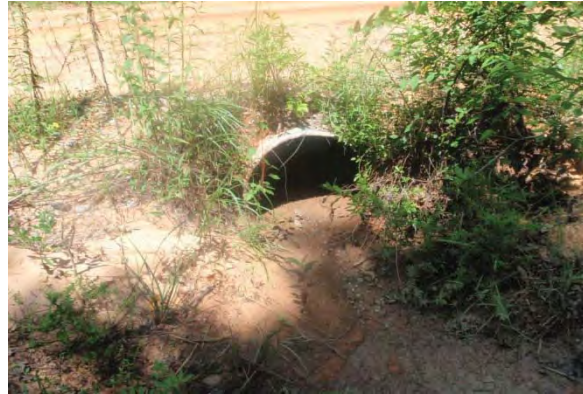
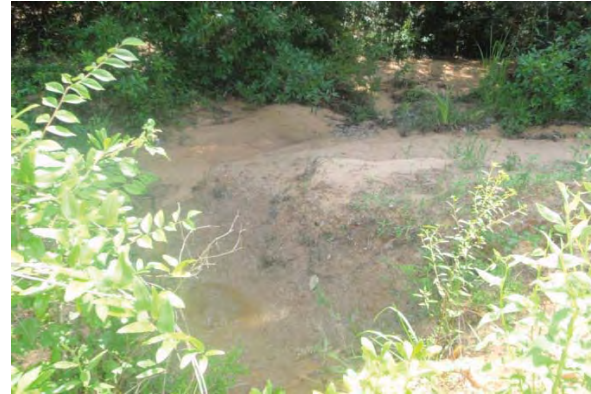
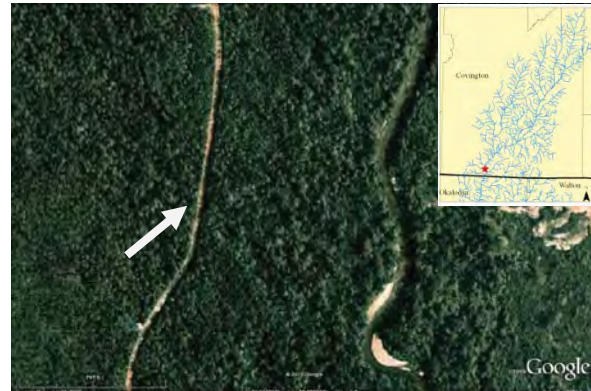
<b>Unnamed tributary</b>	<b>co-0810-r-003</b>	<i>Sedimentation Risk Index</i> <b>42</b>
--------------------------	----------------------	--

Risk Factor	Ranking	Score
<i>US Channel Morph</i>	B	5
<i>DS Channel Morph</i>	E	5
<i>DS Bank Alteration</i>	HIGH	1
<i>Upstream Skew Angle</i>	5-30°	3
<i>Crossing fill condition</i>	Poor/Bare soil	1
<i>Inlet/Outlet Condition</i>	No Impairment	5
<i>Road Approach Material</i>	All Native Soil	1
<i>Potential Eroded Volume Mean</i>	<21 y <sup>3</sup>	5
<i>Approach Slope Mean</i>	<2%	5
<i>Soil K Factor</i>	<0.20	5
<i>Upstream Rt Outlet</i>	Vegetated	1
<i>Upstream Lt Outlet</i>	Bare soil	0
<i>Upstream Rt Ditch</i>	Synthetic	1
<i>Upstream Lt Ditch</i>	Bare soil	0
<i>Downstream Rt Outlet</i>	Bare soil	0
<i>Downstream Lt Outlet</i>	Bare soil	0
<i>Downstream Rt Ditch</i>	Bare soil	0
<i>Downstream Lt Ditch</i>	Bare soil	0
<i>Outlet Total</i>	Partially Improved Outlet System	3
<i>Ditches Total</i>	Partially Improved Drainage System	3
<b>SRI Total</b>	<b>Medium Risk</b>	<b>42</b>

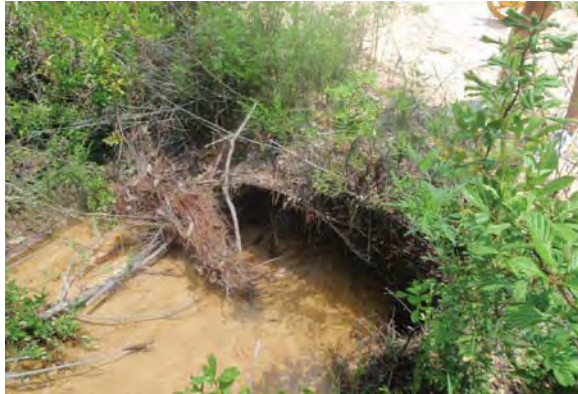
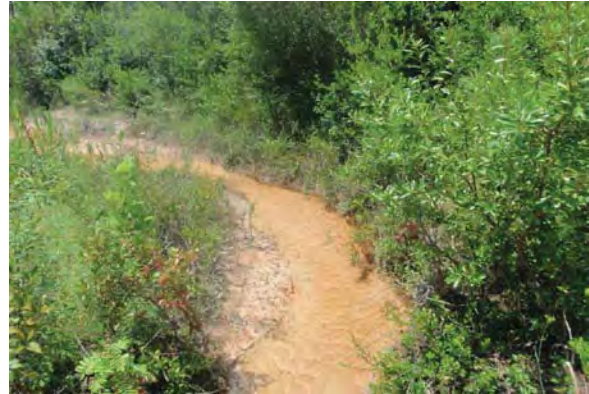
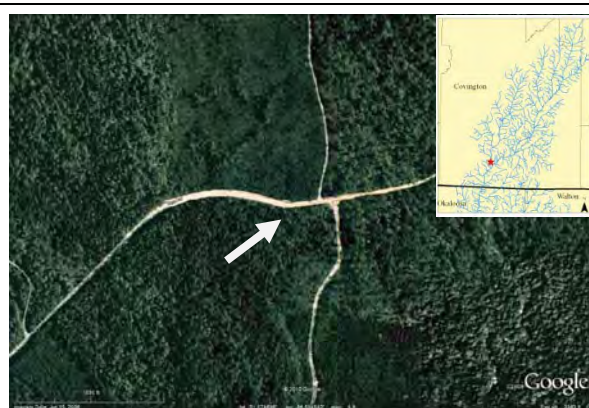
<b>Unnamed tributary</b>	<b>co-0810-r-008</b>	<i>Sedimentation Risk Index</i> <b>42</b>
--------------------------	----------------------	--

Risk Factor	Ranking	Score
<i>US Channel Morph</i>	DA	3
<i>DS Channel Morph</i>	DA	3
<i>DS Bank Alteration</i>	MINOR/PARTIAL	3
<i>Upstream Skew Angle</i>	>30°	1
<i>Crossing fill condition</i>	Good/Vegetated	5
<i>Inlet/Outlet Condition</i>	No Impairment	5
<i>Road Approach Material</i>	All Sand/Clay	3
<i>Potential Eroded Volume Mean</i>	<21 y <sup>3</sup>	5
<i>Approach Slope Mean</i>	2.1-4%	3
<i>Soil K Factor</i>	<0.20	5
<i>Upstream Rt Outlet</i>	Vegetated	1
<i>Upstream Lt Outlet</i>	Vegetated	1
<i>Upstream Rt Ditch</i>	Bare soil	0
<i>Upstream Lt Ditch</i>	Bare soil	0
<i>Downstream Rt Outlet</i>	Vegetated	1
<i>Downstream Lt Outlet</i>	Vegetated	1
<i>Downstream Rt Ditch</i>	Bare soil	0
<i>Downstream Lt Ditch</i>	Bare soil	0
<i>Outlet Total</i>	Improved Outlet System	5
<i>Ditches Total</i>	Unimproved Drainage System	1
<b>SRI Total</b>	<b>Medium Risk</b>	<b>42</b>
<b>Additional Site Features</b>		
<u>Crossing Type and Quantity:</u>	Culvert, 1

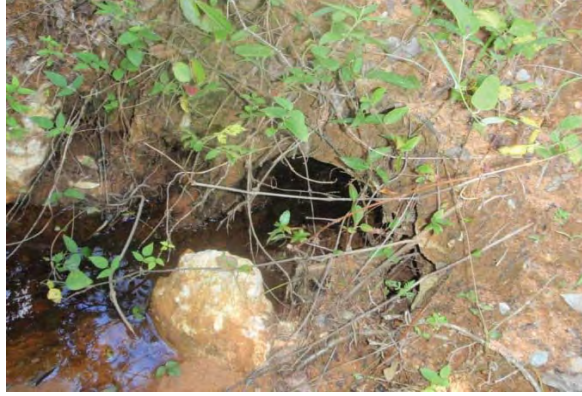
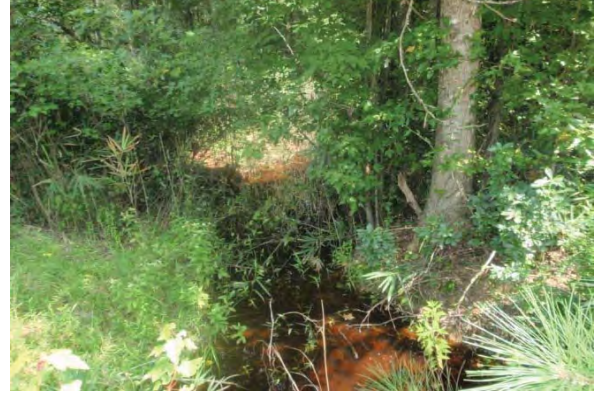
<b>Unnamed tributary</b>	<b>co-0810-r-012</b>	<i>Sedimentation Risk Index</i> <b>42</b>
--------------------------	----------------------	--

Risk Factor	Ranking	Score
<i>US Channel Morph</i>	DA	3
<i>DS Channel Morph</i>	DA	3
<i>DS Bank Alteration</i>	MINOR/PARTIAL	3
<i>Upstream Skew Angle</i>	5-30°	3
<i>Crossing fill condition</i>	Fair/Rip Rap	3
<i>Inlet/Outlet Condition</i>	No Impairment	5
<i>Road Approach Material</i>	All Sand/Clay	3
<i>Potential Eroded Volume Mean</i>	<21 y <sup>3</sup>	5
<i>Approach Slope Mean</i>	2.1-4%	3
<i>Soil K Factor</i>	<0.20	5
<i>Upstream Rt Outlet</i>	Vegetated	1
<i>Upstream Lt Outlet</i>	Vegetated	1
<i>Upstream Rt Ditch</i>	Bare soil	0
<i>Upstream Lt Ditch</i>	Bare soil	0
<i>Downstream Rt Outlet</i>	Vegetated	1
<i>Downstream Lt Outlet</i>	Vegetated	1
<i>Downstream Rt Ditch</i>	Bare soil	0
<i>Downstream Lt Ditch</i>	Bare soil	0
<i>Outlet Total</i>	Improved Outlet System	5
<i>Ditches Total</i>	Unimproved Drainage System	1
<b>SRI Total</b>	<b>Medium Risk</b>	<b>42</b>

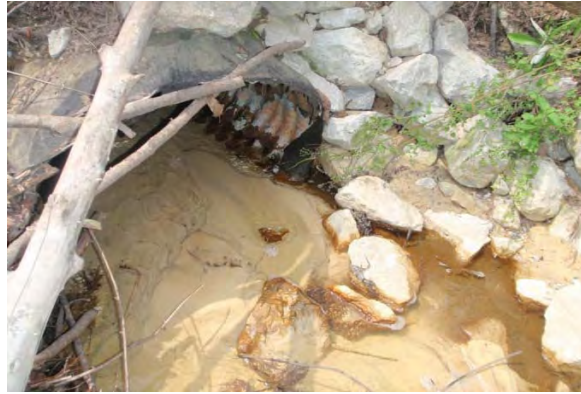
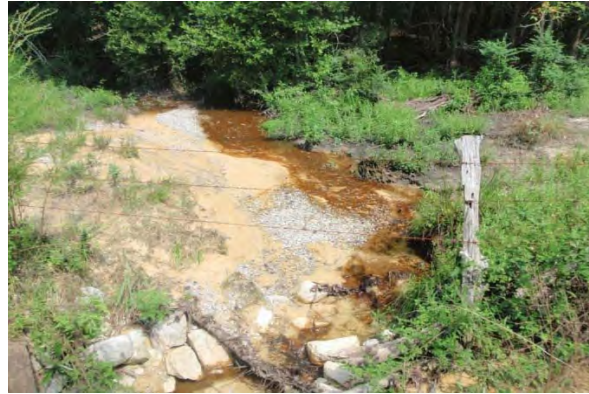
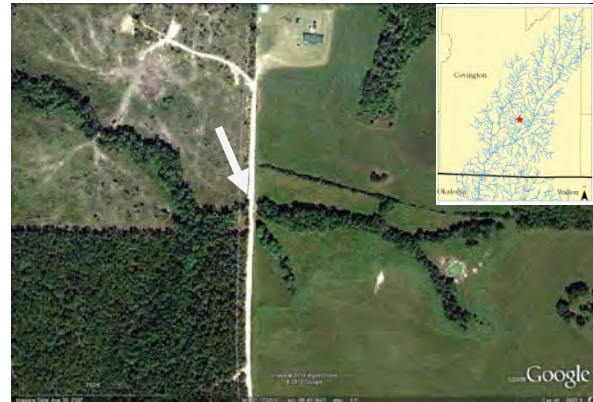
Unnamed tributary	co-0901-r-010	Sedimentation Risk Index <b>42</b>
-------------------	---------------	---------------------------------------

Risk Factor	Ranking	Score
<i>US Channel Morph</i>	E	5
<i>DS Channel Morph</i>	DA	3
<i>DS Bank Alteration</i>	MINOR/PARTIAL	3
<i>Upstream Skew Angle</i>	5-30°	3
<i>Crossing fill condition</i>	Fair/Rip Rap	3
<i>Inlet/Outlet Condition</i>	Sed Islands/Scouring	3
<i>Road Approach Material</i>	All Aggregate	5
<i>Potential Eroded Volume Mean</i>	<21 y <sup>3</sup>	5
<i>Approach Slope Mean</i>	>4%	1
<i>Soil K Factor</i>	<0.20	5
<i>Upstream Rt Outlet</i>	Vegetated	1
<i>Upstream Lt Outlet</i>	Vegetated	1
<i>Upstream Rt Ditch</i>	Bare soil	0
<i>Upstream Lt Ditch</i>	Bare soil	0
<i>Downstream Rt Outlet</i>	Vegetated	1
<i>Downstream Lt Outlet</i>	Vegetated	1
<i>Downstream Rt Ditch</i>	Bare soil	0
<i>Downstream Lt Ditch</i>	Bare soil	0
<i>Outlet Total</i>	Improved Outlet System	5
<i>Ditches Total</i>	Unimproved Drainage System	1
<b>SRI Total</b>	<b>Medium Risk</b>	<b>42</b>

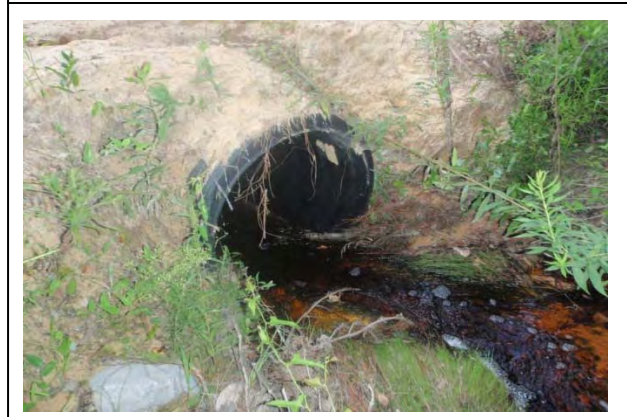
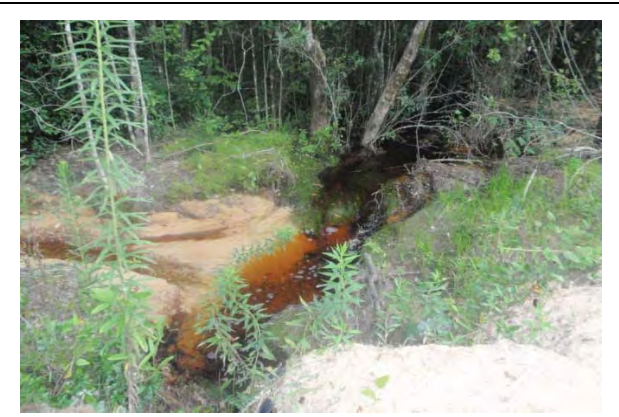
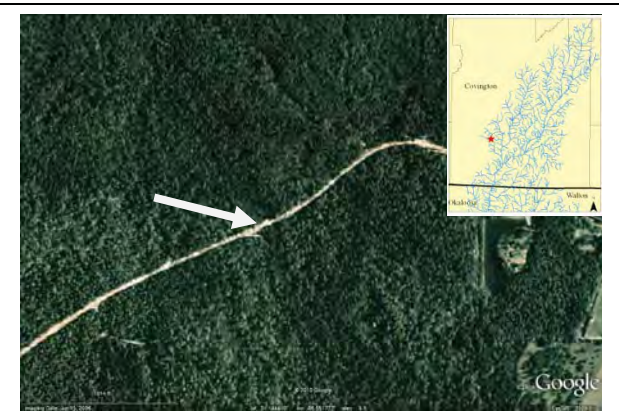
<b>Unnamed tributary</b>	<b>co-0810-r-020</b>	<i>Sedimentation Risk Index</i> <b>44</b>
--------------------------	----------------------	--

Risk Factor	Ranking	Score
<i>US Channel Morph</i>	DA	3
<i>DS Channel Morph</i>	C	5
<i>DS Bank Alteration</i>	NATURAL	5
<i>Upstream Skew Angle</i>	5-30°	3
<i>Crossing fill condition</i>	Poor/Bare soil	1
<i>Inlet/Outlet Condition</i>	No Impairment	5
<i>Road Approach Material</i>	All Sand/Clay	3
<i>Potential Eroded Volume Mean</i>	<21 y <sup>3</sup>	5
<i>Approach Slope Mean</i>	<2%	5
<i>Soil K Factor</i>	<0.20	5
<i>Upstream Rt Outlet</i>	Bare soil	0
<i>Upstream Lt Outlet</i>	Vegetated	1
<i>Upstream Rt Ditch</i>	Bare soil	0
<i>Upstream Lt Ditch</i>	Bare soil	0
<i>Downstream Rt Outlet</i>	Vegetated	1
<i>Downstream Lt Outlet</i>	Bare soil	0
<i>Downstream Rt Ditch</i>	Bare soil	0
<i>Downstream Lt Ditch</i>	Bare soil	0
<i>Outlet Total</i>	Partially Improved Outlet System	3
<i>Ditches Total</i>	Unimproved Drainage System	1
<b><i>SRI Total</i></b>	<b>Medium Risk</b>	<b>44</b>

Notes: Receiving high sediment loads from outlets and bare fill.

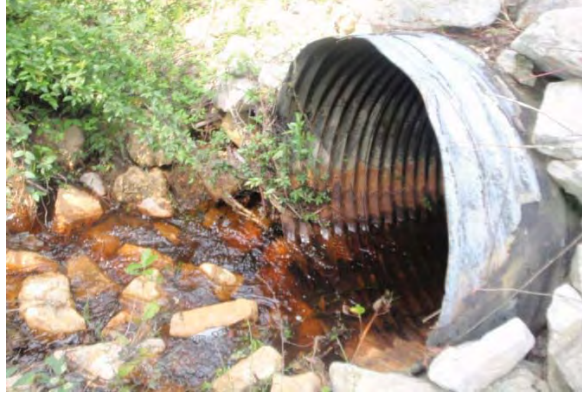
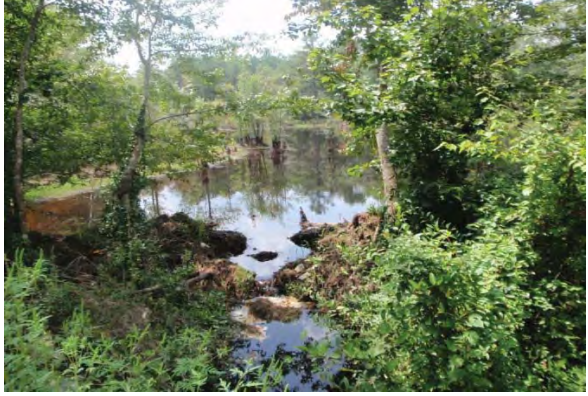
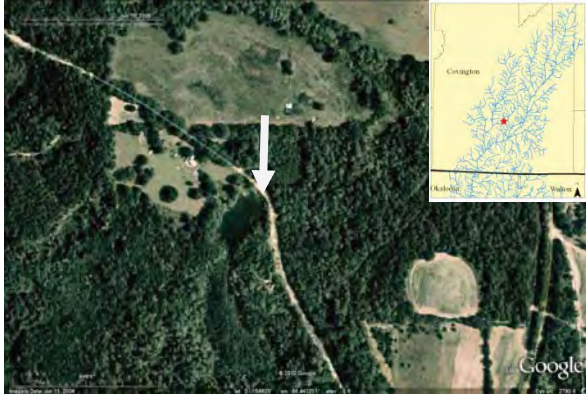
<b>Unnamed tributary</b>	<b>co-0901-r-008</b>	<i>Sedimentation Risk Index</i> <b>44</b>
--------------------------	----------------------	--

Risk Factor	Ranking	Score
<i>US Channel Morph</i>	PONDED	1
<i>DS Channel Morph</i>	E	5
<i>DS Bank Alteration</i>	MINOR/PARTIAL	3
<i>Upstream Skew Angle</i>	<5°	5
<i>Crossing fill condition</i>	Fair/Rip Rap	3
<i>Inlet/Outlet Condition</i>	No Impairment	5
<i>Road Approach Material</i>	All Native Soil	1
<i>Potential Eroded Volume Mean</i>	<21 y <sup>3</sup>	5
<i>Approach Slope Mean</i>	2.1-4%	3
<i>Soil K Factor</i>	<0.20	5
<i>Upstream Rt Outlet</i>	Vegetated	1
<i>Upstream Lt Outlet</i>	Rip Rap	1
<i>Upstream Rt Ditch</i>	Vegetated	1
<i>Upstream Lt Ditch</i>	Bare soil	0
<i>Downstream Rt Outlet</i>	Vegetated	1
<i>Downstream Lt Outlet</i>	Vegetated	1
<i>Downstream Rt Ditch</i>	Bare soil	0
<i>Downstream Lt Ditch</i>	Bare soil	0
<i>Outlet Total</i>	Improved Outlet System	5
<i>Ditches Total</i>	Partially Improved Drainage System	3
<b>SRI Total</b>	<b>Medium Risk</b>	<b>44</b>

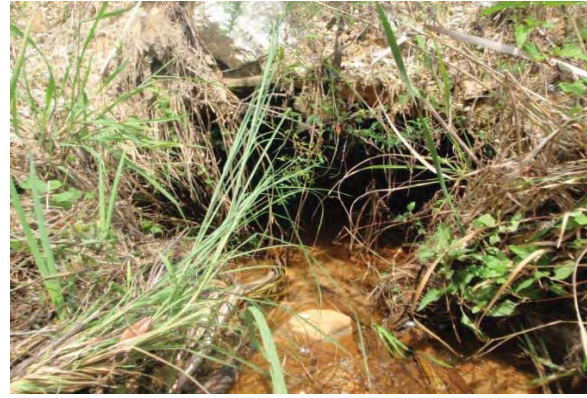
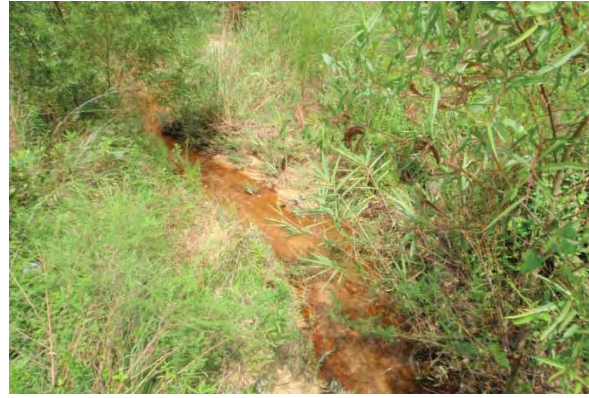
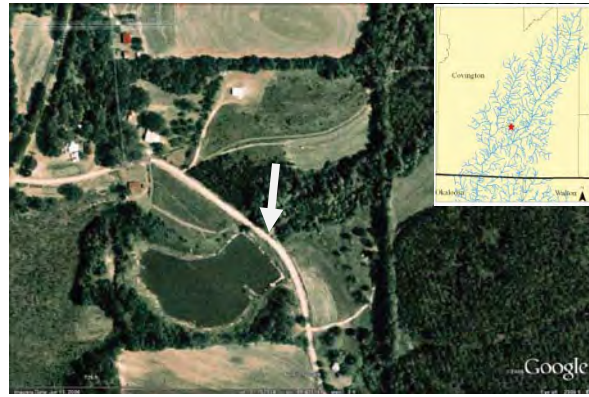
<b>Unnamed tributary</b>	<b>co-0901-r-009</b>	<i>Sedimentation Risk Index</i> <b>44</b>
--------------------------	----------------------	--

Risk Factor	Ranking	Score
<i>US Channel Morph</i>	PONDED	1
<i>DS Channel Morph</i>	E	5
<i>DS Bank Alteration</i>	MINOR/PARTIAL	3
<i>Upstream Skew Angle</i>	<5°	5
<i>Crossing fill condition</i>	Fair/Rip Rap	3
<i>Inlet/Outlet Condition</i>	Sed Islands/Scouring	3
<i>Road Approach Material</i>	All Aggregate	5
<i>Potential Eroded Volume Mean</i>	<21 y <sup>3</sup>	5
<i>Approach Slope Mean</i>	<2%	5
<i>Soil K Factor</i>	0.21-0.40	3
<i>Upstream Rt Outlet</i>	Vegetated	1
<i>Upstream Lt Outlet</i>	Vegetated	1
<i>Upstream Rt Ditch</i>	Bare soil	0
<i>Upstream Lt Ditch</i>	Bare soil	0
<i>Downstream Rt Outlet</i>	Vegetated	1
<i>Downstream Lt Outlet</i>	Vegetated	1
<i>Downstream Rt Ditch</i>	Bare soil	0
<i>Downstream Lt Ditch</i>	Bare soil	0
<i>Outlet Total</i>	Improved Outlet System	5
<i>Ditches Total</i>	Unimproved Drainage System	1
<b>SRI Total</b>	<b>Medium Risk</b>	<b>44</b>

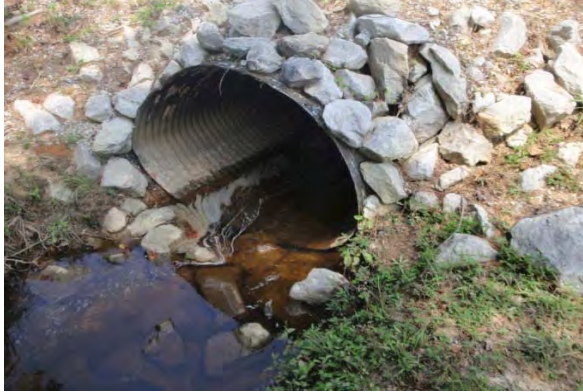
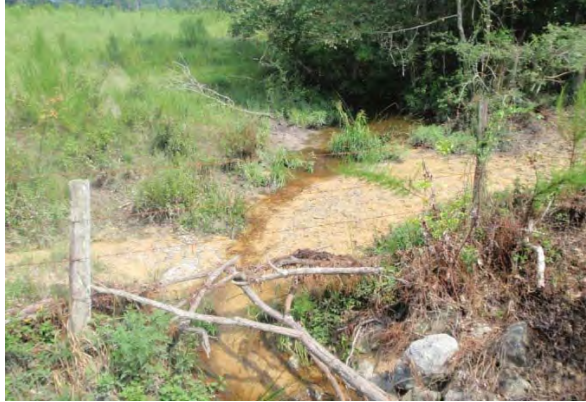
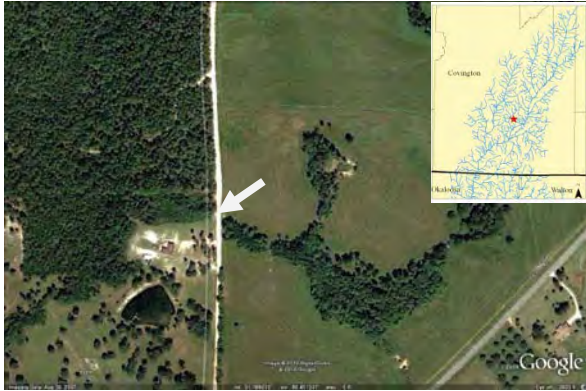
Unnamed tributary	co-0901-r-011	Sedimentation Risk Index <b>42</b>
-------------------	---------------	---------------------------------------

Risk Factor	Ranking	Score
<i>US Channel Morph</i>	E	5
<i>DS Channel Morph</i>	E	5
<i>DS Bank Alteration</i>	MINOR/PARTIAL	3
<i>Upstream Skew Angle</i>	<5°	5
<i>Crossing fill condition</i>	Fair/Rip Rap	3
<i>Inlet/Outlet Condition</i>	Sed Islands/Scouring	3
<i>Road Approach Material</i>	All Aggregate	5
<i>Potential Eroded Volume Mean</i>	<21 y <sup>3</sup>	5
<i>Approach Slope Mean</i>	>4%	1
<i>Soil K Factor</i>	<0.20	5
<i>Upstream Rt Outlet</i>	Bare soil	0
<i>Upstream Lt Outlet</i>	Bare soil	0
<i>Upstream Rt Ditch</i>	Vegetated	1
<i>Upstream Lt Ditch</i>	Bare soil	0
<i>Downstream Rt Outlet</i>	Bare soil	0
<i>Downstream Lt Outlet</i>	Bare soil	0
<i>Downstream Rt Ditch</i>	Vegetated	1
<i>Downstream Lt Ditch</i>	Vegetated	1
<i>Outlet Total</i>	Unimproved Outlet System	1
<i>Ditches Total</i>	Partially Improved Drainage System	3
<b>SRI Total</b>	<b>Medium Risk</b>	<b>44</b>

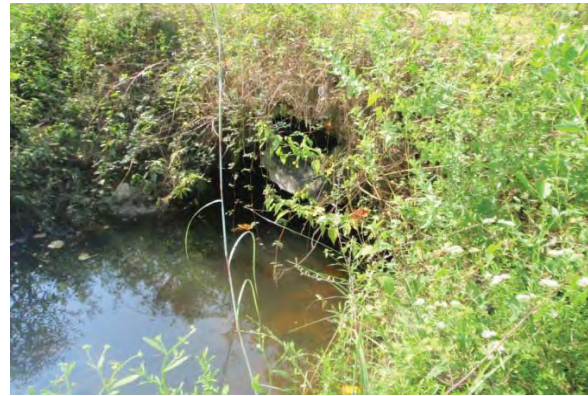
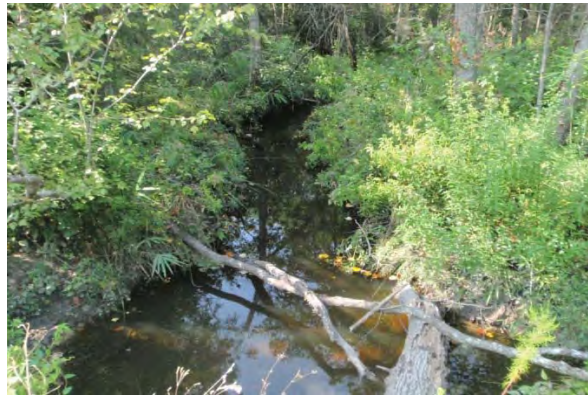
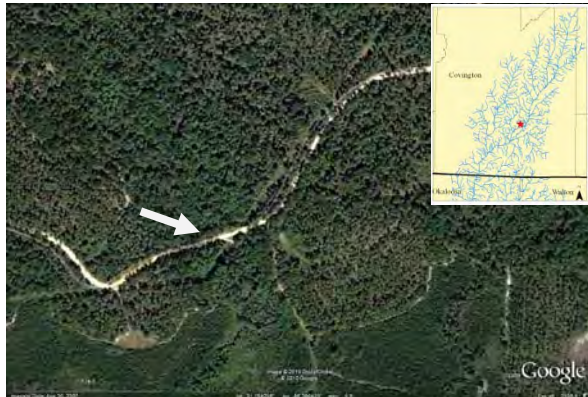
<b>Unnamed tributary</b>	<b>co-0901-r-015</b>	<i>Sedimentation Risk Index</i> <b>44</b>
--------------------------	----------------------	--

Risk Factor	Ranking	Score
<i>US Channel Morph</i>	C	5
<i>DS Channel Morph</i>	C	5
<i>DS Bank Alteration</i>	MINOR/PARTIAL	3
<i>Upstream Skew Angle</i>	<5°	5
<i>Crossing fill condition</i>	Good/Vegetated	5
<i>Inlet/Outlet Condition</i>	Sed Islands/Scouring	3
<i>Road Approach Material</i>	All Sand/Clay	3
<i>Potential Eroded Volume Mean</i>	>40 y <sup>3</sup>	1
<i>Approach Slope Mean</i>	2.1-4%	3
<i>Soil K Factor</i>	<0.20	5
<i>Upstream Rt Outlet</i>	Vegetated	1
<i>Upstream Lt Outlet</i>	Vegetated	1
<i>Upstream Rt Ditch</i>	Bare soil	0
<i>Upstream Lt Ditch</i>	Bare soil	0
<i>Downstream Rt Outlet</i>	Vegetated	1
<i>Downstream Lt Outlet</i>	Vegetated	1
<i>Downstream Rt Ditch</i>	Bare soil	0
<i>Downstream Lt Ditch</i>	Bare soil	0
<i>Outlet Total</i>	Improved Outlet System	5
<i>Ditches Total</i>	Unimproved Drainage System	1
<b>SRI Total</b>	<b>Medium Risk</b>	<b>44</b>
<b>Additional Site Features</b>		
<i>Crossing Type and Quantity:</i>	Culvert, 1

Notes: Highly vegetated

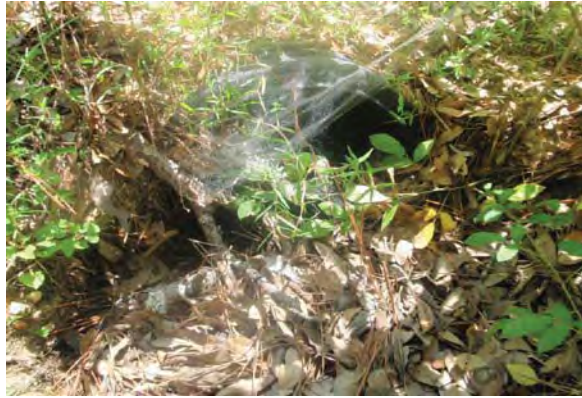
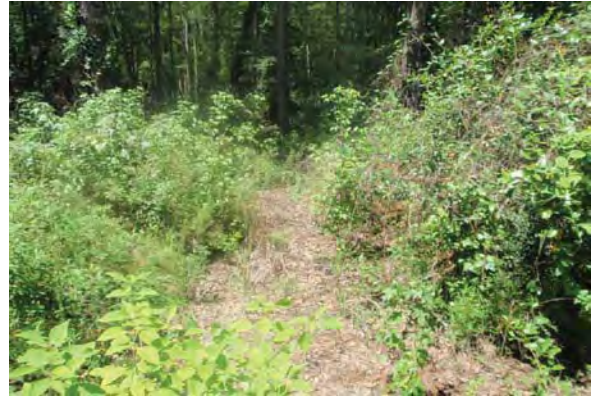
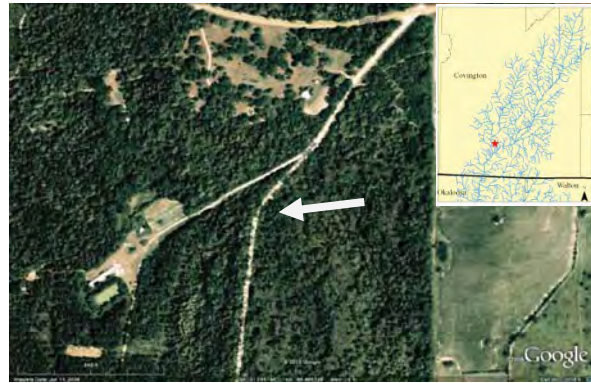
Unnamed tributary	co-0810-r-004	Sedimentation Risk Index <b>46</b>
-------------------	---------------	---------------------------------------

Risk Factor	Ranking	Score
US Channel Morph	E	5
DS Channel Morph	E	5
DS Bank Alteration	MINOR/PARTIAL	3
Upstream Skew Angle	<5°	5
Crossing fill condition	Good/Vegetated	5
Inlet/Outlet Condition	Blocked	1
Road Approach Material	All Sand/Clay	3
Potential Eroded Volume Mean	<21 y <sup>3</sup>	5
Approach Slope Mean	<2%	5
Soil K Factor	<0.20	5
Upstream Rt Outlet	Vegetated	1
Upstream Lt Outlet	Bare soil	0
Upstream Rt Ditch	Bare soil	0
Upstream Lt Ditch	Bare soil	0
Downstream Rt Outlet	Vegetated	1
Downstream Lt Outlet	Vegetated	1
Downstream Rt Ditch	Bare soil	0
Downstream Lt Ditch	Bare soil	0
Outlet Total	Partially Improved Outlet System	3
Ditches Total	Unimproved Drainage System	1
<b>SRI Total</b>	<b>Low Risk</b>	<b>46</b>

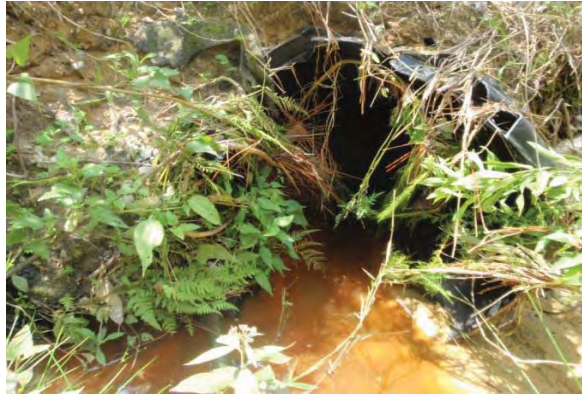
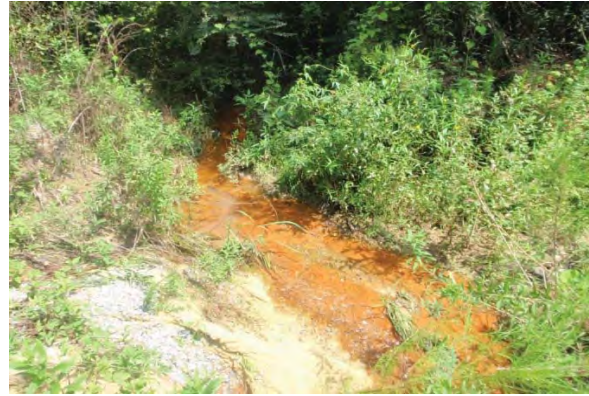
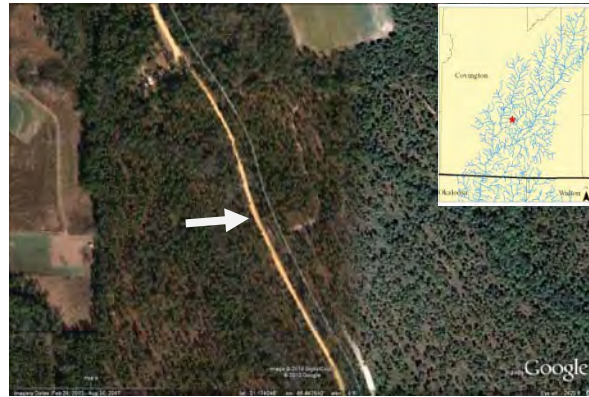
<b>Unnamed tributary</b>	<b>co-0901-r-006</b>	<i>Sedimentation Risk Index</i> <b>46</b>
--------------------------	----------------------	--

Risk Factor	Ranking	Score
<i>US Channel Morph</i>	E	5
<i>DS Channel Morph</i>	E	5
<i>DS Bank Alteration</i>	MINOR/PARTIAL	3
<i>Upstream Skew Angle</i>	<5°	5
<i>Crossing fill condition</i>	Fair/Rip Rap	3
<i>Inlet/Outlet Condition</i>	Sed Islands/Scouring	3
<i>Road Approach Material</i>	All Sand/Clay	3
<i>Potential Eroded Volume Mean</i>	<21 y <sup>3</sup>	5
<i>Approach Slope Mean</i>	<2%	5
<i>Soil K Factor</i>	<0.20	5
<i>Upstream Rt Outlet</i>	Bare soil	0
<i>Upstream Lt Outlet</i>	Bare soil	0
<i>Upstream Rt Ditch</i>	Bare soil	0
<i>Upstream Lt Ditch</i>	Bare soil	0
<i>Downstream Rt Outlet</i>	Rip Rap	1
<i>Downstream Lt Outlet</i>	Vegetated	1
<i>Downstream Rt Ditch</i>	Bare soil	0
<i>Downstream Lt Ditch</i>	Bare soil	0
<i>Outlet Total</i>	Partially Improved Outlet System	3
<i>Ditches Total</i>	Unimproved Drainage System	1
<b>SRI Total</b>	<b>Low Risk</b>	<b>46</b>

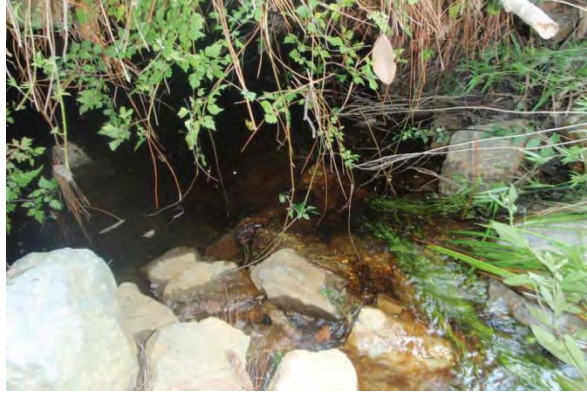
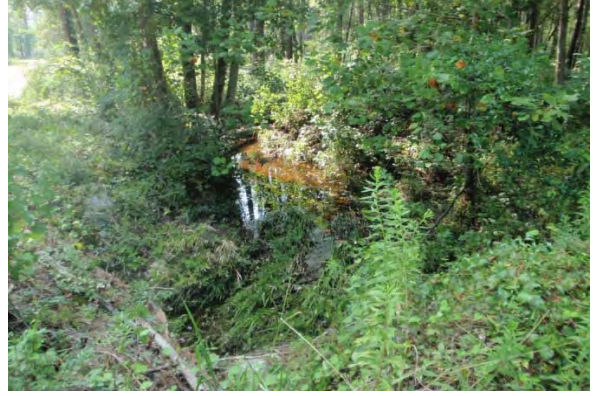
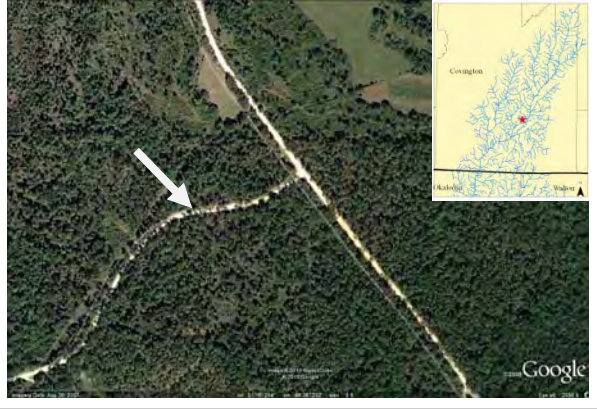
<b>Unnamed tributary</b>	<b>co-0901-r-016</b>	<i>Sedimentation Risk Index</i> <b>46</b>
--------------------------	----------------------	--

Risk Factor	Ranking	Score
<i>US Channel Morph</i>	C	5
<i>DS Channel Morph</i>	C	5
<i>DS Bank Alteration</i>	MINOR/PARTIAL	3
<i>Upstream Skew Angle</i>	>30°	1
<i>Crossing fill condition</i>	Good/Vegetated	5
<i>Inlet/Outlet Condition</i>	No Impairment	5
<i>Road Approach Material</i>	All Sand/Clay	3
<i>Potential Eroded Volume Mean</i>	>40 y <sup>3</sup>	1
<i>Approach Slope Mean</i>	<2%	5
<i>Soil K Factor</i>	<0.20	5
<i>Upstream Rt Outlet</i>	Vegetated	1
<i>Upstream Lt Outlet</i>	Vegetated	1
<i>Upstream Rt Ditch</i>	Bare soil	0
<i>Upstream Lt Ditch</i>	Bare soil	0
<i>Downstream Rt Outlet</i>	Vegetated	1
<i>Downstream Lt Outlet</i>	Vegetated	1
<i>Downstream Rt Ditch</i>	Vegetated	1
<i>Downstream Lt Ditch</i>	Vegetated	1
<i>Outlet Total</i>	Improved Outlet System	5
<i>Ditches Total</i>	Partially Improved Drainage System	3
<b>SRI Total</b>	<b>Low Risk</b>	<b>46</b>

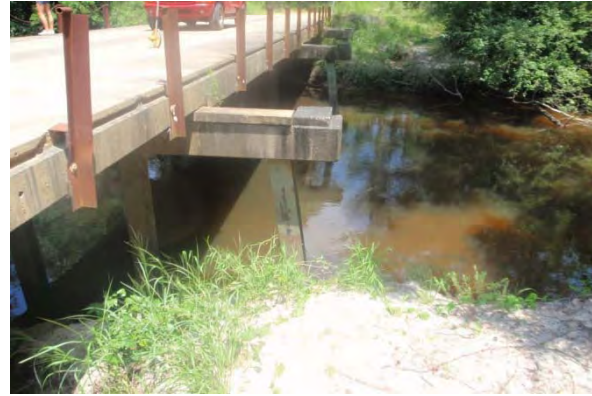
<h1 style="margin:0;">Five Runs Creek</h1>	<h2 style="margin:0;">co-0810-r-007</h2>	<i>Sedimentation Risk Index</i> <b style="font-size: 1.5em;">48</b>
--	--	--

Risk Factor	Ranking	Score
<i>US Channel Morph</i>	E	5
<i>DS Channel Morph</i>	E	5
<i>DS Bank Alteration</i>	MINOR/PARTIAL	3
<i>Upstream Skew Angle</i>	<5°	5
<i>Crossing fill condition</i>	Good/Vegetated	5
<i>Inlet/Outlet Condition</i>	No Impairment	5
<i>Road Approach Material</i>	All Sand/Clay	3
<i>Potential Eroded Volume Mean</i>	21-40 y <sup>3</sup>	3
<i>Approach Slope Mean</i>	<2%	5
<i>Soil K Factor</i>	<0.20	5
<i>Upstream Rt Outlet</i>	Bare soil	0
<i>Upstream Lt Outlet</i>	Vegetated	1
<i>Upstream Rt Ditch</i>	Bare soil	0
<i>Upstream Lt Ditch</i>	Bare soil	0
<i>Downstream Rt Outlet</i>	Bare soil	0
<i>Downstream Lt Outlet</i>	Bare soil	0
<i>Downstream Rt Ditch</i>	Bare soil	0
<i>Downstream Lt Ditch</i>	Bare soil	0
<i>Outlet Total</i>	Partially Improved Outlet System	3
<i>Ditches Total</i>	Unimproved Drainage System	1
<b><i>SRI Total</i></b>	<b>Low Risk</b>	<b>48</b>

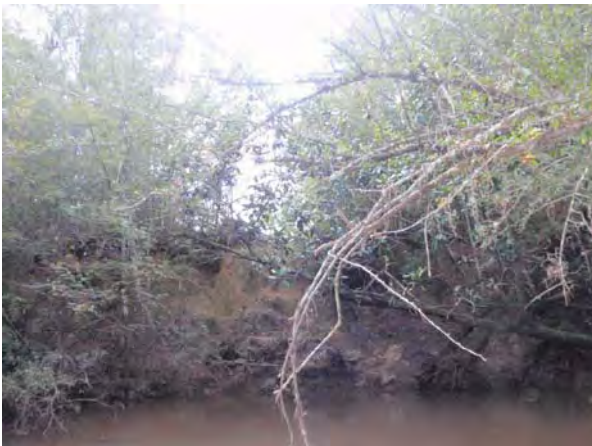
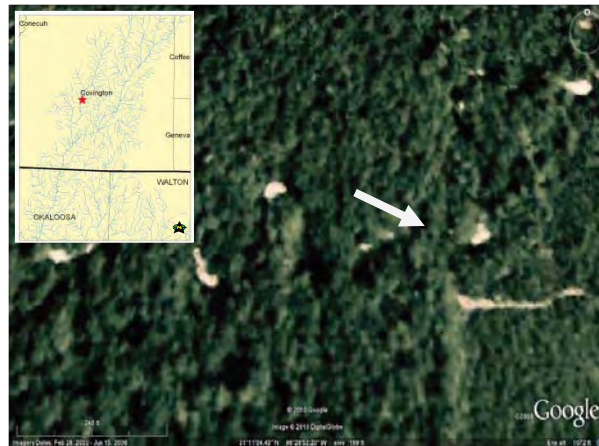
<b>Five Runs Creek</b>	<b>co-0923-001</b>	<i>Severity Score</i> <b>5</b>
------------------------	--------------------	-----------------------------------

Risk Factor	Ranking	Score	Feature	Within Range	Descriptive Field
<i>Channel Stability</i>	Fair	1	303(d)	No	N/A
<i>Channel Alteration</i>	None	0	Wetland Species	No	N/A
<i>Bank Erosion</i>	Active	1	Rare and Imperiled	No	N/A
<i>BEHI</i>	Moderate	0.5	Land Use/Cover	No	N/A
<i>Local NPSP</i>	No Evidence	0	Candidate Mussels	No	N/A
<i>Shoring Structures</i>	Not Present	0	Sturgeon C.H.	No	N/A
<i>Pipe Discharge</i>	Not Present	0	<b>Additional Site Features</b>		
<i>Water Odors</i>	Not Present	0	<i>Stream Channel Woody Material:</i> Moderate		
<i>Fish Passage Barrier</i>	Present	1.5	<i>Impoundments:</i> None		
<i>RB: Riparian Buffer</i>	100+ ft	0	<i>Substrate Composition:</i> Clay Marl		
<i>LB: Riparian Buffer</i>	0-29 ft	0.75	<i>Bank Material:</i> Sand and Clay		
<i>RB: Floodplain Access</i>	Full	0			
<i>LB: Floodplain Access</i>	Partial	0.25			
<b>River Threat Index:</b>		<b>5</b>

Notes: Private road leading to creek's edge, ending at the pictured bare spot.

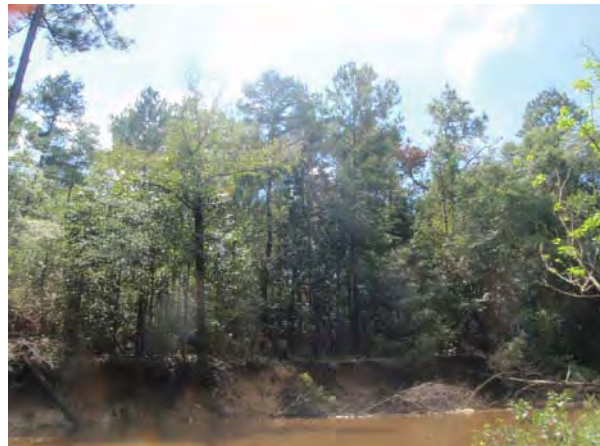
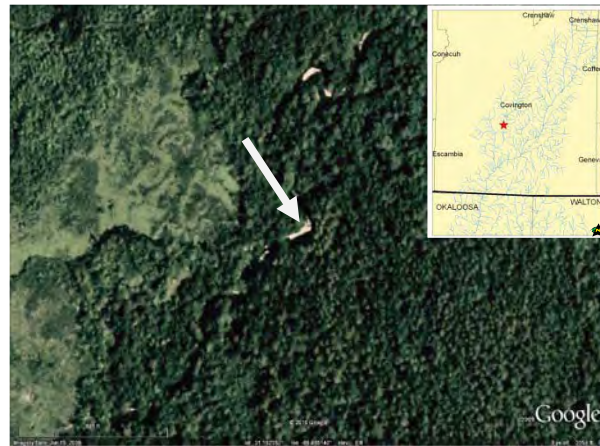
<b>Five Runs Creek</b>	<b>co-0923-002</b>	<i>Severity Score</i> <b>2</b>
------------------------	--------------------	-----------------------------------

Risk Factor	Ranking	Score	Feature	Within Range	Descriptive Field
<i>Channel Stability</i>	Good	0.5	303(d)	No	N/A
<i>Channel Alteration</i>	None	0	Wetland Species	No	N/A
<i>Bank Erosion</i>	Active	1	Rare and Imperiled	No	N/A
<i>BEHI</i>	Moderate	0.5	Land Use/Cover	No	N/A
<i>Local NPSP</i>	No Evidence	0	Candidate Mussels	No	N/A
<i>Shoring Structures</i>	Not Present	0	Sturgeon C.H.	No	N/A
<i>Pipe Discharge</i>	Not Present	0	<b>Additional Site Features</b>		
<i>Water Odors</i>	Not Present	0	<i>Stream Channel Woody Material:</i> Moderate		
<i>Fish Passage Barrier</i>	Not Present	0	<i>Impoundments:</i> None		
<i>RB: Riparian Buffer</i>	100+ ft	0	<i>Substrate Composition:</i> Medium Sand		
<i>LB: Riparian Buffer</i>	100+ ft	0	<i>Bank Material:</i> Sand		
<i>RB: Floodplain Access</i>	Full	0			
<i>LB: Floodplain Access</i>	Full	0			
<b>River Threat Index:</b>		<b>2</b>

Notes: Outside bend- natural feature.

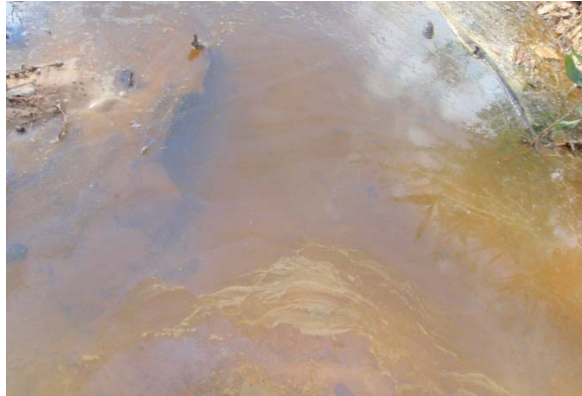
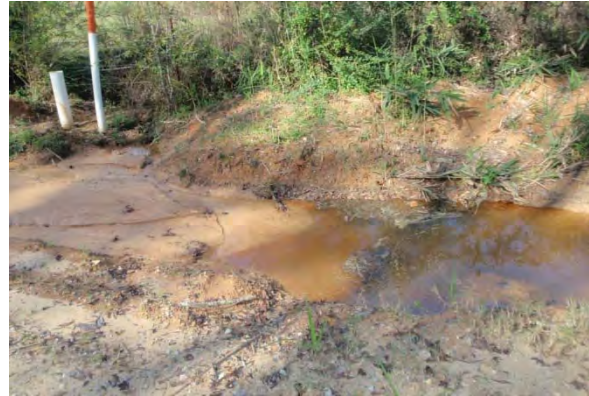
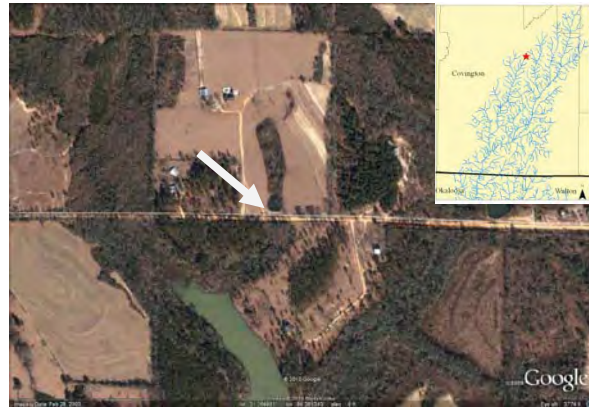
Unnamed tributary	co-1029-r-008	Sedimentation Risk Index <b>24</b>
-------------------	---------------	---------------------------------------

Risk Factor	Ranking	Score
<i>US Channel Morph</i>	PONDED	1
<i>DS Channel Morph</i>	PONDED	1
<i>DS Bank Alteration</i>	HIGH	1
<i>Upstream Skew Angle</i>	>30°	1
<i>Crossing fill condition</i>	Poor/Bare soil	1
<i>Inlet/Outlet Condition</i>	Blocked	1
<i>Road Approach Material</i>	All Sand/Clay	3
<i>Potential Eroded Volume Mean</i>	<21 y <sup>3</sup>	5
<i>Approach Slope Mean</i>	2.1-4%	3
<i>Soil K Factor</i>	<0.20	5
<i>Upstream Rt Outlet</i>	Bare soil	0
<i>Upstream Lt Outlet</i>	Bare soil	0
<i>Upstream Rt Ditch</i>	Bare soil	0
<i>Upstream Lt Ditch</i>	Bare soil	0
<i>Downstream Rt Outlet</i>	Bare soil	0
<i>Downstream Lt Outlet</i>	Bare soil	0
<i>Downstream Rt Ditch</i>	Bare soil	0
<i>Downstream Lt Ditch</i>	Bare soil	0
<i>Outlet Total</i>	Unimproved Outlet System	1
<i>Ditches Total</i>	Unimproved Drainage System	1
<b><i>SRI Total</i></b>	<b>High Risk</b>	<b>24</b>

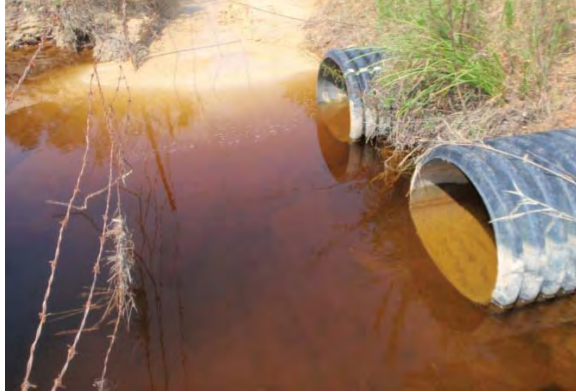
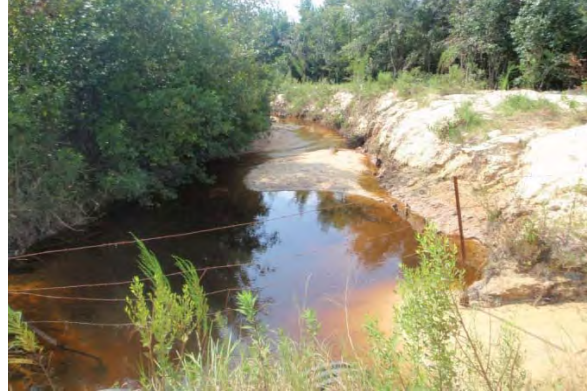
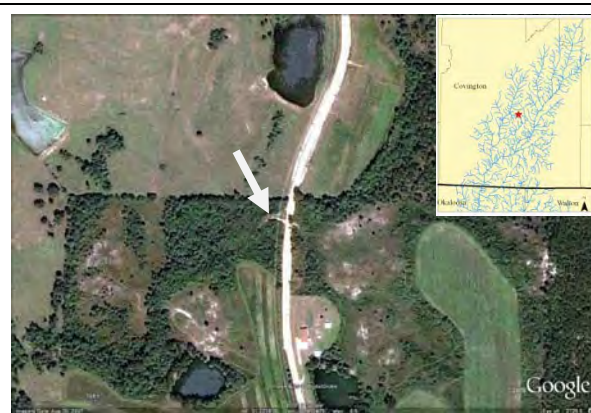
Unnamed tributary	co-0901-r-012	Sedimentation Risk Index <b>30</b>
-------------------	---------------	---------------------------------------

Risk Factor	Ranking	Score
<i>US Channel Morph</i>	E	5
<i>DS Channel Morph</i>	C	5
<i>DS Bank Alteration</i>	HIGH	1
<i>Upstream Skew Angle</i>	>30°	1
<i>Crossing fill condition</i>	Poor/Bare soil	1
<i>Inlet/Outlet Condition</i>	Sed Islands/Scouring	3
<i>Road Approach Material</i>	All Sand/Clay	3
<i>Potential Eroded Volume Mean</i>	>40 y <sup>3</sup>	1
<i>Approach Slope Mean</i>	2.1-4%	3
<i>Soil K Factor</i>	<0.20	5
<i>Upstream Rt Outlet</i>	Bare soil	0
<i>Upstream Lt Outlet</i>	Bare soil	0
<i>Upstream Rt Ditch</i>	Bare soil	0
<i>Upstream Lt Ditch</i>	Bare soil	0
<i>Downstream Rt Outlet</i>	Bare soil	0
<i>Downstream Lt Outlet</i>	Bare soil	0
<i>Downstream Rt Ditch</i>	Bare soil	0
<i>Downstream Lt Ditch</i>	Bare soil	0
<i>Outlet Total</i>	Unimproved Outlet System	1
<i>Ditches Total</i>	Unimproved Drainage System	1
<b>SRI Total</b>	<b>High Risk</b>	<b>30</b>

Notes: Fencing across DS. Channelized.
