Appendix A. River corridor severity scores for impaired sites in the Yellow River Basin, Alabama and Florida

Appendix C. Clear Creek Watershed Focal Area. Sites with orange headings are unpaved road sites. Specific definitions and calculations described for calculating the Sediment Risk Index (SRI) are detailed in Witmer (2009).

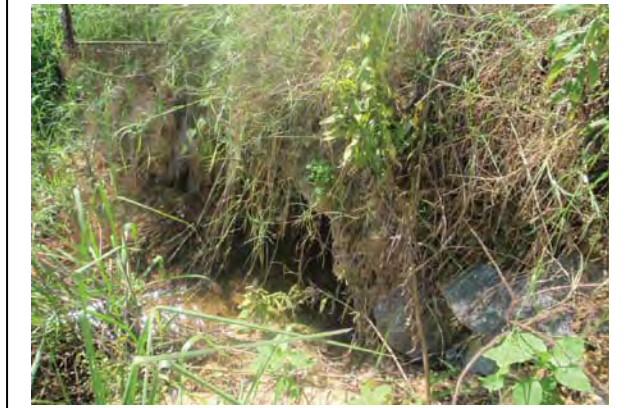
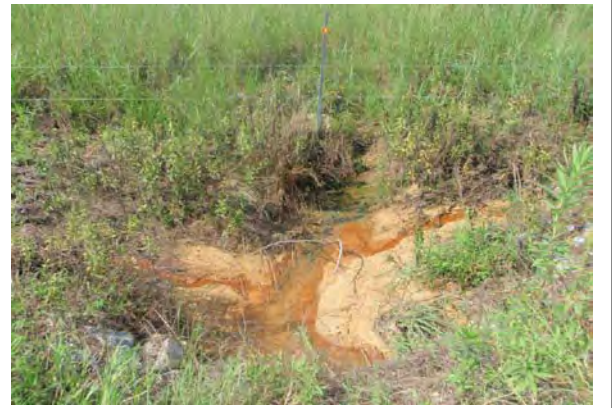
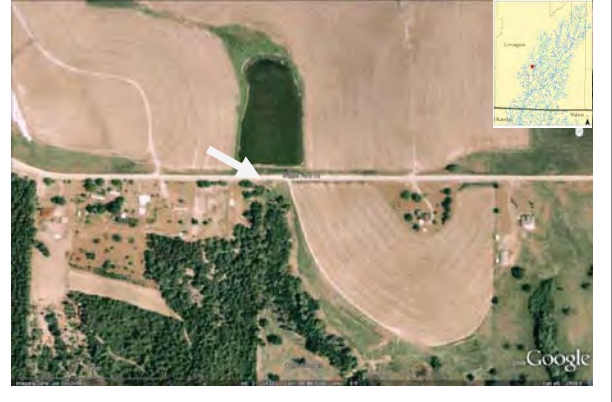
<h1>Unnamed tributary</h1>	<h2>co-0810-r-015</h2>	<i>Sedimentation Risk Index</i> <b>34</b>
----------------------------	------------------------	--

Risk Factor	Ranking	Score
<i>US Channel Morph</i>	PONDED	1
<i>DS Channel Morph</i>	E	5
<i>DS Bank Alteration</i>	HIGH	1
<i>Upstream Skew Angle</i>	>30°	1
<i>Crossing fill condition</i>	Fair/Rip Rap	3
<i>Inlet/Outlet Condition</i>	Sed Islands/Scouring	3
<i>Road Approach Material</i>	All Aggregate	5
<i>Potential Eroded Volume Mean</i>	<21 y <sup>3</sup>	5
<i>Approach Slope Mean</i>	>4%	1
<i>Soil K Factor</i>	<0.20	5
<i>Upstream Rt Outlet</i>	Bare soil	0
<i>Upstream Lt Outlet</i>	Bare soil	0
<i>Upstream Rt Ditch</i>	Bare soil	0
<i>Upstream Lt Ditch</i>	Bare soil	0
<i>Downstream Rt Outlet</i>	Bare soil	0
<i>Downstream Lt Outlet</i>	Rip Rap	1
<i>Downstream Rt Ditch</i>	Bare soil	0
<i>Downstream Lt Ditch</i>	Bare soil	0
<i>Outlet Total</i>	Partially Improved Outlet System	3
<i>Ditches Total</i>	Unimproved Drainage System	1
<b><i>SRI Total</i></b>	<b>High Risk</b>	<b>34</b>
<b>Additional Site Features</b>		
<i>Crossing Type and Quantity:</i>	Culvert, 1

Notes: US agricultural land use.

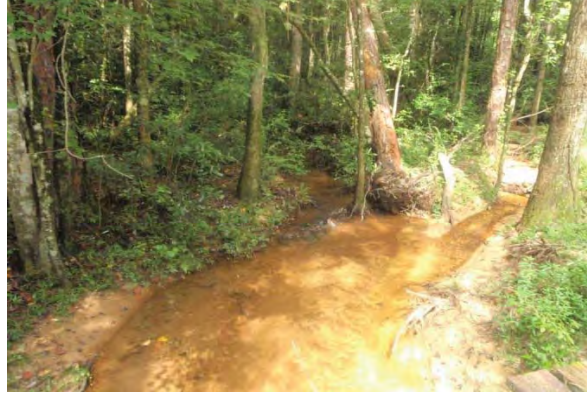
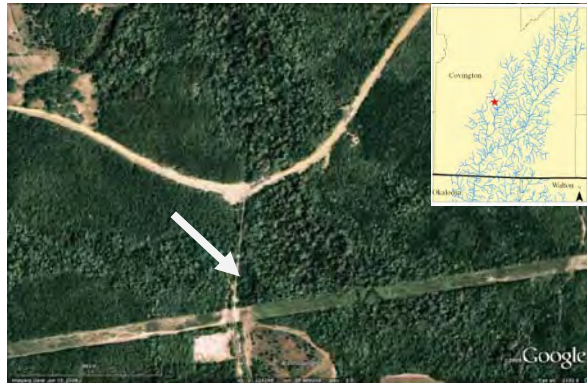
Risk Factor	Ranking	Score
<i>US Channel Morph</i>	DA	3
<i>DS Channel Morph</i>	DA	3
<i>DS Bank Alteration</i>	HIGH	1
<i>Upstream Skew Angle</i>	5-30°	3
<i>Crossing fill condition</i>	Good/Vegetated	5
<i>Inlet/Outlet Condition</i>	Sed Islands/Scouring	3
<i>Road Approach Material</i>	All Sand/Clay	3
<i>Potential Eroded Volume Mean</i>	<21 y <sup>3</sup>	5
<i>Approach Slope Mean</i>	>4%	1
<i>Soil K Factor</i>	<0.20	5
<i>Upstream Rt Outlet</i>	Bare soil	0
<i>Upstream Lt Outlet</i>	Bare soil	0
<i>Upstream Rt Ditch</i>	Bare soil	0
<i>Upstream Lt Ditch</i>	Bare soil	0
<i>Downstream Rt Outlet</i>	Bare soil	0
<i>Downstream Lt Outlet</i>	Bare soil	0
<i>Downstream Rt Ditch</i>	Bare soil	0
<i>Downstream Lt Ditch</i>	Bare soil	0
<i>Outlet Total</i>	Unimproved Outlet System	1
<i>Ditches Total</i>	Unimproved Drainage System	1
<b>SRI Total</b>	<b>High Risk</b>	<b>34</b>

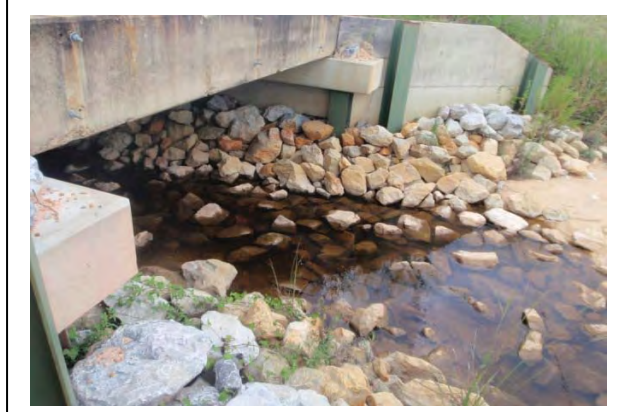
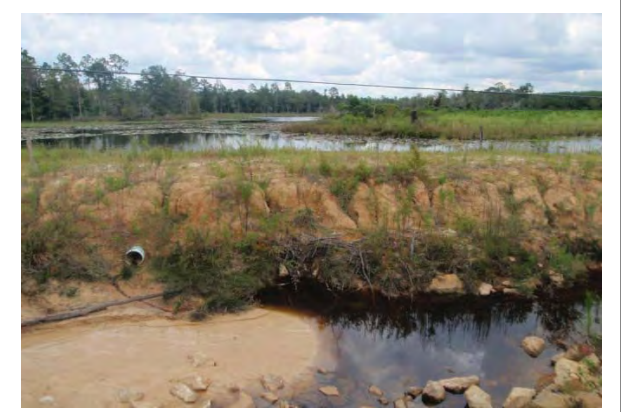
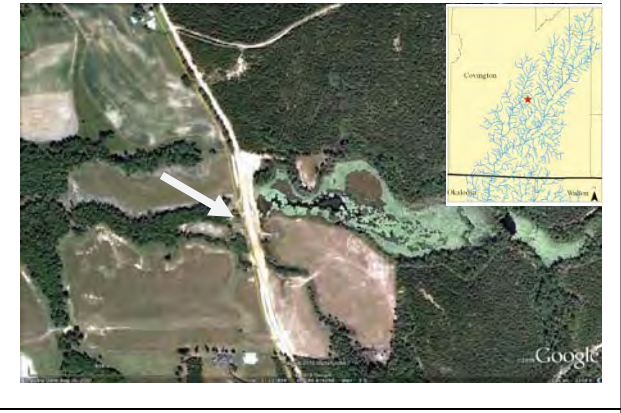
<h1>Unnamed tributary</h1>	<h2>co-0904-r-004</h2>	<i>Sedimentation Risk Index</i> <b>34</b>
----------------------------	------------------------	--

Risk Factor	Ranking	Score
<i>US Channel Morph</i>	PONDED	1
<i>DS Channel Morph</i>	E	5
<i>DS Bank Alteration</i>	HIGH	1
<i>Upstream Skew Angle</i>	>30°	1
<i>Crossing fill condition</i>	Fair/Rip Rap	3
<i>Inlet/Outlet Condition</i>	Sed Islands/Scouring	3
<i>Road Approach Material</i>	All Sand/Clay	3
<i>Potential Eroded Volume Mean</i>	<21 y <sup>3</sup>	5
<i>Approach Slope Mean</i>	2.1-4%	3
<i>Soil K Factor</i>	<0.20	5
<i>Upstream Rt Outlet</i>	Rip Rap	1
<i>Upstream Lt Outlet</i>	Rip Rap	1
<i>Upstream Rt Ditch</i>	Bare soil	0
<i>Upstream Lt Ditch</i>	Bare soil	0
<i>Downstream Rt Outlet</i>	Bare soil	0
<i>Downstream Lt Outlet</i>	Bare soil	0
<i>Downstream Rt Ditch</i>	Bare soil	0
<i>Downstream Lt Ditch</i>	Bare soil	0
<i>Outlet Total</i>	Partially Improved Outlet System	3
<i>Ditches Total</i>	Unimproved Drainage System	1
<b><i>SRI Total</i></b>	<b>High Risk</b>	<b>34</b>
<b>Additional Site Features</b>		
<i>Crossing Type and Quantity:</i>	Bridge,1; Culvert, 2

Notes: 2 culverts draining the pond to the bridge crossing.

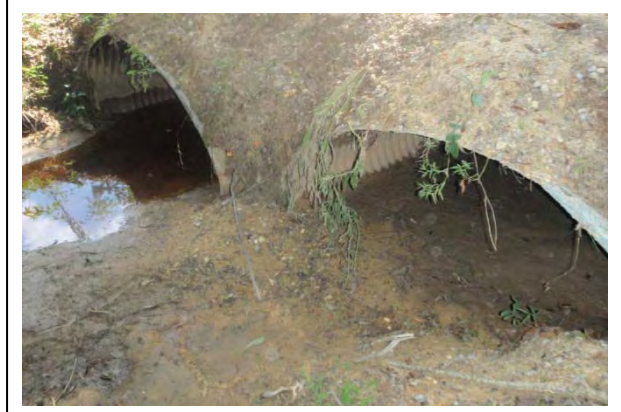
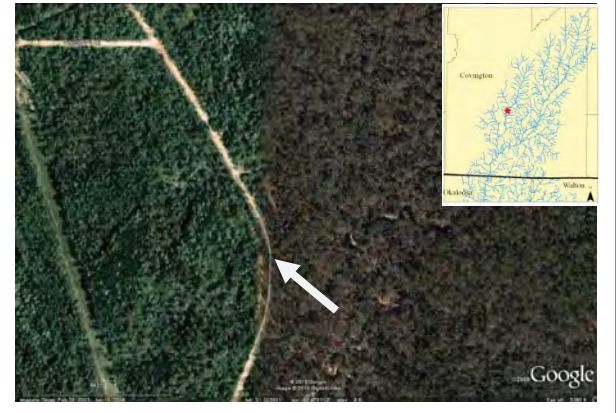
<h1>Unnamed tributary</h1>	<h2>co-0810-r-14a</h2>	<b>Sedimentation Risk Index</b> <h1>38</h1>
----------------------------	------------------------	--

Risk Factor	Ranking	Score
<i>US Channel Morph</i>	DA	3
<i>DS Channel Morph</i>	DA	3
<i>DS Bank Alteration</i>	HIGH	1
<i>Upstream Skew Angle</i>	<5°	5
<i>Crossing fill condition</i>	Poor/Bare soil	1
<i>Inlet/Outlet Condition</i>	No Impairment	5
<i>Road Approach Material</i>	All Sand/Clay	3
<i>Potential Eroded Volume Mean</i>	>40 y <sup>3</sup>	1
<i>Approach Slope Mean</i>	<2%	5
<i>Soil K Factor</i>	<0.20	5
<i>Upstream Rt Outlet</i>	Vegetated	1
<i>Upstream Lt Outlet</i>	Vegetated	1
<i>Upstream Rt Ditch</i>	Bare soil	0
<i>Upstream Lt Ditch</i>	Bare soil	0
<i>Downstream Rt Outlet</i>	Vegetated	1
<i>Downstream Lt Outlet</i>	Vegetated	1
<i>Downstream Rt Ditch</i>	Bare soil	0
<i>Downstream Lt Ditch</i>	Bare soil	0
<b>Outlet Total</b>	Improved Outlet System	<b>5</b>
<b>Ditches Total</b>	Unimproved Drainage System	<b>1</b>
<b>SRI Total</b>	<b>Medium Risk</b>	<b>38</b>

Notes: Significant difference between US and DS channel conditions. No flow through Lt Culvert.

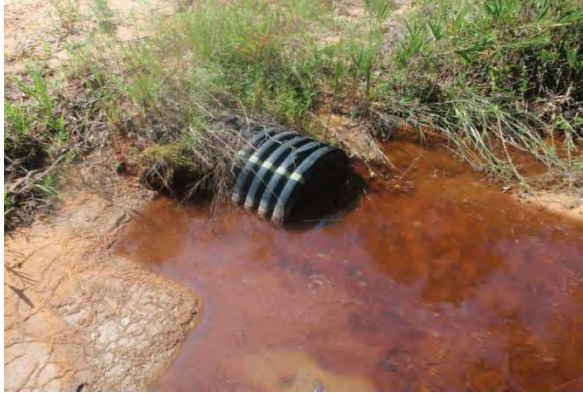
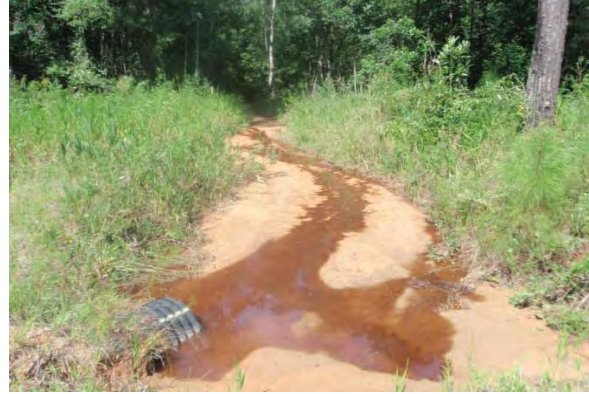
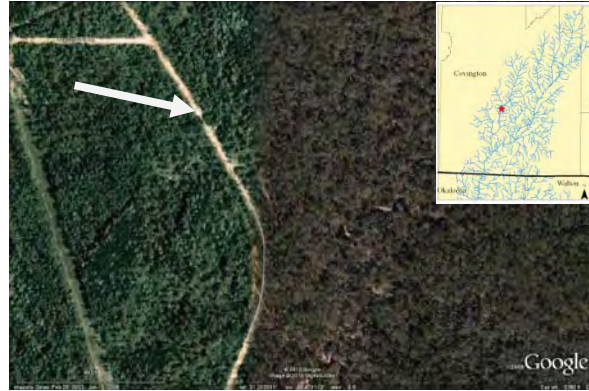
<b>Unnamed tributary</b>	<b>co-0810-r-014b</b>	<i>Sedimentation Risk Index</i> <b>38</b>
--------------------------	-----------------------	--

Risk Factor	Ranking	Score
<i>US Channel Morph</i>	E	5
<i>DS Channel Morph</i>	E	5
<i>DS Bank Alteration</i>	HIGH	1
<i>Upstream Skew Angle</i>	>30°	1
<i>Crossing fill condition</i>	Poor/Bare soil	1
<i>Inlet/Outlet Condition</i>	No Impairment	5
<i>Road Approach Material</i>	All Sand/Clay	3
<i>Potential Eroded Volume Mean</i>	>40 y <sup>3</sup>	1
<i>Approach Slope Mean</i>	<2%	5
<i>Soil K Factor</i>	<0.20	5
<i>Upstream Rt Outlet</i>	Vegetated	1
<i>Upstream Lt Outlet</i>	Vegetated	1
<i>Upstream Rt Ditch</i>	Bare soil	0
<i>Upstream Lt Ditch</i>	Bare soil	0
<i>Downstream Rt Outlet</i>	Vegetated	1
<i>Downstream Lt Outlet</i>	Vegetated	1
<i>Downstream Rt Ditch</i>	Bare soil	0
<i>Downstream Lt Ditch</i>	Bare soil	0
<i>Outlet Total</i>	Improved Outlet System	5
<i>Ditches Total</i>	Unimproved Drainage System	1
<b>SRI Total</b>	<b>Medium Risk</b>	<b>38</b>

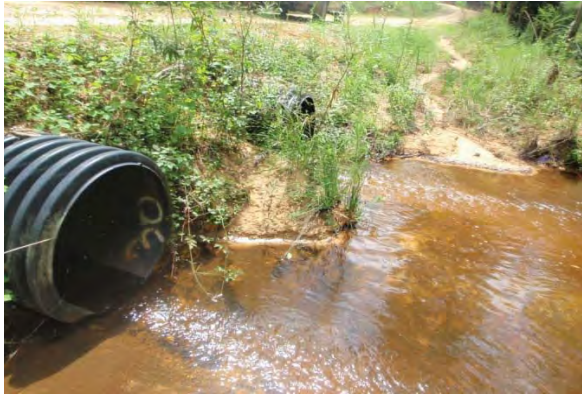
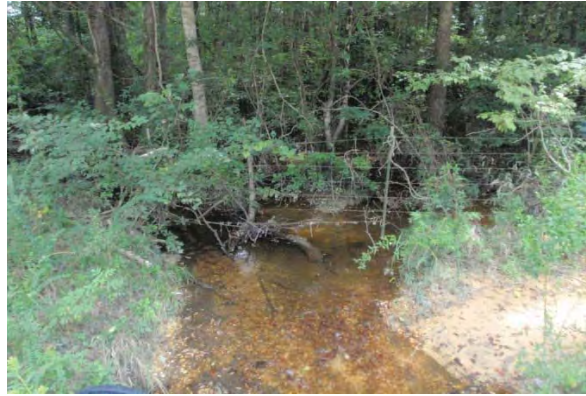
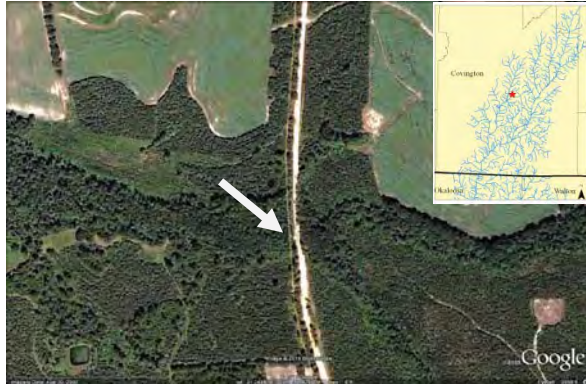
Unnamed tributary	co-0904-r-003	Sedimentation Risk Index <b>38</b>
-------------------	---------------	---------------------------------------

Risk Factor	Ranking	Score
<i>US Channel Morph</i>	DA	3
<i>DS Channel Morph</i>	C	5
<i>DS Bank Alteration</i>	HIGH	1
<i>Upstream Skew Angle</i>	5-30°	3
<i>Crossing fill condition</i>	Poor/Bare soil	1
<i>Inlet/Outlet Condition</i>	No Impairment	5
<i>Road Approach Material</i>	All Sand/Clay	3
<i>Potential Eroded Volume Mean</i>	<21 y <sup>3</sup>	5
<i>Approach Slope Mean</i>	2.1-4%	3
<i>Soil K Factor</i>	<0.20	5
<i>Upstream Rt Outlet</i>	Bare soil	0
<i>Upstream Lt Outlet</i>	Vegetated	1
<i>Upstream Rt Ditch</i>	Bare soil	0
<i>Upstream Lt Ditch</i>	Bare soil	0
<i>Downstream Rt Outlet</i>	Bare soil	0
<i>Downstream Lt Outlet</i>	Bare soil	0
<i>Downstream Rt Ditch</i>	Bare soil	0
<i>Downstream Lt Ditch</i>	Bare soil	0
<i>Outlet Total</i>	Partially Improved Outlet System	3
<i>Ditches Total</i>	Unimproved Drainage System	1
<b>SRI Total</b>	<b>Medium Risk</b>	<b>38</b>

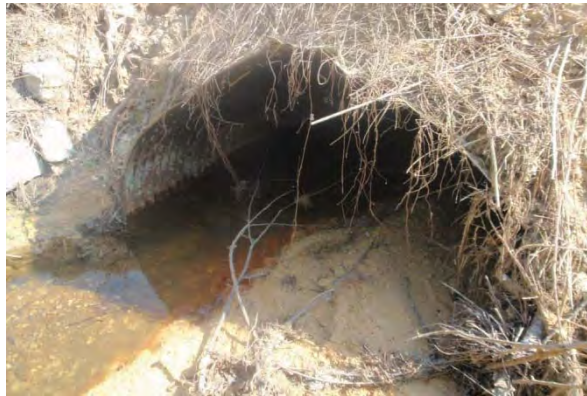
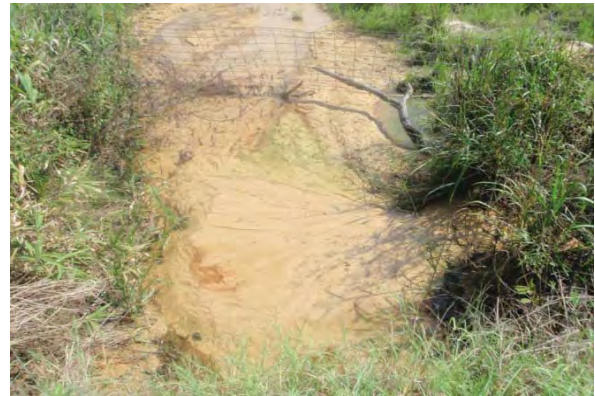
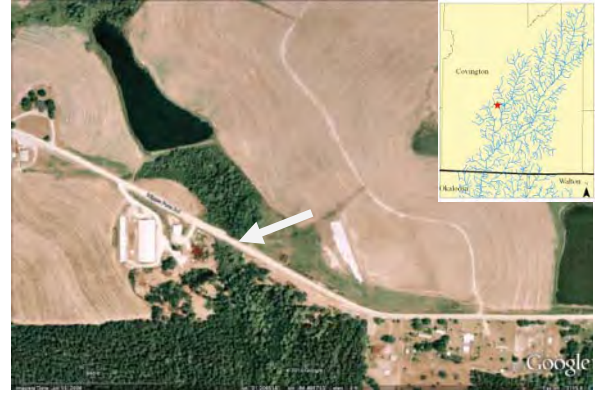
<h1>Unnamed tributary</h1>	<h2>co-0810-r-016</h2>	<b>Sedimentation Risk Index</b> <h1>36</h1>
----------------------------	------------------------	--

Risk Factor	Ranking	Score
<i>US Channel Morph</i>	PONDED	1
<i>DS Channel Morph</i>	C	5
<i>DS Bank Alteration</i>	HIGH	1
<i>Upstream Skew Angle</i>	5-30°	3
<i>Crossing fill condition</i>	Poor/Bare soil	1
<i>Inlet/Outlet Condition</i>	Sed Islands/Scouring	3
<i>Road Approach Material</i>	All Aggregate	5
<i>Potential Eroded Volume Mean</i>	21-40 y <sup>3</sup>	3
<i>Approach Slope Mean</i>	2.1-4%	3
<i>Soil K Factor</i>	<0.20	5
<i>Upstream Rt Outlet</i>	Bare soil	0
<i>Upstream Lt Outlet</i>	Bare soil	0
<i>Upstream Rt Ditch</i>	Bare soil	0
<i>Upstream Lt Ditch</i>	Bare soil	0
<i>Downstream Rt Outlet</i>	Vegetated	1
<i>Downstream Lt Outlet</i>	Vegetated	1
<i>Downstream Rt Ditch</i>	Vegetated	1
<i>Downstream Lt Ditch</i>	Vegetated	1
<i>Outlet Total</i>	Partially Improved Outlet System	3
<i>Ditches Total</i>	Partially Improved Drainage System	3
<b><i>SRI Total</i></b>	<b>High Risk</b>	<b>36</b>

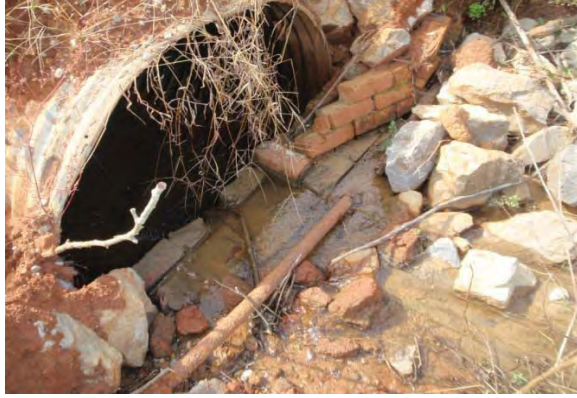
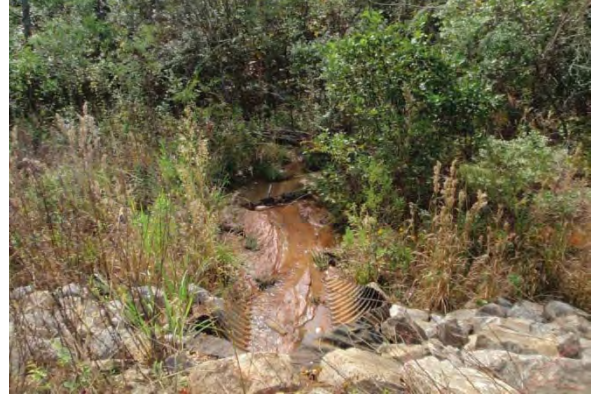
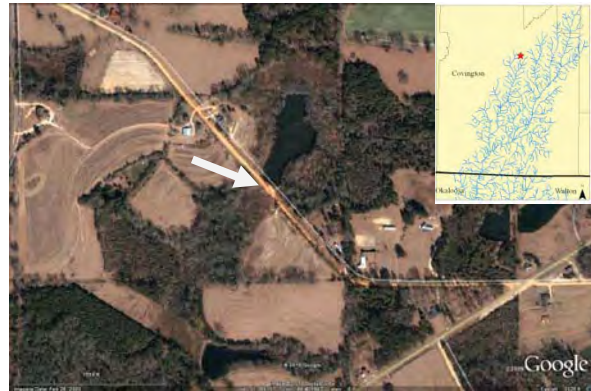
Unnamed tributary	co-1029-r-006	Sedimentation Risk Index <b>40</b>
-------------------	---------------	---------------------------------------

Risk Factor	Ranking	Score
<i>US Channel Morph</i>	BEAVER DAM	3
<i>DS Channel Morph</i>	C	5
<i>DS Bank Alteration</i>	HIGH	1
<i>Upstream Skew Angle</i>	<5°	5
<i>Crossing fill condition</i>	Poor/Bare soil	1
<i>Inlet/Outlet Condition</i>	Sed Islands/Scouring	3
<i>Road Approach Material</i>	All Sand/Clay	3
<i>Potential Eroded Volume Mean</i>	<21 y <sup>3</sup>	5
<i>Approach Slope Mean</i>	2.1-4%	3
<i>Soil K Factor</i>	<0.20	5
<i>Upstream Rt Outlet</i>	Bare soil	0
<i>Upstream Lt Outlet</i>	Bare soil	0
<i>Upstream Rt Ditch</i>	Bare soil	0
<i>Upstream Lt Ditch</i>	Bare soil	0
<i>Downstream Rt Outlet</i>	Bare soil	0
<i>Downstream Lt Outlet</i>	Vegetated	1
<i>Downstream Rt Ditch</i>	Rip Rap	1
<i>Downstream Lt Ditch</i>	Bare soil	0
<b>Outlet Total</b>	Partially Improved Outlet System	<b>3</b>
<b>Ditches Total</b>	Partially Improved Drainage System	<b>3</b>
<b>SRI Total</b>	<b>Medium Risk</b>	<b>40</b>

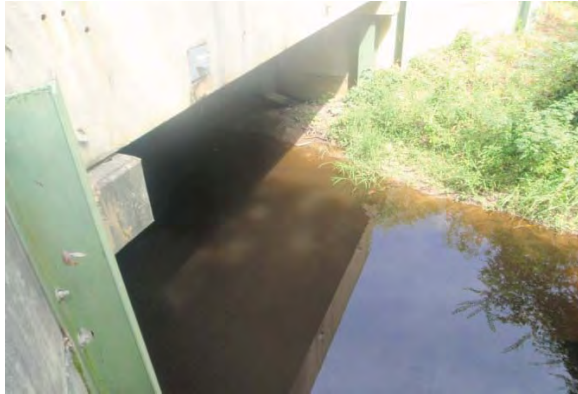
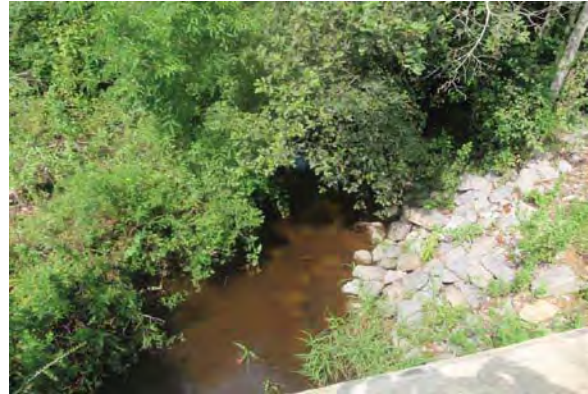
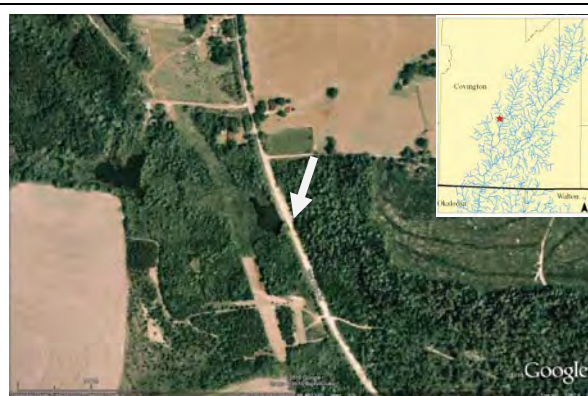
Unnamed tributary	co-0811-r-005	Sedimentation Risk Index <b>42</b>
-------------------	---------------	---------------------------------------

Risk Factor	Ranking	Score
<i>US Channel Morph</i>	WETLAND	5
<i>DS Channel Morph</i>	D	1
<i>DS Bank Alteration</i>	HIGH	1
<i>Upstream Skew Angle</i>	5-30°	3
<i>Crossing fill condition</i>	Good/Vegetated	5
<i>Inlet/Outlet Condition</i>	No Impairment	5
<i>Road Approach Material</i>	All Sand/Clay	3
<i>Potential Eroded Volume Mean</i>	<21 y <sup>3</sup>	5
<i>Approach Slope Mean</i>	<2%	5
<i>Soil K Factor</i>	<0.20	5
<i>Upstream Rt Outlet</i>	Vegetated	1
<i>Upstream Lt Outlet</i>	Rip Rap	1
<i>Upstream Rt Ditch</i>	Bare soil	0
<i>Upstream Lt Ditch</i>	Bare soil	0
<i>Downstream Rt Outlet</i>	Vegetated	1
<i>Downstream Lt Outlet</i>	Bare soil	0
<i>Downstream Rt Ditch</i>	Bare soil	0
<i>Downstream Lt Ditch</i>	Bare soil	0
<i>Outlet Total</i>	Partially Improved Outlet System	3
<i>Ditches Total</i>	Unimproved Drainage System	1
<b>SRI Total</b>	<b>Medium Risk</b>	<b>42</b>

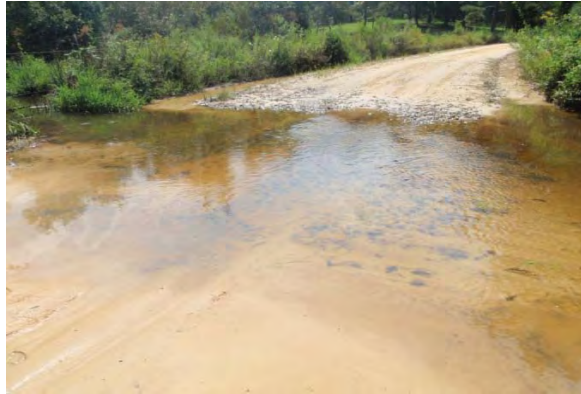
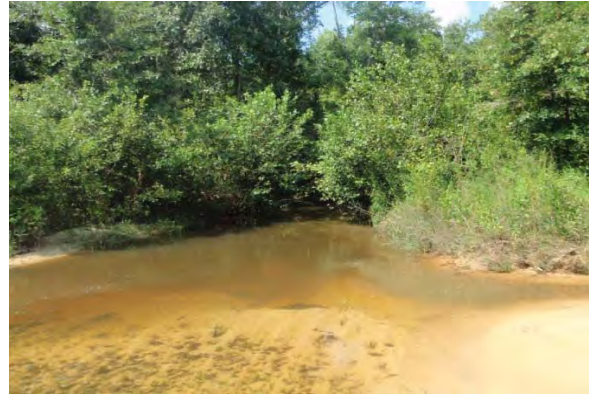
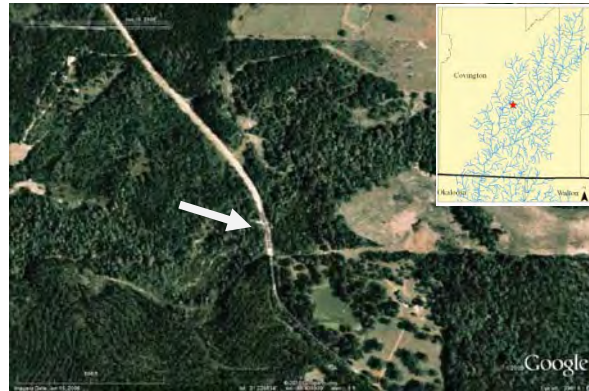
<b>Unnamed tributary</b>	<b>co-0901-r-001</b>	<i>Sedimentation Risk Index</i> <b>42</b>
--------------------------	----------------------	--

Risk Factor	Ranking	Score
<i>US Channel Morph</i>	C	5
<i>DS Channel Morph</i>	C	5
<i>DS Bank Alteration</i>	MINOR/PARTIAL	3
<i>Upstream Skew Angle</i>	5-30°	3
<i>Crossing fill condition</i>	Good/Vegetated	5
<i>Inlet/Outlet Condition</i>	No Impairment	5
<i>Road Approach Material</i>	All Native Soil	1
<i>Potential Eroded Volume Mean</i>	>40 y <sup>3</sup>	1
<i>Approach Slope Mean</i>	<2%	5
<i>Soil K Factor</i>	<0.20	5
<i>Upstream Rt Outlet</i>	Vegetated	1
<i>Upstream Lt Outlet</i>	Vegetated	1
<i>Upstream Rt Ditch</i>	Bare soil	0
<i>Upstream Lt Ditch</i>	Bare soil	0
<i>Downstream Rt Outlet</i>	Bare soil	0
<i>Downstream Lt Outlet</i>	Bare soil	0
<i>Downstream Rt Ditch</i>	Bare soil	0
<i>Downstream Lt Ditch</i>	Bare soil	0
<i>Outlet Total</i>	Partially Improved Outlet System	3
<i>Ditches Total</i>	Unimproved Drainage System	1
<b>SRI Total</b>	<b>Medium Risk</b>	<b>42</b>

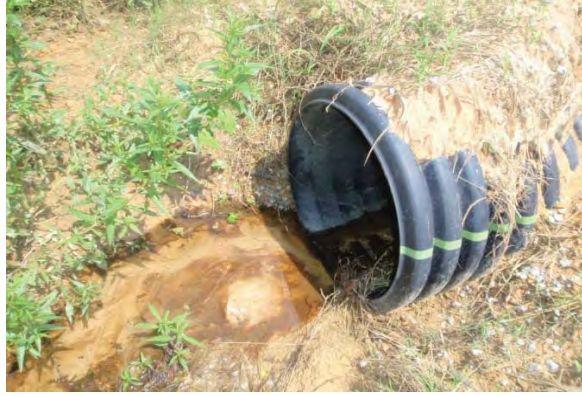
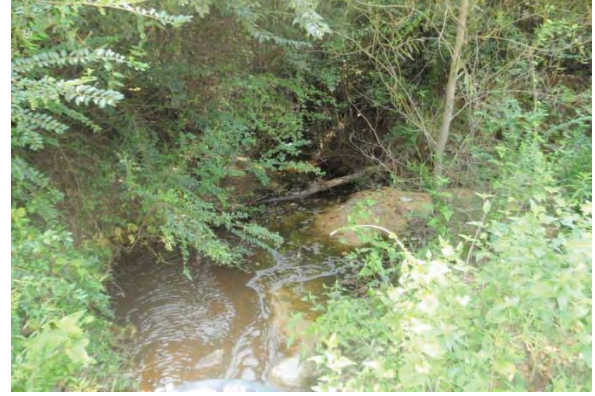
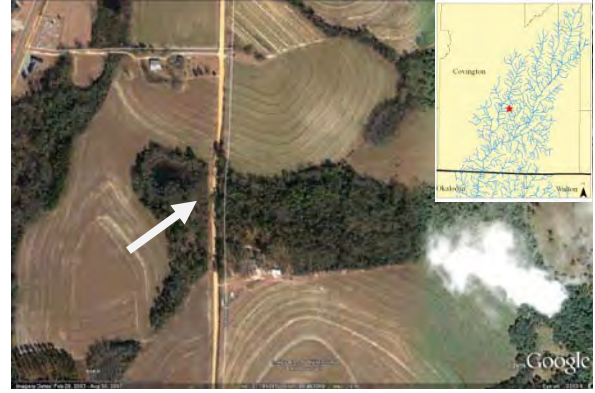
<h1>Unnamed tributary</h1>	<h2>co-0901-r-004</h2>	<i>Sedimentation Risk Index</i> <b>42</b>
----------------------------	------------------------	--

Risk Factor	Ranking	Score
<i>US Channel Morph</i>	E	5
<i>DS Channel Morph</i>	E	5
<i>DS Bank Alteration</i>	HIGH	1
<i>Upstream Skew Angle</i>	5-30°	3
<i>Crossing fill condition</i>	Poor/Bare soil	1
<i>Inlet/Outlet Condition</i>	Sed Islands/Scouring	3
<i>Road Approach Material</i>	All Aggregate	5
<i>Potential Eroded Volume Mean</i>	<21 y <sup>3</sup>	5
<i>Approach Slope Mean</i>	2.1-4%	3
<i>Soil K Factor</i>	<0.20	5
<i>Upstream Rt Outlet</i>	Bare soil	0
<i>Upstream Lt Outlet</i>	Vegetated	1
<i>Upstream Rt Ditch</i>	Bare soil	0
<i>Upstream Lt Ditch</i>	Vegetated	1
<i>Downstream Rt Outlet</i>	Vegetated	1
<i>Downstream Lt Outlet</i>	Vegetated	1
<i>Downstream Rt Ditch</i>	Vegetated	1
<i>Downstream Lt Ditch</i>	Vegetated	1
<i>Outlet Total</i>	Partially Improved Outlet System	3
<i>Ditches Total</i>	Partially Improved Drainage System	3
<b>SRI Total</b>	<b>Medium Risk</b>	<b>42</b>

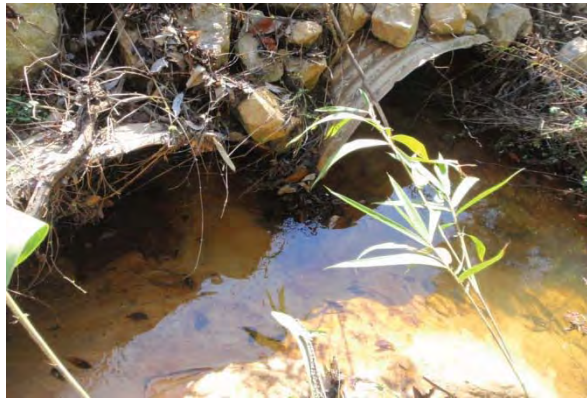
Unnamed tributary	co-1029-r-009	Sedimentation Risk Index <b>42</b>
-------------------	---------------	---------------------------------------

Risk Factor	Ranking	Score
<i>US Channel Morph</i>	E	5
<i>DS Channel Morph</i>	E	5
<i>DS Bank Alteration</i>	MINOR/PARTIAL	3
<i>Upstream Skew Angle</i>	<5°	5
<i>Crossing fill condition</i>	Poor/Bare soil	1
<i>Inlet/Outlet Condition</i>	Sed Islands/Scouring	3
<i>Road Approach Material</i>	All Sand/Clay	3
<i>Potential Eroded Volume Mean</i>	<21 y <sup>3</sup>	5
<i>Approach Slope Mean</i>	2.1-4%	3
<i>Soil K Factor</i>	<0.20	5
<i>Upstream Rt Outlet</i>	Bare soil	0
<i>Upstream Lt Outlet</i>	Bare soil	0
<i>Upstream Rt Ditch</i>	Bare soil	0
<i>Upstream Lt Ditch</i>	Bare soil	0
<i>Downstream Rt Outlet</i>	Bare soil	0
<i>Downstream Lt Outlet</i>	Bare soil	0
<i>Downstream Rt Ditch</i>	Bare soil	0
<i>Downstream Lt Ditch</i>	Rip Rap	1
<b>Outlet Total</b>	Unimproved Outlet System	1
<b>Ditches Total</b>	Partially Improved Drainage System	3
<b>SRI Total</b>	<b>Medium Risk</b>	<b>42</b>

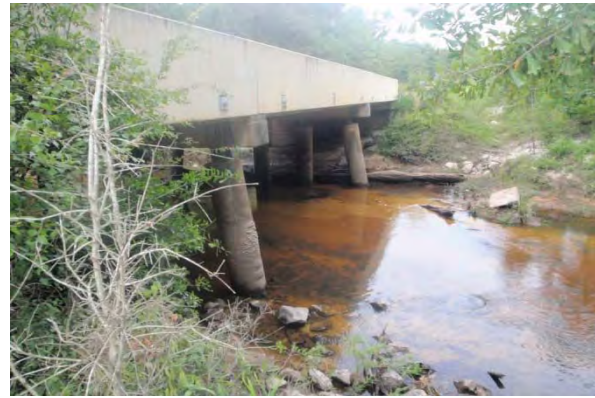
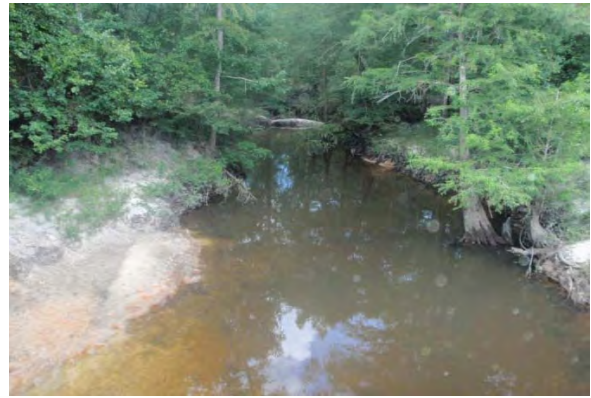
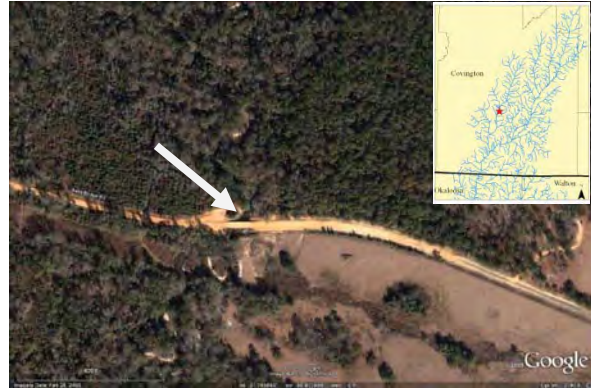
<h1>Five Runs Creek</h1>	<h2>co-0810-r-013</h2>	<i>Sedimentation Risk Index</i> <b>44</b>
--------------------------	------------------------	--

Risk Factor	Ranking	Score
<i>US Channel Morph</i>	C	5
<i>DS Channel Morph</i>	C	5
<i>DS Bank Alteration</i>	MINOR/PARTIAL	3
<i>Upstream Skew Angle</i>	<5°	5
<i>Crossing fill condition</i>	Good/Vegetated	5
<i>Inlet/Outlet Condition</i>	Sed Islands/Scouring	3
<i>Road Approach Material</i>	All Sand/Clay	3
<i>Potential Eroded Volume Mean</i>	21-40 y <sup>3</sup>	3
<i>Approach Slope Mean</i>	2.1-4%	3
<i>Soil K Factor</i>	<0.20	5
<i>Upstream Rt Outlet</i>	Bare soil	0
<i>Upstream Lt Outlet</i>	Vegetated	1
<i>Upstream Rt Ditch</i>	Bare soil	0
<i>Upstream Lt Ditch</i>	Bare soil	0
<i>Downstream Rt Outlet</i>	Rip Rap	1
<i>Downstream Lt Outlet</i>	Rip Rap	1
<i>Downstream Rt Ditch</i>	Bare soil	0
<i>Downstream Lt Ditch</i>	Bare soil	0
<i>Outlet Total</i>	Partially Improved Outlet System	3
<i>Ditches Total</i>	Unimproved Drainage System	1
<b><i>SRI Total</i></b>	<b>Medium Risk</b>	<b>44</b>
<b>Additional Site Features</b>

Notes: Some rip rap loading into stream. Public access area. Highly sediment loaded outlets.

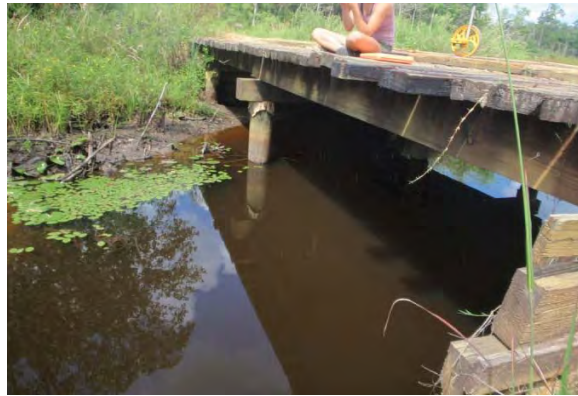
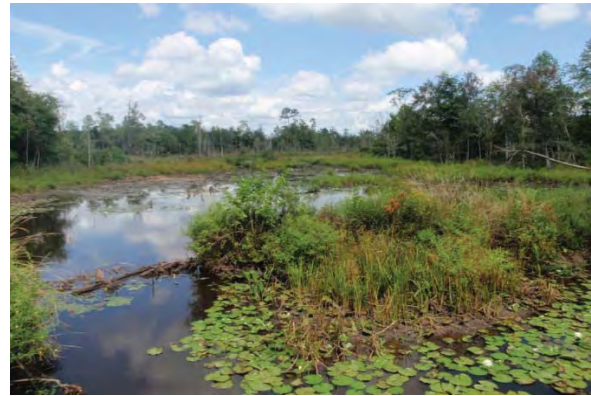
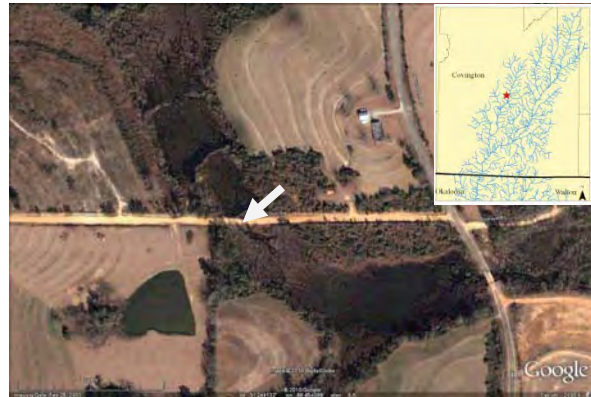
Unnamed tributary	co-0904-r-001	Sedimentation Risk Index <b>44</b>
-------------------	---------------	---------------------------------------

Risk Factor	Ranking	Score
<i>US Channel Morph</i>	BEAVER DAM	3
<i>DS Channel Morph</i>	BEAVER DAM	3
<i>DS Bank Alteration</i>	NATURAL	5
<i>Upstream Skew Angle</i>	5-30°	3
<i>Crossing fill condition</i>	Good/Vegetated	5
<i>Inlet/Outlet Condition</i>	No Impairment	5
<i>Road Approach Material</i>	All Sand/Clay	3
<i>Potential Eroded Volume Mean</i>	<21 y <sup>3</sup>	5
<i>Approach Slope Mean</i>	>4%	1
<i>Soil K Factor</i>	<0.20	5
<i>Upstream Rt Outlet</i>	Bare soil	0
<i>Upstream Lt Outlet</i>	Bare soil	0
<i>Upstream Rt Ditch</i>	Bare soil	0
<i>Upstream Lt Ditch</i>	Vegetated	1
<i>Downstream Rt Outlet</i>	Vegetated	1
<i>Downstream Lt Outlet</i>	Vegetated	1
<i>Downstream Rt Ditch</i>	Vegetated	1
<i>Downstream Lt Ditch</i>	Vegetated	1
<i>Outlet Total</i>	Partially Improved Outlet System	3
<i>Ditches Total</i>	Partially Improved Drainage System	3
<b>SRI Total</b>	<b>Medium Risk</b>	<b>44</b>
<b>Additional Site Features</b>

Notes: Multiple beaver dams US

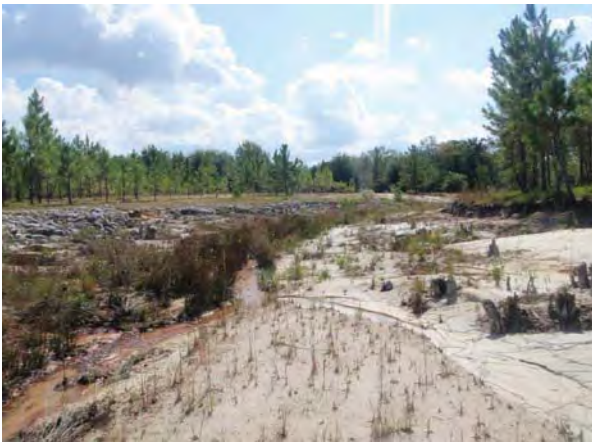
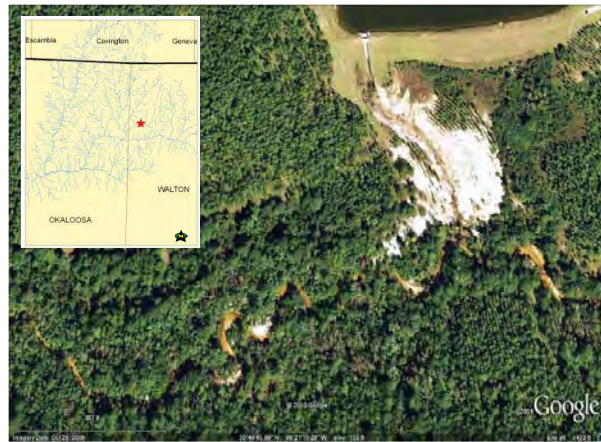
Unnamed tributary	wa-1007-001	Severity Score <b>12</b>
-------------------	-------------	-----------------------------

**Pond overflow channel going into Long Creek (tree line)- DS**

Risk Factor	Ranking	Score	Feature	Within Range	Descriptive Field
<i>Channel Stability</i>	Fair	1	<b>303(d)</b>	No	N/A
<i>Channel Alteration</i>	In Recovery	1.5	<b>Wetland Species</b>	No	N/A
<i>Bank Erosion</i>	Active	1	<b>Rare and Imperiled</b>	No	N/A
<i>BEHI</i>	High	1	<b>Land Use/ Cover</b>	Yes	AGRICULTURAL/ RURAL LAND IN TRANSITION WITHOUT POSITIVE INDICATORS OF INTENDED ACTIVITY
<i>Local NPSP</i>	Obvious Sources	1.5	<b>Candidate Mussels</b>	No	N/A
<i>Shoring Structures</i>	Present	1.5	<b>Sturgeon C.H.</b>	No	N/A
<i>Pipe Discharge</i>	Not Present	0	<b>Additional Site Features</b>		
<i>Water Odors</i>	Not Present	0	<i>Stream Channel Woody Material:</i> None		
<i>Fish Passage Barrier</i>	Present	1.5	<i>Impoundments:</i> Manmade (Large Pond)		
<i>RB: Riparian Buffer</i>	0-29 ft	0.75	<i>Substrate Composition:</i> Medium Sand		
<i>LB: Riparian Buffer</i>	0-29 ft	0.75	<i>Bank Material:</i> Sand		
<i>RB: Floodplain Access</i>	None	0.75

Notes: The overflow channel is lacking a riparian buffer leading to excessive runoff during flood events. Some shoring structure has been used, but, ineffectively. Obvious aggradations are found downstream from this site.

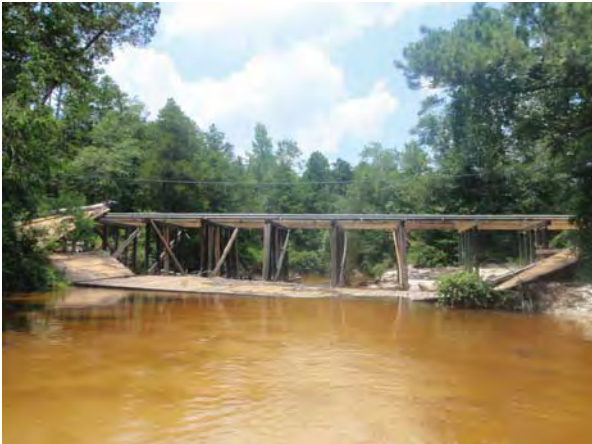
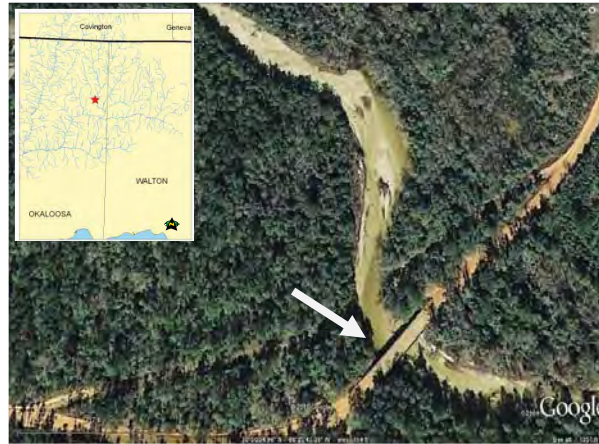
Lake Ella Rd bridge crossing- US

Risk Factor	Ranking	Score	Feature	Within Range	Descriptive Field
<i>Channel Stability</i>	Good	0.5	303(d)	No	N/A
<i>Channel Alteration</i>	Historic	0.5	Wetland Species	No	N/A
<i>Bank Erosion</i>	Active	1	Rare and Imperiled	Yes	IRONCOLOR SHINER SPECKLED CHUB
<i>BEHI</i>	High	1	Land Use/Cover	Yes	AGRICULTURAL/ STREAMS AND WATERWAYS
<i>Local NPSP</i>	Obvious Sources	1.5	Candidate Mussels	No	N/A
<i>Shoring Structures</i>	Present	1.5	Sturgeon C.H.	No	N/A
<i>Pipe Discharge</i>	Not Present	0	<b>Additional Site Features</b>		
<i>Water Odors</i>	Not Present	0	<i>Stream Channel Woody Material:</i> Numerous		
<i>Fish Passage Barrier</i>	Present	1.5	<i>Impoundments:</i> Manmade (Wooden Bridge)		
<i>RB: Riparian Buffer</i>	0-29 ft	0.75	<i>Substrate Composition:</i> Medium Sand		
<i>LB: Riparian Buffer</i>	0-29 ft	0.75	<i>Bank Material:</i> Sand		
<i>RB: Floodplain Access</i>	Partial	0.25			
<i>LB: Floodplain Access</i>	Partial	0.25

Notes: Collapsed bridge causes a possible fish passage barrier and collects trash. Bridge blow out is likely due to high velocity flows during storm events from the widening and straightening of Pond Creek after it's confluence with Juniper Creek 0.10 miles upstream.

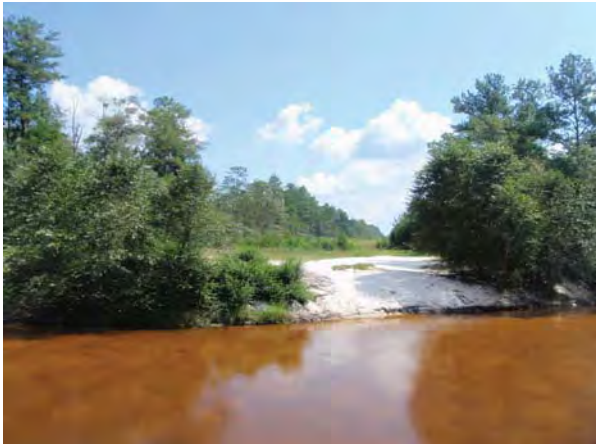
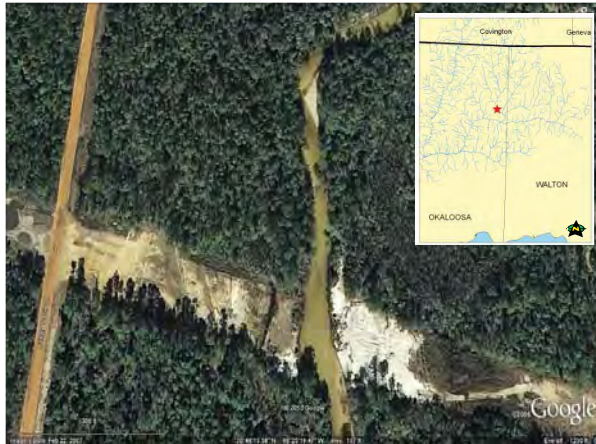
LB					
Risk Factor	Ranking	Score	Feature	Within Range	Descriptive Field
<i>Channel Stability</i>	Poor	1.5	303(d)	No	N/A
<i>Channel Alteration</i>	In Recovery	1	Wetland Species	No	N/A
<i>Bank Erosion</i>	Active	1	Rare and Imperiled	Yes	SPECKLED CHUB IRONCOLOR SHINER
<i>BEHI</i>	High	1	Land Use/ Cover	Yes	N/A / STREAMS AND WATERWAYS
<i>Local NPSP</i>	Moderate Potential	1	Candidate Mussels	No	N/A
<i>Shoring Structures</i>	Present	1.5	Sturgeon C.H.	No	N/A
<i>Pipe Discharge</i>	Not Present	0	<b>. Additional Site Features</b>		
<i>Water Odors</i>	Not Present	0	<i>Stream Channel Woody Material:</i> Infrequent

<i>Fish Passage Barrier</i>	Not Present	0	<i>Impoundments:</i> None		
<i>RB: Riparian Buffer</i>	0-29ft	0.75	<i>Substrate Composition:</i> Medium Sand		
<i>LB: Riparian Buffer</i>	0-29 ft	0.75	<i>Bank Material:</i> Sand and Gabion		
<i>RB: Floodplain Access</i>	Partial	0.25			
<i>LB: Floodplain Access</i>	Partial	0.25			
<b>River Threat Index:</b>		<b>9</b>

Notes: Shoring structure on right bank covers about 10% of site and is composed of rip rap and gabion Beer cans and primitive campsite indicate private use and access from local residents. Old power line crossing intersects this site. Sediment/sand loading into stream.

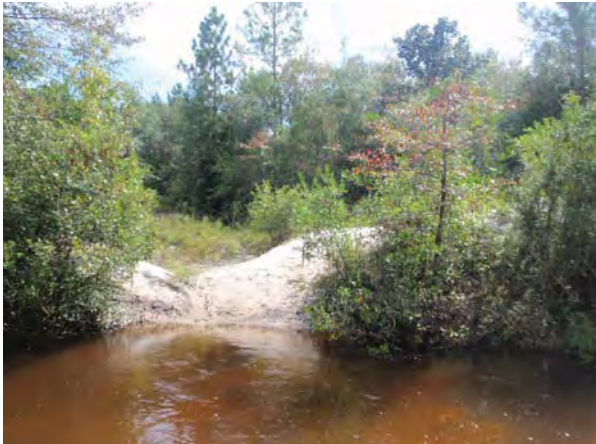
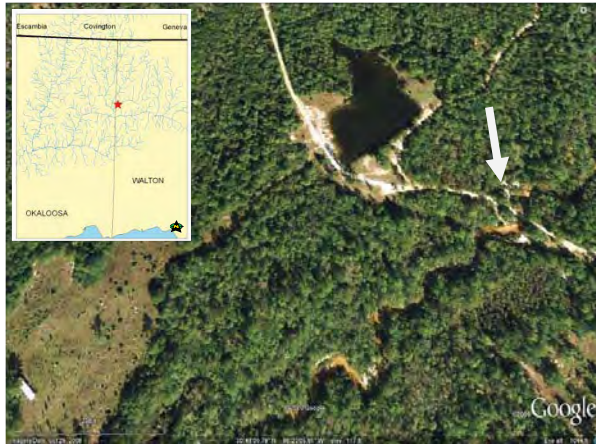
LB			
Risk Factor	Ranking	Score	Feature Within Range Descriptive Field
<i>Channel Stability</i>	Good	0.5	303(d) No N/A
<i>Channel Alteration</i>	In Recovery	1	Wetland Species Yes 1-3 FOCAL SPECIES IN WETLAND AREAS
<i>Bank Erosion</i>	Active	1	Rare and Imperiled No N/A
<i>BEHI</i>	Historic	0.5	Land Use/Cover Yes VACANT RESIDENTIAL/ WETLAND FORESTED MIX
<i>Local NPSP</i>	Moderate Potential	1	Candidate Mussels No N/A
<i>Shoring Structures</i>	Present	1.5	Sturgeon C.H. No N/A
<i>Pipe Discharge</i>	Not Present	0	
<i>Water Odors</i>	Not Present	0	
<i>Fish Passage Barrier</i>	Not Present	0

<i>RB: Riparian Buffer</i>	0-29 ft	0.75	
<i>LB: Riparian Buffer</i>	0-29 ft	0.75	
<i>RB: Floodplain Access</i>	Full	0	
<i>LB: Floodplain Access</i>	Full	0	
<b>River Threat Index:</b>			<b>7</b>
<b>Additional Site Features</b>			
<i>Stream Channel Woody Material:</i>			Infrequent
<i>Impoundments:</i>			None
<i>Substrate Composition:</i>			Medium Sand
<i>Bank Material:</i>			Sand and Clay

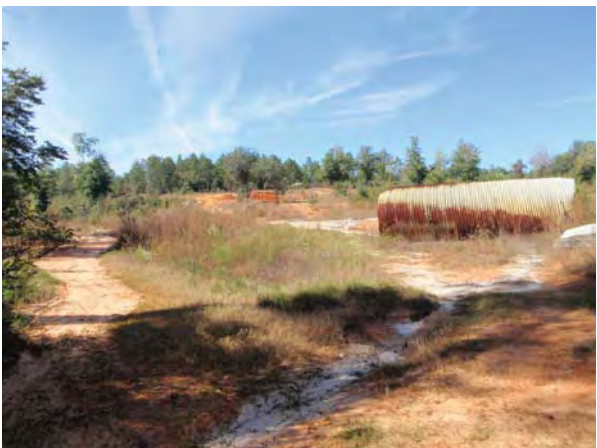
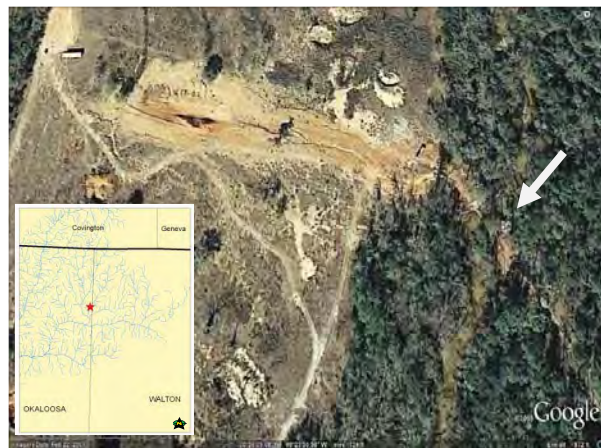
<b>Pine Log Creek</b>	<b>ok-1106-001</b>	<i>Severity Score</i> <b>7</b>
-----------------------	--------------------	-----------------------------------

Risk Factor	Ranking	Score	Feature	Within Range	Descriptive Field
<i>Channel Stability</i>	Good	0.5	<b>303(d)</b>	No	N/A
<i>Channel Alteration</i>	In Recovery	1	<b>Wetland Species</b>	Yes	1-3 FOCAL SPECIES IN WETLAND AREAS
<i>Bank Erosion</i>	Not Eroding	0	<b>Rare and Imperiled</b>	No	N/A
<i>BEHI</i>	High	1	<b>Land Use/ Cover</b>	Yes	AGRICULTURAL/ STREAMS AND WATERWAYS
<i>Local NPSP</i>	Obvious Sources	1.5	<b>Candidate Mussels</b>	No	N/A
<i>Shoring Structures</i>	Present	1.5	<b>Sturgeon C.H.</b>	No	N/A
<i>Pipe Discharge</i>	Not Present	0	<b>Additional Site Features</b>		
<i>Water Odors</i>	Not Present	0	<i>Stream Channel Woody Material:</i> Moderate		
<i>Fish Passage Barrier</i>	Not Present	0	<i>Impoundments:</i> Manmade- Collapsed Bridge		
<i>RB: Riparian Buffer</i>	0-29 ft	0.75	<i>Substrate Composition:</i> Medium Sand		
<i>LB: Riparian Buffer</i>	0-29 ft	0.75	<i>Bank Material:</i> Sand and Clay		
<i>RB: Floodplain Access</i>	Full	0

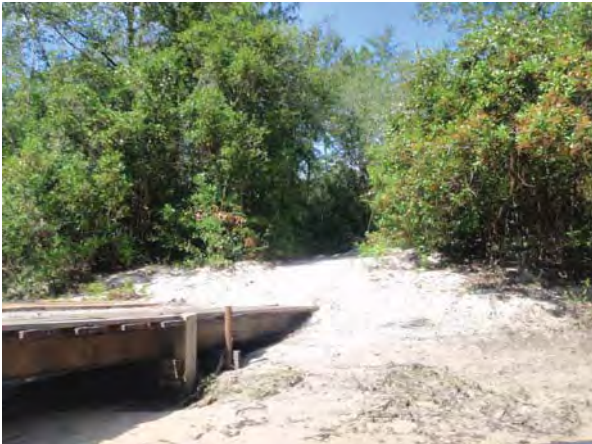
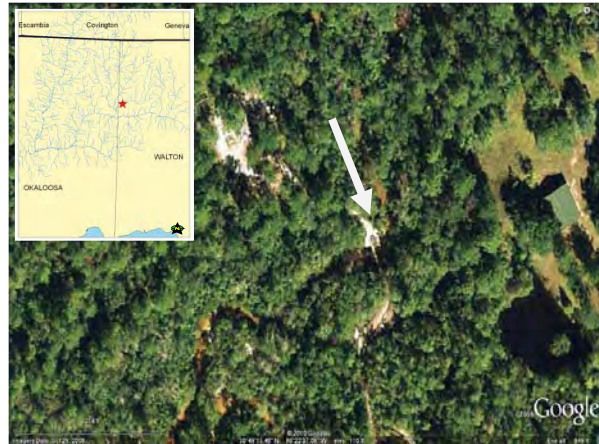
<b>Long Creek</b>	<b>wa-1007-002</b>	<i>Severity Score</i> <b>5</b>
-------------------	--------------------	-----------------------------------

Risk Factor	Ranking	Score	Feature	Within Range	Descriptive Field
<i>Channel Stability</i>	Good	0.5	303(d)	No	N/A
<i>Channel Alteration</i>	Historic, Mostly Recovered	0.5	Wetland Species	No	N/A
<i>Bank Erosion</i>	Not Eroding	0	Rare and Imperiled	No	N/A
<i>BEHI</i>	Moderate	0.5	Land Use/Cover	Yes	RESIDENTIAL/ STREAMS AND WATERWAYS
<i>Local NPSP</i>	Obvious Sources	1.5	Candidate Mussels	No	N/A
<i>Shoring Structures</i>	Present	1.5	Sturgeon C.H.	No	N/A
<i>Pipe Discharge</i>	Not Present	0	<b>Additional Site Features</b>		
<i>Water Odors</i>	Not Present	0	<i>Stream Channel Woody Material:</i> Infrequent		
<i>Fish Passage Barrier</i>	Not Present	0	<i>Impoundments:</i> None		
<i>RB: Riparian Buffer</i>	0-29 ft	0.25	<i>Substrate Composition:</i> Medium Sand		
<i>LB: Riparian Buffer</i>	0-29 ft	0.25	<i>Bank Material:</i> Sand		
<i>RB: Floodplain Access</i>	Full	0			
<i>LB: Floodplain Access</i>	Full	0			
<b>River Threat Index:</b>		<b>5</b>

Notes: House 50 yards off right bank and road crossing.

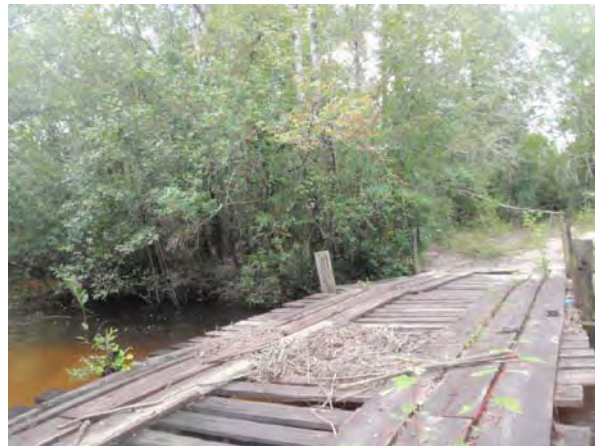
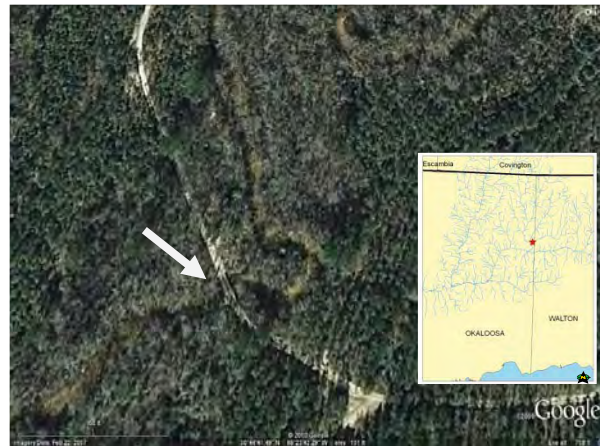
<b>Long Creek</b>	<b>ok-1007-004</b>	<b>Severity Score</b> <b>4.5</b>
-------------------	--------------------	-------------------------------------

Risk Factor	Ranking	Score	Feature	Within Range	Descriptive Field
<i>Channel Stability</i>	Good	0.5	303(d)	No	N/A
<i>Channel Alteration</i>	Historic, Mostly Recovered	0.5	Wetland Species	No	N/A
<i>Bank Erosion</i>	Not Eroding	0	Rare and Imperiled	No	N/A
<i>BEHI</i>	Moderate	0.5	Land Use/Cover	Yes	AGRICULTURAL/ STREAMS AND WATERWAYS
<i>Local NPSP</i>	Moderate Potential	1	Candidate Mussels	No	N/A
<i>Shoring Structures</i>	Present	1.5	Sturgeon C.H.	No	N/A
<i>Pipe Discharge</i>	Not Present	0	<b>Additional Site Features</b>		
<i>Water Odors</i>	Not Present	0	<i>Stream Channel Woody Material:</i> Infrequent		
<i>Fish Passage Barrier</i>	Not Present	0	<i>Impoundments:</i> None		
<i>RB: Riparian Buffer</i>	50-99 ft	0.25	<i>Substrate Composition:</i> Medium Sand		
<i>LB: Riparian Buffer</i>	50-99 ft	0.25	<i>Bank Material:</i> Sand		
<i>RB: Floodplain Access</i>	Full	0			
<i>LB: Floodplain Access</i>	Full	0			
<b>River Threat Index:</b>		<b>4.5</b>

Notes: Logging road.

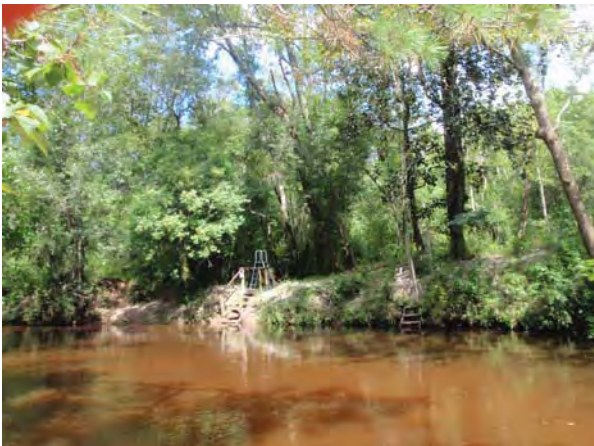
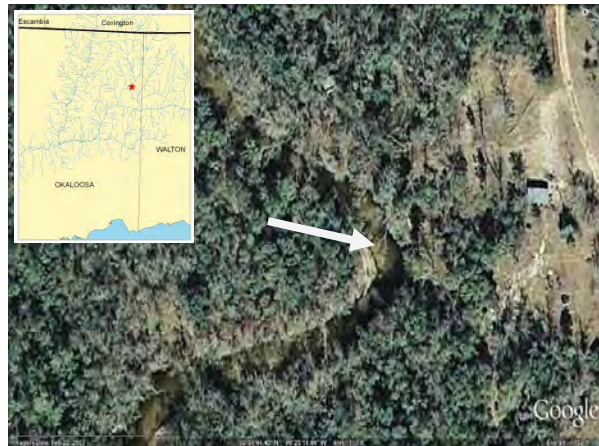
Pond Creek	ok-0922-003	Severity Score 3.75
------------	-------------	------------------------

Risk Factor	Ranking	Score	Feature	Within Range	Descriptive Field
<i>Channel Stability</i>	Good	0.5	303(d)	No	N/A
<i>Channel Alteration</i>	None	0	<b>Wetland Species</b>	Yes	1-3 FOCAL SPECIES IN UPLAND AREAS
<i>Bank Erosion</i>	Not Eroding	0	<b>Rare and Imperiled</b>	Yes	IRONCOLOR SHINER, SPECKLED CHUB
<i>BEHI</i>	Low-Very Low	0	<b>Land Use/ Cover</b>	Yes	VACANT RESIDENTIAL/ STREAMS AND WATERWAYS
<i>Local NPSP</i>	Obvious Sources	1.5	<b>Candidate Mussels</b>	No	N/A
<i>Shoring Structures</i>	Present	1.5	<b>Sturgeon C.H.</b>	No	N/A
<i>Pipe Discharge</i>	Not Present	0	<b>Additional Site Features</b>		
<i>Water Odors</i>	Not Present	0	<i>Stream Channel Woody Material:</i> Infrequent		
<i>Fish Passage Barrier</i>	Not Present	0	<i>Impoundments:</i> None		
<i>RB: Riparian Buffer</i>	100+ ft	0	<i>Substrate Composition:</i> Medium Sand		
<i>LB: Riparian Buffer</i>	0-29 ft	0.25	<i>Bank Material:</i> Sand and Roots

<i>RB: Floodplain Access</i>	Full	0			
<i>LB: Floodplain Access</i>	Full	0			
<b>River Threat Index:</b>		<b>3.75</b>

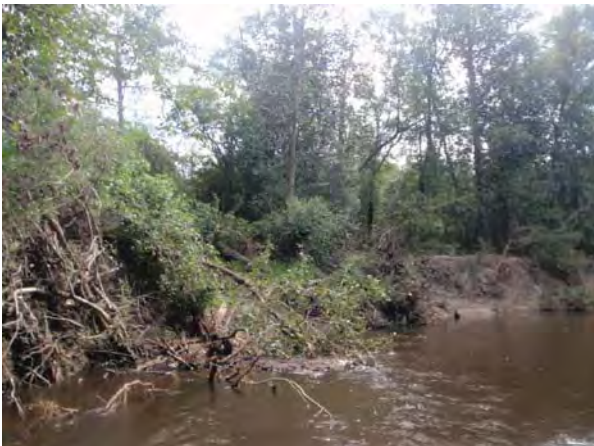
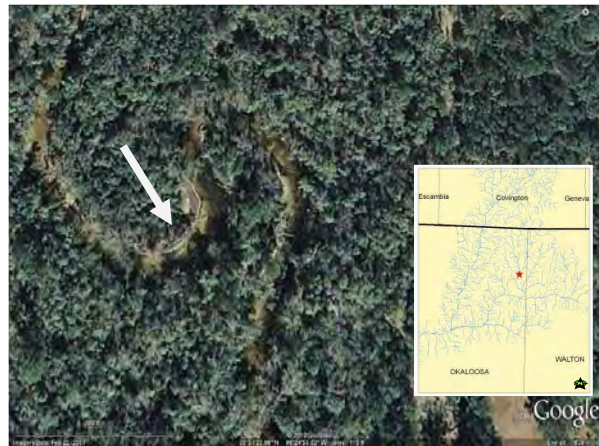
<b>Pond Creek</b>	<b>ok-0922-002</b>	<i>Severity Score</i> <b>3</b>
-------------------	--------------------	-----------------------------------

Risk Factor	Ranking	Score	Feature	Within Range	Descriptive Field
<i>Channel Stability</i>	Good	0.5	<b>303(d)</b>	No	N/A
<i>Channel Alteration</i>	None	0	<b>Wetland Species</b>	No	N/A
<i>Bank Erosion</i>	Historic	0.5	<b>Rare and Imperiled</b>	Yes	IRONCOLOR SHINER, SPECKLED CHUB
<i>BEHI</i>	Moderate	0.5	<b>Land Use/Cover</b>	Yes	ACREAGE NOT ZONED FOR AGRICULTURE/WETLAND FORESTED MIX
<i>Local NPSP</i>	No Evidence	0	<b>Candidate Mussels</b>	No	N/A
<i>Shoring Structures</i>	Not Present	0	<b>Sturgeon C.H.</b>	No	N/A
<i>Pipe Discharge</i>	Not Present	0	<b>Additional Site Features</b>		
<i>Water Odors</i>	Not Present	0	<i>Stream Channel Woody Material:</i> Moderate		
<i>Fish Passage Barrier</i>	Not Present	0	<i>Impoundments:</i> None		
<b>RB: Riparian Buffer</b>	0-29 ft	0.75	<i>Substrate Composition:</i> Medium Sand		
<b>LB: Riparian Buffer</b>	100+ ft	0	<i>Bank Material:</i> Sand		
<b>RB: Floodplain Access</b>	None	0.75

<b>LB: Floodplain Access</b>	Full	0			
<b>River Threat Index:</b>		<b>3</b>

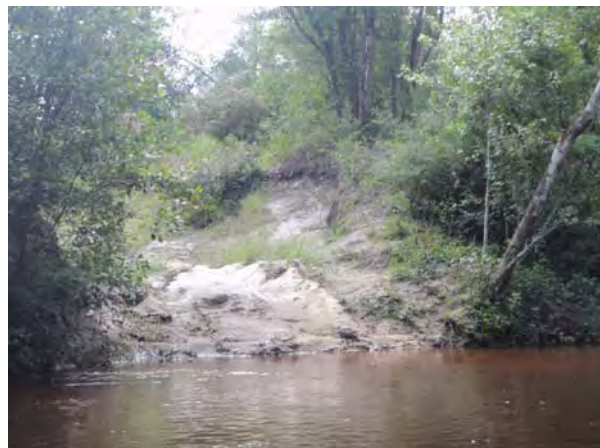
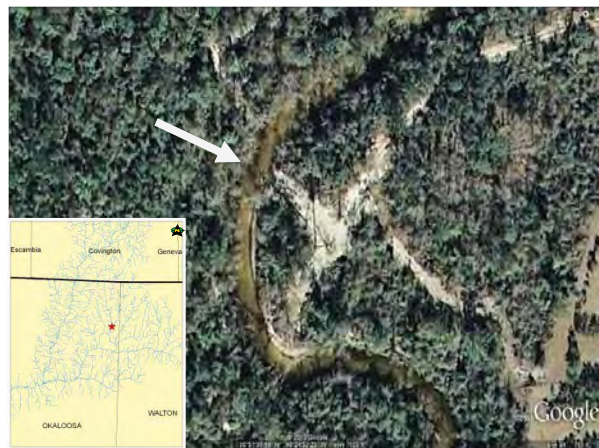
Pond Creek	ok-0922-001	Severity Score 3
------------	-------------	---------------------

Risk Factor	Ranking	Score	Feature	Within Range	Descriptive Field
<i>Channel Stability</i>	Good	0.5	303(d)	No	N/A
<i>Channel Alteration</i>	None	0	Wetland Species	No	N/A
<i>Bank Erosion</i>	Not Eroding	0	Rare and Imperiled	Yes	IRONCOLOR SHINER, SPECKLED CHUB
<i>BEHI</i>	Moderate	0.5	Land Use/Cover	Yes	RESIDENTIAL/ STREAMS AND WATERWAYS
<i>Local NPSP</i>	Slight	0.5	Candidate Mussels	No	N/A
<i>Shoring Structures</i>	Not Present	0	Sturgeon C.H.	No	N/A
<i>Pipe Discharge</i>	Not Present	0	<b>Additional Site Features</b>		
<i>Water Odors</i>	Present	1.5	<i>Stream Channel Woody Material:</i> Infrequent		
<i>Fish Passage Barrier</i>	Not Present	0	<i>Impoundments:</i> None		
<i>RB: Riparian Buffer</i>	100+ ft	0	<i>Substrate Composition:</i> Medium Sand		
<i>LB: Riparian Buffer</i>	100+ ft	0	<i>Bank Material:</i> Sand and Clay		
<i>RB: Floodplain Access</i>	Full	0			
<i>LB: Floodplain Access</i>	Full	0			
<b>River Threat Index:</b>		<b>3</b>

Notes: Anaerobic water odors. Private road access site or old logging road?
