Appendix A. River corridor severity scores for impaired sites in the Yellow River Basin, Alabama and Florida

Appendix C. Clear Creek Watershed Focal Area. Sites with orange headings are unpaved road sites. Specific definitions and calculations described for calculating the Sediment Risk Index (SRI) are detailed in Witmer (2009).

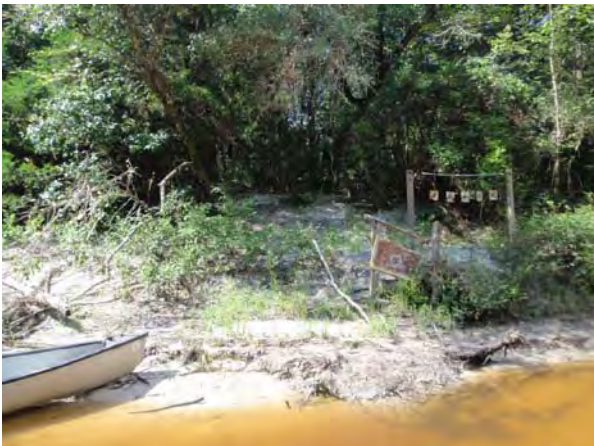
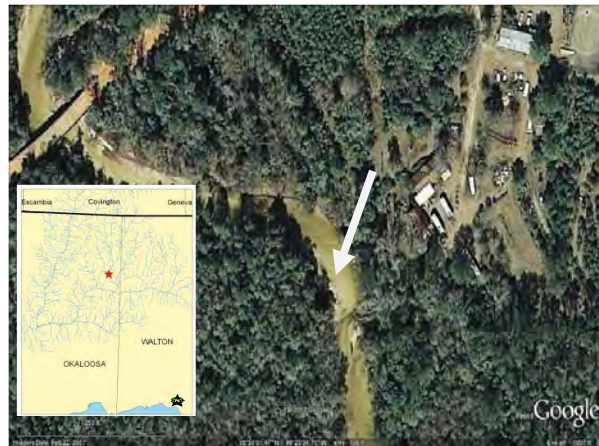
Pond Creek	ok-0928-002	Severity Score 2.75
------------	-------------	------------------------

Risk Factor	Ranking	Score	Feature	Within Range	Descriptive Field
<i>Channel Stability</i>	Good	0.5	303(d)	No	N/A
<i>Channel Alteration</i>	None	0	Wetland Species	No	N/A
<i>Bank Erosion</i>	Not Eroding	0	Rare and Imperiled	Yes	IRONCOLOR SHINER, SPECKLED CHUB
<i>BEHI</i>	Moderate	0.5	Land Use/Cover	Yes	AGRICULTURAL/ STREAMS AND WATERWAYS
<i>Local NPSP</i>	Obvious Sources	1.5	Candidate Mussels	No	N/A
<i>Shoring Structures</i>	Not Present	0	Sturgeon C.H.	No	N/A
<i>Pipe Discharge</i>	Not Present	0	<b>Additional Site Features</b>		
<i>Water Odors</i>	Not Present	0	<i>Stream Channel Woody Material:</i> Moderate		
<i>Fish Passage Barrier</i>	Not Present	0	<i>Impoundments:</i> None		
<i>RB: Riparian Buffer</i>	100+ ft	0	<i>Substrate Composition:</i> Medium Sand		
<i>LB: Riparian Buffer</i>	50-99 ft	0.25	<i>Bank Material:</i> Sand		
<i>RB: Floodplain Access</i>	Full	0			
<i>LB: Floodplain Access</i>	Full	0			
<b>River Threat Index:</b>		<b>2.75</b>

Notes: RT bank target practice for residence/camp on LB

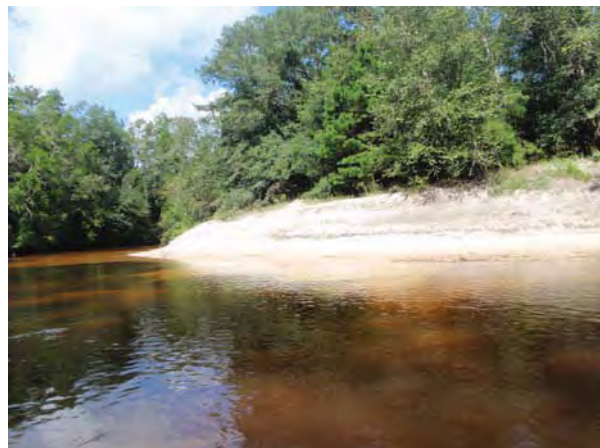
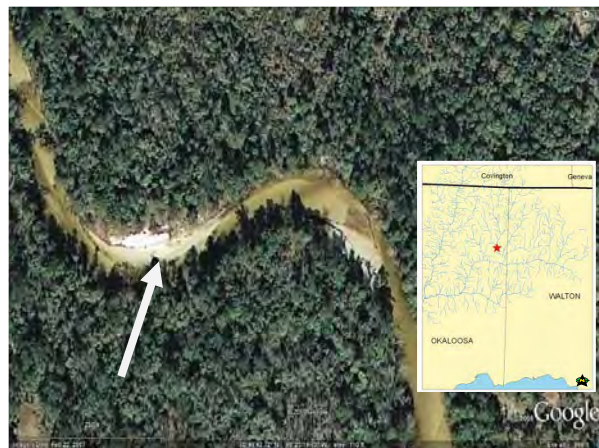
<b>Pond Creek</b>	<b>ok-0928-003</b>	<i>Severity Score</i> <b>1.75</b>
-------------------	--------------------	--------------------------------------

Risk Factor	Ranking	Score	Feature	Within Range	Descriptive Field
<i>Channel Stability</i>	Good	0.5	303(d)	No	N/A
<i>Channel Alteration</i>	None	0	Wetland Species	No	N/A
<i>Bank Erosion</i>	Not Eroding	0	Rare and Imperiled	Yes	IRONCOLOR SHINER, SPECKLED CHUB
<i>BEHI</i>	High	1	Land Use/Cover	Yes	N/A / WETLAND FORESTED MIX, STREAMS AND WATERWAYS
<i>Local NPSP</i>	No Evidence	0	Candidate Mussels	No	N/A
<i>Shoring Structures</i>	Not Present	0	Sturgeon C.H.	No	N/A
<i>Pipe Discharge</i>	Not Present	0	<b>Additional Site Features</b>		
<i>Water Odors</i>	Not Present	0	<i>Stream Channel Woody Material:</i> Infrequent		
<i>Fish Passage Barrier</i>	Not Present	0	<i>Impoundments:</i> None		
<i>RB: Riparian Buffer</i>	100+ ft	0	<i>Substrate Composition:</i> Medium Sand		
<i>LB: Riparian Buffer</i>	100+ ft	0	<i>Bank Material:</i> Sand		
<i>RB: Floodplain Access</i>	Partial	0.25			
<i>LB: Floodplain Access</i>	Full	0

<b>River Threat Index:</b>		<b>1.75</b>

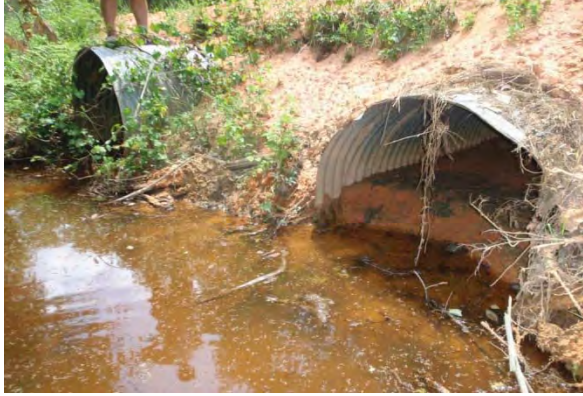
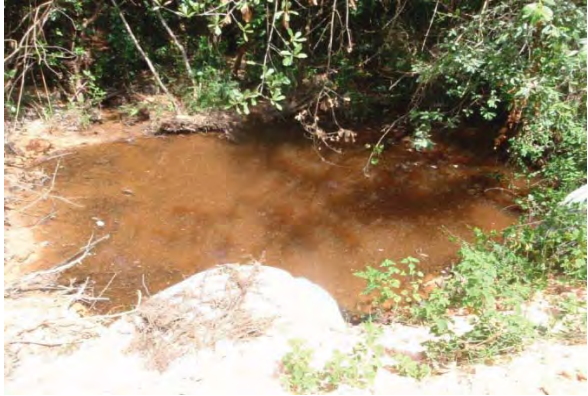
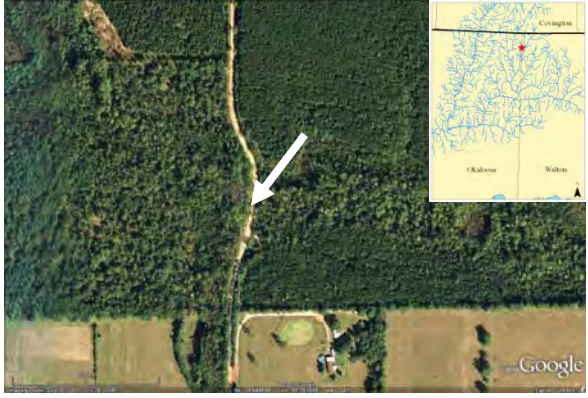
Unnamed tributary	wa-0617-r-004	Sedimentation Risk Index <b>24</b>
-------------------	---------------	---------------------------------------

Risk Factor	Ranking	Score
<i>US Channel Morph</i>	DA	3
<i>DS Channel Morph</i>	DA	3
<i>DS Bank Alteration</i>	HIGH	1
<i>Upstream Skew Angle</i>	>30°	1
<i>Crossing fill condition</i>	Poor/Bare soil	1
<i>Inlet/Outlet Condition</i>	Blocked	1
<i>Road Approach Material</i>	All Sand/Clay	3
<i>Potential Eroded Volume Mean</i>	>40 y <sup>3</sup>	1
<i>Approach Slope Mean</i>	>4%	1
<i>Soil K Factor</i>	<0.20	5
<i>Upstream Rt Outlet</i>	Vegetated	1
<i>Upstream Lt Outlet</i>	Vegetated	1
<i>Upstream Rt Ditch</i>	Bare soil	0
<i>Upstream Lt Ditch</i>	Bare soil	0
<i>Downstream Rt Outlet</i>	Vegetated	1
<i>Downstream Lt Outlet</i>	Bare soil	0
<i>Downstream Rt Ditch</i>	Bare soil	0
<i>Downstream Lt Ditch</i>	Bare soil	0
<i>Outlet Total</i>	Partially Improved Outlet System	3
<i>Ditches Total</i>	Unimproved Drainage System	1
<b>SRI Total</b>	<b>High Risk</b>	<b>24</b>

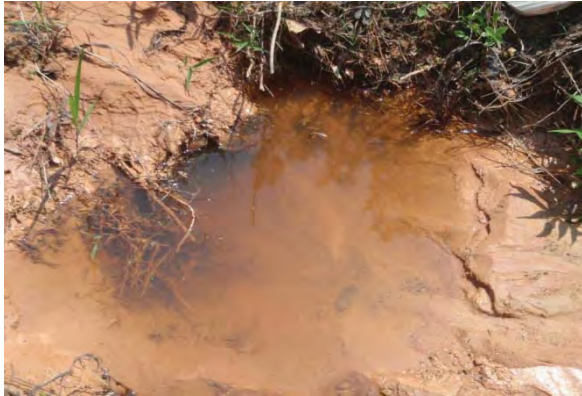
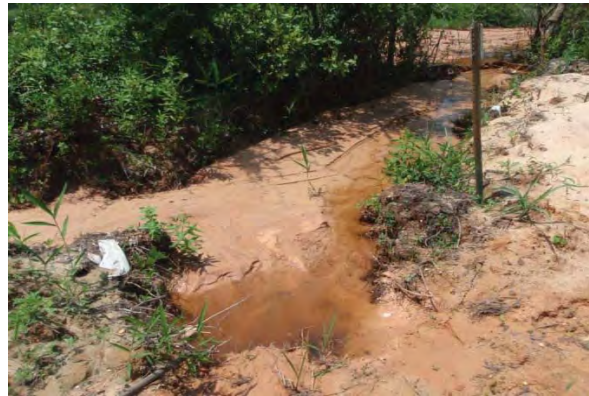
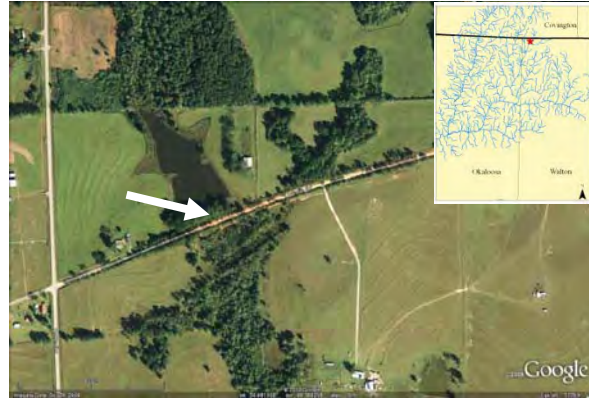
<h1>Unnamed tributary</h1>	<h2>wa-0625-r-002</h2>	<i>Sedimentation Risk Index</i> <b>24</b>
----------------------------	------------------------	--

Risk Factor	Ranking	Score
<i>US Channel Morph</i>	PONDED	1
<i>DS Channel Morph</i>	C	5
<i>DS Bank Alteration</i>	HIGH	1
<i>Upstream Skew Angle</i>	5-30°	3
<i>Crossing fill condition</i>	Poor/Bare soil	1
<i>Inlet/Outlet Condition</i>	Blocked	1
<i>Road Approach Material</i>	All Sand/Clay	3
<i>Potential Eroded Volume Mean</i>	21-40 y <sup>3</sup>	3
<i>Approach Slope Mean</i>	>4%	1
<i>Soil K Factor</i>	0.21-0.40	3
<i>Upstream Rt Outlet</i>	Bare soil	0
<i>Upstream Lt Outlet</i>	Bare soil	0
<i>Upstream Rt Ditch</i>	Bare soil	0
<i>Upstream Lt Ditch</i>	Bare soil	0
<i>Downstream Rt Outlet</i>	Bare soil	0
<i>Downstream Lt Outlet</i>	Bare soil	0
<i>Downstream Rt Ditch</i>	Bare soil	0
<i>Downstream Lt Ditch</i>	Bare soil	0
<i>Outlet Total</i>	Unimproved Outlet System	1
<i>Ditches Total</i>	Unimproved Drainage System	1
<b>SRI Total</b>	<b>High Risk</b>	<b>24</b>

Notes: Pond drainage with buried culvert

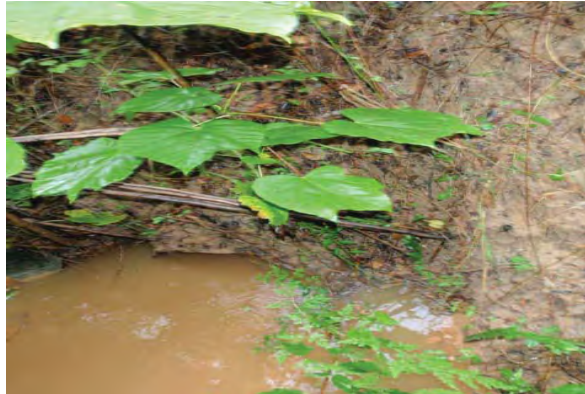
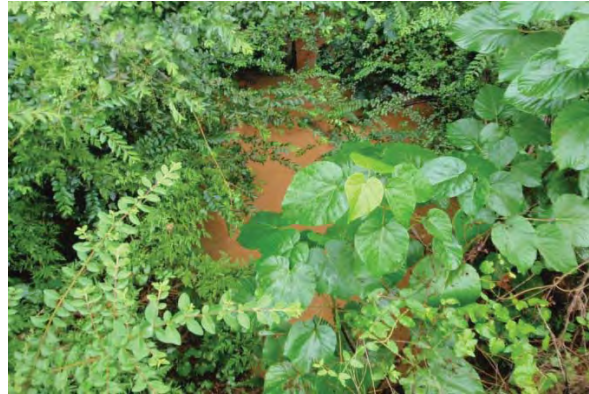
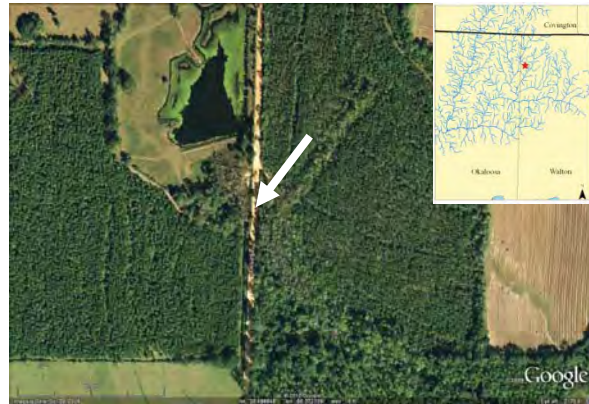
<h1>Unnamed tributary</h1>	<h2>wa-0706-r-003</h2>	<b>Sedimentation Risk Index</b> <h1>24</h1>
----------------------------	------------------------	--

Risk Factor	Ranking	Score
<i>US Channel Morph</i>	PONDED	1
<i>DS Channel Morph</i>	D	1
<i>DS Bank Alteration</i>	HIGH	1
<i>Upstream Skew Angle</i>	5-30°	3
<i>Crossing fill condition</i>	Poor/Bare soil	1
<i>Inlet/Outlet Condition</i>	Sed Islands/Scouring	3
<i>Road Approach Material</i>	All Sand/Clay	3
<i>Potential Eroded Volume Mean</i>	>40 y <sup>3</sup>	1
<i>Approach Slope Mean</i>	>4%	1
<i>Soil K Factor</i>	<0.20	5
<i>Upstream Rt Outlet</i>	Bare soil	0
<i>Upstream Lt Outlet</i>	Bare soil	0
<i>Upstream Rt Ditch</i>	Bare soil	0
<i>Upstream Lt Ditch</i>	Bare soil	0
<i>Downstream Rt Outlet</i>	Bare soil	0
<i>Downstream Lt Outlet</i>	Bare soil	0
<i>Downstream Rt Ditch</i>	Bare soil	0
<i>Downstream Lt Ditch</i>	Vegetated	1
<b>Outlet Total</b>	Unimproved Outlet System	1
<b>Ditches Total</b>	Partially Improved Drainage System	3
<b>SRI Total</b>	<b>High Risk</b>	<b>24</b>

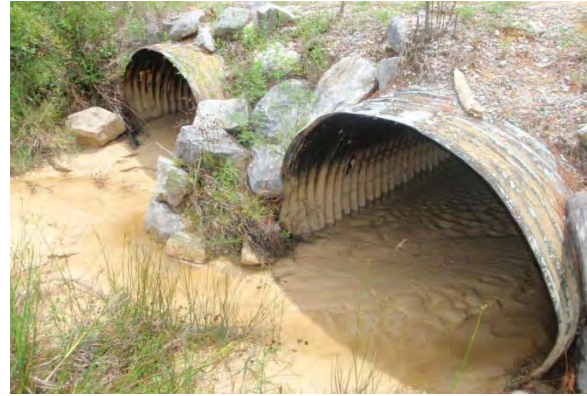
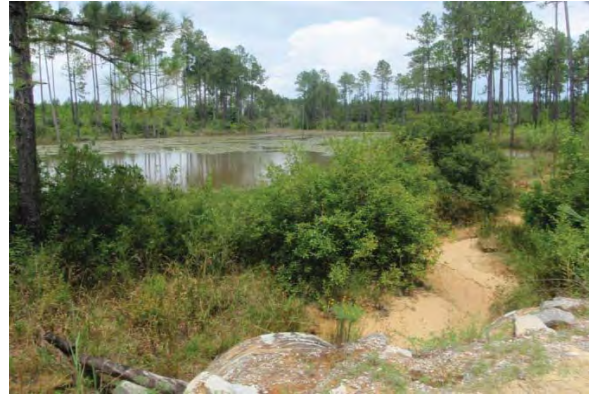
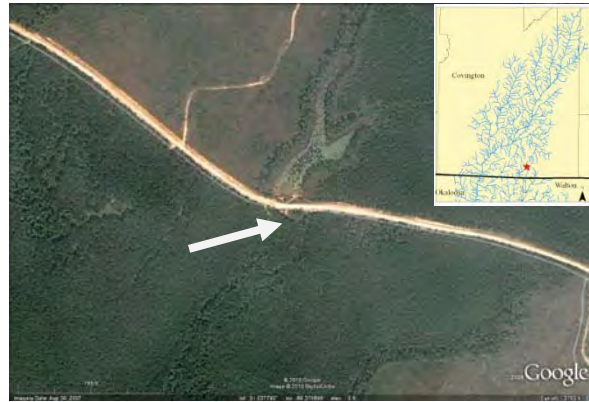
<h1>Horsehead Creek</h1>	<h2>co-0731-r-008</h2>	<i>Sedimentation Risk Index</i> <b>28</b>
--------------------------	------------------------	--

Risk Factor	Ranking	Score
<i>US Channel Morph</i>	PONDED	1
<i>DS Channel Morph</i>	E	5
<i>DS Bank Alteration</i>	HIGH	1
<i>Upstream Skew Angle</i>	>30°	1
<i>Crossing fill condition</i>	Poor/Bare soil	1
<i>Inlet/Outlet Condition</i>	Sed Islands/Scouring	3
<i>Road Approach Material</i>	All Sand/Clay	3
<i>Potential Eroded Volume Mean</i>	>40 y <sup>3</sup>	1
<i>Approach Slope Mean</i>	2.1-4%	3
<i>Soil K Factor</i>	<0.20	5
<i>Upstream Rt Outlet</i>	Bare soil	0
<i>Upstream Lt Outlet</i>	Bare soil	0
<i>Upstream Rt Ditch</i>	Bare soil	0
<i>Upstream Lt Ditch</i>	Bare soil	0
<i>Downstream Rt Outlet</i>	Vegetated	1
<i>Downstream Lt Outlet</i>	Bare soil	0
<i>Downstream Rt Ditch</i>	Bare soil	0
<i>Downstream Lt Ditch</i>	Bare soil	0
<i>Outlet Total</i>	Partially Improved Outlet System	3
<i>Ditches Total</i>	Unimproved Drainage System	1
<b><i>SRI Total</i></b>	<b>High Risk</b>	<b>28</b>
<b>Additional Site Features</b>		
<u>Crossing Type and Quantity:</u>	Culvert, 2

Notes: Misplaced culverts, also evident in aerial photo.

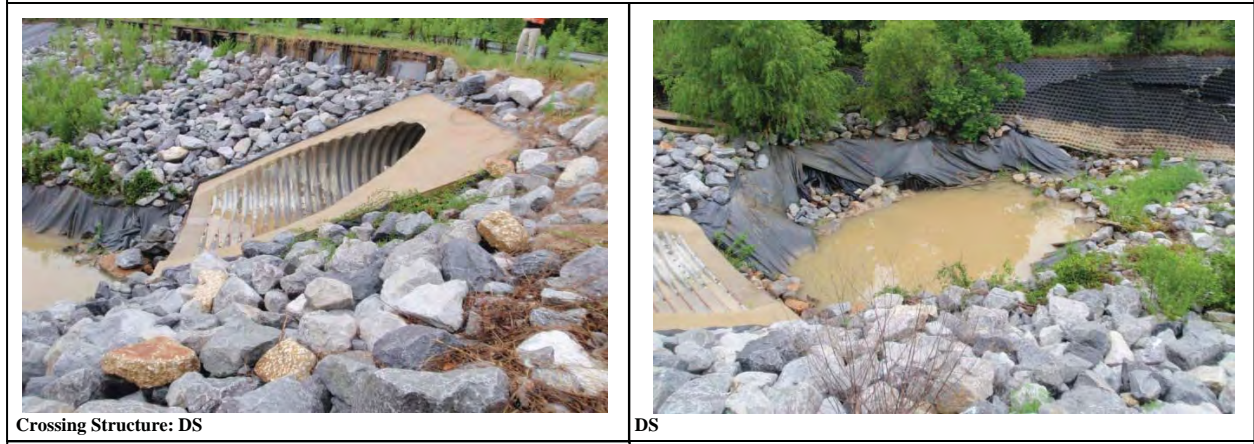
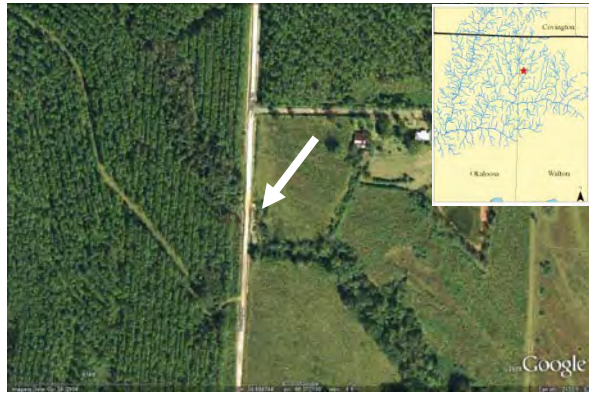
<h1>Unnamed tributary</h1>	<h2>wa-0706-r-001</h2>	<b>Sedimentation Risk Index</b> <h1>28</h1>
----------------------------	------------------------	--

Risk Factor	Ranking	Score	
<i>US Channel Morph</i>	PONDED	1	
<i>DS Channel Morph</i>	PONDED	1	
<i>DS Bank Alteration</i>	HIGH	1	
<i>Upstream Skew Angle</i>	>30°	1	
<i>Crossing fill condition</i>	Fair/Rip Rap	3	
<i>Inlet/Outlet Condition</i>	Blocked	1	
<i>Road Approach Material</i>	All Aggregate	5	
<i>Potential Eroded Volume Mean</i>	<21 y <sup>3</sup>	5	
<i>Approach Slope Mean</i>	2.1-4%	3	
<i>Soil K Factor</i>	<0.20	5	
<i>Upstream Rt Outlet</i>	Concrete	0	
<i>Upstream Lt Outlet</i>	Concrete	0	
<i>Upstream Rt Ditch</i>	Concrete	0	
<i>Upstream Lt Ditch</i>	Concrete	0	
<i>Downstream Rt Outlet</i>	Concrete	0	
<i>Downstream Lt Outlet</i>	Concrete	0	
<i>Downstream Rt Ditch</i>	Concrete	0	
<i>Downstream Lt Ditch</i>	Concrete	0	
<i>Outlet Total</i>	Unimproved Outlet System	1	
<i>Ditches Total</i>	Unimproved Drainage System	1	
<b><i>SRI Total</i></b>	<b>High Risk</b>	<b>28</b>

Notes: DS drop off

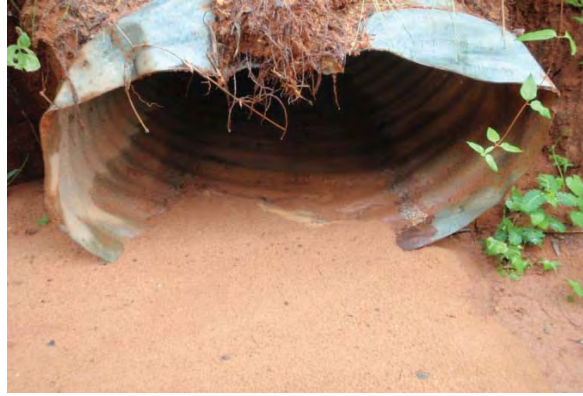
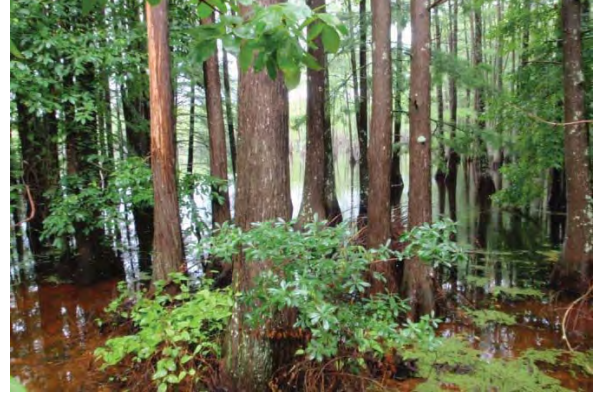
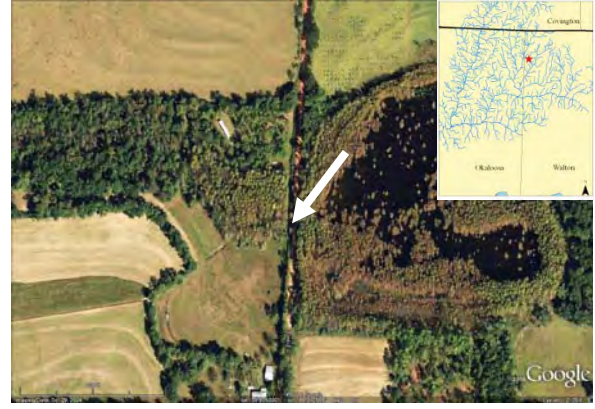
Unnamed tributary	wa-0706-r-002	Sedimentation Risk Index <b>30</b>
-------------------	---------------	---------------------------------------

Risk Factor	Ranking	Score
<i>US Channel Morph</i>	WETLAND	5
<i>DS Channel Morph</i>	D	1
<i>DS Bank Alteration</i>	HIGH	1
<i>Upstream Skew Angle</i>	>30°	1
<i>Crossing fill condition</i>	Poor/Bare soil	1
<i>Inlet/Outlet Condition</i>	Sed Islands/Scouring	3
<i>Road Approach Material</i>	All Sand/Clay	3
<i>Potential Eroded Volume Mean</i>	21-40 y <sup>3</sup>	3
<i>Approach Slope Mean</i>	2.1-4%	3
<i>Soil K Factor</i>	<0.20	5
<i>Upstream Rt Outlet</i>	Bare soil	0
<i>Upstream Lt Outlet</i>	Vegetated	1
<i>Upstream Rt Ditch</i>	Bare soil	0
<i>Upstream Lt Ditch</i>	Bare soil	0
<i>Downstream Rt Outlet</i>	Vegetated	1
<i>Downstream Lt Outlet</i>	Vegetated	1
<i>Downstream Rt Ditch</i>	Bare soil	0
<i>Downstream Lt Ditch</i>	Bare soil	0
<i>Outlet Total</i>	Partially Improved Outlet System	3
<i>Ditches Total</i>	Unimproved Drainage System	1
<b>SRI Total</b>	<b>High Risk</b>	<b>30</b>

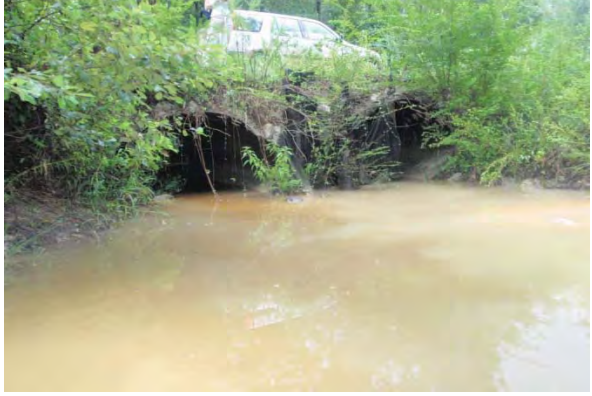
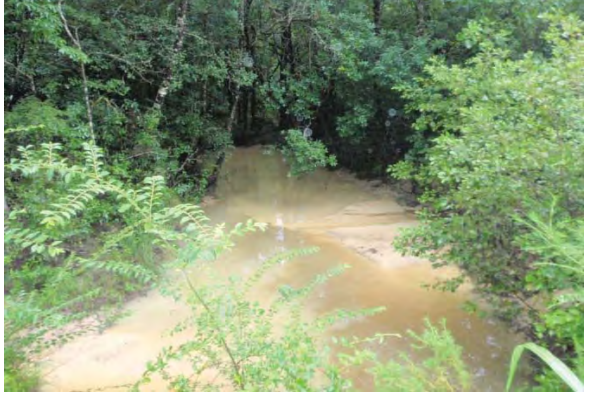
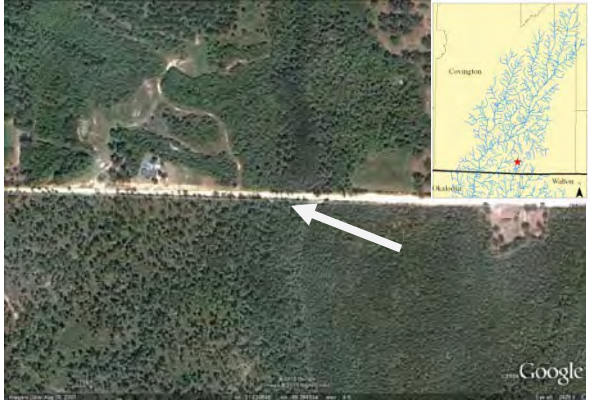
<h1>Unnamed tributary</h1>	<h2>co-0731-r-004</h2>	<b>Sedimentation Risk Index</b> <h1>34</h1>
----------------------------	------------------------	--

Risk Factor	Ranking	Score
<i>US Channel Morph</i>	DA	3
<i>DS Channel Morph</i>	C	5
<i>DS Bank Alteration</i>	HIGH	1
<i>Upstream Skew Angle</i>	5-30°	3
<i>Crossing fill condition</i>	Fair/Rip Rap	3
<i>Inlet/Outlet Condition</i>	Sed Islands/Scouring	3
<i>Road Approach Material</i>	All Sand/Clay	3
<i>Potential Eroded Volume Mean</i>	>40 y <sup>3</sup>	1
<i>Approach Slope Mean</i>	2.1-4%	3
<i>Soil K Factor</i>	<0.20	5
<i>Upstream Rt Outlet</i>	Vegetated	1
<i>Upstream Lt Outlet</i>	Vegetated	1
<i>Upstream Rt Ditch</i>	Bare soil	0
<i>Upstream Lt Ditch</i>	Bare soil	0
<i>Downstream Rt Outlet</i>	Bare soil	0
<i>Downstream Lt Outlet</i>	Bare soil	0
<i>Downstream Rt Ditch</i>	Bare soil	0
<i>Downstream Lt Ditch</i>	Bare soil	0
<i>Outlet Total</i>	Partially Improved Outlet System	3
<i>Ditches Total</i>	Unimproved Drainage System	1
<b>SRI Total</b>	<b>High Risk</b>	<b>34</b>

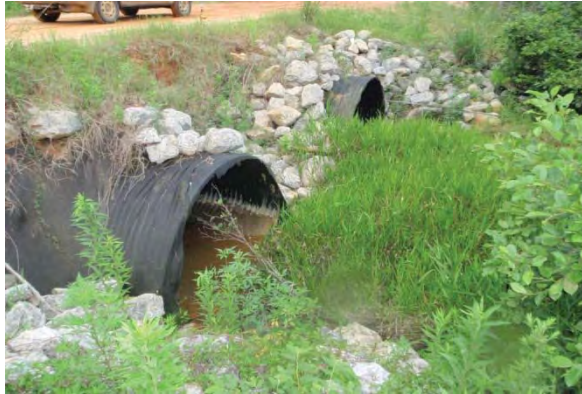
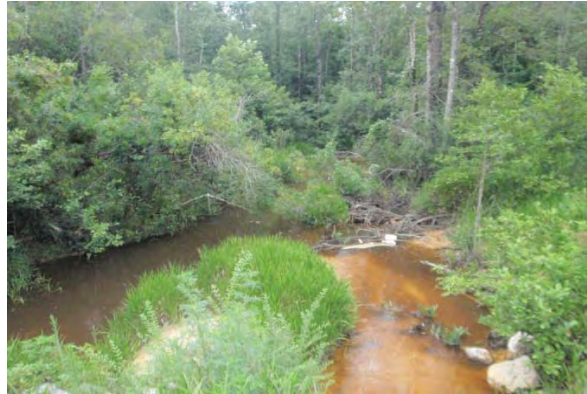
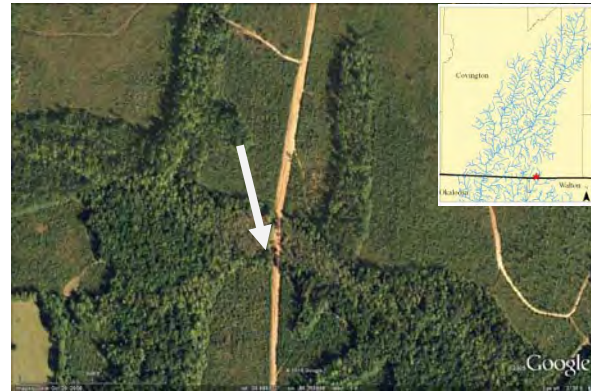
Unnamed tributary	co-0731-r-011	Sedimentation Risk Index <b>34</b>
-------------------	---------------	---------------------------------------

Risk Factor	Ranking	Score
<i>US Channel Morph</i>	BEAVER DAM	3
<i>DS Channel Morph</i>	DA	3
<i>DS Bank Alteration</i>	HIGH	1
<i>Upstream Skew Angle</i>	5-30°	3
<i>Crossing fill condition</i>	Fair/Rip Rap	3
<i>Inlet/Outlet Condition</i>	Sed Islands/Scouring	3
<i>Road Approach Material</i>	All Sand/Clay	3
<i>Potential Eroded Volume Mean</i>	21-40 y <sup>3</sup>	3
<i>Approach Slope Mean</i>	2.1-4%	3
<i>Soil K Factor</i>	<0.20	5
<i>Upstream Rt Outlet</i>	Vegetated	1
<i>Upstream Lt Outlet</i>	Bare soil	0
<i>Upstream Rt Ditch</i>	Bare soil	0
<i>Upstream Lt Ditch</i>	Bare soil	0
<i>Downstream Rt Outlet</i>	Vegetated	1
<i>Downstream Lt Outlet</i>	Vegetated	1
<i>Downstream Rt Ditch</i>	Bare soil	0
<i>Downstream Lt Ditch</i>	Bare soil	0
<i>Outlet Total</i>	Partially Improved Outlet System	3
<i>Ditches Total</i>	Unimproved Drainage System	1
<b>SRI Total</b>	<b>High Risk</b>	<b>34</b>
<b>Additional Site Features</b>		
<i>Crossing Type and Quantity:</i>	Culvert, 2

Notes: Vegetated island between culverts DS

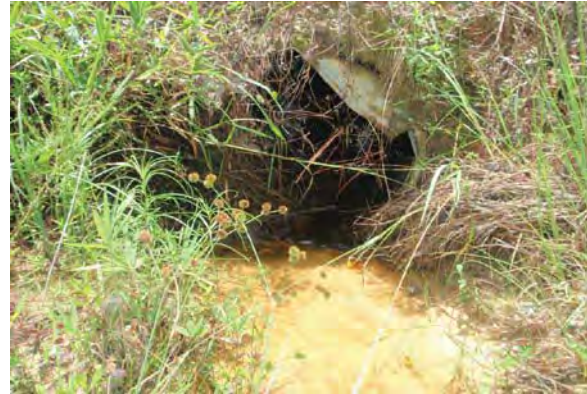
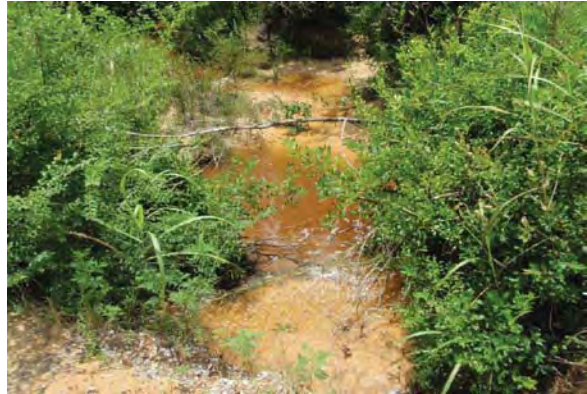
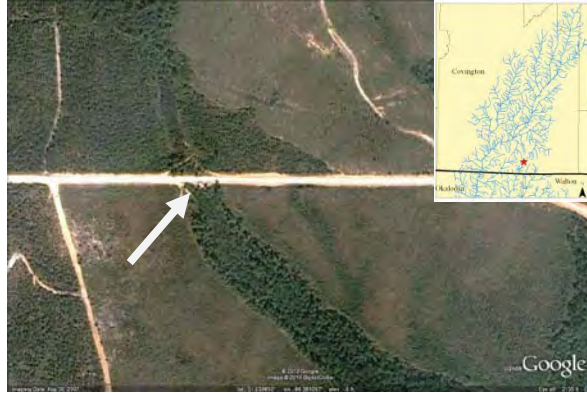
<b>Unnamed tributary</b>	<b>co-0731-r-006</b>	<b>Sedimentation Risk Index</b> <b>36</b>
--------------------------	----------------------	--

Risk Factor	Ranking	Score
<i>US Channel Morph</i>	E	5
<i>DS Channel Morph</i>	E	5
<i>DS Bank Alteration</i>	HIGH	1
<i>Upstream Skew Angle</i>	<5°	5
<i>Crossing fill condition</i>	Poor/Bare soil	1
<i>Inlet/Outlet Condition</i>	Sed Islands/Scouring	3
<i>Road Approach Material</i>	All Sand/Clay	3
<i>Potential Eroded Volume Mean</i>	>40 y <sup>3</sup>	1
<i>Approach Slope Mean</i>	2.1-4%	3
<i>Soil K Factor</i>	<0.20	5
<i>Upstream Rt Outlet</i>	Vegetated	1
<i>Upstream Lt Outlet</i>	Vegetated	1
<i>Upstream Rt Ditch</i>	Bare soil	0
<i>Upstream Lt Ditch</i>	Bare soil	0
<i>Downstream Rt Outlet</i>	Bare soil	0
<i>Downstream Lt Outlet</i>	Bare soil	0
<i>Downstream Rt Ditch</i>	Bare soil	0
<i>Downstream Lt Ditch</i>	Bare soil	0
<i>Outlet Total</i>	Partially Improved Outlet System	3
<i>Ditches Total</i>	Unimproved Drainage System	1
<b><i>SRI Total</i></b>	<b>High Risk</b>	<b>36</b>
<b>Additional Site Features</b>		
<i>Crossing Type and Quantity:</i>	Culvert, 1

Notes: Undersized culvert.

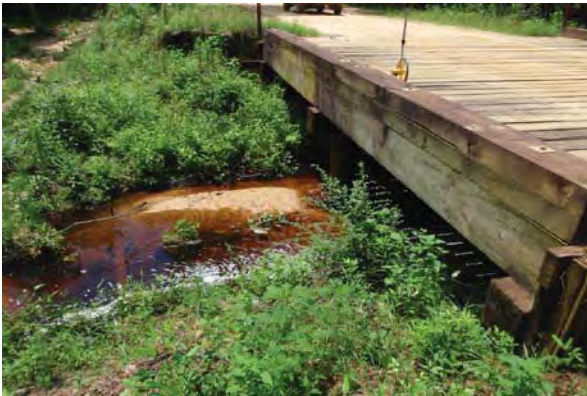
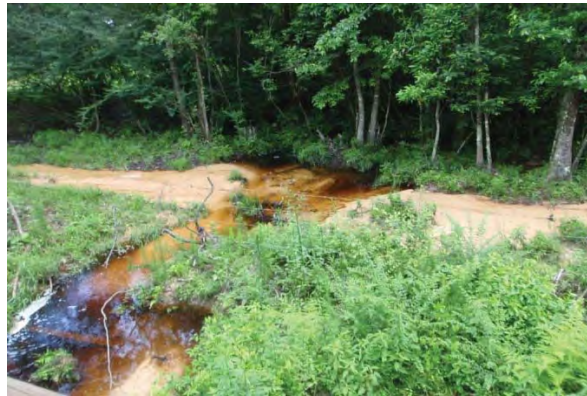
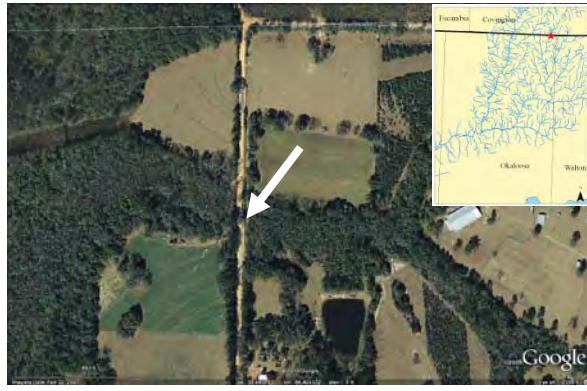
<h1>Unnamed tributary</h1>	<h2>ok-0528-r-002</h2>	<i>Sedimentation Risk Index</i> <b>36</b>
----------------------------	------------------------	--

Risk Factor	Ranking	Score
<i>US Channel Morph</i>	DA	3
<i>DS Channel Morph</i>	DA	3
<i>DS Bank Alteration</i>	HIGH	1
<i>Upstream Skew Angle</i>	<5°	5
<i>Crossing fill condition</i>	Good/Vegetated	5
<i>Inlet/Outlet Condition</i>	Sed Islands/Scouring	3
<i>Road Approach Material</i>	All Sand/Clay	3
<i>Potential Eroded Volume Mean</i>	21-40 y <sup>3</sup>	3
<i>Approach Slope Mean</i>	>4%	1
<i>Soil K Factor</i>	<0.20	5
<i>Upstream Rt Outlet</i>	Bare soil	0
<i>Upstream Lt Outlet</i>	Bare soil	0
<i>Upstream Rt Ditch</i>	Bare soil	0
<i>Upstream Lt Ditch</i>	Bare soil	0
<i>Downstream Rt Outlet</i>	Vegetated	1
<i>Downstream Lt Outlet</i>	Vegetated	1
<i>Downstream Rt Ditch</i>	Bare soil	0
<i>Downstream Lt Ditch</i>	Bare soil	0
<i>Outlet Total</i>	Partially Improved Outlet System	3
<i>Ditches Total</i>	Unimproved Drainage System	1
<b><i>SRI Total</i></b>	<b>High Risk</b>	<b>36</b>

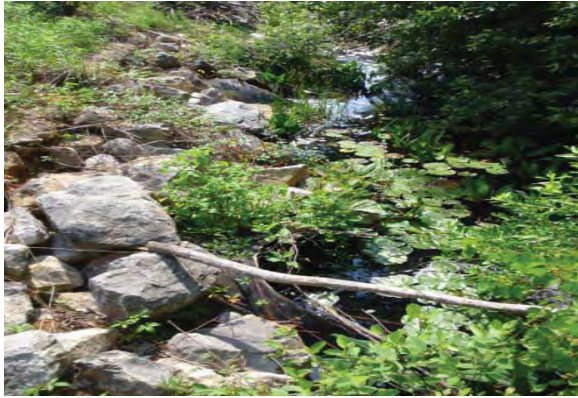
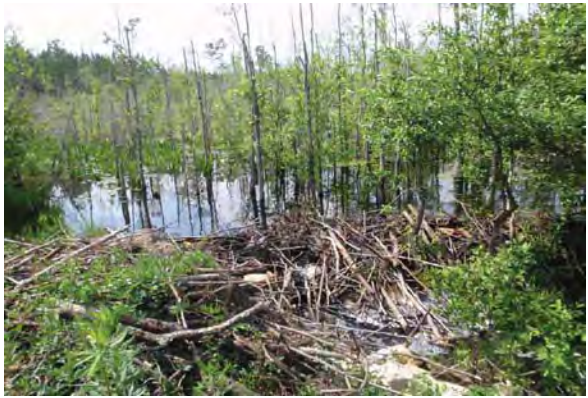
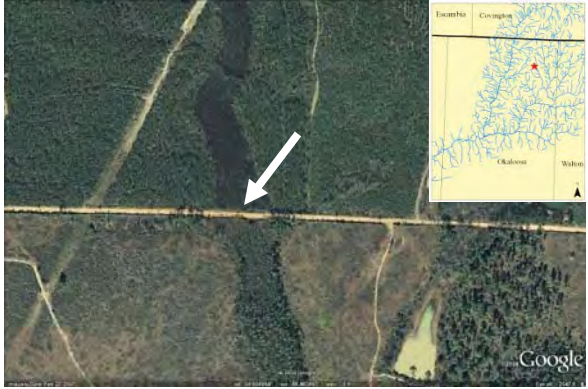
<h1>Juniper Creek</h1>	<h2>ok-0528-r-008</h2>	<i>Sedimentation Risk Index</i> <b>36</b>
------------------------	------------------------	--

Risk Factor	Ranking	Score
<i>US Channel Morph</i>	BEAVER DAM	3
<i>DS Channel Morph</i>	DA	3
<i>DS Bank Alteration</i>	MINOR/PARTIAL	3
<i>Upstream Skew Angle</i>	>30°	1
<i>Crossing fill condition</i>	Fair/Rip Rap	3
<i>Inlet/Outlet Condition</i>	No Impairment	5
<i>Road Approach Material</i>	All Sand/Clay	3
<i>Potential Eroded Volume Mean</i>	>40 y <sup>3</sup>	1
<i>Approach Slope Mean</i>	2.1-4%	3
<i>Soil K Factor</i>	<0.20	5
<i>Upstream Rt Outlet</i>	Rip Rap	1
<i>Upstream Lt Outlet</i>	Vegetated	1
<i>Upstream Rt Ditch</i>	Bare soil	0
<i>Upstream Lt Ditch</i>	Bare soil	0
<i>Downstream Rt Outlet</i>	Vegetated	1
<i>Downstream Lt Outlet</i>	Rip Rap	1
<i>Downstream Rt Ditch</i>	Bare soil	0
<i>Downstream Lt Ditch</i>	Bare soil	0
<i>Outlet Total</i>	Improved Outlet System	5
<i>Ditches Total</i>	Unimproved Drainage System	1
<b><i>SRI Total</i></b>	<b>High Risk</b>	<b>36</b>
<b>Additional Site Features</b>		
<i>Crossing Type and Quantity:</i>	Culvert, 3

Notes: Outlets mix of vegetation and rip rap--beaver dam skewing angle

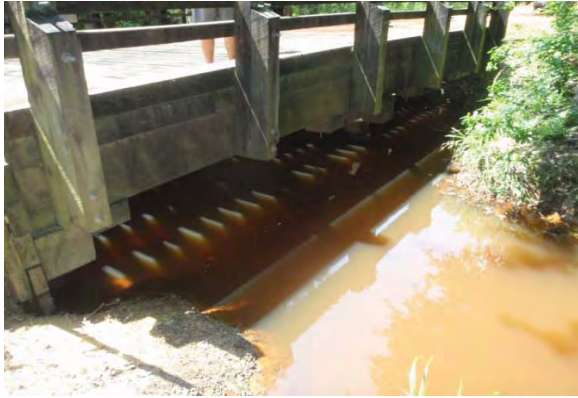
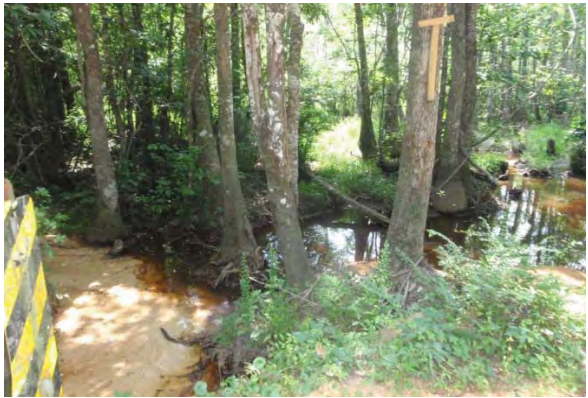
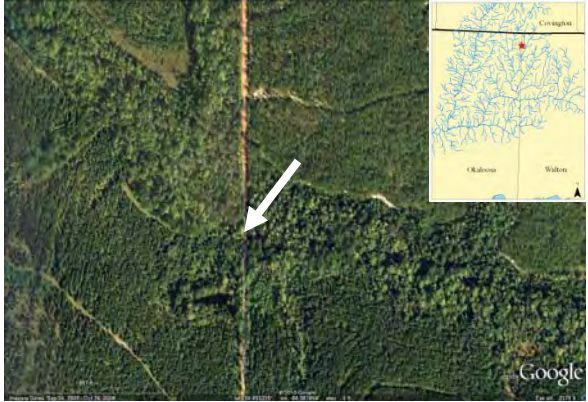
<h1>Unnamed tributary</h1>	<h2>wa-0617-r-005</h2>	<i>Sedimentation Risk Index</i> <b>36</b>
----------------------------	------------------------	--

Risk Factor	Ranking	Score
<i>US Channel Morph</i>	WETLAND	5
<i>DS Channel Morph</i>	DA	3
<i>DS Bank Alteration</i>	MINOR/PARTIAL	3
<i>Upstream Skew Angle</i>	5-30°	3
<i>Crossing fill condition</i>	Poor/Bare soil	1
<i>Inlet/Outlet Condition</i>	No Impairment	5
<i>Road Approach Material</i>	All Sand/Clay	3
<i>Potential Eroded Volume Mean</i>	>40 y <sup>3</sup>	1
<i>Approach Slope Mean</i>	>4%	1
<i>Soil K Factor</i>	<0.20	5
<i>Upstream Rt Outlet</i>	Bare soil	0
<i>Upstream Lt Outlet</i>	Vegetated	1
<i>Upstream Rt Ditch</i>	Synthetic	1
<i>Upstream Lt Ditch</i>	Bare soil	0
<i>Downstream Rt Outlet</i>	Vegetated	1
<i>Downstream Lt Outlet</i>	Vegetated	1
<i>Downstream Rt Ditch</i>	Bare soil	0
<i>Downstream Lt Ditch</i>	Bare soil	0
<i>Outlet Total</i>	Partially Improved Outlet System	3
<i>Ditches Total</i>	Partially Improved Drainage System	3
<b><i>SRI Total</i></b>	<b>High Risk</b>	<b>36</b>

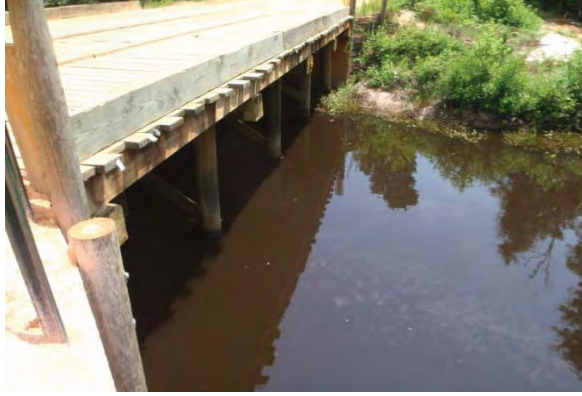
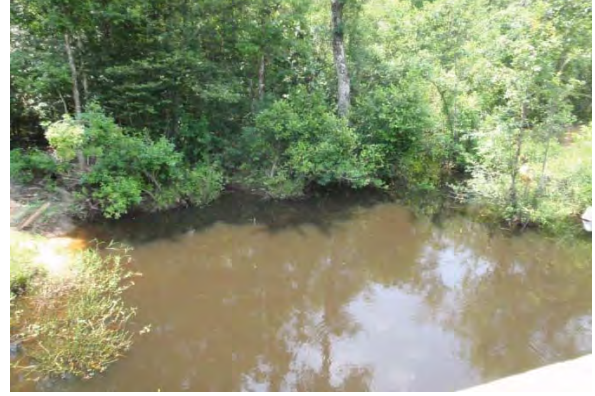
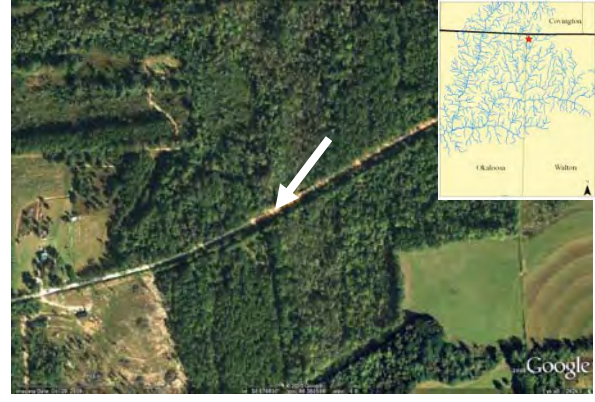
<h1 style="margin:0;">Fleming Creek</h1>	<h2 style="margin:0;">wa-0625-r-003</h2>	<b>Sedimentation Risk Index</b> <h1 style="margin:0;">36</h1>
--	--	--

Risk Factor	Ranking	Score
<i>US Channel Morph</i>	B	5
<i>DS Channel Morph</i>	DA	3
<i>DS Bank Alteration</i>	MINOR/PARTIAL	3
<i>Upstream Skew Angle</i>	<5°	5
<i>Crossing fill condition</i>	Poor/Bare soil	1
<i>Inlet/Outlet Condition</i>	No Impairment	5
<i>Road Approach Material</i>	All Sand/Clay	3
<i>Potential Eroded Volume Mean</i>	>40 y <sup>3</sup>	1
<i>Approach Slope Mean</i>	>4%	1
<i>Soil K Factor</i>	<0.20	5
<i>Upstream Rt Outlet</i>	Vegetated	1
<i>Upstream Lt Outlet</i>	Vegetated	1
<i>Upstream Rt Ditch</i>	Bare soil	0
<i>Upstream Lt Ditch</i>	Bare soil	0
<i>Downstream Rt Outlet</i>	Bare soil	0
<i>Downstream Lt Outlet</i>	Bare soil	0
<i>Downstream Rt Ditch</i>	Bare soil	0
<i>Downstream Lt Ditch</i>	Bare soil	0
<i>Outlet Total</i>	Partially Improved Outlet System	3
<i>Ditches Total</i>	Unimproved Drainage System	1
<b><i>SRI Total</i></b>	<b>High Risk</b>	<b>36</b>
<b>Additional Site Features</b>		
<i>Crossing Type and Quantity:</i>	Bridge, 1

Notes: Need to stabilize prism fill on approaches.

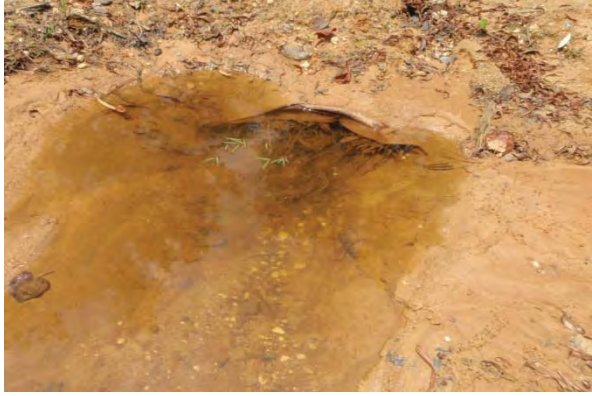
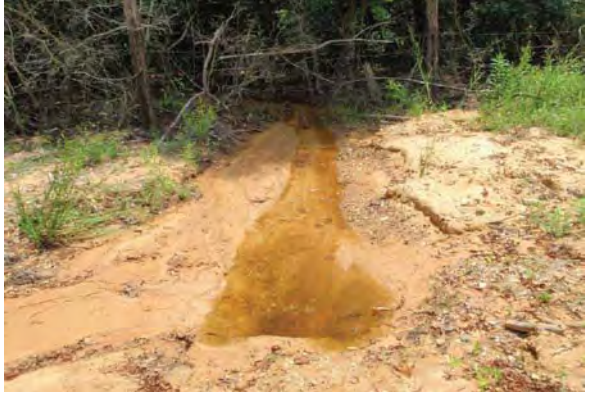
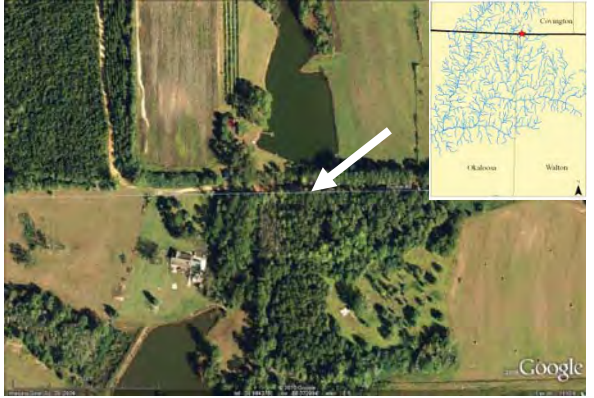
Unnamed tributary	wa-0625-r-006	Sedimentation Risk Index <b>28</b>
-------------------	---------------	---------------------------------------

Risk Factor	Ranking	Score
US Channel Morph	PONDED	1
DS Channel Morph	PONDED	1
DS Bank Alteration	MINOR/PARTIAL	3
Upstream Skew Angle	>30°	1
Crossing fill condition	Poor/Bare soil	1
Inlet/Outlet Condition	Blocked	1
Road Approach Material	All Sand/Clay	3
Potential Eroded Volume Mean	21-40 y <sup>3</sup>	3
Approach Slope Mean	2.1-4%	3
Soil K Factor	<0.20	5
Upstream Rt Outlet	Vegetated	1
Upstream Lt Outlet	Vegetated	1
Upstream Rt Ditch	Bare soil	0
Upstream Lt Ditch	Bare soil	0
Downstream Rt Outlet	Vegetated	1
Downstream Lt Outlet	Vegetated	1
Downstream Rt Ditch	Bare soil	0
Downstream Lt Ditch	Bare soil	0
Outlet Total	Improved Outlet System	5
Ditches Total	Unimproved Drainage System	1
<b>SRI Total</b>	<b>High Risk</b>	<b>28</b>

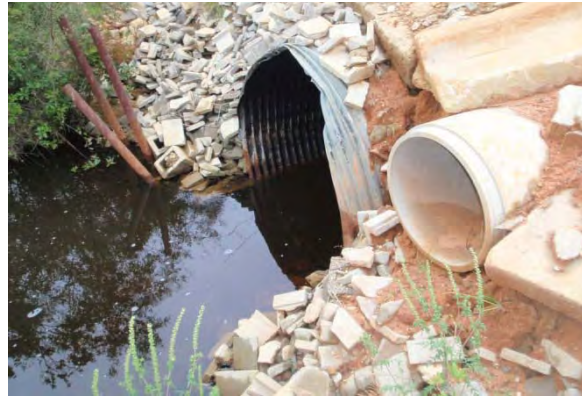
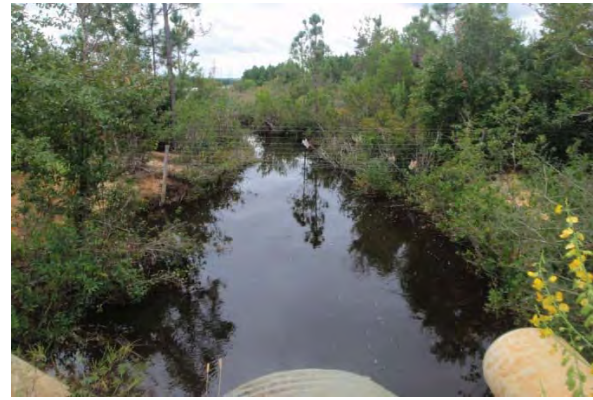
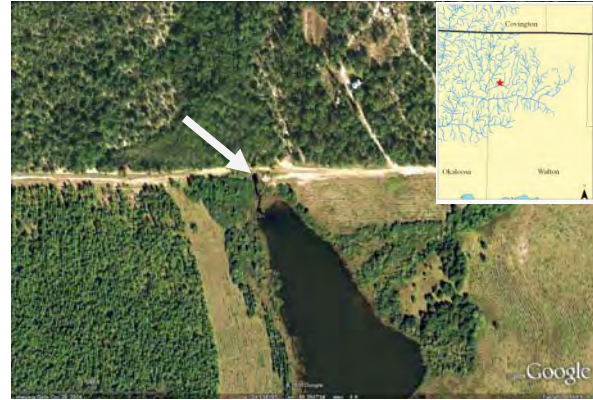
Crossing Structure: US

Risk Factor	Ranking	Score
<i>US Channel Morph</i>	WETLAND	5
<i>DS Channel Morph</i>	PONDED	1
<i>DS Bank Alteration</i>	MINOR/PARTIAL	3
<i>Upstream Skew Angle</i>	<5°	5
<i>Crossing fill condition</i>	Fair/Rip Rap	3
<i>Inlet/Outlet Condition</i>	No Impairment	5
<i>Road Approach Material</i>	All Sand/Clay	3
<i>Potential Eroded Volume Mean</i>	21-40 y <sup>3</sup>	3
<i>Approach Slope Mean</i>	>4%	1
<i>Soil K Factor</i>	0.21-0.40	3
<i>Upstream Rt Outlet</i>	Vegetated	1
<i>Upstream Lt Outlet</i>	Vegetated	1
<i>Upstream Rt Ditch</i>	Bare soil	0
<i>Upstream Lt Ditch</i>	Bare soil	0
<i>Downstream Rt Outlet</i>	Vegetated	1
<i>Downstream Lt Outlet</i>	Bare soil	0
<i>Downstream Rt Ditch</i>	Bare soil	0
<i>Downstream Lt Ditch</i>	Bare soil	0
<i>Outlet Total</i>	Partially Improved Outlet System	3
<i>Ditches Total</i>	Unimproved Drainage System	1
<b>SRI Total</b>	<b>High Risk</b>	<b>36</b>

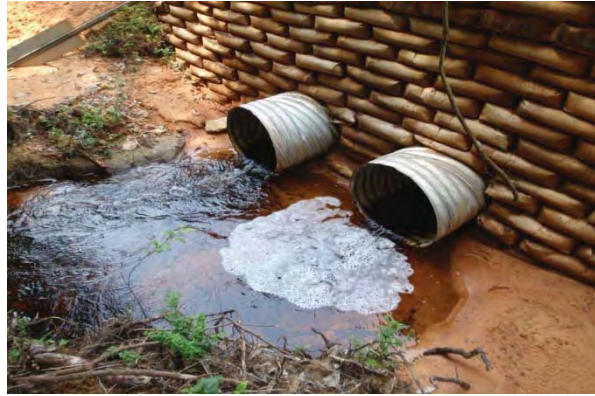
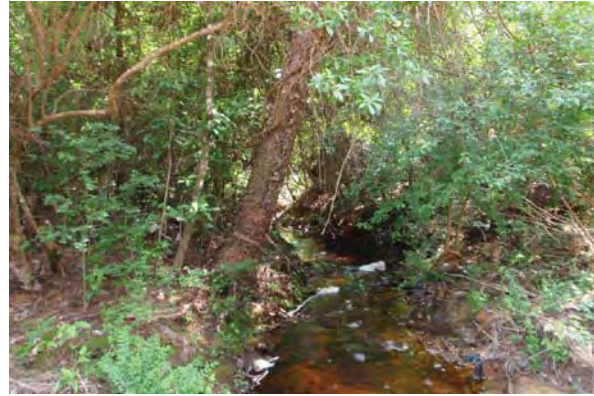
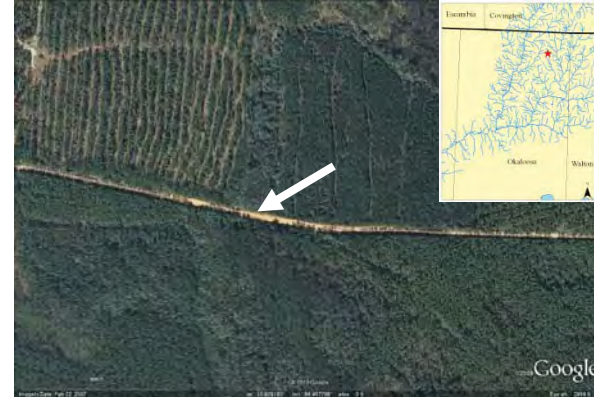
Crossing Structure: DS

Risk Factor	Ranking	Score
<i>US Channel Morph</i>	DA	3
<i>DS Channel Morph</i>	E	5
<i>DS Bank Alteration</i>	MINOR/PARTIAL	3
<i>Upstream Skew Angle</i>	<5°	5
<i>Crossing fill condition</i>	Poor/Bare soil	1
<i>Inlet/Outlet Condition</i>	Sed Islands/Scouring	3
<i>Road Approach Material</i>	All Sand/Clay	3
<i>Potential Eroded Volume Mean</i>	<21 y <sup>3</sup>	5
<i>Approach Slope Mean</i>	2.1-4%	3
<i>Soil K Factor</i>	<0.20	5
<i>Upstream Rt Outlet</i>	Bare soil	0
<i>Upstream Lt Outlet</i>	Bare soil	0
<i>Upstream Rt Ditch</i>	Bare soil	0
<i>Upstream Lt Ditch</i>	Bare soil	0
<i>Downstream Rt Outlet</i>	Bare soil	0
<i>Downstream Lt Outlet</i>	Bare soil	0
<i>Downstream Rt Ditch</i>	Bare soil	0
<i>Downstream Lt Ditch</i>	Bare soil	0
<i>Outlet Total</i>	Unimproved Outlet System	1
<i>Ditches Total</i>	Unimproved Drainage System	1
<b>SRI Total</b>	<b>Medium Risk</b>	<b>38</b>

Notes: Newly reconstructed crossing. DS drop off.

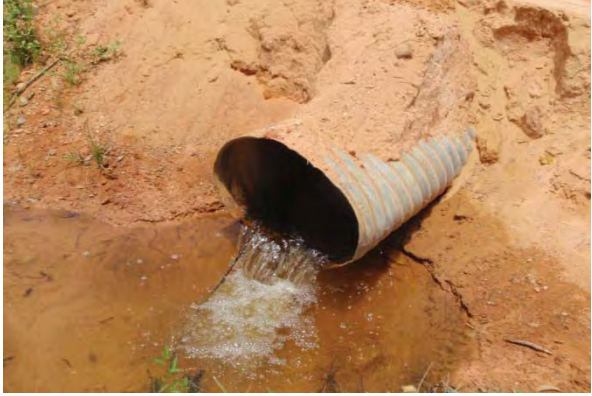
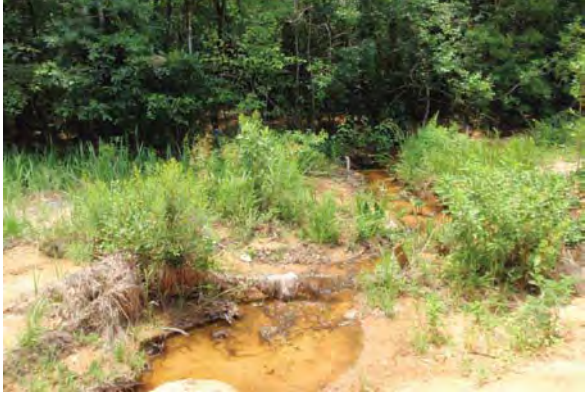
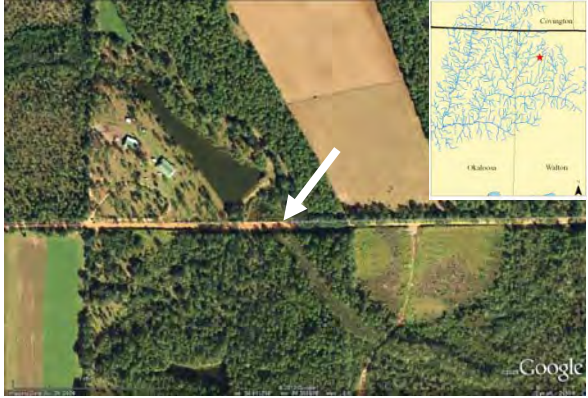
Crossing Structure: DS

Risk Factor	Ranking	Score
<i>US Channel Morph</i>	PONDED	1
<i>DS Channel Morph</i>	E	5
<i>DS Bank Alteration</i>	HIGH	1
<i>Upstream Skew Angle</i>	<5°	5
<i>Crossing fill condition</i>	Poor/Bare soil	1
<i>Inlet/Outlet Condition</i>	No Impairment	5
<i>Road Approach Material</i>	All Sand/Clay	3
<i>Potential Eroded Volume Mean</i>	<21 y <sup>3</sup>	5
<i>Approach Slope Mean</i>	>4%	1
<i>Soil K Factor</i>	<0.20	5
<i>Upstream Rt Outlet</i>	Bare soil	0
<i>Upstream Lt Outlet</i>	Bare soil	0
<i>Upstream Rt Ditch</i>	Bare soil	0
<i>Upstream Lt Ditch</i>	Bare soil	0
<i>Downstream Rt Outlet</i>	Bare soil	0
<i>Downstream Lt Outlet</i>	Bare soil	0
<i>Downstream Rt Ditch</i>	Bare soil	0
<i>Downstream Lt Ditch</i>	Bare soil	0
<i>Outlet Total</i>	Unimproved Outlet System	1
<i>Ditches Total</i>	Unimproved Drainage System	1
<b>SRI Total</b>	<b>High Risk</b>	<b>34</b>

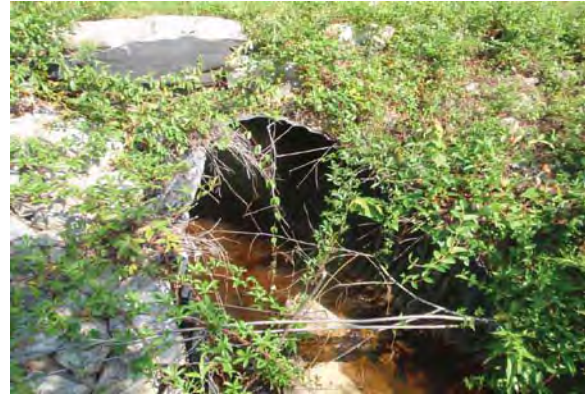
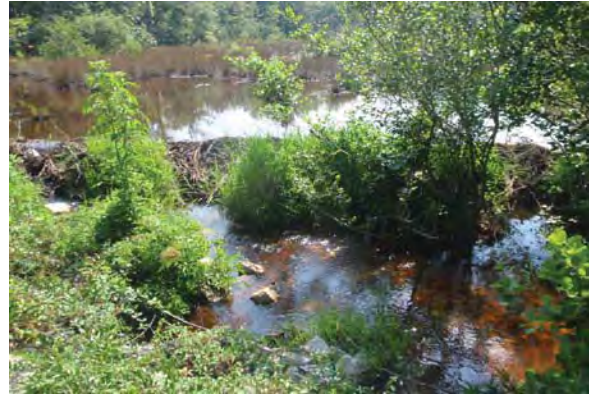
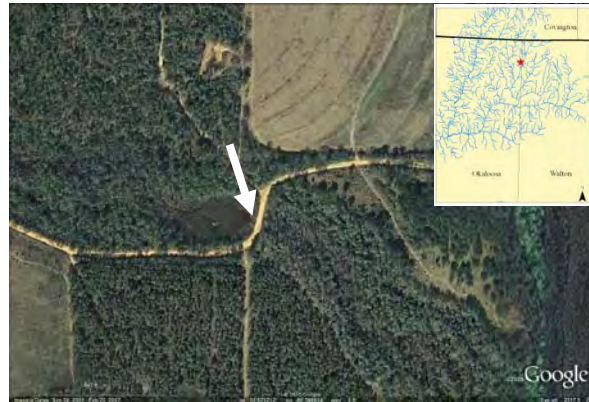
Crossing Structure: US

Risk Factor	Ranking	Score
<i>US Channel Morph</i>	BEAVER DAM	3
<i>DS Channel Morph</i>	DA	3
<i>DS Bank Alteration</i>	HIGH	1
<i>Upstream Skew Angle</i>	5-30°	3
<i>Crossing fill condition</i>	Good/Vegetated	5
<i>Inlet/Outlet Condition</i>	No Impairment	5
<i>Road Approach Material</i>	All Sand/Clay	3
<i>Potential Eroded Volume Mean</i>	>40 y <sup>3</sup>	1
<i>Approach Slope Mean</i>	<2%	5
<i>Soil K Factor</i>	<0.20	5
<i>Upstream Rt Outlet</i>	Vegetated	1
<i>Upstream Lt Outlet</i>	Vegetated	1
<i>Upstream Rt Ditch</i>	Bare soil	0
<i>Upstream Lt Ditch</i>	Bare soil	0
<i>Downstream Rt Outlet</i>	Vegetated	1
<i>Downstream Lt Outlet</i>	Vegetated	1
<i>Downstream Rt Ditch</i>	Bare soil	0
<i>Downstream Lt Ditch</i>	Bare soil	0
<i>Outlet Total</i>	Improved Outlet System	5
<i>Ditches Total</i>	Unimproved Drainage System	1
<b>SRI Total</b>	<b>Medium Risk</b>	<b>40</b>

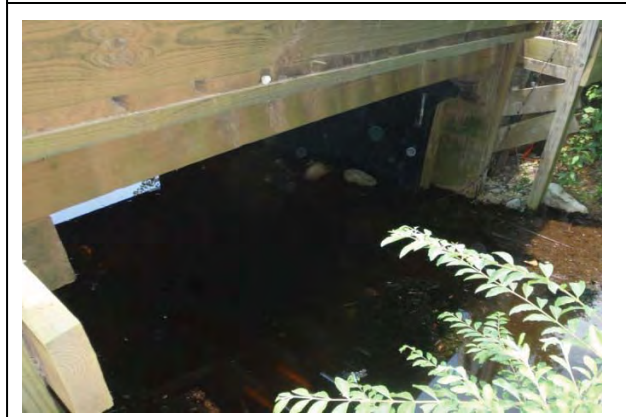
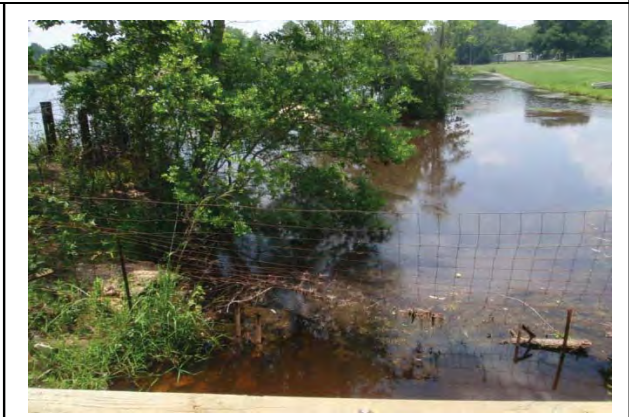
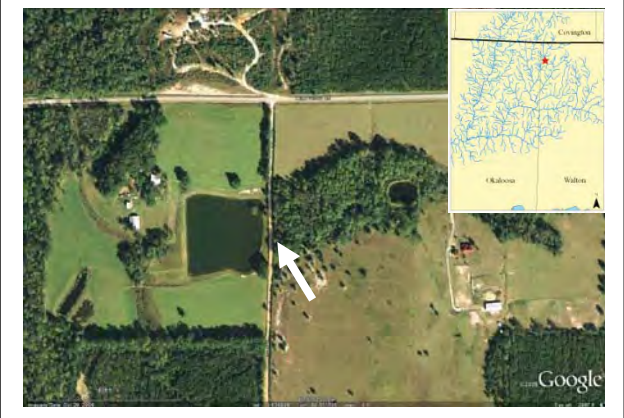
Crossing Structure: US

Risk Factor	Ranking	Score
US Channel Morph	PONDED	1
DS Channel Morph	PONDED	1
DS Bank Alteration	HIGH	1
Upstream Skew Angle	5-30°	3
Crossing fill condition	Fair/Rip Rap	3
Inlet/Outlet Condition	No Impairment	5
Road Approach Material	All Aggregate	5
Potential Eroded Volume Mean	<21 y <sup>3</sup>	5
Approach Slope Mean	2.1-4%	3
Soil K Factor	<0.20	5
Upstream Rt Outlet	Bare soil	0
Upstream Lt Outlet	Rip Rap	1
Upstream Rt Ditch	Bare soil	0
Upstream Lt Ditch	Bare soil	0
Downstream Rt Outlet	Vegetated	1
Downstream Lt Outlet	Bare soil	0
Downstream Rt Ditch	Rip Rap	1
Downstream Lt Ditch	Bare soil	0
Outlet Total	Partially Improved Outlet System	3
Ditches Total	Partially Improved Drainage System	3
<b>SRI Total</b>	<b>Medium Risk</b>	<b>38</b>

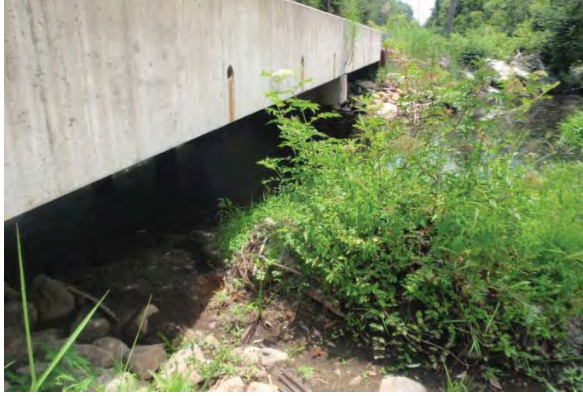
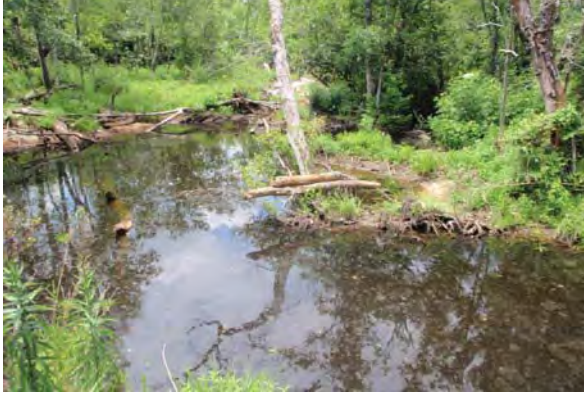
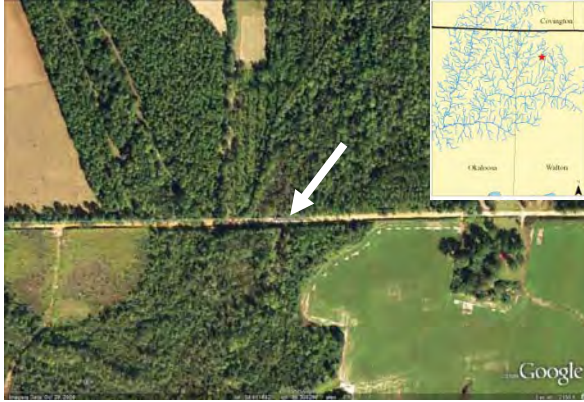
Crossing Structure: DS

Risk Factor	Ranking	Score
<i>US Channel Morph</i>	DA	3
<i>DS Channel Morph</i>	DA	3
<i>DS Bank Alteration</i>	NATURAL	5
<i>Upstream Skew Angle</i>	<5°	5
<i>Crossing fill condition</i>	Fair/Rip Rap	3
<i>Inlet/Outlet Condition</i>	No Impairment	5
<i>Road Approach Material</i>	All Sand/Clay	3
<i>Potential Eroded Volume Mean</i>	21-40 y <sup>3</sup>	3
<i>Approach Slope Mean</i>	2.1-4%	3
<i>Soil K Factor</i>	0.21-0.40	3
<i>Upstream Rt Outlet</i>	Vegetated	1
<i>Upstream Lt Outlet</i>	Vegetated	1
<i>Upstream Rt Ditch</i>	Bare soil	0
<i>Upstream Lt Ditch</i>	Bare soil	0
<i>Downstream Rt Outlet</i>	Bare soil	0
<i>Downstream Lt Outlet</i>	Bare soil	0
<i>Downstream Rt Ditch</i>	Bare soil	0
<i>Downstream Lt Ditch</i>	Bare soil	0
<i>Outlet Total</i>	Partially Improved Outlet System	3
<i>Ditches Total</i>	Unimproved Drainage System	1
<b><i>SRI Total</i></b>	<b>Medium Risk</b>	<b>40</b>
<b>Additional Site Features</b>		
<i>Crossing Type and Quantity:</i>	Bridge, 1

Notes: Water not flowing.

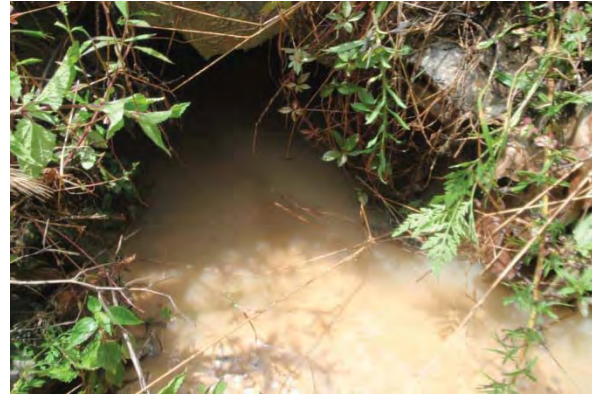
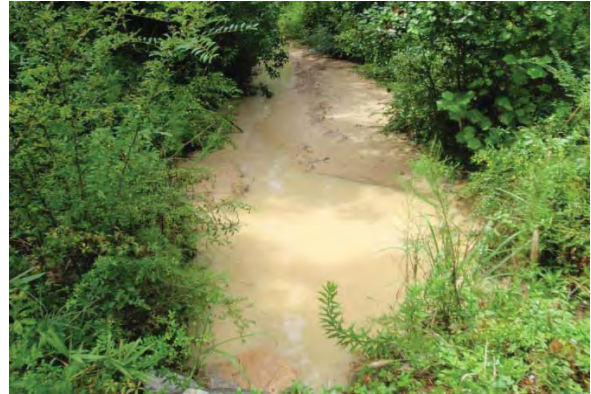
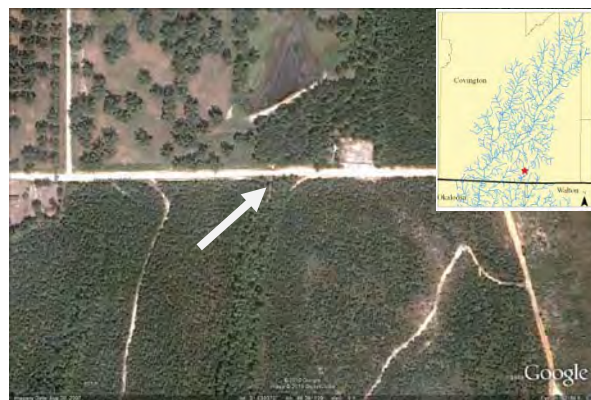
Crossing Structure: US

Risk Factor	Ranking	Score
US Channel Morph	E	5
DS Channel Morph	E	5
DS Bank Alteration	HIGH	1
Upstream Skew Angle	<5°	5
Crossing fill condition	Good/Vegetated	5
Inlet/Outlet Condition	Sed Islands/Scouring	3
Road Approach Material	All Sand/Clay	3
Potential Eroded Volume Mean	>40 y <sup>3</sup>	1
Approach Slope Mean	2.1-4%	3
Soil K Factor	<0.20	5
Upstream Rt Outlet	Vegetated	1
Upstream Lt Outlet	Vegetated	1
Upstream Rt Ditch	Bare soil	0
Upstream Lt Ditch	Bare soil	0
Downstream Rt Outlet	Vegetated	1
Downstream Lt Outlet	Vegetated	1
Downstream Rt Ditch	Bare soil	0
Downstream Lt Ditch	Bare soil	0
Outlet Total	Improved Outlet System	5
Ditches Total	Unimproved Drainage System	1
<b>SRI Total</b>	<b>Medium Risk</b>	<b>42</b>
