Appendix A. River corridor severity scores for impaired sites in the Yellow River Basin, Alabama and Florida

Appendix C. Clear Creek Watershed Focal Area. Sites with orange headings are unpaved road sites. Specific definitions and calculations described for calculating the Sediment Risk Index (SRI) are detailed in Witmer (2009).

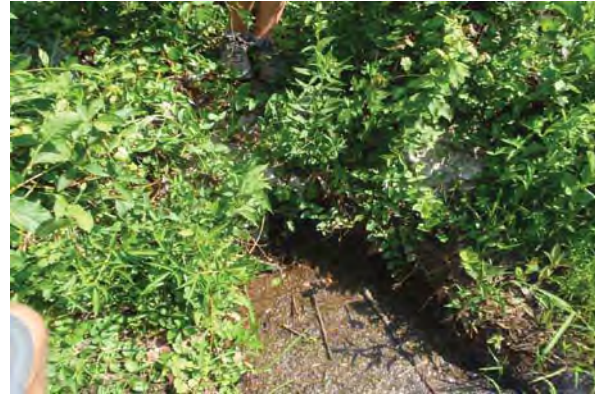
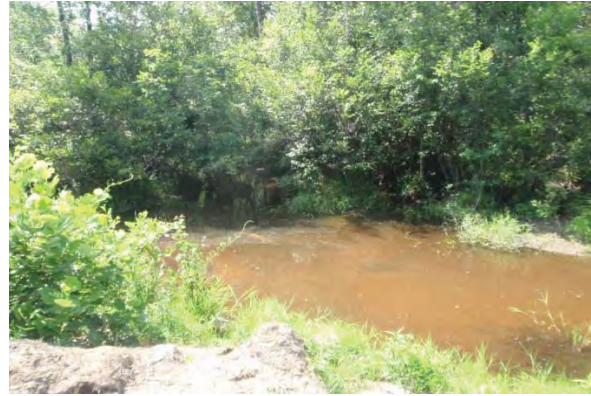
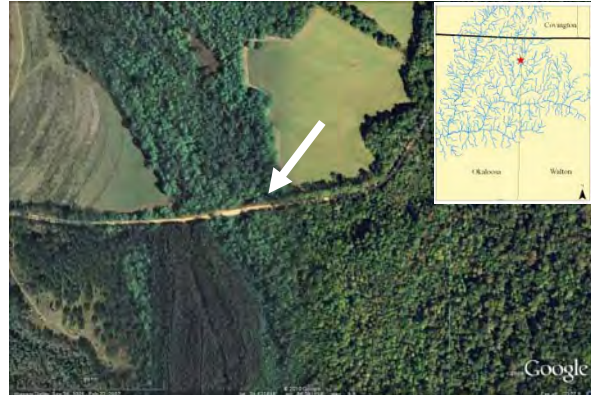
Crossing Structure: US

Risk Factor	Ranking	Score
<i>US Channel Morph</i>	DA	3
<i>DS Channel Morph</i>	DA	3
<i>DS Bank Alteration</i>	MINOR/PARTIAL	3
<i>Upstream Skew Angle</i>	>30°	1
<i>Crossing fill condition</i>	Good/Vegetated	5
<i>Inlet/Outlet Condition</i>	No Impairment	5
<i>Road Approach Material</i>	All Sand/Clay	3
<i>Potential Eroded Volume Mean</i>	>40 y <sup>3</sup>	1
<i>Approach Slope Mean</i>	<2%	5
<i>Soil K Factor</i>	<0.20	5
<i>Upstream Rt Outlet</i>	Vegetated	1
<i>Upstream Lt Outlet</i>	Vegetated	1
<i>Upstream Rt Ditch</i>	Bare soil	0
<i>Upstream Lt Ditch</i>	Bare soil	0
<i>Downstream Rt Outlet</i>	Vegetated	1
<i>Downstream Lt Outlet</i>	Vegetated	1
<i>Downstream Rt Ditch</i>	Bare soil	0
<i>Downstream Lt Ditch</i>	Synthetic	1
<i>Outlet Total</i>	Improved Outlet System	5
<i>Ditches Total</i>	Partially Improved Drainage System	3
<b>SRI Total</b>	<b>Medium Risk</b>	<b>42</b>

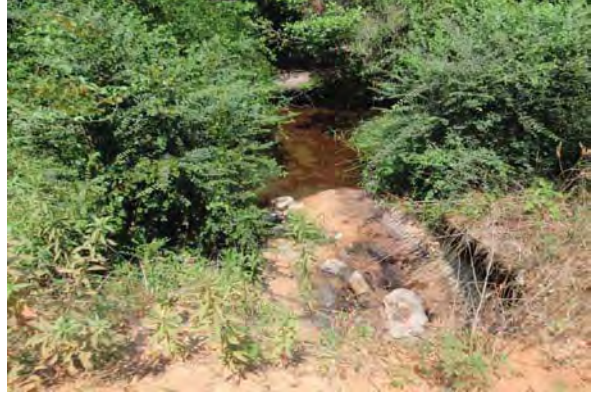
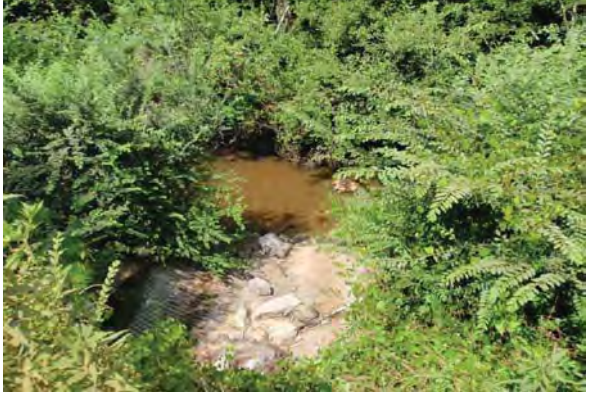
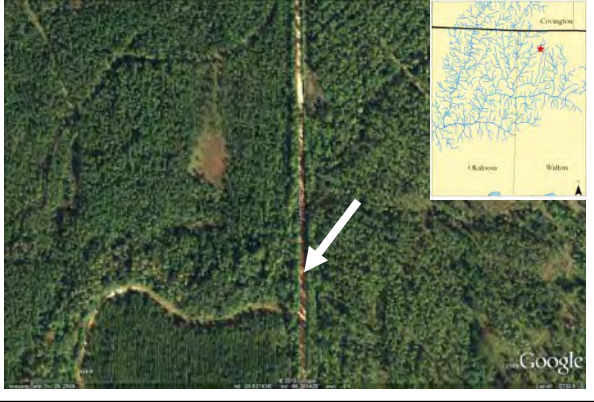
Crossing Structure: US

Risk Factor	Ranking	Score
<i>US Channel Morph</i>	WETLAND	5
<i>DS Channel Morph</i>	DA	3
<i>DS Bank Alteration</i>	HIGH	1
<i>Upstream Skew Angle</i>	<5°	5
<i>Crossing fill condition</i>	Fair/Rip Rap	3
<i>Inlet/Outlet Condition</i>	No Impairment	5
<i>Road Approach Material</i>	All Sand/Clay	3
<i>Potential Eroded Volume Mean</i>	<21 y <sup>3</sup>	5
<i>Approach Slope Mean</i>	<2%	5
<i>Soil K Factor</i>	<0.20	5
<i>Upstream Rt Outlet</i>	Vegetated	1
<i>Upstream Lt Outlet</i>	Vegetated	1
<i>Upstream Rt Ditch</i>	Bare soil	0
<i>Upstream Lt Ditch</i>	Bare soil	0
<i>Downstream Rt Outlet</i>	Vegetated	1
<i>Downstream Lt Outlet</i>	Vegetated	1
<i>Downstream Rt Ditch</i>	Bare soil	0
<i>Downstream Lt Ditch</i>	Bare soil	0
<i>Outlet Total</i>	Improved Outlet System	5
<i>Ditches Total</i>	Unimproved Drainage System	1
<b><i>SRI Total</i></b>	<b>Low Risk</b>	<b>42</b>
<b>Additional Site Features</b>		
<i>Crossing Type and Quantity:</i>	Culvert, 3

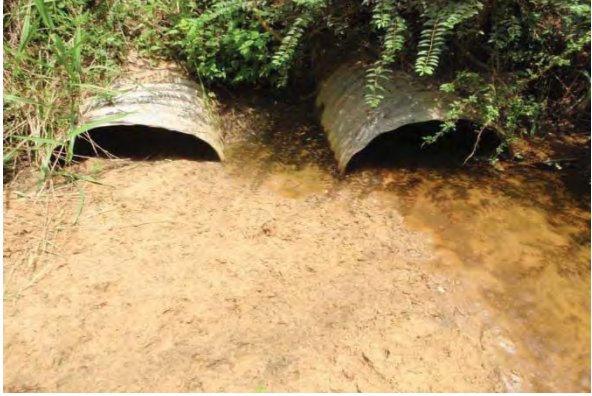
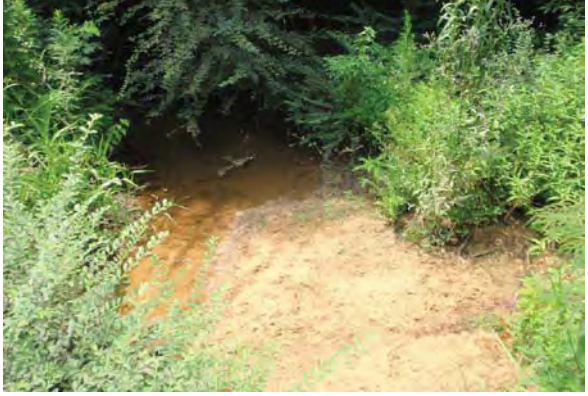
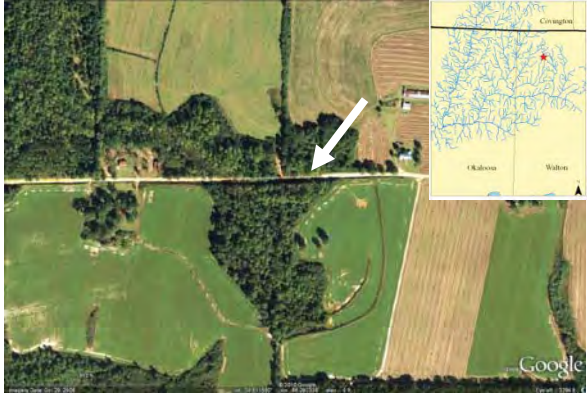
Crossing Structure: US

Risk Factor	Ranking	Score
<i>US Channel Morph</i>	C	5
<i>DS Channel Morph</i>	C	5
<i>DS Bank Alteration</i>	HIGH	1
<i>Upstream Skew Angle</i>	<5°	5
<i>Crossing fill condition</i>	Good/Vegetated	5
<i>Inlet/Outlet Condition</i>	Sed Islands/Scouring	3
<i>Road Approach Material</i>	All Sand/Clay	3
<i>Potential Eroded Volume Mean</i>	21-40 y <sup>3</sup>	3
<i>Approach Slope Mean</i>	2.1-4%	3
<i>Soil K Factor</i>	0.21-0.40	3
<i>Upstream Rt Outlet</i>	Vegetated	1
<i>Upstream Lt Outlet</i>	Vegetated	1
<i>Upstream Rt Ditch</i>	Bare soil	0
<i>Upstream Lt Ditch</i>	Bare soil	0
<i>Downstream Rt Outlet</i>	Vegetated	1
<i>Downstream Lt Outlet</i>	Vegetated	1
<i>Downstream Rt Ditch</i>	Bare soil	0
<i>Downstream Lt Ditch</i>	Bare soil	0
<i>Outlet Total</i>	Improved Outlet System	5
<i>Ditches Total</i>	Unimproved Drainage System	1
<b>SRI Total</b>	<b>Medium Risk</b>	<b>42</b>

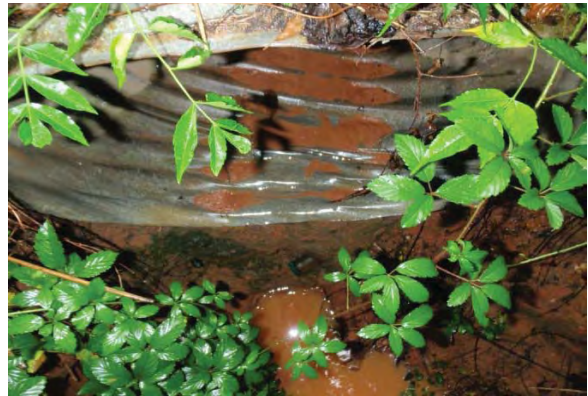
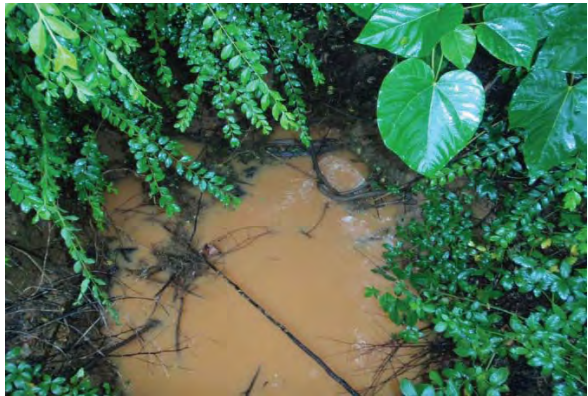
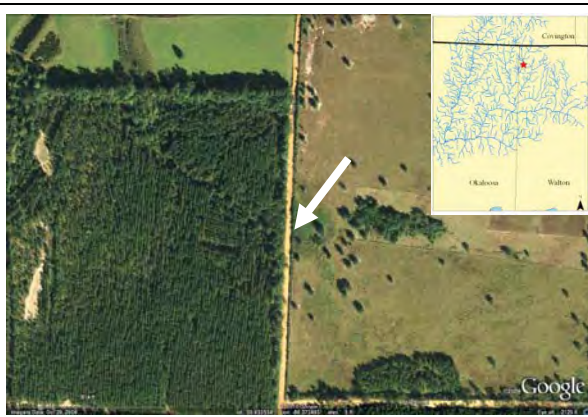
<b>Unnamed tributary</b>	<b>wa-0706-r-004</b>	<i>Sedimentation Risk Index</i> <b>42</b>
--------------------------	----------------------	--

Risk Factor	Ranking	Score
<i>US Channel Morph</i>	D	1
<i>DS Channel Morph</i>	DA	3
<i>DS Bank Alteration</i>	HIGH	1
<i>Upstream Skew Angle</i>	<5°	5
<i>Crossing fill condition</i>	Good/Vegetated	5
<i>Inlet/Outlet Condition</i>	No Impairment	5
<i>Road Approach Material</i>	All Sand/Clay	3
<i>Potential Eroded Volume Mean</i>	<21 y <sup>3</sup>	5
<i>Approach Slope Mean</i>	2.1-4%	3
<i>Soil K Factor</i>	<0.20	5
<i>Upstream Rt Outlet</i>	Vegetated	1
<i>Upstream Lt Outlet</i>	Vegetated	1
<i>Upstream Rt Ditch</i>	Bare soil	0
<i>Upstream Lt Ditch</i>	Bare soil	0
<i>Downstream Rt Outlet</i>	Vegetated	1
<i>Downstream Lt Outlet</i>	Vegetated	1
<i>Downstream Rt Ditch</i>	Bare soil	0
<i>Downstream Lt Ditch</i>	Bare soil	0
<i>Outlet Total</i>	Improved Outlet System	5
<i>Ditches Total</i>	Unimproved Drainage System	1
<b>SRI Total</b>	<b>Medium Risk</b>	<b>42</b>

Notes: DS outfall drop

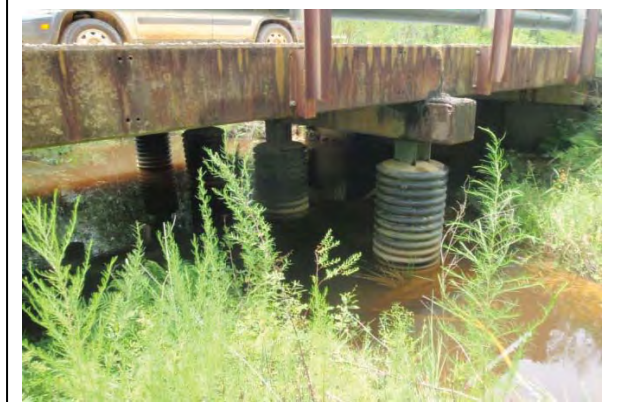
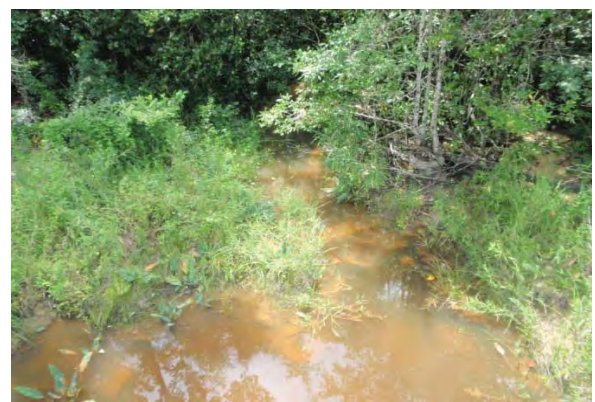
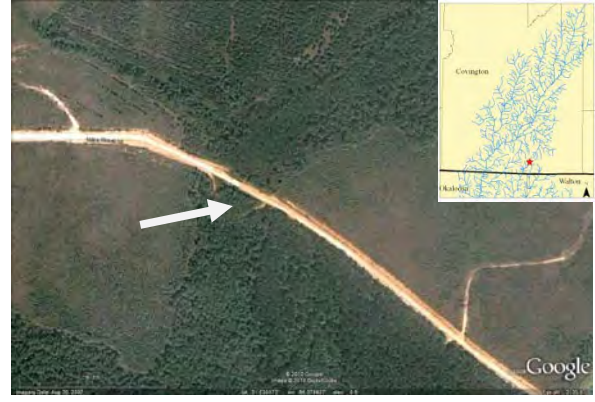
Unnamed tributary	co-0731-r-007	Sedimentation Risk Index <b>44</b>
-------------------	---------------	---------------------------------------

Risk Factor	Ranking	Score
<i>US Channel Morph</i>	C	5
<i>DS Channel Morph</i>	C	5
<i>DS Bank Alteration</i>	HIGH	1
<i>Upstream Skew Angle</i>	<5°	5
<i>Crossing fill condition</i>	Good/Vegetated	5
<i>Inlet/Outlet Condition</i>	No Impairment	5
<i>Road Approach Material</i>	All Sand/Clay	3
<i>Potential Eroded Volume Mean</i>	>40 y <sup>3</sup>	1
<i>Approach Slope Mean</i>	2.1-4%	3
<i>Soil K Factor</i>	<0.20	5
<i>Upstream Rt Outlet</i>	Vegetated	1
<i>Upstream Lt Outlet</i>	Vegetated	1
<i>Upstream Rt Ditch</i>	Bare soil	0
<i>Upstream Lt Ditch</i>	Bare soil	0
<i>Downstream Rt Outlet</i>	Vegetated	1
<i>Downstream Lt Outlet</i>	Vegetated	1
<i>Downstream Rt Ditch</i>	Bare soil	0
<i>Downstream Lt Ditch</i>	Bare soil	0
<i>Outlet Total</i>	Improved Outlet System	5
<i>Ditches Total</i>	Unimproved Drainage System	1
<b>SRI Total</b>	<b>Medium Risk</b>	<b>44</b>

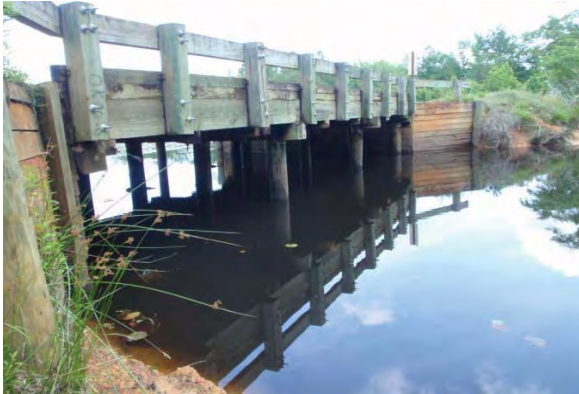
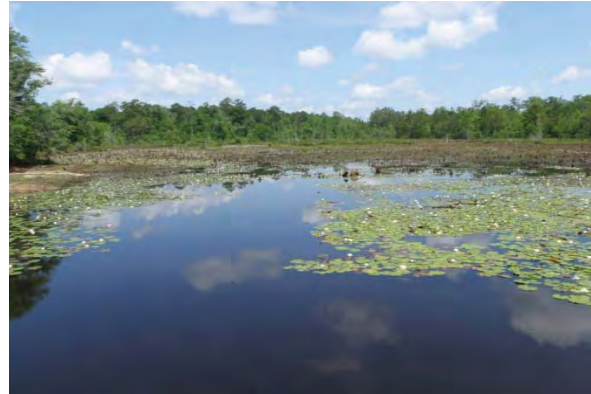
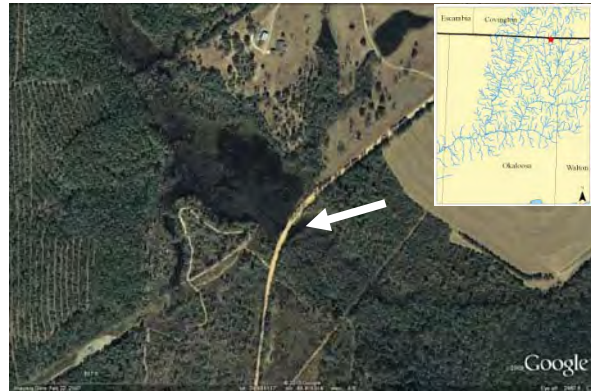
Unnamed tributary	ok-0528-r-001	Sedimentation Risk Index <b>44</b>
-------------------	---------------	---------------------------------------

Risk Factor	Ranking	Score
US Channel Morph	WETLAND	5
DS Channel Morph	DA	3
DS Bank Alteration	MINOR/PARTIAL	3
Upstream Skew Angle	<5°	5
Crossing fill condition	Good/Vegetated	5
Inlet/Outlet Condition	No Impairment	5
Road Approach Material	All Sand/Clay	3
Potential Eroded Volume Mean	>40 y <sup>3</sup>	1
Approach Slope Mean	>4%	1
Soil K Factor	<0.20	5
Upstream Rt Outlet	Vegetated	1
Upstream Lt Outlet	Vegetated	1
Upstream Rt Ditch	Vegetated	1
Upstream Lt Ditch	Vegetated	1
Downstream Rt Outlet	Bare soil	0
Downstream Lt Outlet	Vegetated	1
Downstream Rt Ditch	Vegetated	1
Downstream Lt Ditch	Vegetated	1
Outlet Total	Partially Improved Outlet System	3
Ditches Total	Improved Drainage System	5
<b>SRI Total</b>	<b>Medium Risk</b>	<b>44</b>

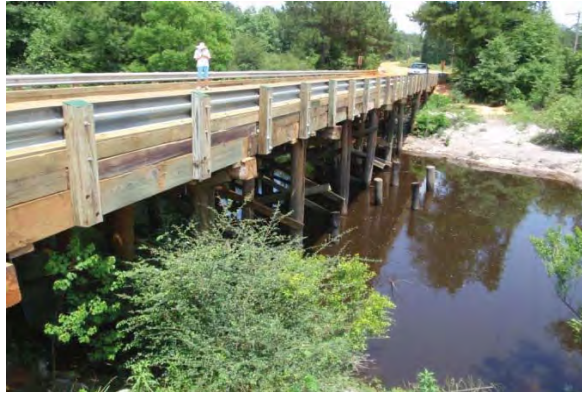
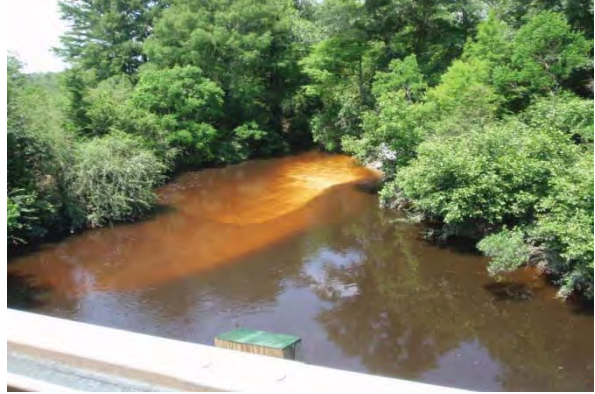
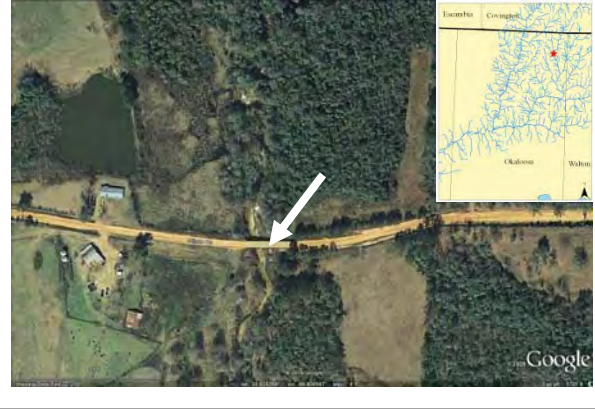
<h1>Horsehead Creek</h1>	<h2>ok-0528-r-004</h2>	<i>Sedimentation Risk Index</i> <b>44</b>
--------------------------	------------------------	--

Risk Factor	Ranking	Score
<i>US Channel Morph</i>	C	5
<i>DS Channel Morph</i>	C	5
<i>DS Bank Alteration</i>	MINOR/PARTIAL	3
<i>Upstream Skew Angle</i>	<5°	5
<i>Crossing fill condition</i>	Fair/Rip Rap	3
<i>Inlet/Outlet Condition</i>	No Impairment	5
<i>Road Approach Material</i>	All Sand/Clay	3
<i>Potential Eroded Volume Mean</i>	>40 y <sup>3</sup>	1
<i>Approach Slope Mean</i>	<2%	5
<i>Soil K Factor</i>	<0.20	5
<i>Upstream Rt Outlet</i>	Concrete	0
<i>Upstream Lt Outlet</i>	Rip Rap	1
<i>Upstream Rt Ditch</i>	Concrete	0
<i>Upstream Lt Ditch</i>	Bare soil	0
<i>Downstream Rt Outlet</i>	Rip Rap	1
<i>Downstream Lt Outlet</i>	Bare soil	0
<i>Downstream Rt Ditch</i>	Bare soil	0
<i>Downstream Lt Ditch</i>	Bare soil	0
<i>Outlet Total</i>	Partially Improved Outlet System	3
<i>Ditches Total</i>	Unimproved Drainage System	1
<b><i>SRI Total</i></b>	<b>Medium Risk</b>	<b>44</b>

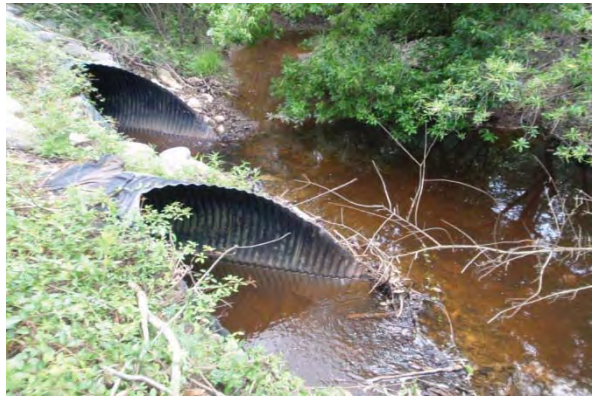
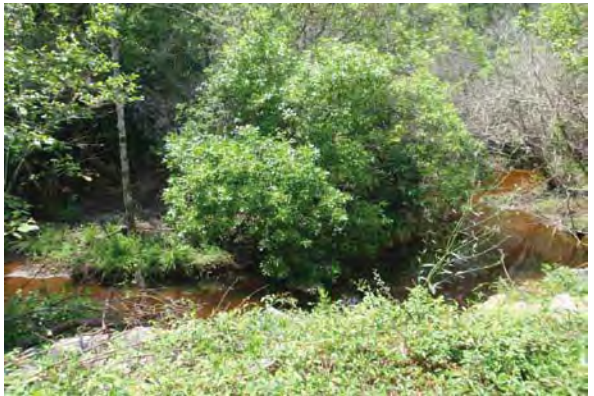
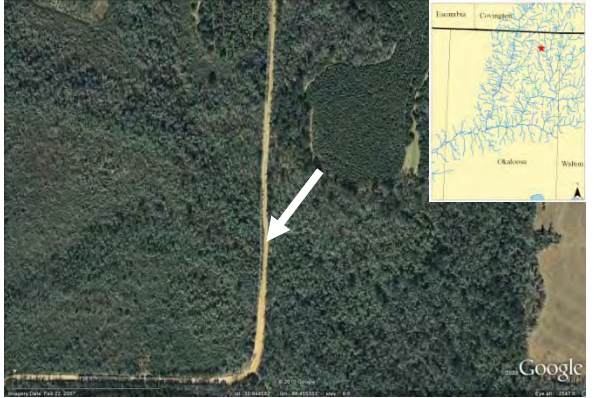
<h1 style="margin:0;">Green Branch</h1>	<h2 style="margin:0;">ok-0528-r-005</h2>	<i>Sedimentation Risk Index</i> <b style="font-size: 1.5em;">44</b>
---	--	--

Risk Factor	Ranking	Score
<i>US Channel Morph</i>	DA	3
<i>DS Channel Morph</i>	C	5
<i>DS Bank Alteration</i>	HIGH	1
<i>Upstream Skew Angle</i>	>30°	1
<i>Crossing fill condition</i>	Good/Vegetated	5
<i>Inlet/Outlet Condition</i>	No Impairment	5
<i>Road Approach Material</i>	All Sand/Clay	3
<i>Potential Eroded Volume Mean</i>	21-40 y <sup>3</sup>	3
<i>Approach Slope Mean</i>	<2%	5
<i>Soil K Factor</i>	<0.20	5
<i>Upstream Rt Outlet</i>	Rip Rap	1
<i>Upstream Lt Outlet</i>	Vegetated	1
<i>Upstream Rt Ditch</i>	Vegetated	1
<i>Upstream Lt Ditch</i>	Vegetated	1
<i>Downstream Rt Outlet</i>	Vegetated	1
<i>Downstream Lt Outlet</i>	Vegetated	1
<i>Downstream Rt Ditch</i>	Bare soil	0
<i>Downstream Lt Ditch</i>	Bare soil	0
<i>Outlet Total</i>	Improved Outlet System	5
<i>Ditches Total</i>	Partially Improved Drainage System	3
<b><i>SRI Total</i></b>	<b>Medium Risk</b>	<b>44</b>

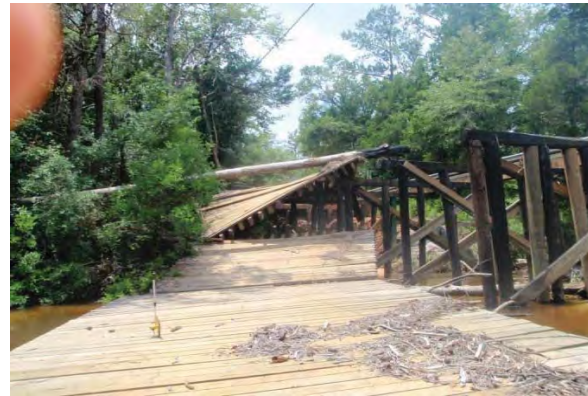
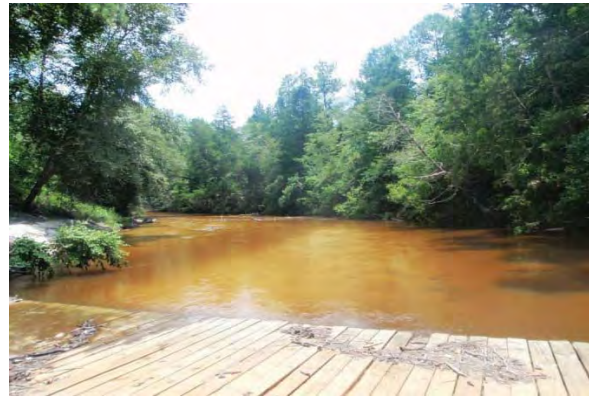
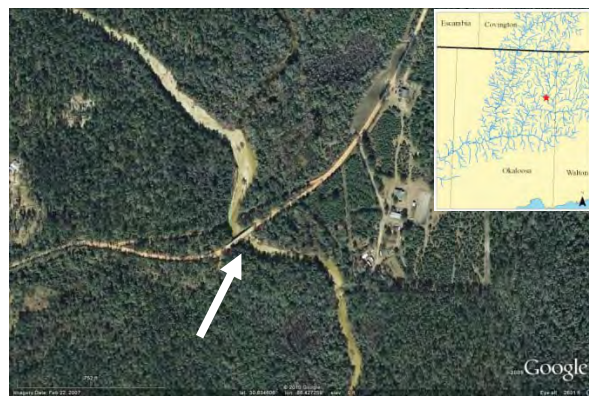
<b>Pond Creek</b>	<b>ok-0710-r-003</b>	<i>Sedimentation Risk Index</i> <b>44</b>
-------------------	----------------------	--

Risk Factor	Ranking	Score
<i>US Channel Morph</i>	E	5
<i>DS Channel Morph</i>	E	5
<i>DS Bank Alteration</i>	NATURAL	5
<i>Upstream Skew Angle</i>	<5°	5
<i>Crossing fill condition</i>	Good/Vegetated	5
<i>Inlet/Outlet Condition</i>	Blocked	1
<i>Road Approach Material</i>	All Sand/Clay	3
<i>Potential Eroded Volume Mean</i>	>40 y <sup>3</sup>	1
<i>Approach Slope Mean</i>	<2%	5
<i>Soil K Factor</i>	<0.20	5
<i>Upstream Rt Outlet</i>	Bare soil	0
<i>Upstream Lt Outlet</i>	Bare soil	0
<i>Upstream Rt Ditch</i>	Bare soil	0
<i>Upstream Lt Ditch</i>	Bare soil	0
<i>Downstream Rt Outlet</i>	Vegetated	1
<i>Downstream Lt Outlet</i>	Bare soil	0
<i>Downstream Rt Ditch</i>	Bare soil	0
<i>Downstream Lt Ditch</i>	Bare soil	0
<i>Outlet Total</i>	Partially Improved Outlet System	3
<i>Ditches Total</i>	Unimproved Drainage System	1
<b>SRI Total</b>	<b>Medium Risk</b>	<b>44</b>
<b>Additional Site Features</b>		
<u>Crossing Type and Quantity:</u>	Bridge, 1

Notes: Bridge blew out in March 2009 rainstorm; has not been repaired. 0.1 mi DS from Juniper Creek

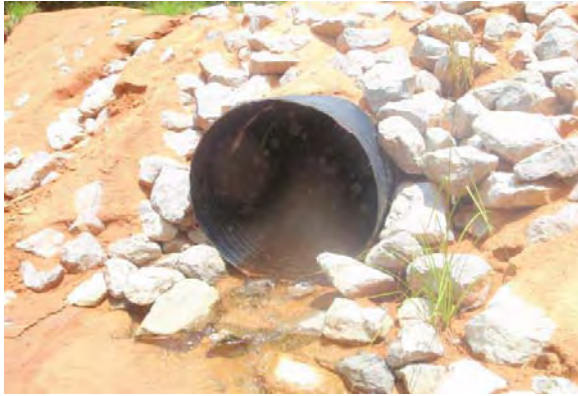
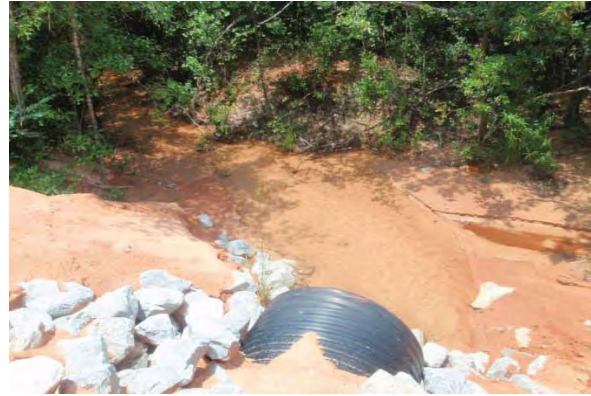
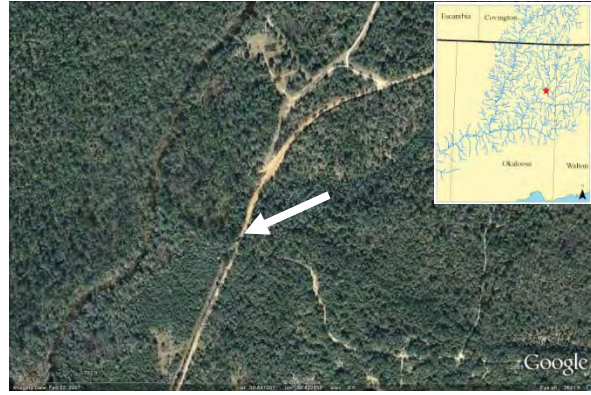
<b>Spring Branch</b>	<b>ok-0710-r-004</b>	<i>Sedimentation Risk Index</i> <b>44</b>
----------------------	----------------------	--

Risk Factor	Ranking	Score
<i>US Channel Morph</i>	E	5
<i>DS Channel Morph</i>	C	5
<i>DS Bank Alteration</i>	MINOR/PARTIAL	3
<i>Upstream Skew Angle</i>	<5°	5
<i>Crossing fill condition</i>	Fair/Rip Rap	3
<i>Inlet/Outlet Condition</i>	No Impairment	5
<i>Road Approach Material</i>	All Sand/Clay	3
<i>Potential Eroded Volume Mean</i>	21-40 y <sup>3</sup>	3
<i>Approach Slope Mean</i>	2.1-4%	3
<i>Soil K Factor</i>	<0.20	5
<i>Upstream Rt Outlet</i>	Bare soil	0
<i>Upstream Lt Outlet</i>	Vegetated	1
<i>Upstream Rt Ditch</i>	Bare soil	0
<i>Upstream Lt Ditch</i>	Bare soil	0
<i>Downstream Rt Outlet</i>	Bare soil	0
<i>Downstream Lt Outlet</i>	Bare soil	0
<i>Downstream Rt Ditch</i>	Bare soil	0
<i>Downstream Lt Ditch</i>	Bare soil	0
<i>Outlet Total</i>	Partially Improved Outlet System	3
<i>Ditches Total</i>	Unimproved Drainage System	1
<b>SRI Total</b>	<b>Medium Risk</b>	<b>44</b>
<b>Additional Site Features</b>		
<i>Crossing Type and Quantity:</i>	Culvert, 1

Notes: Lots of sediment loading. Outfall drop blocking fish passage

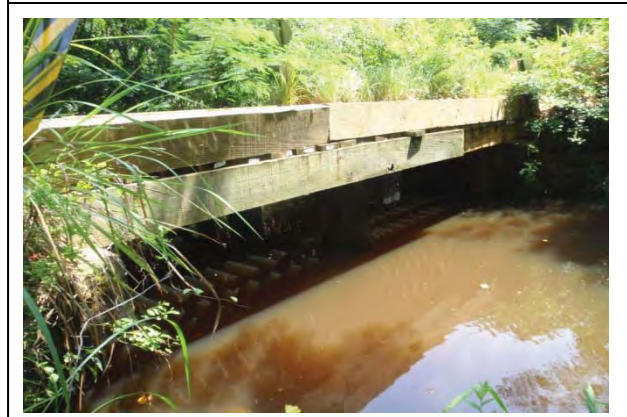
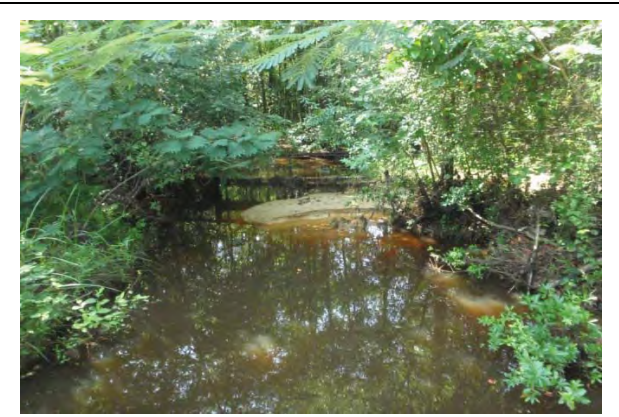
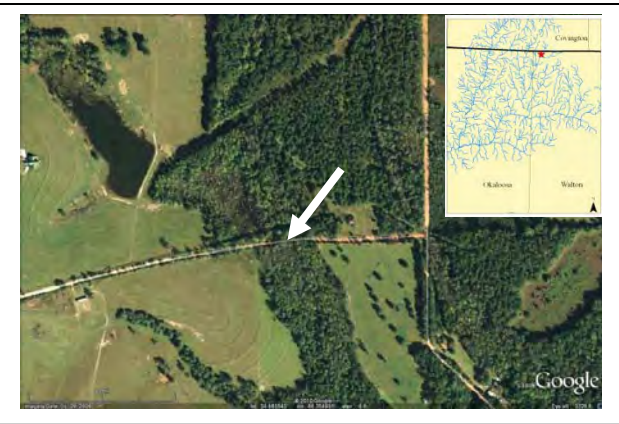
<b>Unnamed tributary</b>	<b>wa-0625-r-001</b>	<i>Sedimentation Risk Index</i> <b>44</b>
--------------------------	----------------------	--

Risk Factor	Ranking	Score
<i>US Channel Morph</i>	PONDED	1
<i>DS Channel Morph</i>	C	5
<i>DS Bank Alteration</i>	MINOR/PARTIAL	3
<i>Upstream Skew Angle</i>	<5°	5
<i>Crossing fill condition</i>	Good/Vegetated	5
<i>Inlet/Outlet Condition</i>	No Impairment	5
<i>Road Approach Material</i>	All Sand/Clay	3
<i>Potential Eroded Volume Mean</i>	<21 y <sup>3</sup>	5
<i>Approach Slope Mean</i>	2.1-4%	3
<i>Soil K Factor</i>	0.21-0.40	3
<i>Upstream Rt Outlet</i>	Vegetated	1
<i>Upstream Lt Outlet</i>	Vegetated	1
<i>Upstream Rt Ditch</i>	Bare soil	0
<i>Upstream Lt Ditch</i>	Bare soil	0
<i>Downstream Rt Outlet</i>	Vegetated	1
<i>Downstream Lt Outlet</i>	Vegetated	1
<i>Downstream Rt Ditch</i>	Bare soil	0
<i>Downstream Lt Ditch</i>	Bare soil	0
<i>Outlet Total</i>	Improved Outlet System	5
<i>Ditches Total</i>	Unimproved Drainage System	1
<b>SRI Total</b>	<b>Medium Risk</b>	<b>44</b>
<b>Additional Site Features</b>		
<i>Crossing Type and Quantity:</i>	Bridge, 1

Notes: Fencing across DS channel causing sediment buildup

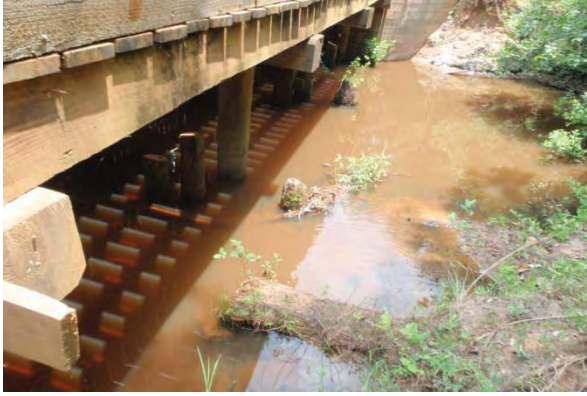
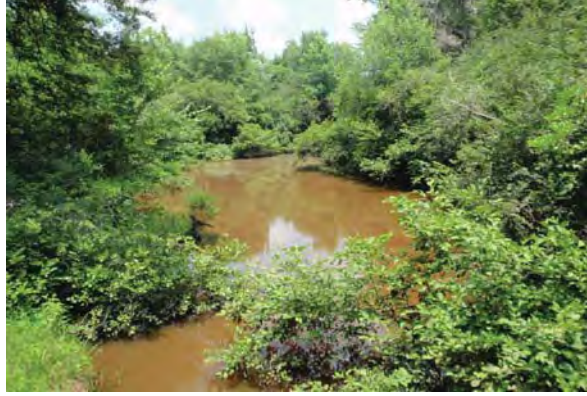
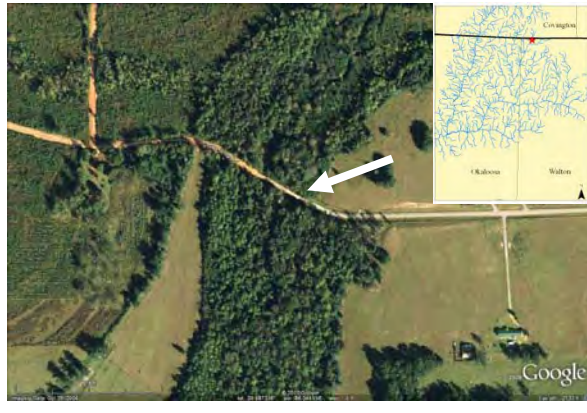
Pond Creek	wa-0625-r-005a	Sedimentation Risk Index <b>44</b>
------------	----------------	---------------------------------------

Risk Factor	Ranking	Score
<i>US Channel Morph</i>	DA	3
<i>DS Channel Morph</i>	DA	3
<i>DS Bank Alteration</i>	NATURAL	5
<i>Upstream Skew Angle</i>	<5°	5
<i>Crossing fill condition</i>	Poor/Bare soil	1
<i>Inlet/Outlet Condition</i>	No Impairment	5
<i>Road Approach Material</i>	All Aggregate	5
<i>Potential Eroded Volume Mean</i>	<21 y <sup>3</sup>	5
<i>Approach Slope Mean</i>	>4%	1
<i>Soil K Factor</i>	<0.20	5
<i>Upstream Rt Outlet</i>	Vegetated	1
<i>Upstream Lt Outlet</i>	Vegetated	1
<i>Upstream Rt Ditch</i>	Vegetated	1
<i>Upstream Lt Ditch</i>	Bare soil	0
<i>Downstream Rt Outlet</i>	Bare soil	0
<i>Downstream Lt Outlet</i>	Vegetated	1
<i>Downstream Rt Ditch</i>	Vegetated	1
<i>Downstream Lt Ditch</i>	Vegetated	1
<i>Outlet Total</i>	Partially Improved Outlet System	3
<i>Ditches Total</i>	Partially Improved Drainage System	3
<b>SRI Total</b>	<b>Medium Risk</b>	<b>44</b>

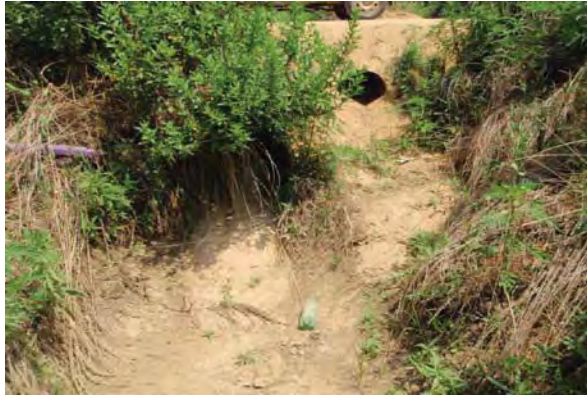
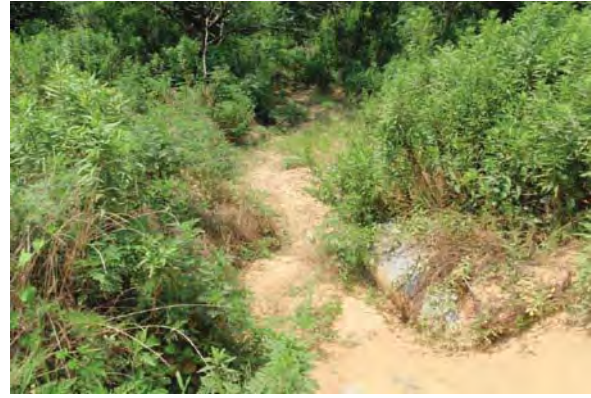
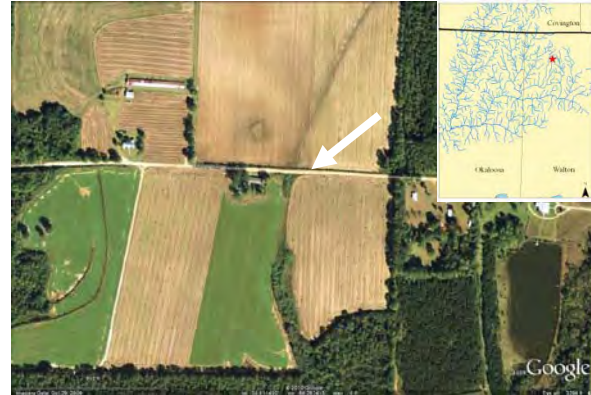
Little Creek	wa-0626-r-002	Sedimentation Risk Index <b>44</b>
--------------	---------------	---------------------------------------

Risk Factor	Ranking	Score
<i>US Channel Morph</i>	C	5
<i>DS Channel Morph</i>	C	5
<i>DS Bank Alteration</i>	MINOR/PARTIAL	3
<i>Upstream Skew Angle</i>	<5°	5
<i>Crossing fill condition</i>	Poor/Bare soil	1
<i>Inlet/Outlet Condition</i>	No Impairment	5
<i>Road Approach Material</i>	All Sand/Clay	3
<i>Potential Eroded Volume Mean</i>	21-40 y <sup>3</sup>	3
<i>Approach Slope Mean</i>	<2%	5
<i>Soil K Factor</i>	0.21-0.40	3
<i>Upstream Rt Outlet</i>	Vegetated	1
<i>Upstream Lt Outlet</i>	Vegetated	1
<i>Upstream Rt Ditch</i>	Bare soil	0
<i>Upstream Lt Ditch</i>	Bare soil	0
<i>Downstream Rt Outlet</i>	Vegetated	1
<i>Downstream Lt Outlet</i>	Vegetated	1
<i>Downstream Rt Ditch</i>	Bare soil	0
<i>Downstream Lt Ditch</i>	Bare soil	0
<i>Outlet Total</i>	Improved Outlet System	5
<i>Ditches Total</i>	Unimproved Drainage System	1
<b>SRI Total</b>	<b>Medium Risk</b>	<b>44</b>

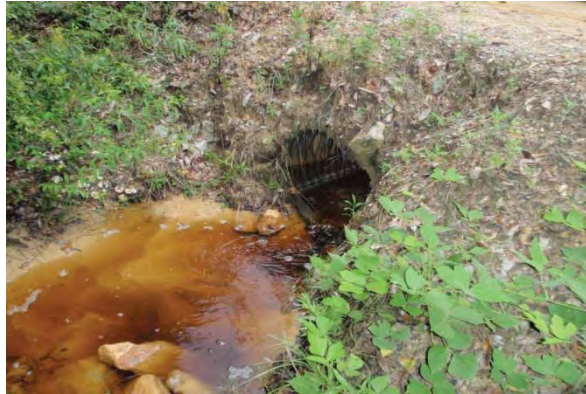
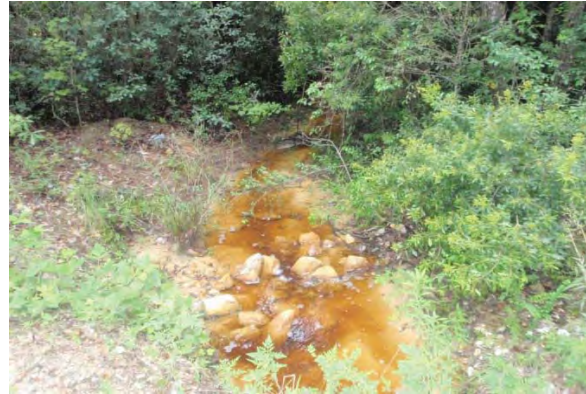
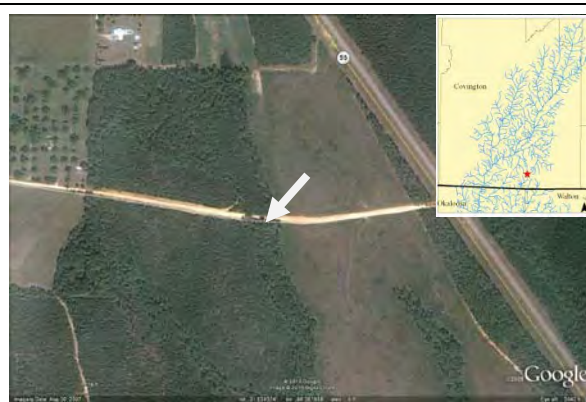
Unnamed tributary	co-0731-r-009	Sedimentation Risk Index <b>46</b>
-------------------	---------------	---------------------------------------

Risk Factor	Ranking	Score
US Channel Morph	E	5
DS Channel Morph	E	5
DS Bank Alteration	MINOR/PARTIAL	3
Upstream Skew Angle	<5°	5
Crossing fill condition	Poor/Bare soil	1
Inlet/Outlet Condition	No Impairment	5
Road Approach Material	All Native Soil	1
Potential Eroded Volume Mean	<21 y <sup>3</sup>	5
Approach Slope Mean	2.1-4%	3
Soil K Factor	<0.20	5
Upstream Rt Outlet	Vegetated	1
Upstream Lt Outlet	Vegetated	1
Upstream Rt Ditch	Vegetated	1
Upstream Lt Ditch	Vegetated	1
Downstream Rt Outlet	Vegetated	1
Downstream Lt Outlet	Vegetated	1
Downstream Rt Ditch	Bare soil	0
Downstream Lt Ditch	Bare soil	0
Outlet Total	Improved Outlet System	5
Ditches Total	Partially Improved Drainage System	3
<b>SRI Total</b>	<b>Low Risk</b>	<b>46</b>
<b>Additional Site Features</b>		
<u>Crossing Type and Quantity:</u>	Culvert, 1	
<u>Crossing Materials:</u>	Metal	
<u>Soil Types:</u>	CdC,DmB,MBA,OrB	
<u>Rt Approach Prism Fill:</u>	0.25in	
<u>Lt Approach Prism Fill:</u>	0.2in

Notes: Rip rap in stream bed.

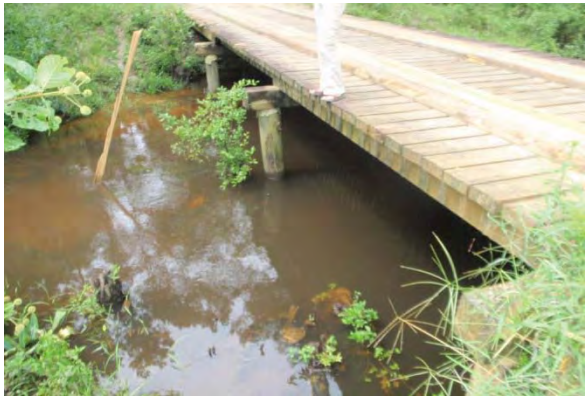
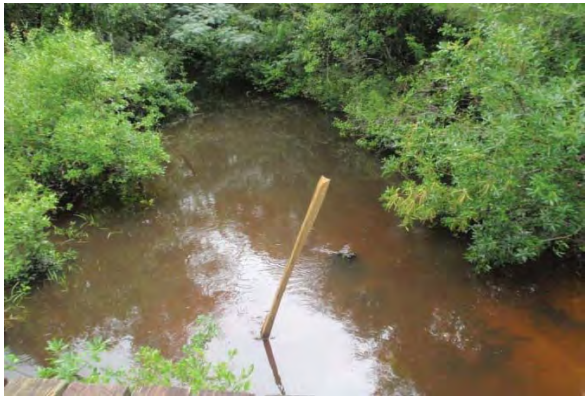
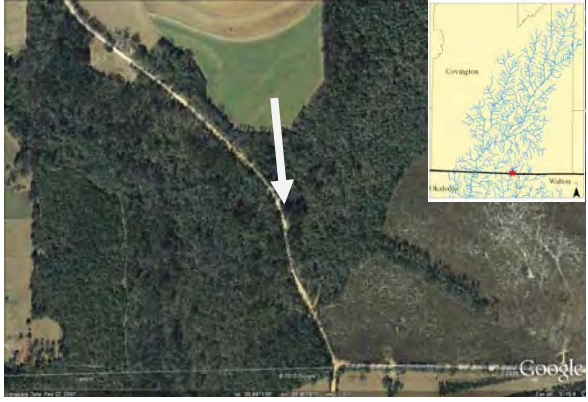
<h1>Horsehead Creek</h1>	<h2>co-0731-r-012</h2>	<i>Sedimentation Risk Index</i> <b>46</b>
--------------------------	------------------------	--

Risk Factor	Ranking	Score
<i>US Channel Morph</i>	DA	3
<i>DS Channel Morph</i>	C	5
<i>DS Bank Alteration</i>	MINOR/PARTIAL	3
<i>Upstream Skew Angle</i>	<5°	5
<i>Crossing fill condition</i>	Fair/Rip Rap	3
<i>Inlet/Outlet Condition</i>	No Impairment	5
<i>Road Approach Material</i>	All Sand/Clay	3
<i>Potential Eroded Volume Mean</i>	<21 y <sup>3</sup>	5
<i>Approach Slope Mean</i>	>4%	1
<i>Soil K Factor</i>	<0.20	5
<i>Upstream Rt Outlet</i>	Vegetated	1
<i>Upstream Lt Outlet</i>	Vegetated	1
<i>Upstream Rt Ditch</i>	Synthetic	1
<i>Upstream Lt Ditch</i>	Bare soil	0
<i>Downstream Rt Outlet</i>	Vegetated	1
<i>Downstream Lt Outlet</i>	Vegetated	1
<i>Downstream Rt Ditch</i>	Bare soil	0
<i>Downstream Lt Ditch</i>	Bare soil	0
<i>Outlet Total</i>	Improved Outlet System	5
<i>Ditches Total</i>	Partially Improved Drainage System	3
<b><i>SRI Total</i></b>	<b>Low Risk</b>	<b>46</b>

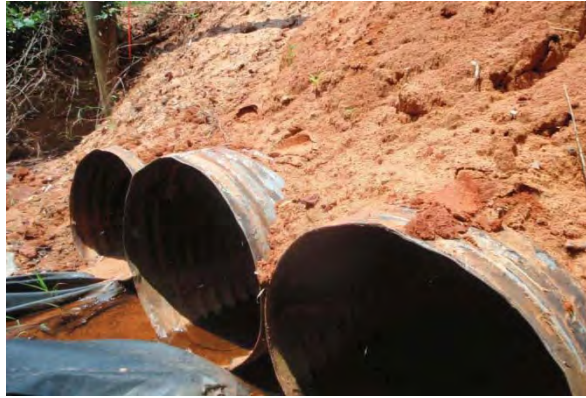
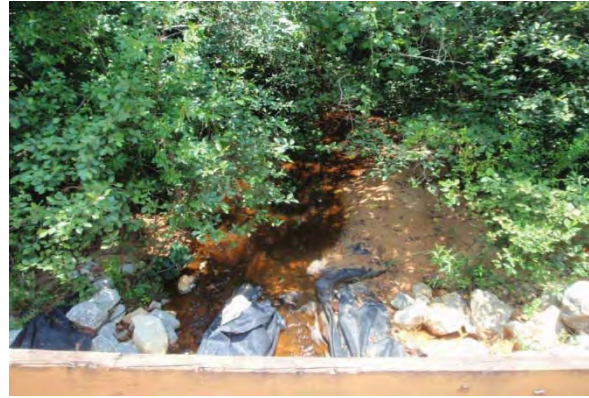
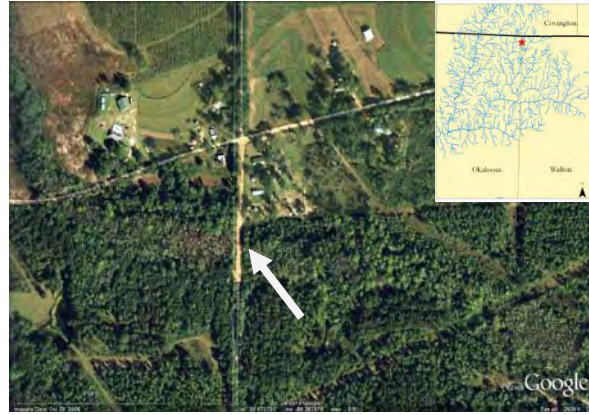
Unnamed tributary	wa-0625-r-004	Sedimentation Risk Index <b>46</b>
-------------------	---------------	---------------------------------------

Risk Factor	Ranking	Score
<i>US Channel Morph</i>	WETLAND	5
<i>DS Channel Morph</i>	C	5
<i>DS Bank Alteration</i>	MINOR/PARTIAL	3
<i>Upstream Skew Angle</i>	<5o	5
<i>Crossing fill condition</i>	Fair/Rip Rap	3
<i>Inlet/Outlet Condition</i>	Sed Islands/Scouring	3
<i>Road Approach Material</i>	All Sand/Clay	3
<i>Potential Eroded Volume Mean</i>	21-40 y3	3
<i>Approach Slope Mean</i>	<2%	5
<i>Soil K Factor</i>	<0.20	5
<i>Upstream Rt Outlet</i>	Vegetated	1
<i>Upstream Lt Outlet</i>	Vegetated	1
<i>Upstream Rt Ditch</i>	Bare soil	0
<i>Upstream Lt Ditch</i>	Bare soil	0
<i>Downstream Rt Outlet</i>	Vegetated	1
<i>Downstream Lt Outlet</i>	Vegetated	1
<i>Downstream Rt Ditch</i>	Bare soil	0
<i>Downstream Lt Ditch</i>	Bare soil	0
<i>Outlet Total</i>	Improved Outlet System	5
<i>Ditches Total</i>	Unimproved Drainage System	1
<b>SRI Total</b>	<b>Low Risk</b>	<b>46</b>

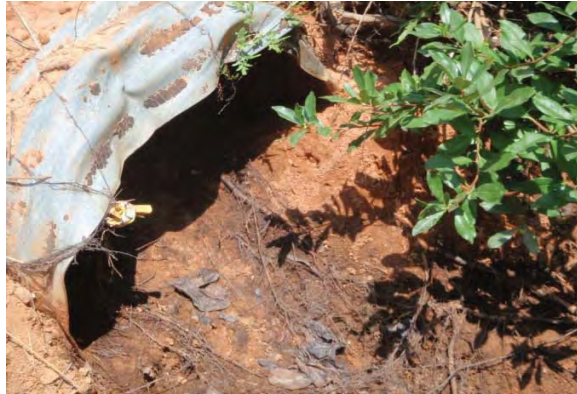
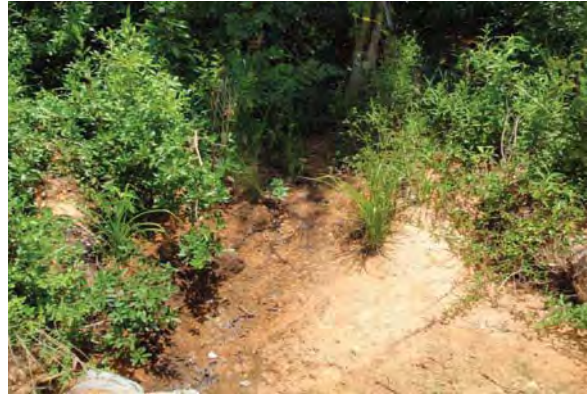
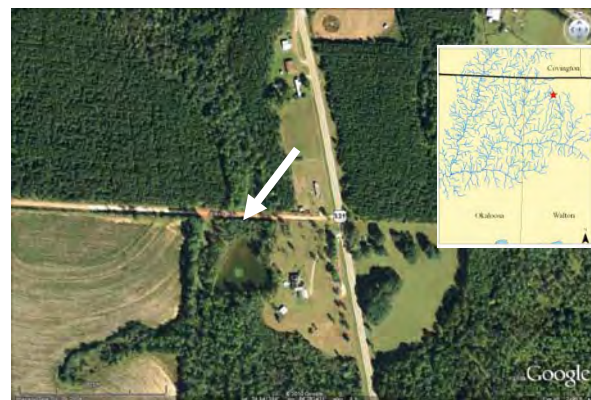
Unnamed tributary	wa-0626-r-006	Sedimentation Risk Index <b>46</b>
-------------------	---------------	---------------------------------------

Risk Factor	Ranking	Score
<i>US Channel Morph</i>	C	5
<i>DS Channel Morph</i>	PONDED	1
<i>DS Bank Alteration</i>	MINOR/PARTIAL	3
<i>Upstream Skew Angle</i>	<5°	5
<i>Crossing fill condition</i>	Poor/Bare soil	1
<i>Inlet/Outlet Condition</i>	No Impairment	5
<i>Road Approach Material</i>	All Sand/Clay	3
<i>Potential Eroded Volume Mean</i>	<21 y <sup>3</sup>	5
<i>Approach Slope Mean</i>	<2%	5
<i>Soil K Factor</i>	<0.20	5
<i>Upstream Rt Outlet</i>	Vegetated	1
<i>Upstream Lt Outlet</i>	Vegetated	1
<i>Upstream Rt Ditch</i>	Vegetated	1
<i>Upstream Lt Ditch</i>	Bare soil	0
<i>Downstream Rt Outlet</i>	Vegetated	1
<i>Downstream Lt Outlet</i>	Vegetated	1
<i>Downstream Rt Ditch</i>	Vegetated	1
<i>Downstream Lt Ditch</i>	Bare soil	0
<i>Outlet Total</i>	Improved Outlet System	5
<i>Ditches Total</i>	Partially Improved Drainage System	3
<b>SRI Total</b>	<b>Low Risk</b>	<b>46</b>

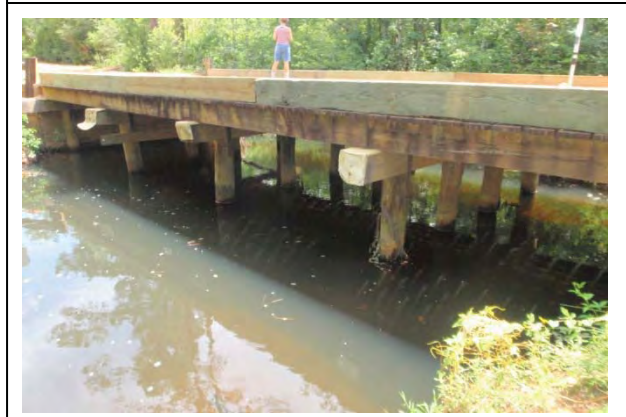
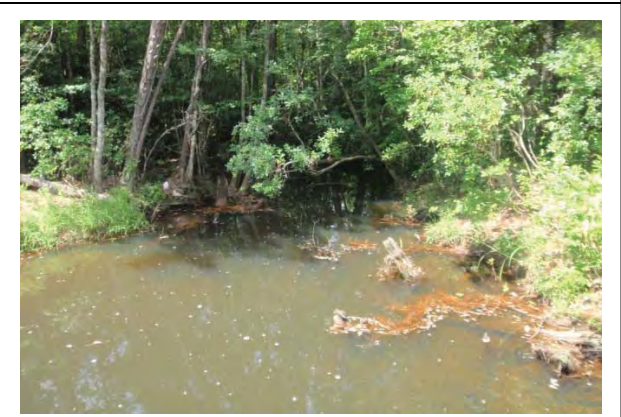
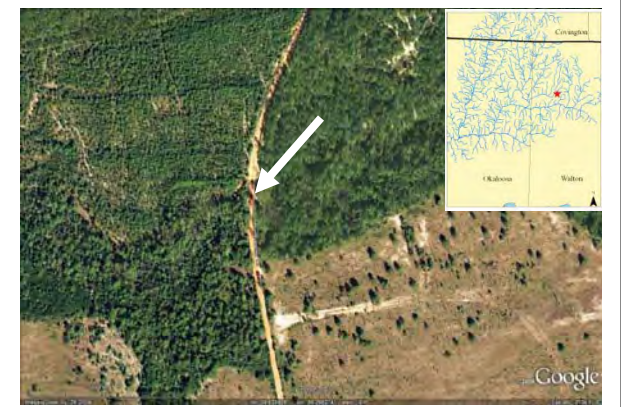
<h1>Big Branch</h1>	<h2>wa-0722-r-001</h2>	<i>Sedimentation Risk Index</i> <b>46</b>
---------------------	------------------------	--

Risk Factor	Ranking	Score
<i>US Channel Morph</i>	DA	3
<i>DS Channel Morph</i>	C	5
<i>DS Bank Alteration</i>	NATURAL	5
<i>Upstream Skew Angle</i>	<5°	5
<i>Crossing fill condition</i>	Fair/Rip Rap	3
<i>Inlet/Outlet Condition</i>	No Impairment	5
<i>Road Approach Material</i>	All Sand/Clay	3
<i>Potential Eroded Volume Mean</i>	<21 y <sup>3</sup>	5
<i>Approach Slope Mean</i>	>4%	1
<i>Soil K Factor</i>	<0.20	5
<i>Upstream Rt Outlet</i>	Vegetated	1
<i>Upstream Lt Outlet</i>	Vegetated	1
<i>Upstream Rt Ditch</i>	Bare soil	0
<i>Upstream Lt Ditch</i>	Bare soil	0
<i>Downstream Rt Outlet</i>	Vegetated	1
<i>Downstream Lt Outlet</i>	Vegetated	1
<i>Downstream Rt Ditch</i>	Bare soil	0
<i>Downstream Lt Ditch</i>	Bare soil	0
<i>Outlet Total</i>	Improved Outlet System	5
<i>Ditches Total</i>	Unimproved Drainage System	1
<b><i>SRI Total</i></b>	<b>Low Risk</b>	<b>46</b>

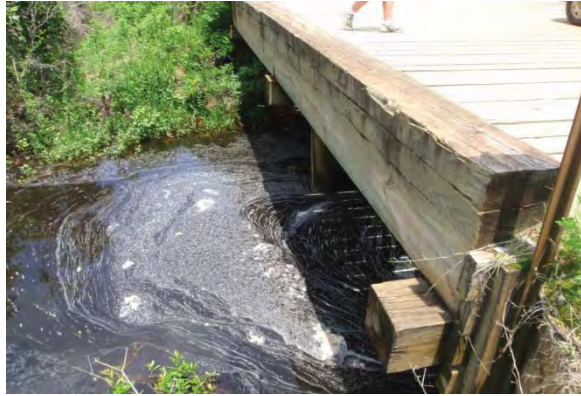
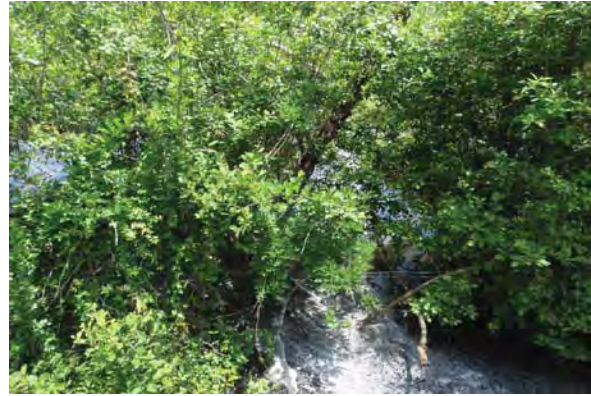
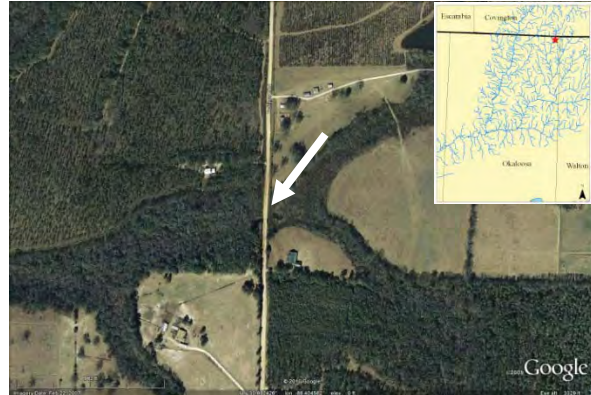
Unnamed tributary	ok-0528-r-003	Sedimentation Risk Index <b>48</b>
-------------------	---------------	---------------------------------------

Risk Factor	Ranking	Score
<i>US Channel Morph</i>	BEAVER DAM	3
<i>DS Channel Morph</i>	DA	3
<i>DS Bank Alteration</i>	MINOR/PARTIAL	3
<i>Upstream Skew Angle</i>	<5°	5
<i>Crossing fill condition</i>	Good/Vegetated	5
<i>Inlet/Outlet Condition</i>	No Impairment	5
<i>Road Approach Material</i>	All Sand/Clay	3
<i>Potential Eroded Volume Mean</i>	21-40 y <sup>3</sup>	3
<i>Approach Slope Mean</i>	2.1-4%	3
<i>Soil K Factor</i>	<0.20	5
<i>Upstream Rt Outlet</i>	Vegetated	1
<i>Upstream Lt Outlet</i>	Vegetated	1
<i>Upstream Rt Ditch</i>	Vegetated	1
<i>Upstream Lt Ditch</i>	Vegetated	1
<i>Downstream Rt Outlet</i>	Vegetated	1
<i>Downstream Lt Outlet</i>	Vegetated	1
<i>Downstream Rt Ditch</i>	Vegetated	1
<i>Downstream Lt Ditch</i>	Vegetated	1
<i>Outlet Total</i>	Improved Outlet System	5
<i>Ditches Total</i>	Improved Drainage System	5
<b>SRI Total</b>	<b>Low Risk</b>	<b>48</b>

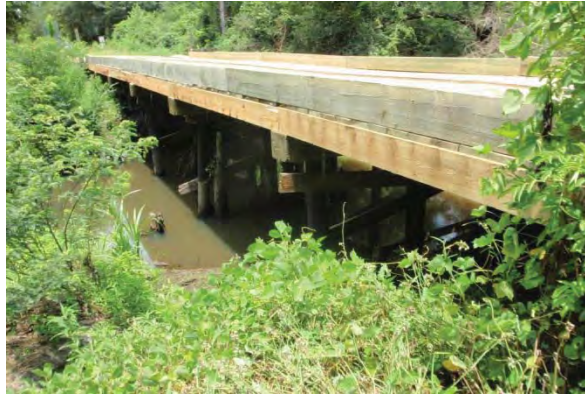
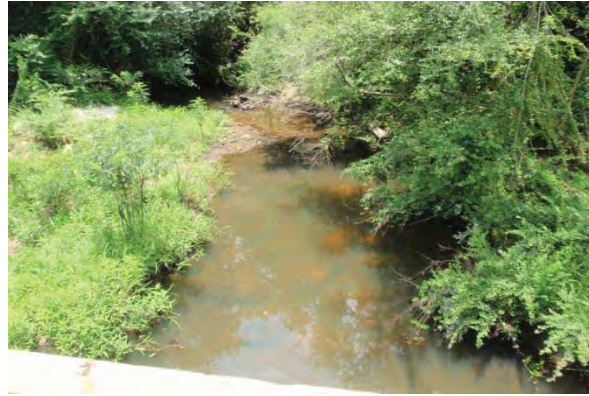
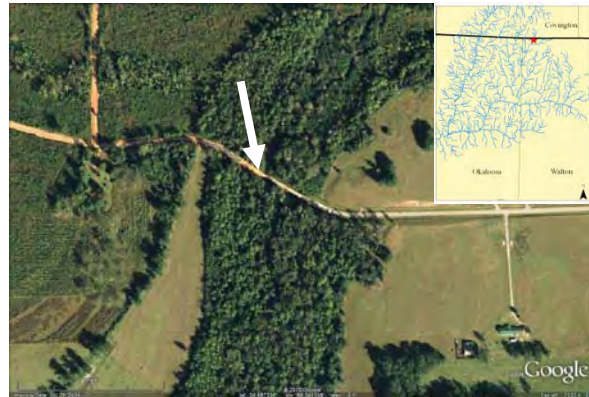
<b>Pond Creek</b>	<b>wa-0625-r-005b</b>	<i>Sedimentation Risk Index</i> <b>48</b>
-------------------	-----------------------	--

Risk Factor	Ranking	Score
<i>US Channel Morph</i>	DA	3
<i>DS Channel Morph</i>	DA	3
<i>DS Bank Alteration</i>	NATURAL	5
<i>Upstream Skew Angle</i>	<5°	5
<i>Crossing fill condition</i>	Good/Vegetated	5
<i>Inlet/Outlet Condition</i>	No Impairment	5
<i>Road Approach Material</i>	All Aggregate	5
<i>Potential Eroded Volume Mean</i>	<21 y <sup>3</sup>	5
<i>Approach Slope Mean</i>	>4%	1
<i>Soil K Factor</i>	<0.20	5
<i>Upstream Rt Outlet</i>	Vegetated	1
<i>Upstream Lt Outlet</i>	Vegetated	1
<i>Upstream Rt Ditch</i>	Vegetated	1
<i>Upstream Lt Ditch</i>	Bare soil	0
<i>Downstream Rt Outlet</i>	Bare soil	0
<i>Downstream Lt Outlet</i>	Vegetated	1
<i>Downstream Rt Ditch</i>	Vegetated	1
<i>Downstream Lt Ditch</i>	Vegetated	1
<i>Outlet Total</i>	Partially Improved Outlet System	3
<i>Ditches Total</i>	Partially Improved Drainage System	3
<b>SRI Total</b>	<b>Low Risk</b>	<b>48</b>
<b>Additional Site Features</b>		
<i>Crossing Type and Quantity:</i>	Bridge, 1

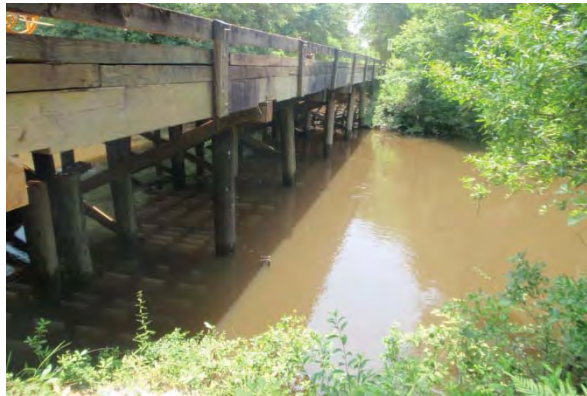
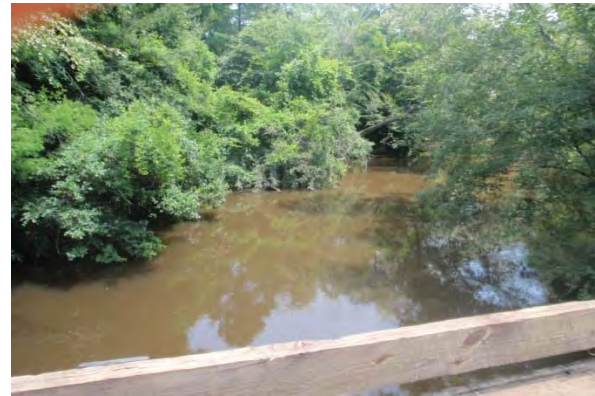
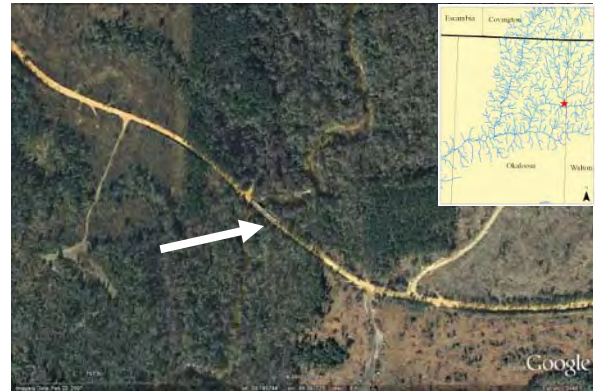
<h1>Pond Creek</h1>	<h2>ok-0710-r-002</h2>	<i>Sedimentation Risk Index</i> <b>50</b>
---------------------	------------------------	--

Risk Factor	Ranking	Score
<i>US Channel Morph</i>	C	5
<i>DS Channel Morph</i>	C	5
<i>DS Bank Alteration</i>	NATURAL	5
<i>Upstream Skew Angle</i>	<5°	5
<i>Crossing fill condition</i>	Good/Vegetated	5
<i>Inlet/Outlet Condition</i>	No Impairment	5
<i>Road Approach Material</i>	All Sand/Clay	3
<i>Potential Eroded Volume Mean</i>	<21 y <sup>3</sup>	5
<i>Approach Slope Mean</i>	2.1-4%	3
<i>Soil K Factor</i>	<0.20	5
<i>Upstream Rt Outlet</i>	Bare soil	0
<i>Upstream Lt Outlet</i>	Vegetated	1
<i>Upstream Rt Ditch</i>	Bare soil	0
<i>Upstream Lt Ditch</i>	Bare soil	0
<i>Downstream Rt Outlet</i>	Vegetated	1
<i>Downstream Lt Outlet</i>	Vegetated	1
<i>Downstream Rt Ditch</i>	Bare soil	0
<i>Downstream Lt Ditch</i>	Bare soil	0
<i>Outlet Total</i>	Partially Improved Outlet System	3
<i>Ditches Total</i>	Unimproved Drainage System	1
<b><i>SRI Total</i></b>	<b>Low Risk</b>	<b>50</b>
<b>Additional Site Features</b>		
<i>Crossing Type and Quantity:</i>	Bridge, 1

Notes: Small foot path DS Lt floodplain.

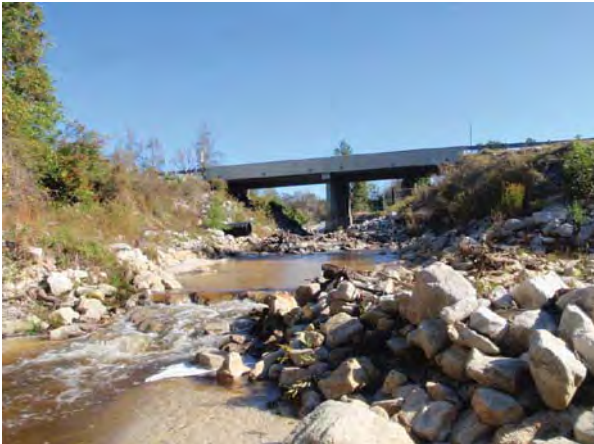
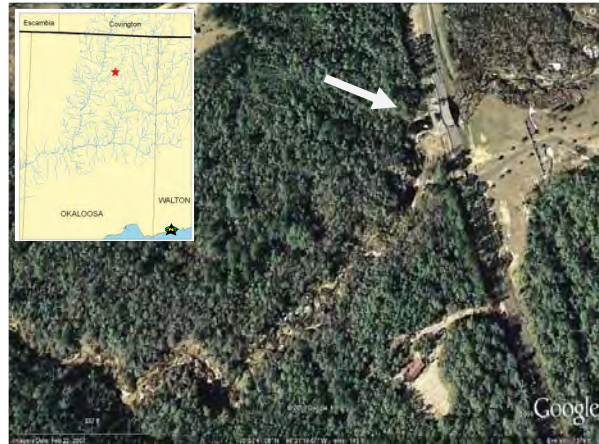
<b>Murder Creek</b>	<b>ok-1105-001</b>	<i>Severity Score</i> <b>12.5</b>
---------------------	--------------------	--------------------------------------

Risk Factor	Ranking	Score	Feature	Within Range	Descriptive Field
<i>Channel Stability</i>	Fair	1	303(d)	Yes	COLIFORMS, DISSOLVED OXYGEN
<i>Channel Alteration</i>	In Recovery	1	Wetland Species	No	N/A
<i>Bank Erosion</i>	Active	1.5	Rare and Imperiled	Yes	BLACKTIP SHINER IRONCOLOR SHINER
<i>BEHI</i>	High	1	Land Use/ Cover	Yes	AGRICULTURAL/ WETLAND FORESTED MIX
<i>Local NPSP</i>	Moderate Potential	1	Candidate Mussels	No	N/A
<i>Shoring Structures</i>	Present	1.5	Sturgeon C.H.	No	N/A
<i>Pipe Discharge</i>	Present	1.5	<b>Additional Site Features</b>		
<i>Water Odors</i>	Not Present	0	<i>Stream Channel Woody Material:</i> Infrequent		
<i>Fish Passage Barrier</i>	Present	1.5	<i>Impoundments:</i> Manmade (Fence and Rip Rap)		
<i>RB: Riparian Buffer</i>	100+ft	0.75	<i>Substrate Composition:</i> Medium Sand		
<i>LB: Riparian Buffer</i>	0-29 ft	0.75	<i>Bank Material:</i> Sand and Clay		
<i>RB: Floodplain Access</i>	Full	0.75

<i>LB: Floodplain Access</i>	None	0.25			
<b>River Threat Index:</b>		<b>12.5</b>

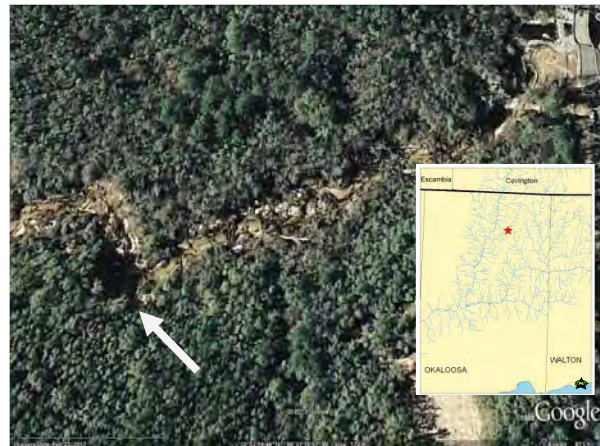
LB

Risk Factor	Ranking	Score	Feature	Within Range	Descriptive Field
<i>Channel Stability</i>	Poor	1.5	303(d)	Yes	COLIFORMS, DISSOLVED OXYGEN
<i>Channel Alteration</i>	None	0	Wetland Species	No	N/A
<i>Bank Erosion</i>	Mass- Wasting	1.5	Rare and Imperiled	Yes	BLACKTIP SHINER, IRONCOLOR SHINER
<i>BEHI</i>	Extreme- Very High	1.5	Land Use/ Cover	Yes	AGRICULTURAL/ STREAMS AND WATERWAYS
<i>Local NPSP</i>	None	0	Candidate Mussels	No	N/A
<i>Shoring Structures</i>	Not Present	0	Sturgeon C.H.	No	N/A
<i>Pipe Discharge</i>	Not Present	0	<b>Additional Site Features</b>		
<i>Water Odors</i>	Not Present	0	<i>Stream Channel Woody Material:</i> Extensive		
<i>Fish Passage Barrier</i>	Not Present	0	<i>Impoundments:</i> Woody Material Jams		
<i>RB: Riparian Buffer</i>	0-29 ft	0.25	<i>Substrate Composition:</i> Medium Sand		
<i>LB: Riparian Buffer</i>	0-29 ft	0.75	<i>Bank Material:</i> Clay		
<i>RB: Floodplain Access</i>	Partial	0.25

<i>LB: Floodplain Access</i>	None	0.75			
<b>River Threat Index:</b>		<b>6.5</b>
